# STRATHCONA POOL ASSESSMENT

OCTOBER 07, 2009

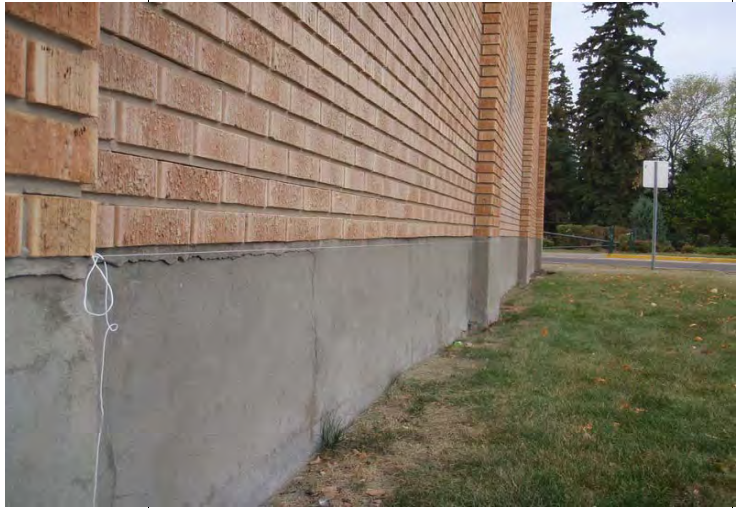
Photo No.	7
Reference	A1010-1
Comment	Differential movement within north elevation foundations. First and fourth columns from west end are displaced downward approximately 1 inch in relation to second and third columns.

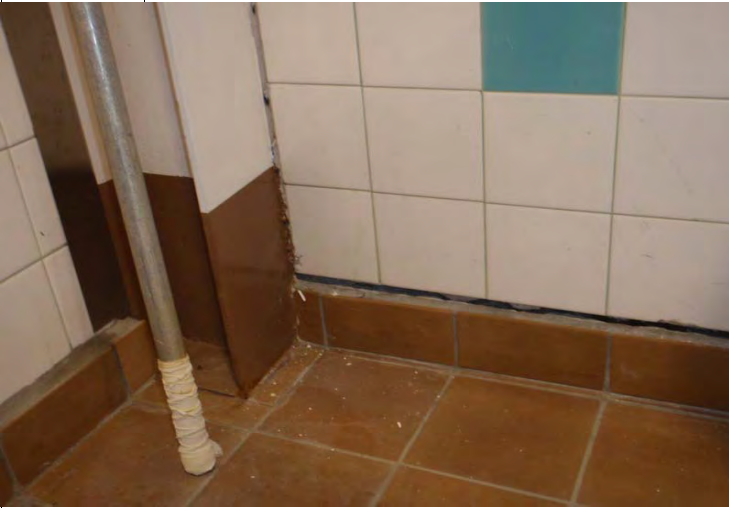
Photo No.	8
Reference	A1010-2
Comment	Approximate ¾ inch gap between floor tile return and tile finished wall above at northwest corner.

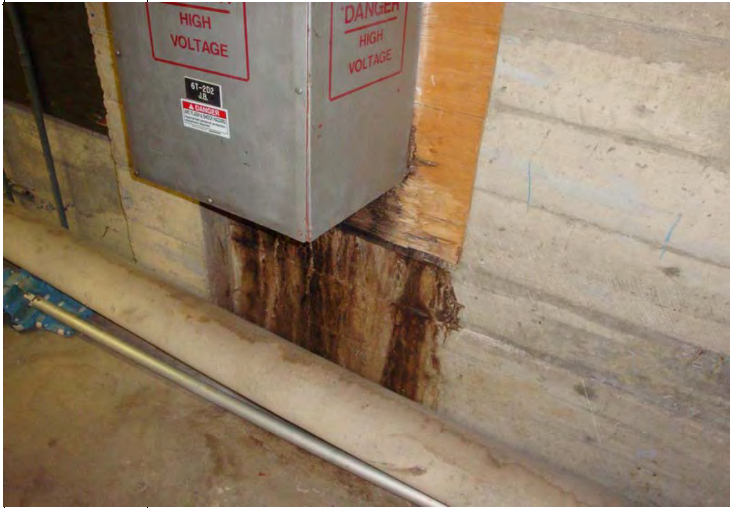
Photo No.	9
Reference	A2020-1
Comment	Water leakage through east basement wall of mechanical room.

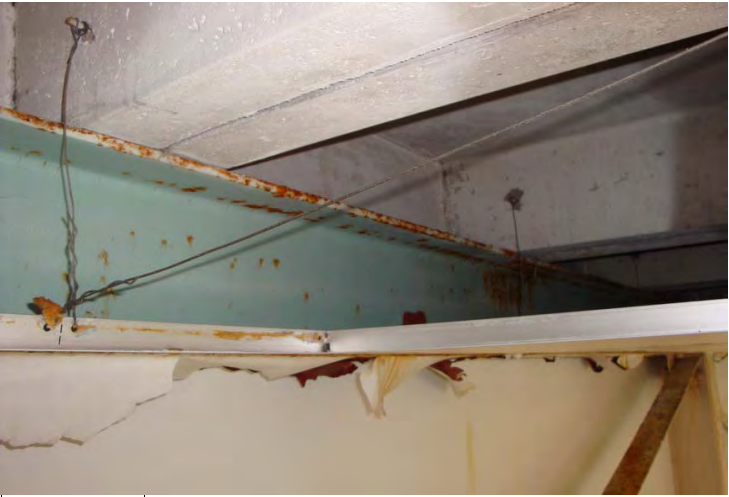
Photo No.	11
Reference	B1020.01-2
Comment	Peeling paint on structural steel due to condensation. No significant loss of steel section was observed.

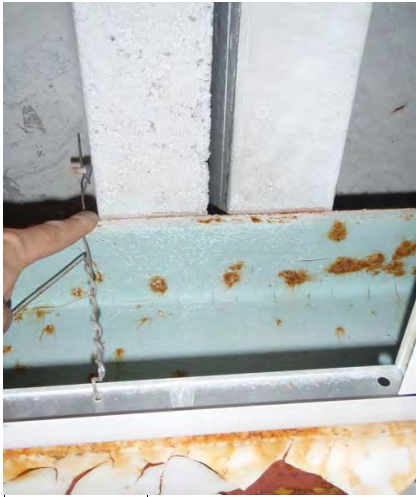
Photo No.	12
Reference	B1020.01-3
Comment	Precast concrete beams displaced approximately 5/32 inches off north elevation steel roof beam at northwest corner. This is not considered a large displacement.

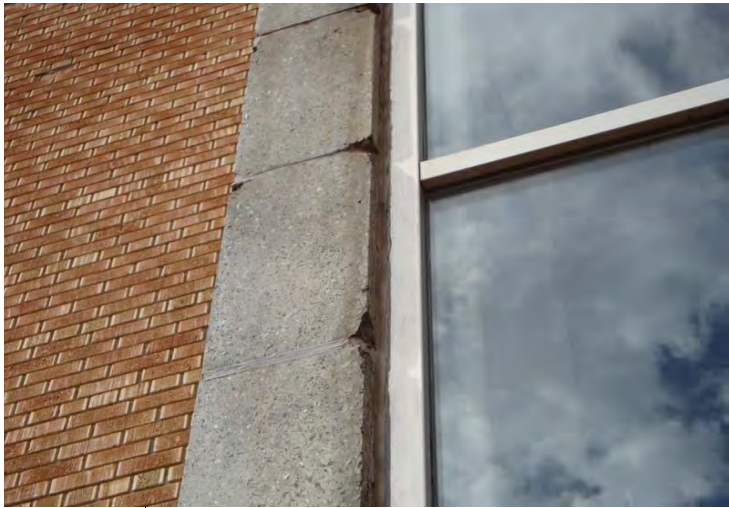
Photo No.	13
Reference	B2010.01.01-1
Comment	The precast terrazzo around the south curtainwall glazing has numerous chips and spalls and joints need repointing.

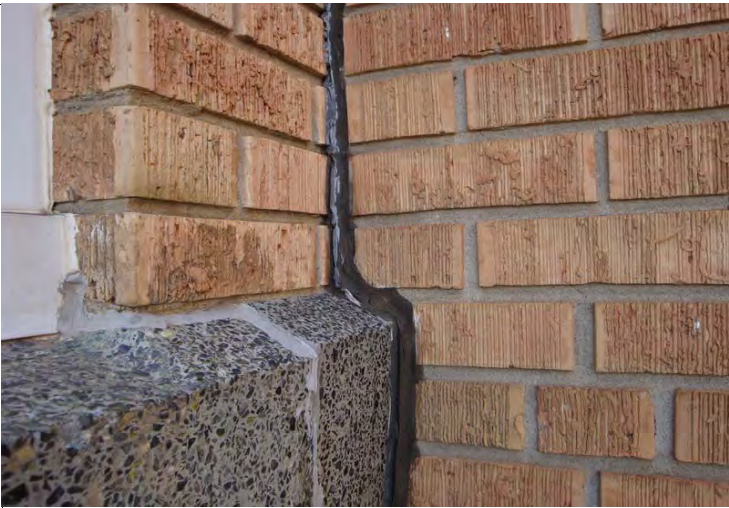
Photo No.	14
Reference	B2010.01.09-1
Comment	Movement joint in brick requires re-caulking.

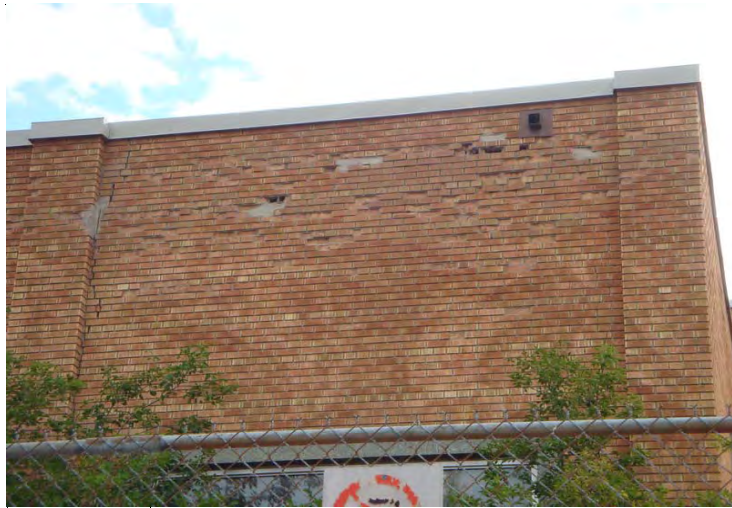
Photo No.	15
Reference	B2010.02.03-1
Comment	Typical freeze-thaw damage to brick on west elevation due to condensation within wall system.

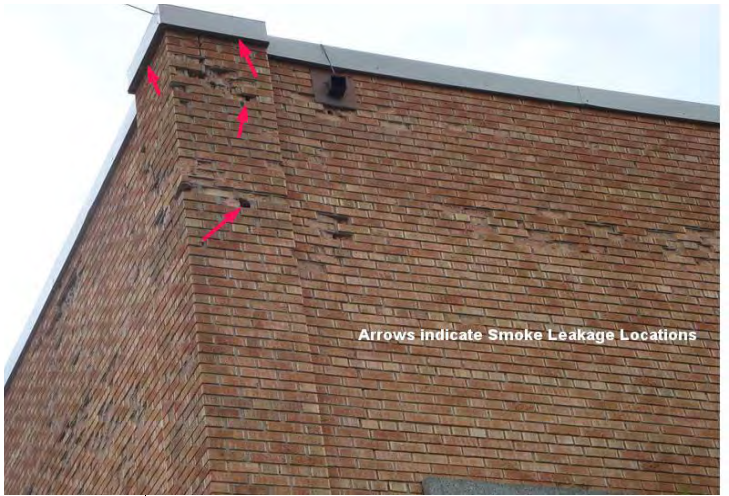
Photo No.	16
Reference	B2010.02.03-2
Comment	This corner of the wall is out of plumb 2½ to 3½ inches in each direction. Note deterioration of brick. Arrows indicate location of smoke exfiltration during air leakage testing.

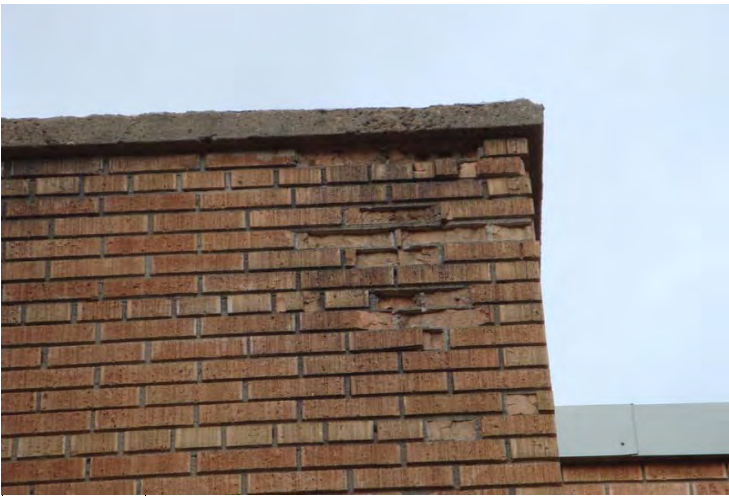
Photo No.	17
Reference	B2010.02.03-3
Comment	Typical damage to brick at parapet level.

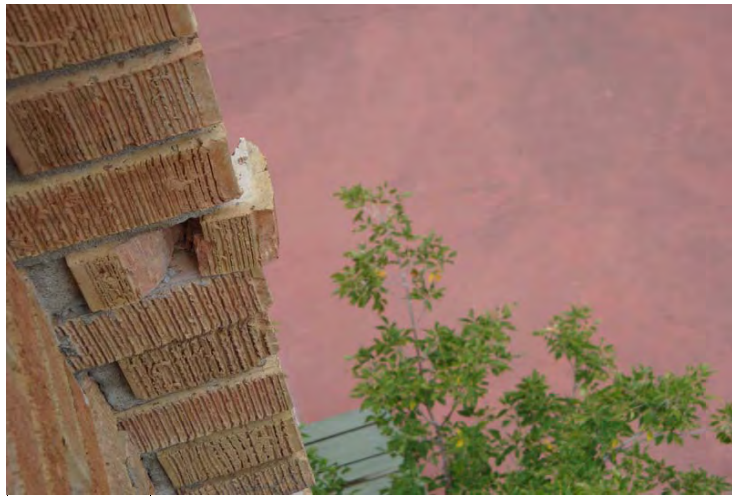
Photo No.	18
Reference	B2010.02.03-4
Comment	Brick fragment ready to fall.

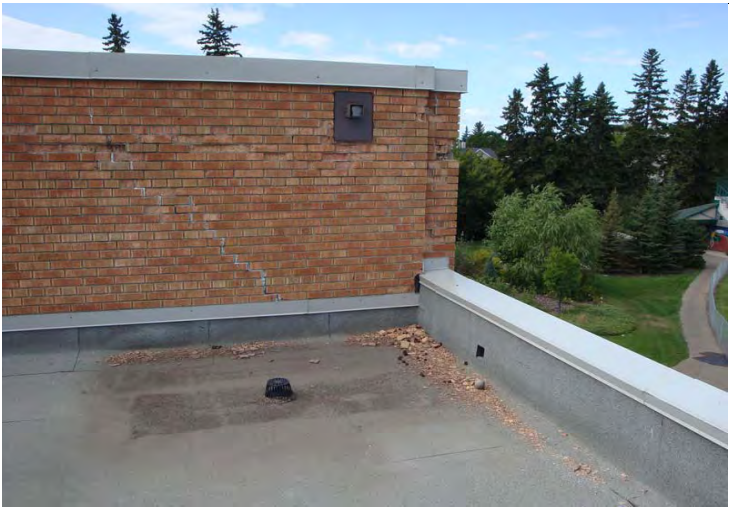
Photo No.	20
Reference	B2010.02.03-6
Comment	Typical freeze-thaw damage to brick on east elevation. Note accumulation of fragments on the roof.

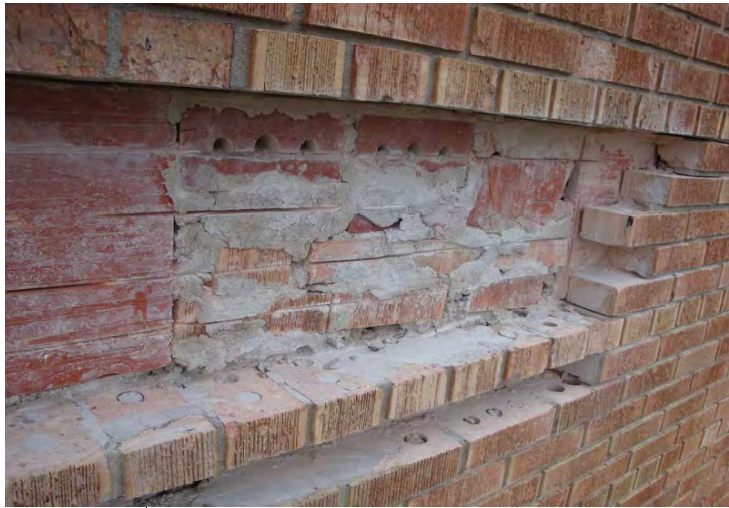
Photo No.	21
Reference	B2010.02.03-7
Comment	Test opening in exterior wall on north elevation. The opening showed that there were two wythes of hollow clay tile behind the brick. The outer clay tile showed signs of freeze-thaw damage.

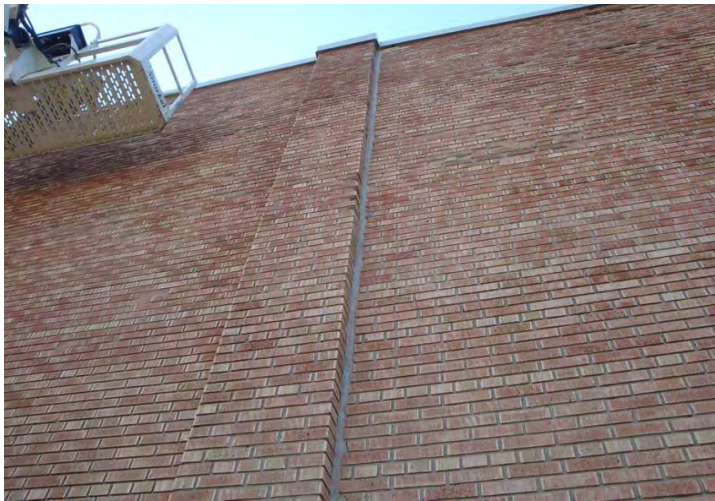
Photo No.	22
Reference	B2010.02.03-8
Comment	There is a 2½ inch wide vertical crack in the masonry along the second column on the north elevation. It is likely related to foundation movements. The crack was recently caulked.

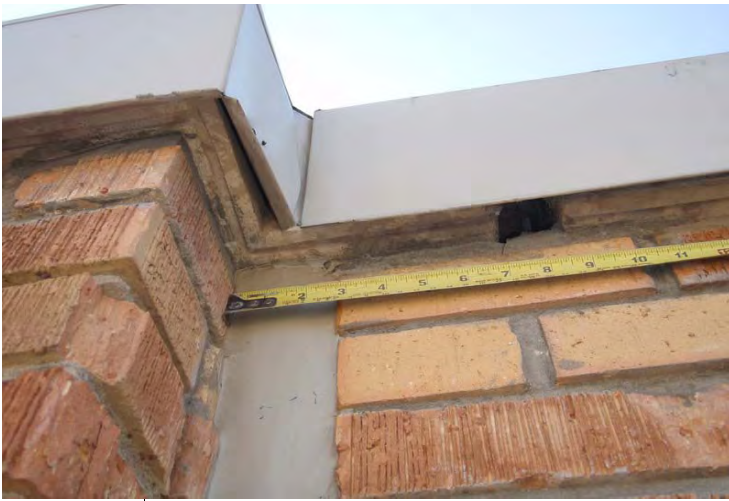
Photo No.	23
Reference	B2010.02.03-9
Comment	Close-up of crack at second column on the north elevation, also showing gap that opened up between coping stone units and deformed metal parapet flashing. Note crack is caulked.

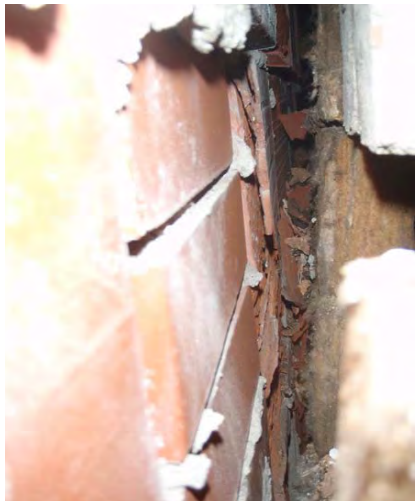
Photo No.	24
Reference	B2010.02.03-10
Comment	Spalling of interior face of inner clay tile at northwest corner. This is a view into cavity.

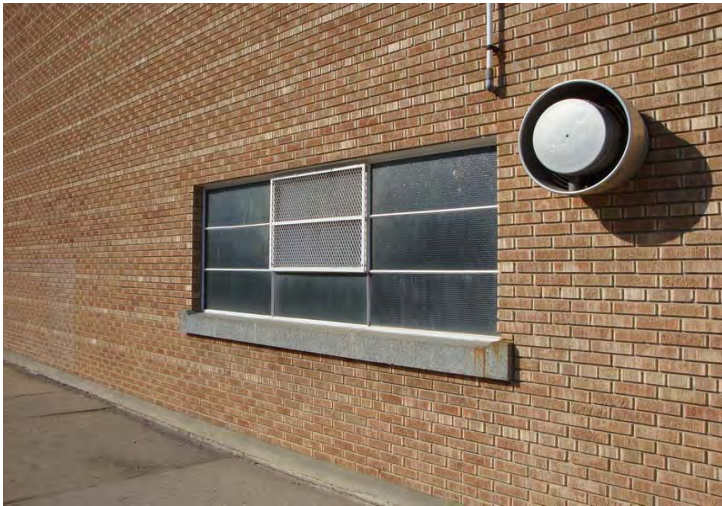
29

This window in the mechanical room is cracked and has poor thermal resistance.

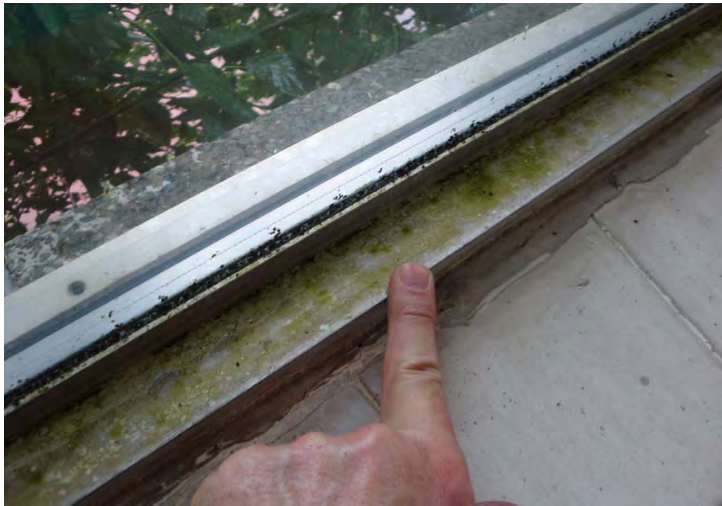
30

There has been so much condensation on this pool window sill that algae has started to grow on it. We also saw black spots that are suggestive of mold in some locations. The window framing system is not

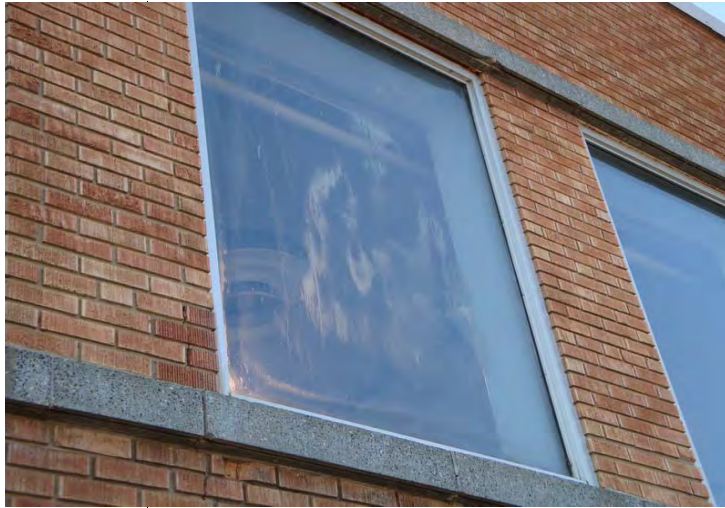
Photo No.	31
Reference	B2020.01.01.02-2
Comment	This sealed unit in the pool has fogged. There have been numerous sealed unit replacements over the years as indicated by the various dates on spacer bars.

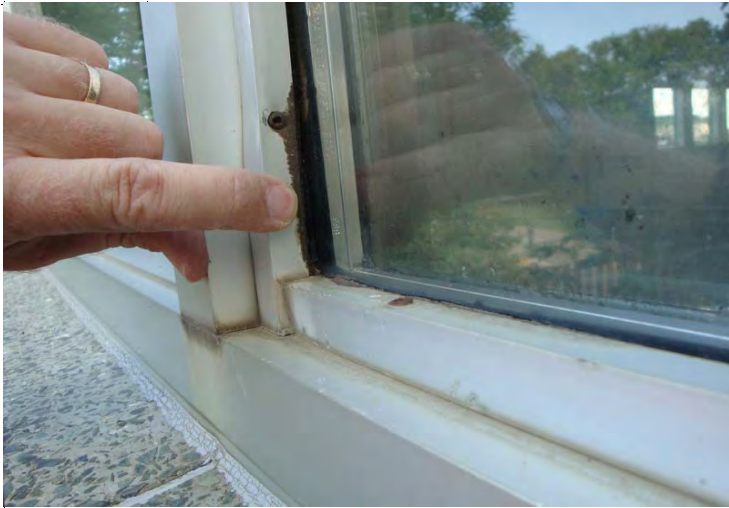
Photo No.	32
Reference	B2020.01.01.02-3
Comment	The glazing seals on the pool windows are deteriorating.

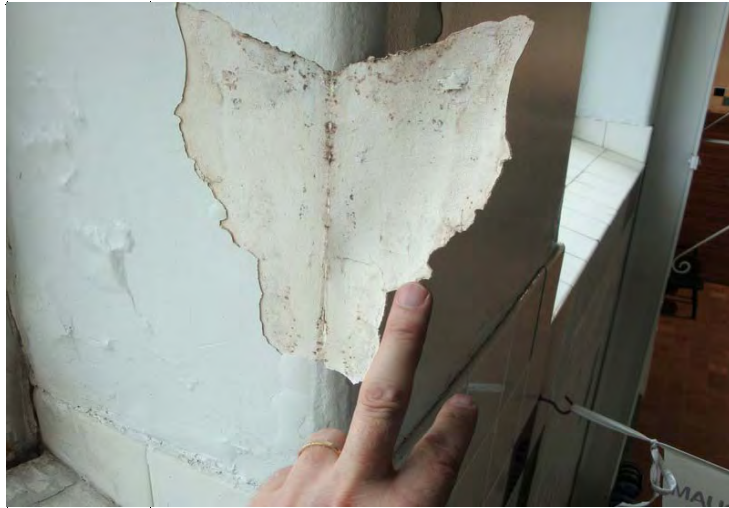
Photo No.	33
Reference	B2020.01.01.02-4
Comment	Condensation around the windows has caused extensive blistering and peeling paint. The dark spots are suggestive of mold.

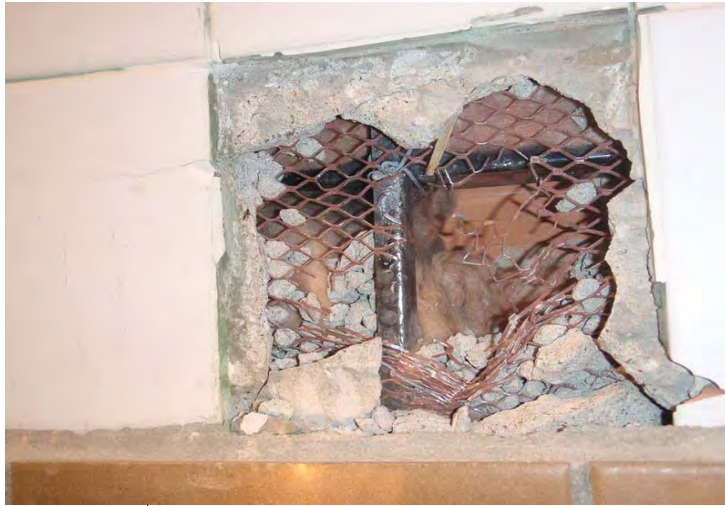
Photo No.	34
Reference	B2020.01.01.02-5
Comment	Typical opening in tile on interior of north wall. There was no significant deterioration inside the opening. Note dirt in insulation is suggestive of air leakage.

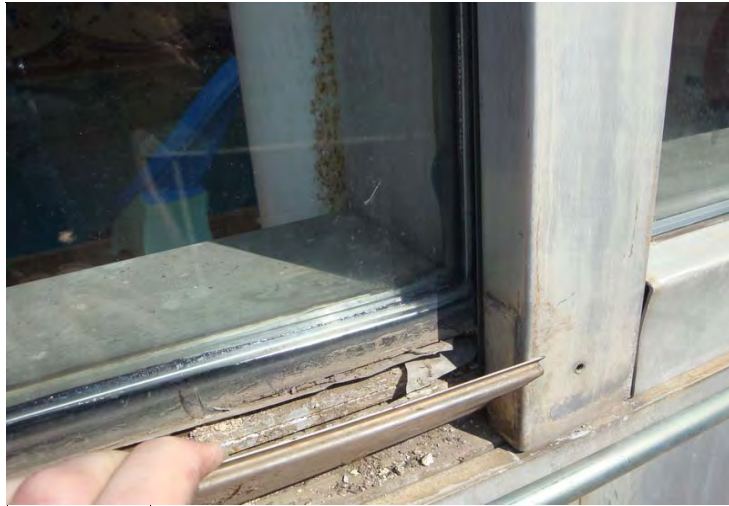
Photo No.	36
Reference	B2020.03-2
Comment	The curtain wall is a very early version and is not thermally broken and does not have exterior gaskets.

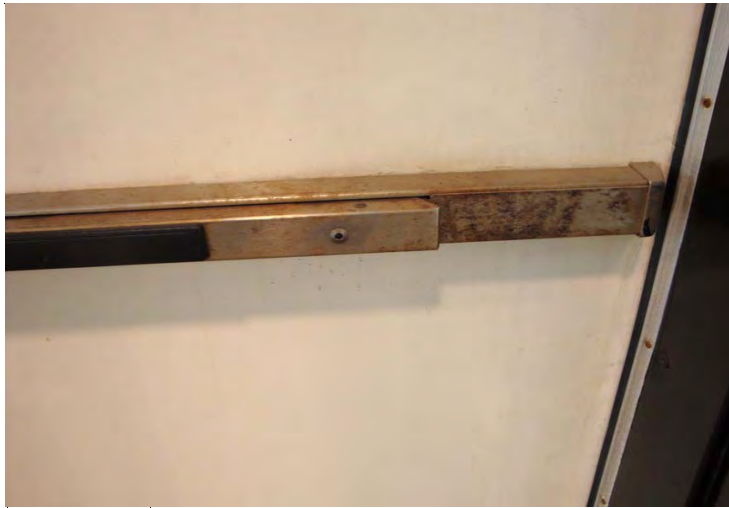
Photo No.	37
Reference	B2030.02-1
Comment	The hardware on the west exit door is rusting.

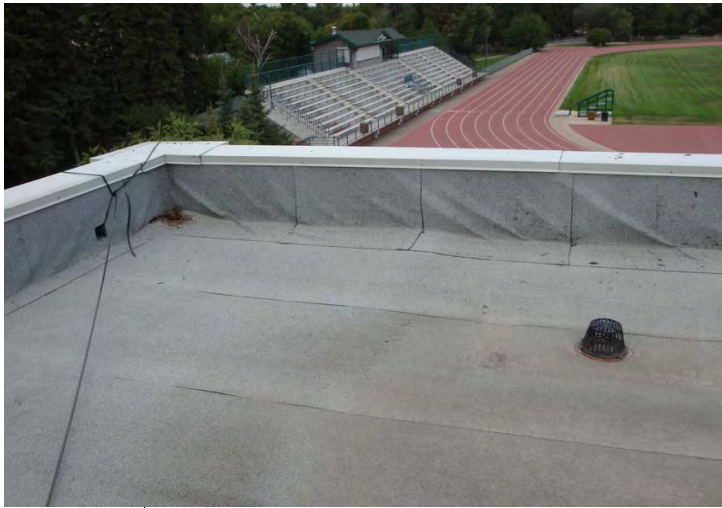
Photo No.	39
Reference	B3010.04.04-2
Comment	There are wrinkles in the parapet stripping in a number of locations. This wrinkling could be caused by movement of the parapets due to differential settlement of footings.

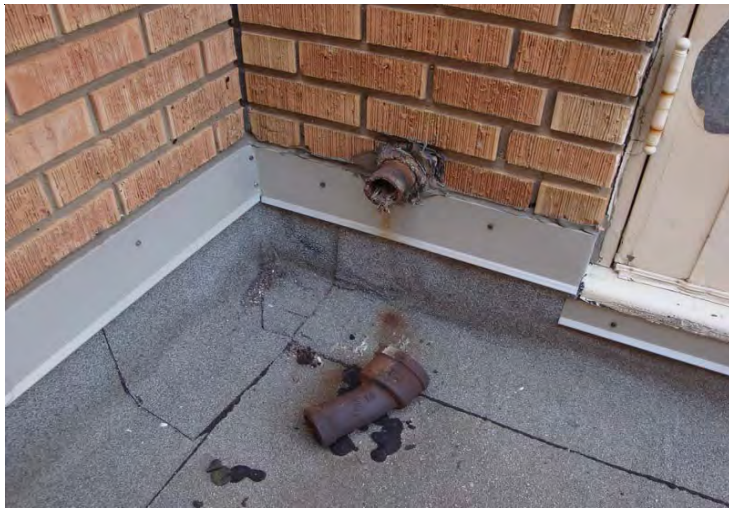
Photo No.	40
Reference	B3010.04.04-3
Comment	This is a drain from R4 on to R5. The drain is only 2 inches diameter.

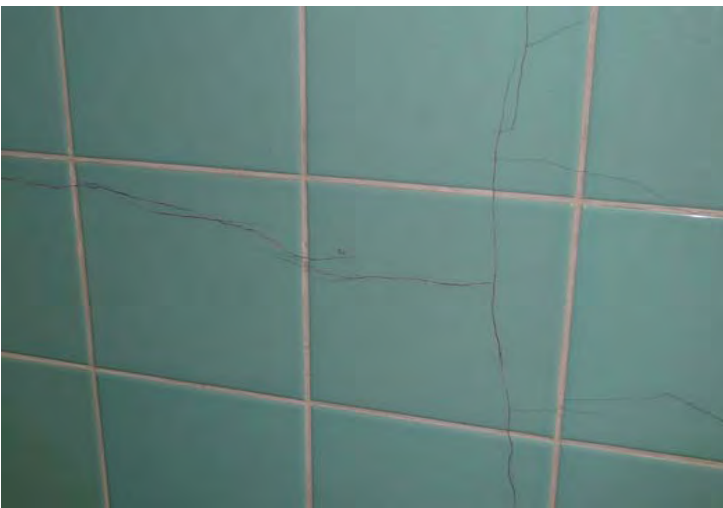
Photo No.	48
Reference	C3010.06-2
Comment	Original ceramic tile is old but with only a few hairline cracks in 2-3 locations.

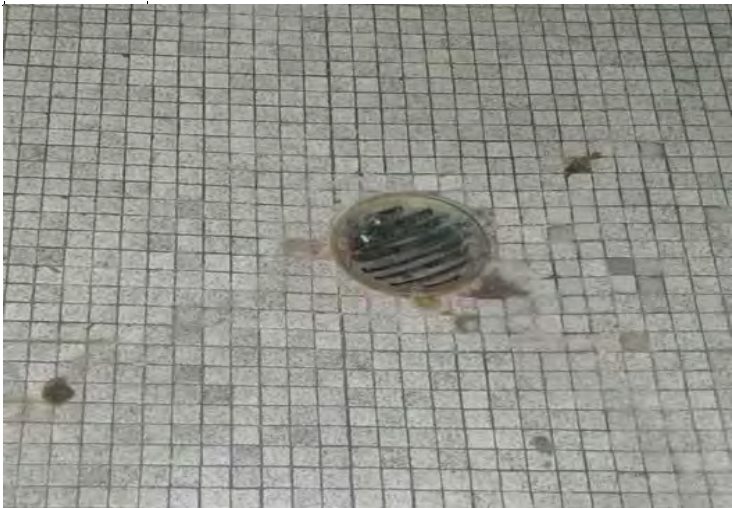
Photo No.	49
Reference	C3020.02
Comment	1975 Ceramic mosaic tile is in marginal condition but would be replaced as part of code upgrade under K4020.08

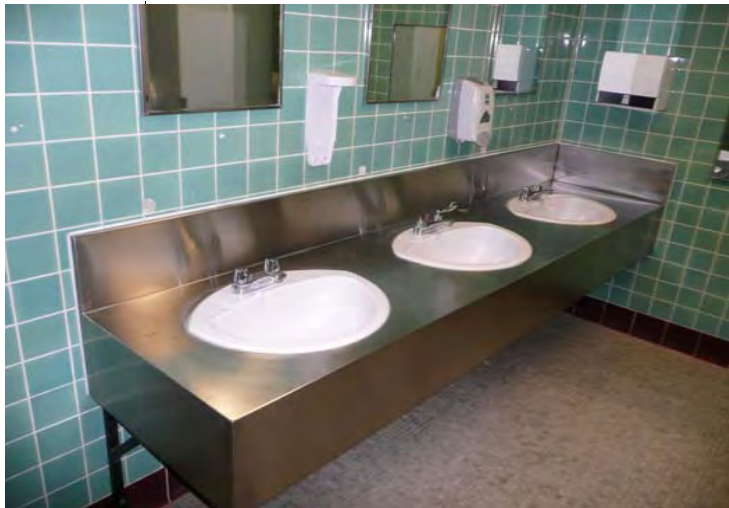
Photo No.	50
Reference	E2010.02
Comment	Stainless steel clad casework in good condition but does not comply to current BFA standards.

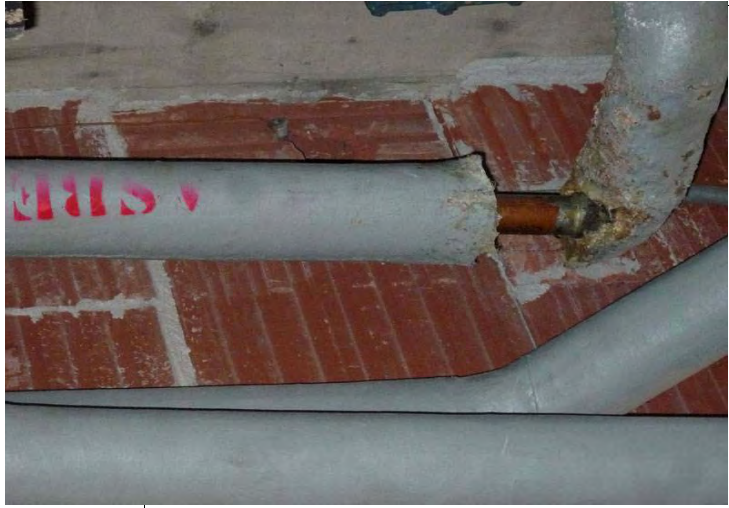
Photo No.	51
Reference	F2020.01
Comment	Asbestos insulated pipe elbows and straight run chases.

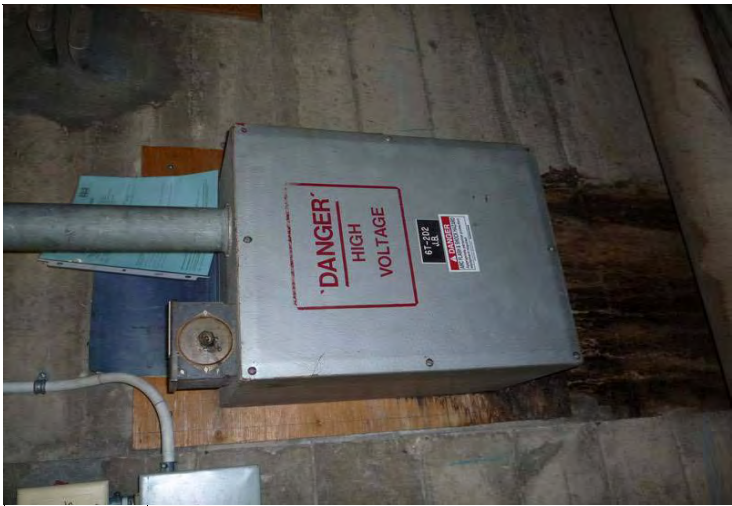
Photo No.	52
Reference	F2020.02-1
Comment	High voltage transformer 6T-2D2 leaking PCBs.

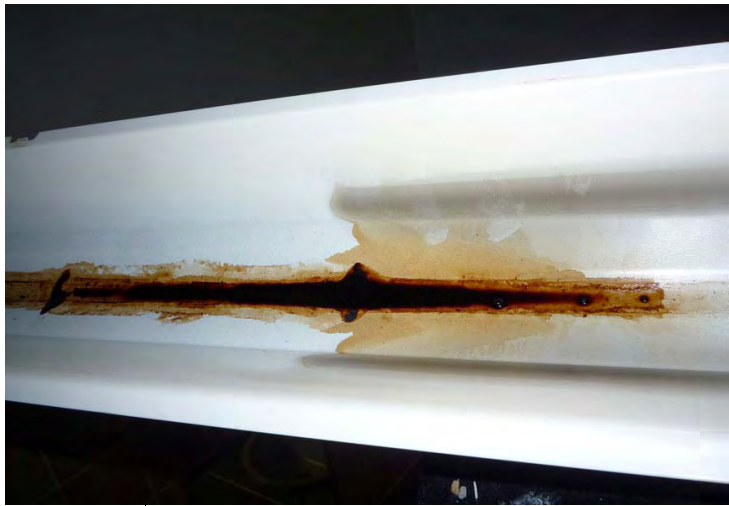
Photo No.	53
Reference	F2020.02-2
Comment	PCB leakage in light fixture. Ballast was already replaced.

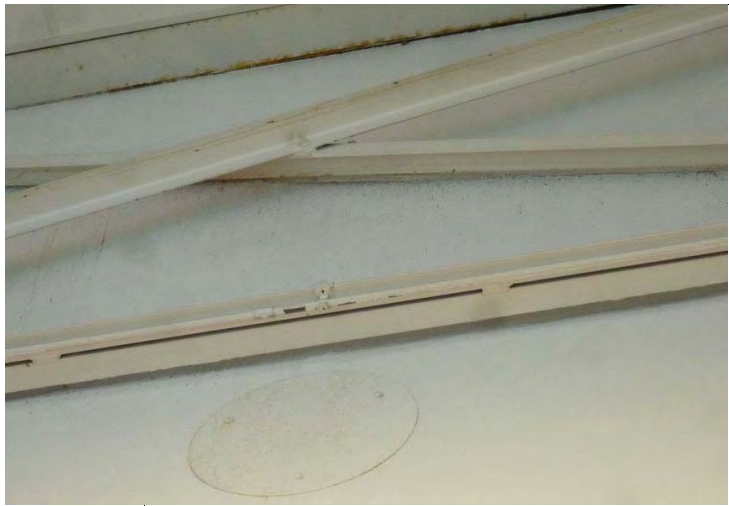
Photo No.	54
Reference	F2020.04
Comment	Mould found on plaster wall.

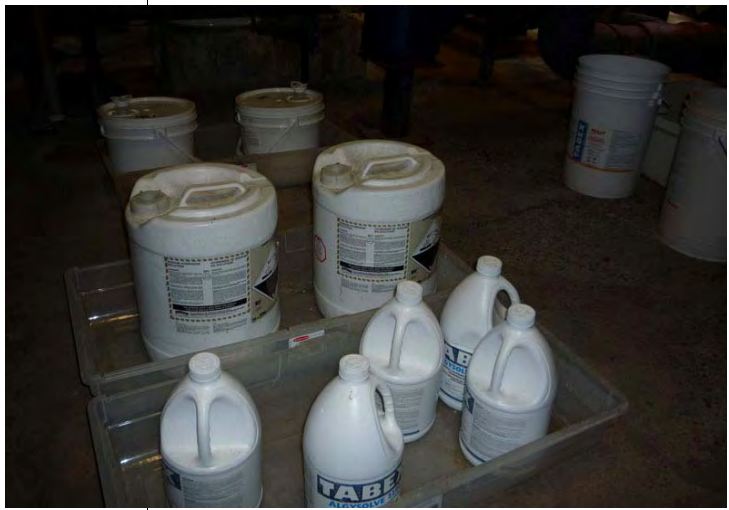
Photo No.	57
Reference	F2020.09-3
Comment	Hazardous chemicals stored in plastic tubs.

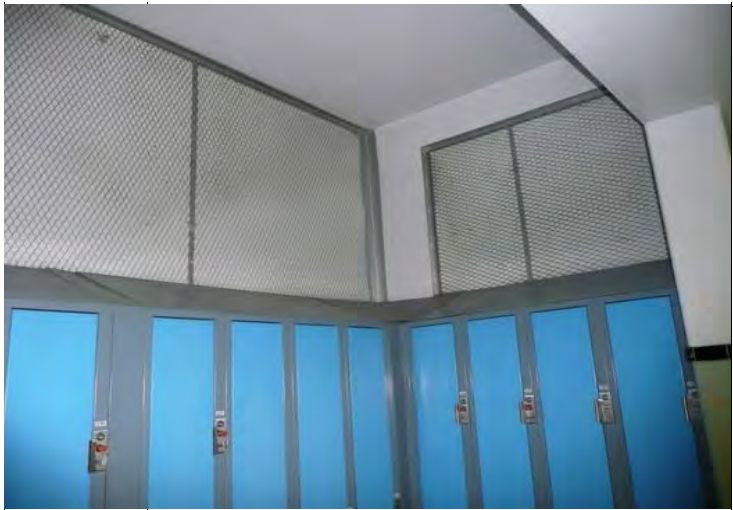
Photo No.	58
Reference	K4020.02
Comment	Wire mesh poartition with plywood backing used to separate change rooms from adjacent school locker rooms does not comply to code. Partition should be a fire separation.

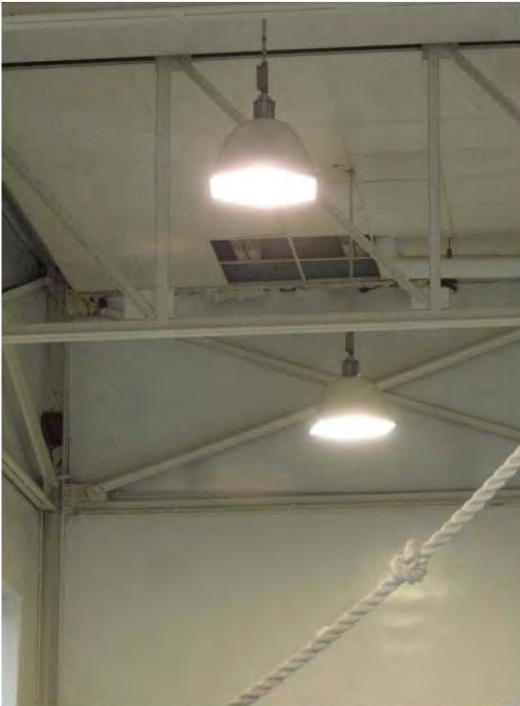
Figure 2: PCB leakage in light fixture. Ballast was already replaced

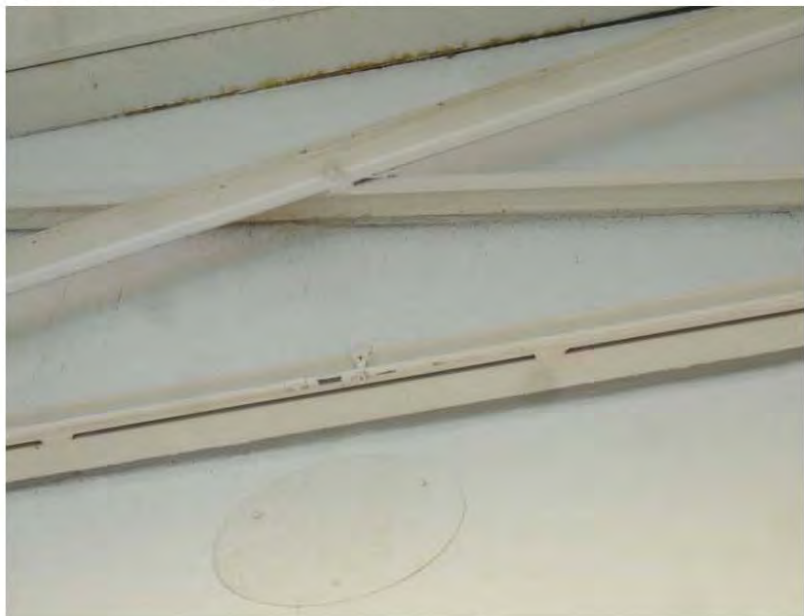
Figure 9: Marked asbestos insulation around duct

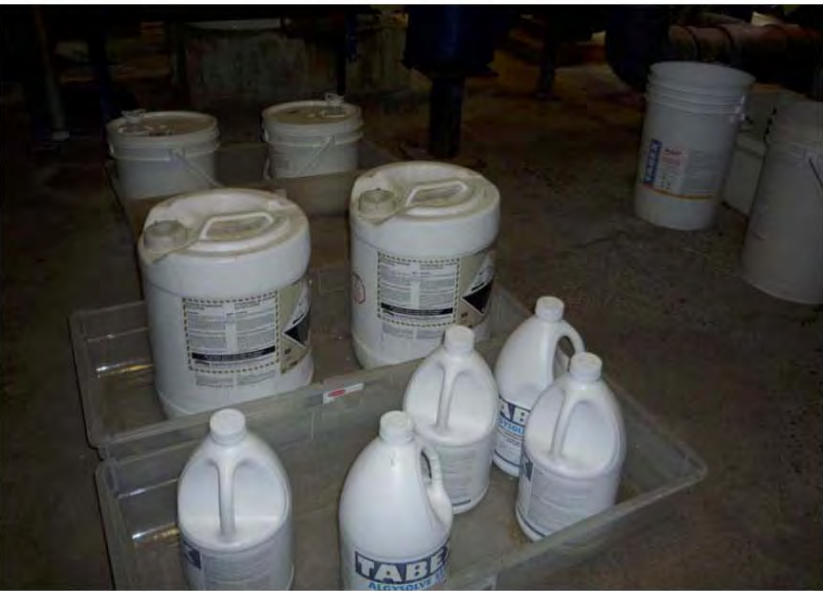
Figure 14: Hazardous chemicals stored in plastic tubs
