## EXISTING SITE REVIEW

Based on several site visits and interviews with site stakeholders in the fall of 2006 and in the spring and summer of 2007, this section summarizes information about the current conditions at the site.

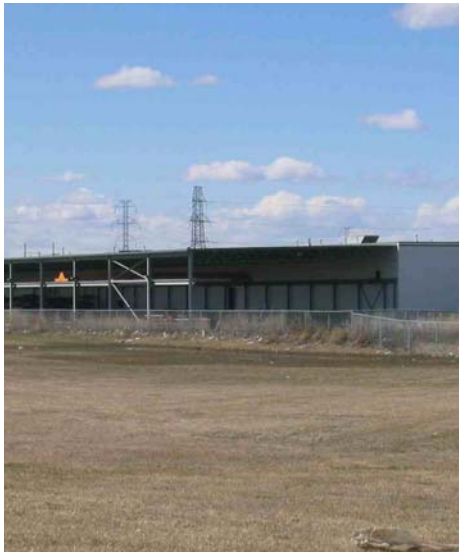
There are several low areas within and adjacent to the site that do not drain properly. Specific problem areas include: the east end of Billy D's Driving Range, the sand volleyball court area, and the northwest corner of the rugby field area. The photo to the left shows the

low area northwest of the rugby fields which is frequently wet and in major rain events will drain onto the adjacent industrial property; drainage also flows towards this same property from the south. The west portion of the park drains towards a property to the northwest, however, in 2006 a drainage swale and catch basin were constructed to intercept the run-off prior to leaving the site.

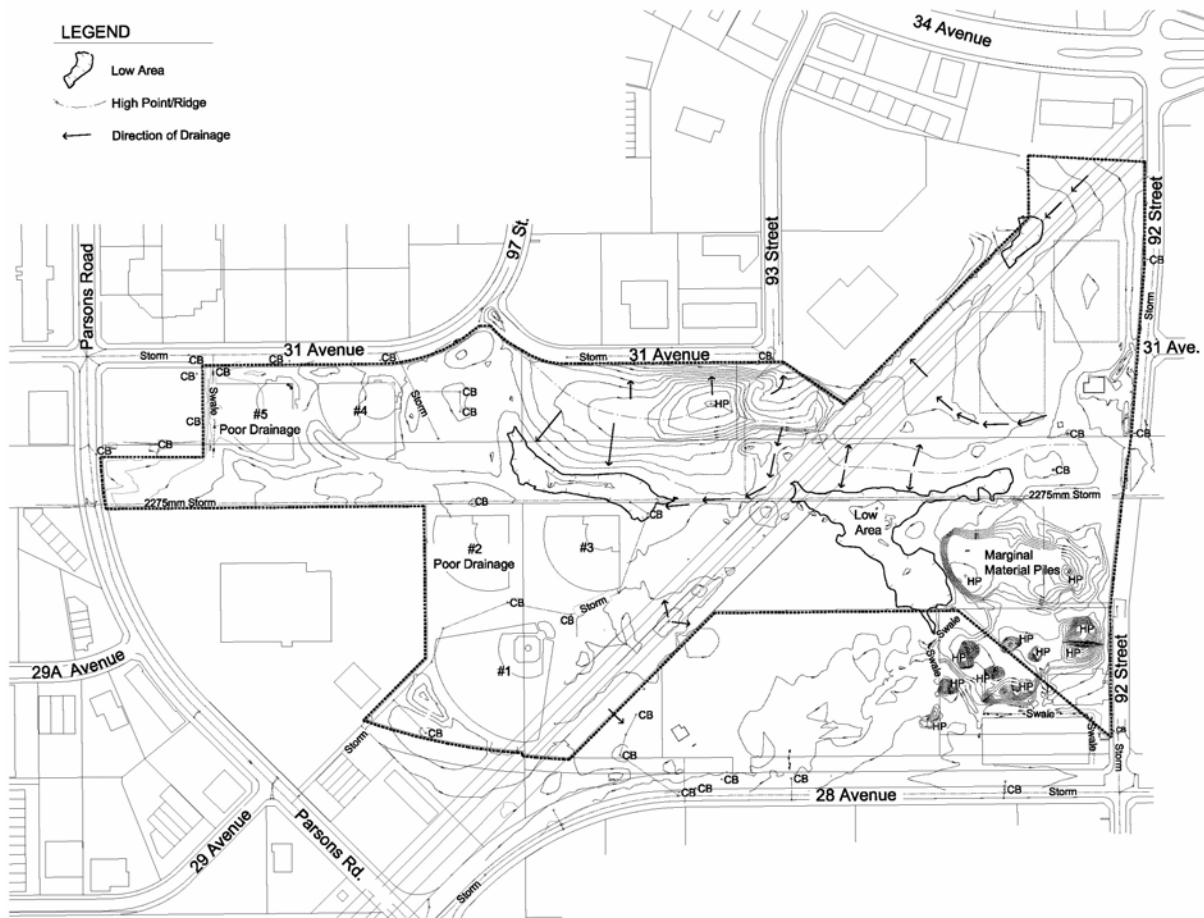
Figure 4 - Grading and Drainage Issues

The entire site was not graded to base level standard when it was developed. Several site grading and drainage issues were identified in the Concept Plan and reviewed in more detail during this study. These issues are shown on figure 4 and described below.

Sport fields in the park were constructed at different times and to different standards. Three of the ball diamonds drain well and are usable shortly after rain storms; the other two diamonds do not drain well and remain wet for some time after a rain. The rugby fields also do not drain well, and have some water ponding issues after rain storms.

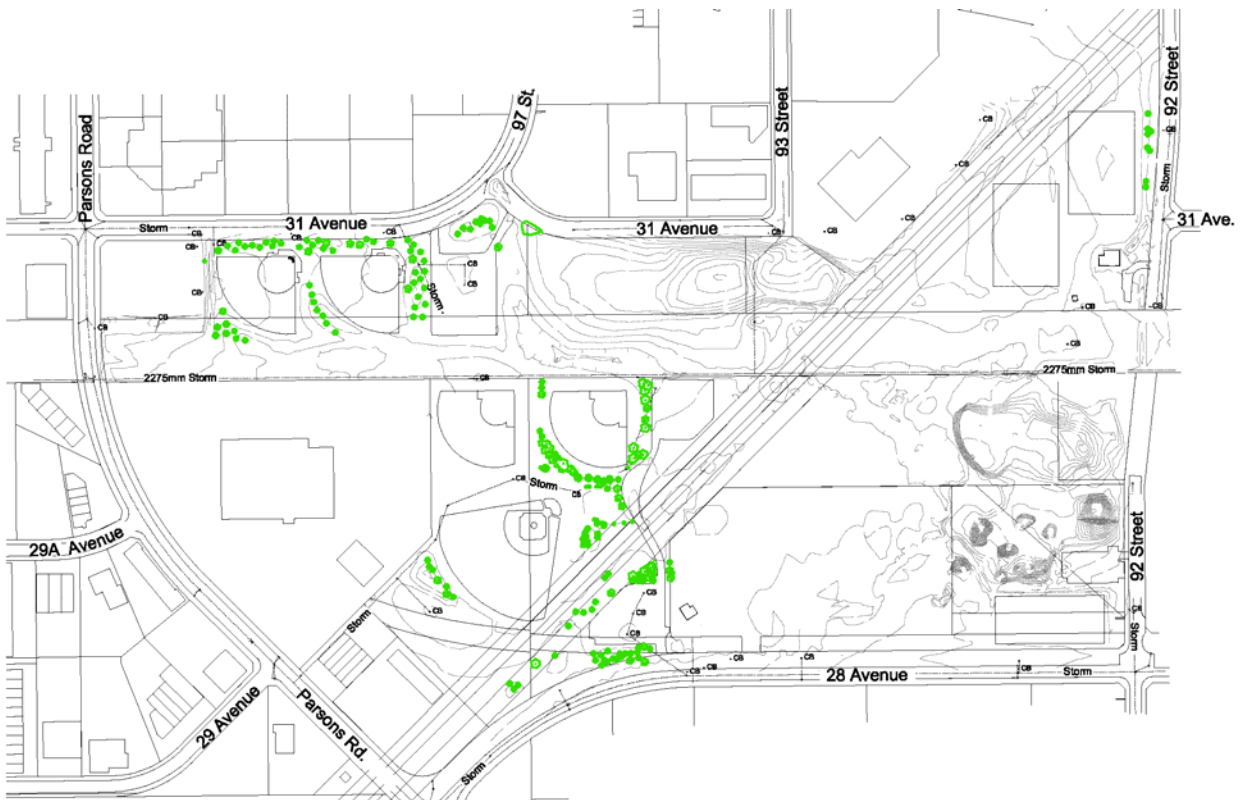
Figure 6 - Existing Site Planting

Landscaping of the site was completed with the original ball diamond development and there are many mature trees in the west half of the site and surrounding the ball diamonds. More recent development of the site, however, has not included a landscape component and overall, the site is deficient in landscaping. Currently there are approximately 155 trees on site. The City of Edmonton parks standard planting rate for park development is 70 trees per plantable hectare. With this standard, the total tree requirement

would be 877 trees, implying a shortage of 722 trees. Landscape enhancements are a key component of the upgrading proposals for the park.

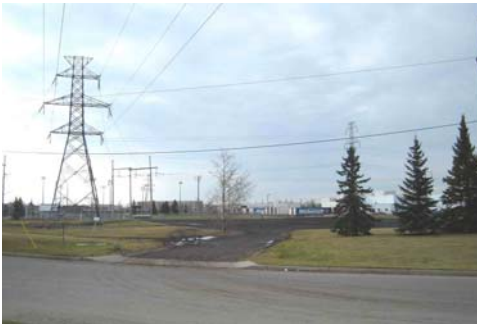
There are currently three vehicular access points into the site. Users of the northwest diamonds enter the site from 31 Avenue between 93 Street and Parsons Road and use an undefined, gravel parking area (photo to left).

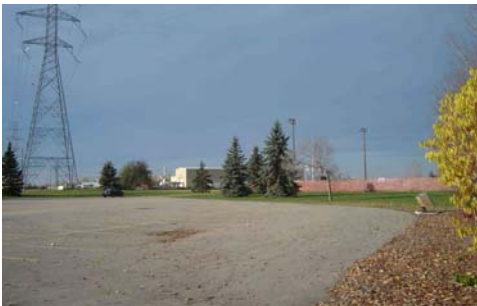
Users of the three southern diamonds enter the site from 28 Avenue, using the access road adjacent to Billy D's Driving Range. A paved parking lot is currently accessed from this entrance and serves the southern ball diamonds (photo to left). This lot has had painted lines, but they are somewhat faded and not fully effective. This connection must be removed prior to development of the Transportation maintenance site.

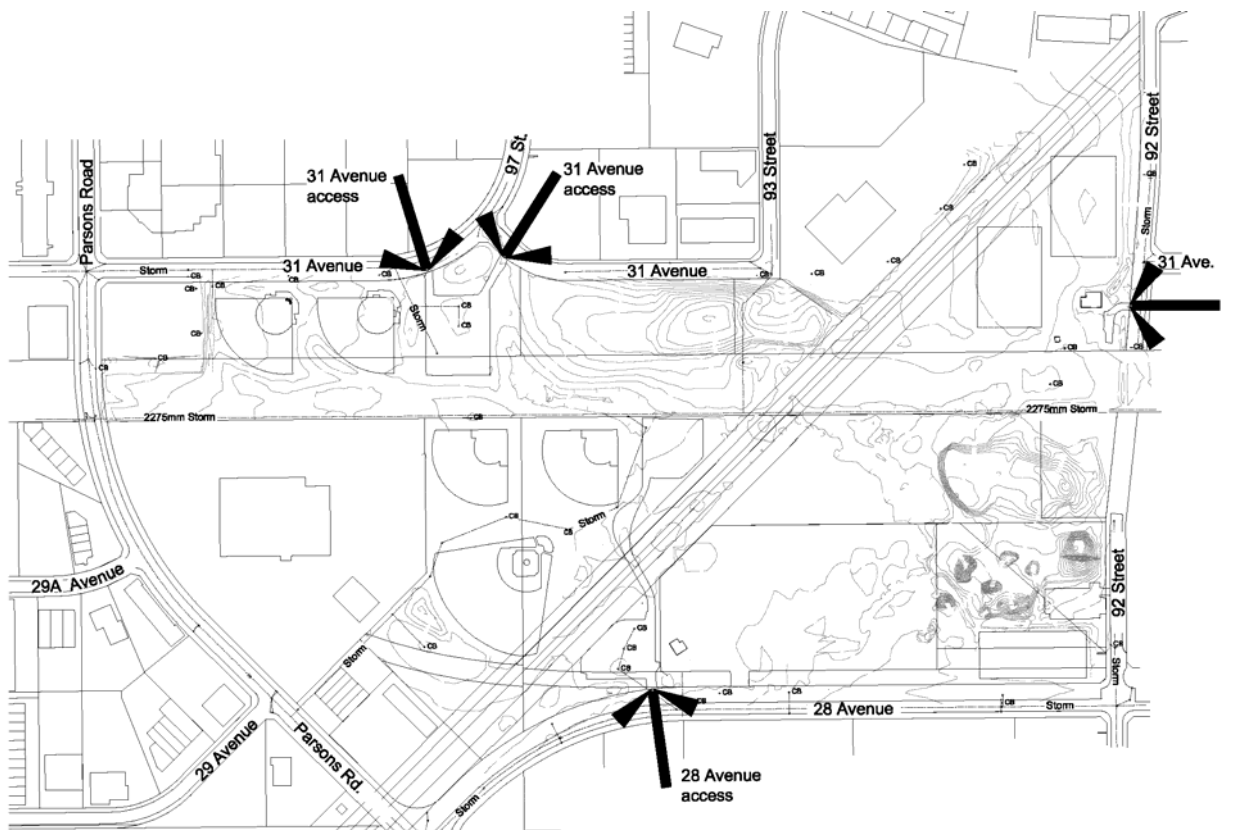
Figure 7 - Existing Site Access

In the past, movable concrete curbs restricted vehicles to the parking areas and designated roads; these have been recently removed and unauthorized traffic throughout the park has become an issue. People often drive between the north and south parking lots across the grass, and drive onto the Altalink ROW, accessing it from both the north parking lot and from the rugby parking lot. The Master Plan provides recommendations to improve efficiency and to provide control for unauthorized vehicular traffic on site.
