Scona Road – Traffic Safety and Speed Mitigation Strategies

*This presentation summarizes the results
of two independent traffic safety assessments*

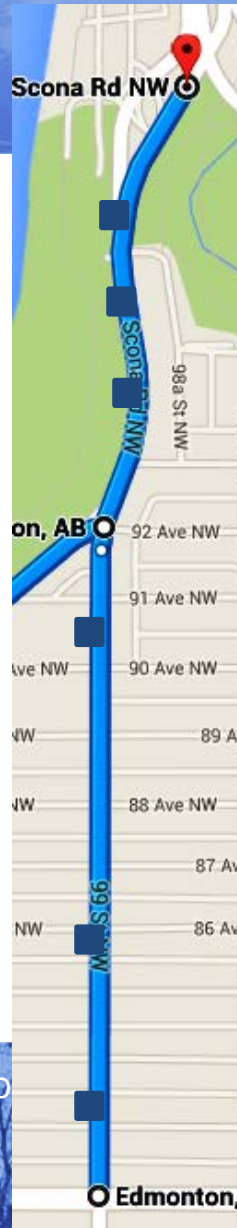
Average Speed Profile

Speed Profile
Consistent
~60 km/h

Speed Profile
Consistent
~50 km/h

Speed Profile
Consistent
~55 km/h

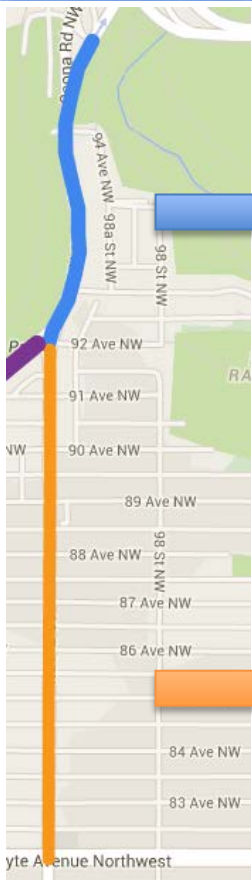
Collision Profile

Scona Road

After reconstruction

- No change in intersection collisions
- Collisions at midblock sections decreased in the after period

99 Street

- Collisions increased at intersections closest to Scona Road
- Collisions at midblock sections decreased in the after period
