July 24, 2019

City of Edmonton
11004 – 190 Street NW
Edmonton, AB T5S 0G9

ISSUED FOR USE
FILE: ENG.EMAT03618-01
Email: Wanda.Goulden@edmonton.ca

Subject: Concrete Sidewalk & Curb Brine Impact Study
Edmonton, AB

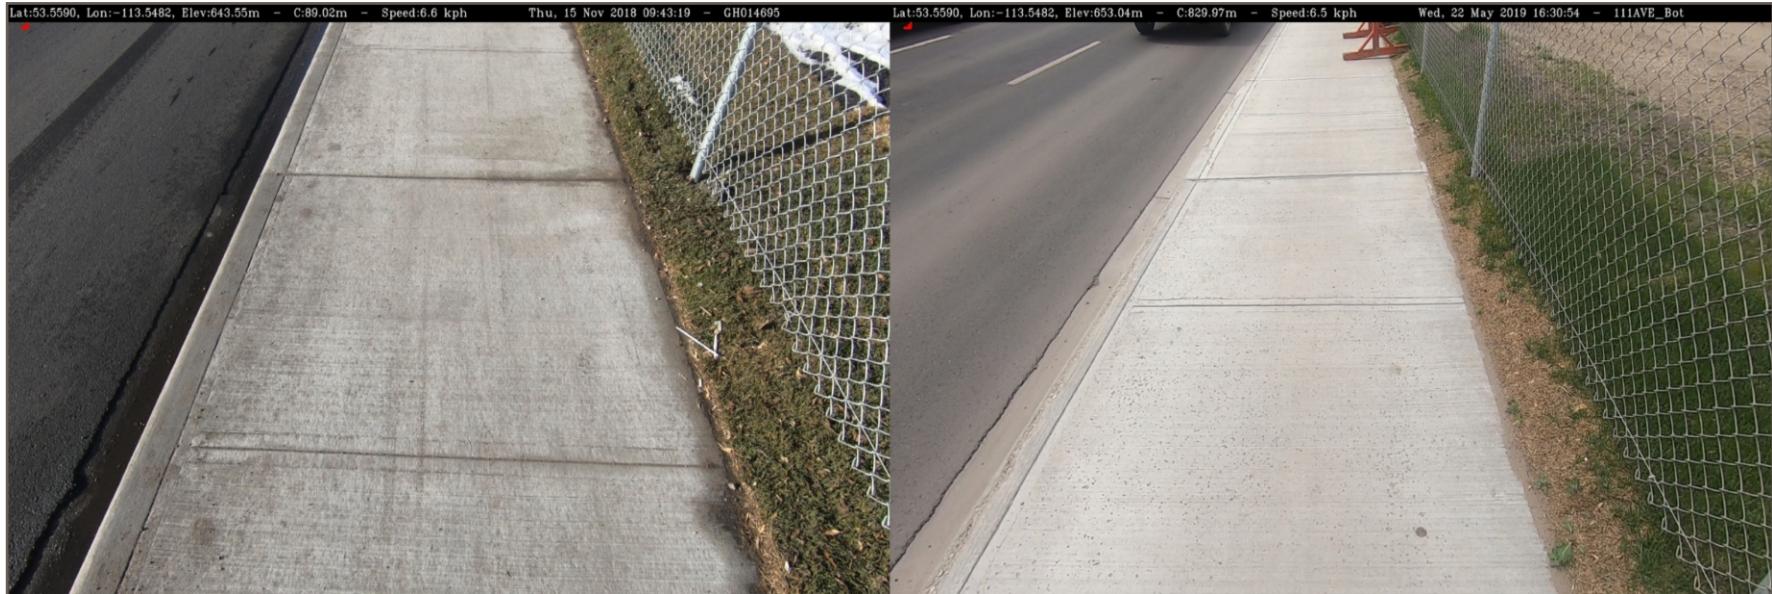
The concrete sidewalks and curbs on the south side of 111 Avenue generally appeared in good condition; however, some mortar flaking was observed at some locations on the north side of the roadway. Mortar flaking is the loss of surface mortar over a sound coarse aggregate particle. Mortar flaking is generally attributed to surface drying caused when the coarse aggregate prevents bleedwater from moving to the surface and balancing evaporation. Mortar flaking from the curb to about 1 m back could be observed in about 20 panels (Photos 1 and 2). It appears that the defect may have been exposure related as this concrete would have been subjected to more freeze thaw cycles than the south side of the road. It is also possible that the snow clearing may have been different along the curb. Two panels also exhibited spalled concrete (Photo 3). This issue seems isolated to only this portion of the sidewalk.

Photo 1: 111 Avenue. 2018 photo on left, 2019 photo on right. 2018 photo indicating little surface damage while in 2019 some mortar flaking is visible within ~1 m of the curb.

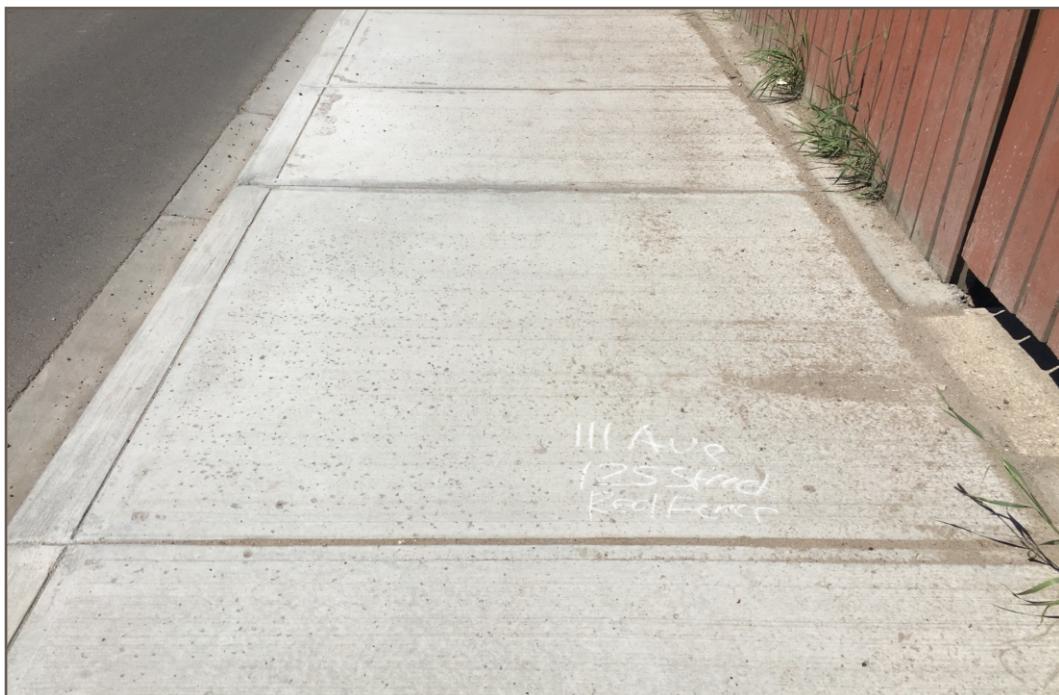
Photo 2: 111 Avenue and 125 Street. Photo obtained in spring of 2019. Concrete with mortar flaking on surface.

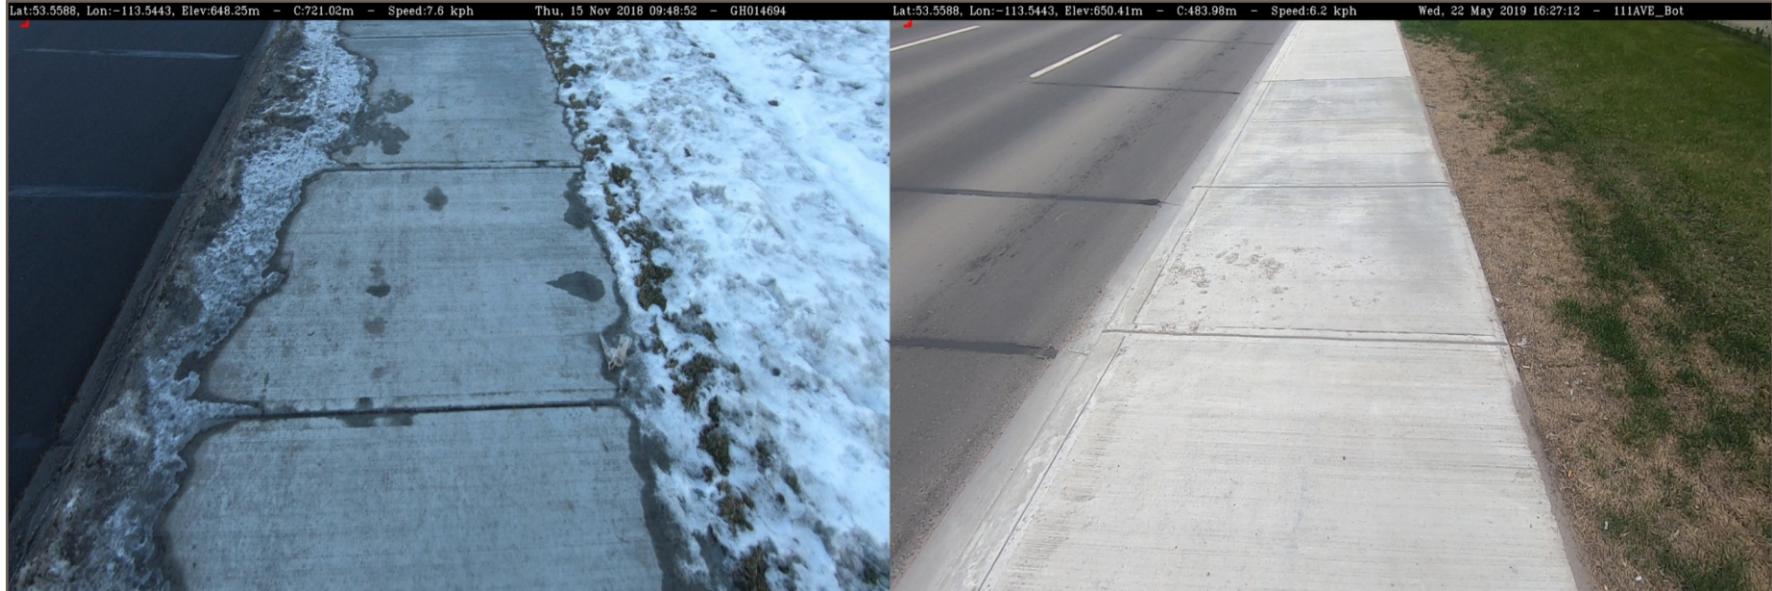
Photo 3: 111 Avenue. 2018 photo on left, 2019 photo on right. Spalling of concrete observed in 2019 image on right. Significant damage observed only on a single panel.

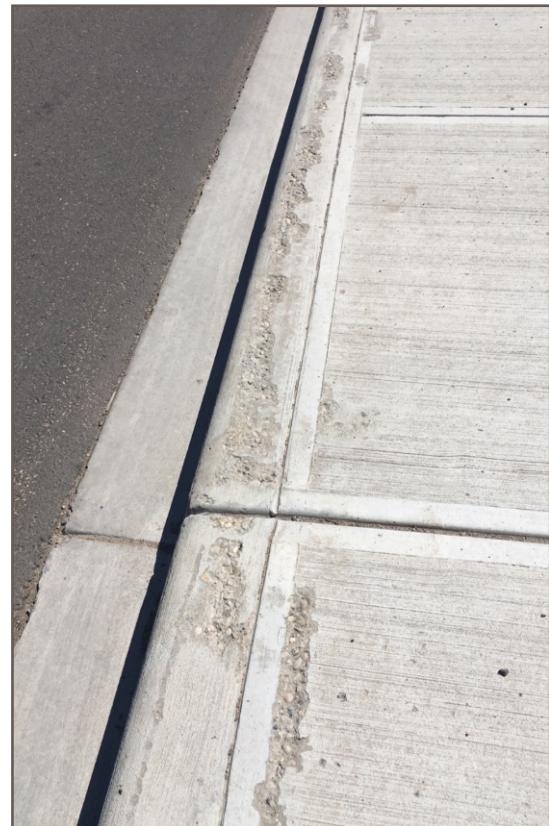
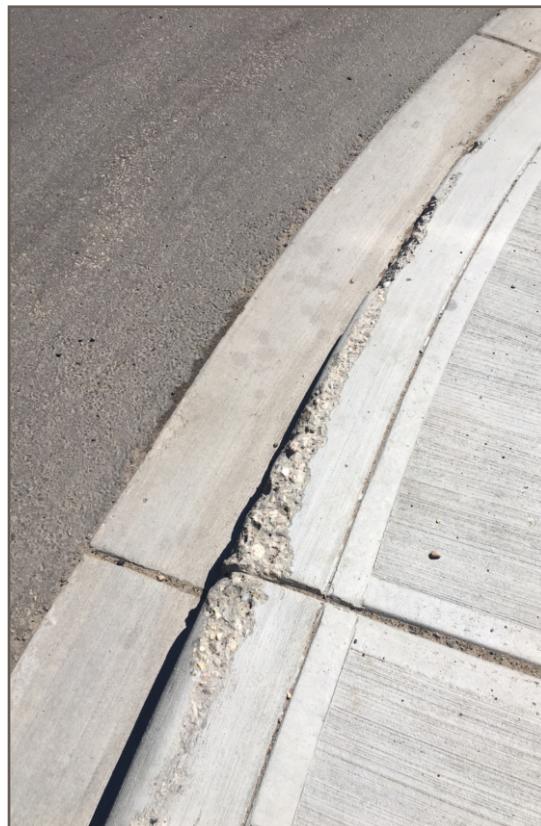
Significant concrete damage was observed on the curbs and sidewalks (Photos 4 to 7). The damage appears to be caused by snow clearing equipment. It appears that snow plows would place the edge of the blade to the edge/face of curb. It also appears that skid steers loaders (or equivalent equipment) may have been used to clear snow from the sidewalks. As this is completed, some of the concrete surface may have been removed. Once the concrete surface mortar is removed, the exposed interior is more prone to be damaged leading to a decrease in service life.

The primary issue observed on the concrete infrastructure was damage from the snow removal equipment on 111 Avenue and the Uplands. The areas of significant damage at 111 Avenue due to snow removal are now somewhat more susceptible to freeze-thaw attack exacerbated by anti-icing and de-icing chemicals and deterioration in general. Some snow removal scraping was observed at the Uplands; however, the damage is not expected to reduce the service life.

Photo 4: 111 Avenue. Photo obtained in 2019. Surface damage on surface of curb and sidewalk likely caused during snow removal.

Photo 5: 111 Avenue. Photos obtained in 2019. Significant amount of damage to curb constructed in 2018.

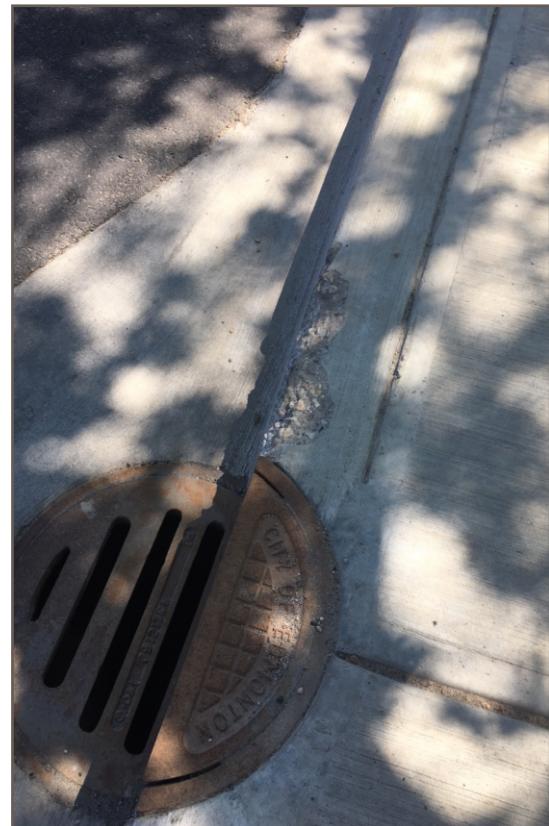
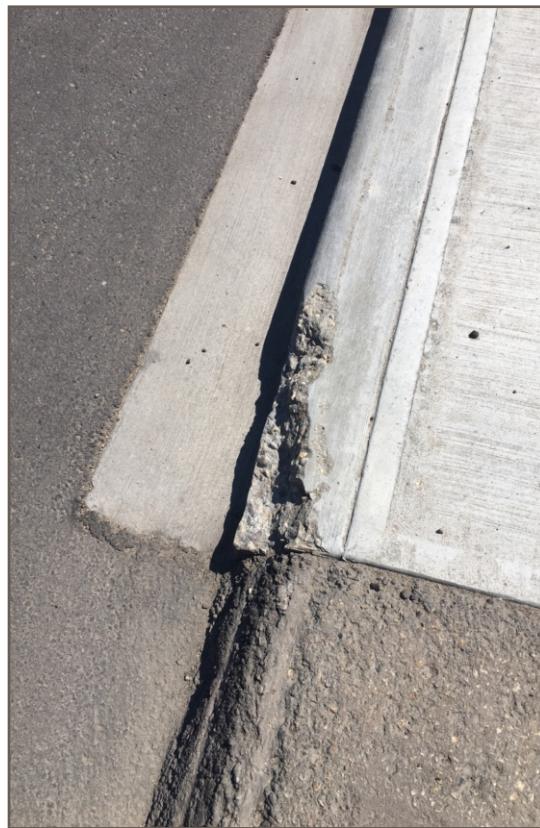
Photo 6: 111 Avenue. Photo obtained in 2019.
Chipped concrete curb next to catch basin.

Photo 7: 111 Avenue. Photo obtained in 2019.
Chipped concrete curb next to asphalt path.

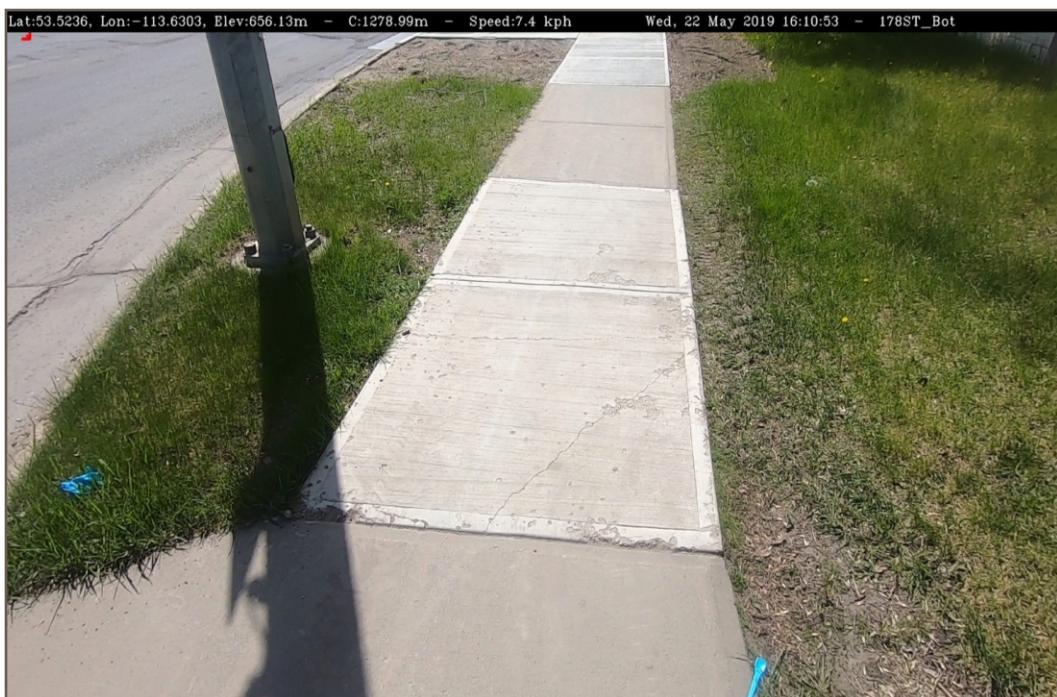
It appears only some replacement panels were constructed in 2018 rather than full reconstruction of the sidewalks and curbs. Two panels indicate moderate scaling and cracking damage; however, the scaling and cracking may be subgrade or loading related and not from chemical attack (Photo 8). The new concrete for the sidewalk and bus pad (top of Photo 8) exhibits good concrete with no signs of freeze/thaw distress or chemical attack.

Photo 8: 178 Street. 2019 photo. Appears the two replacement concrete panels were poorly constructed. Newer concrete 2 panels up appear in good condition.

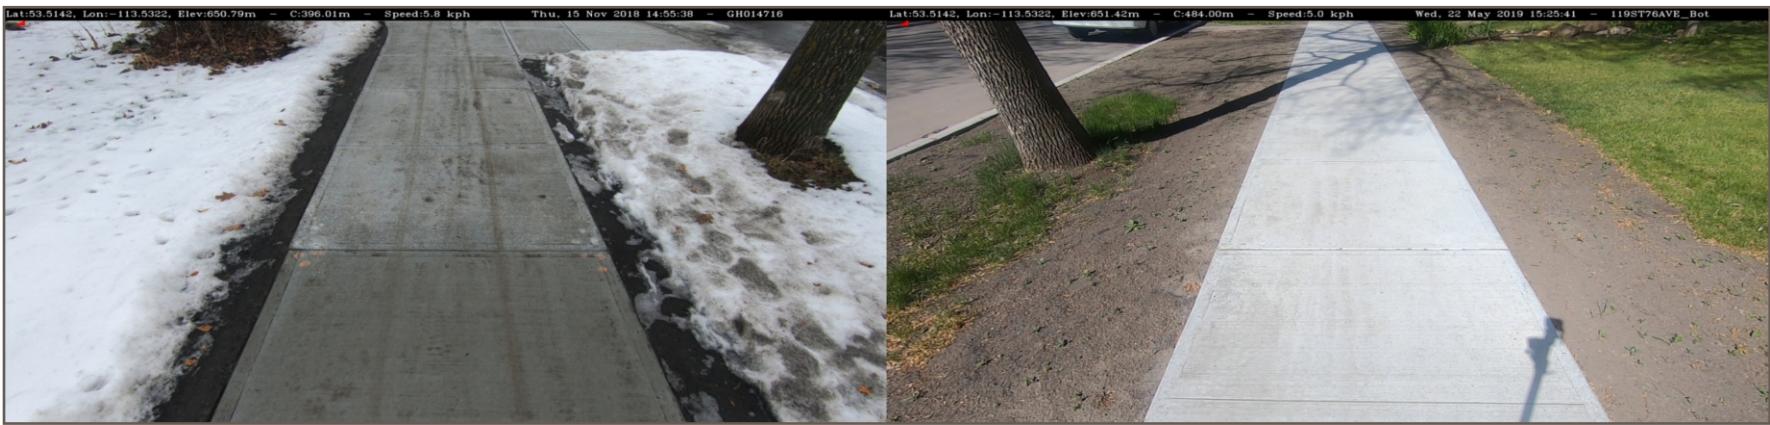
The concrete was generally in good condition (Photo 9). Several 2019 images indicate dark spots on the sidewalks. After a visual observation by the Author, it was determined that the spots were caused by tracking of topsoil on the concrete sidewalks.

Photo 9: Belgravia. 2018 photo on left, 2019 photo on right. Typical concrete section at Belgravia neighborhood.

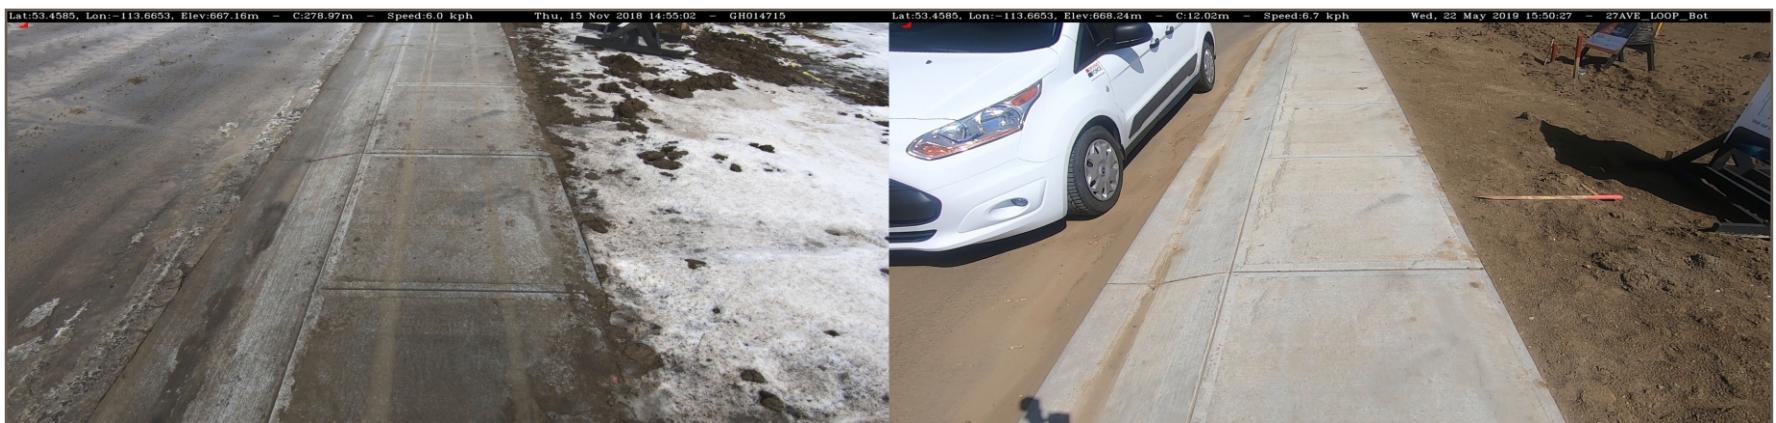
Due to few residents in the area, most sidewalks were cleared, and salt applied with sand by city of Edmonton contractors. The snow removal would have comprised of skid steers with buckets or brooms removing the snow. Some surface scraping (Photo 10) of the concrete was observed possibly due to snow removal activities.

Photo 10: Uplands. 2018 photo on left, 2019 photo on right. Surface scrapping of the sidewalk near the back of curb is visible in spring 2019. Scrapping not present in fall 2018.

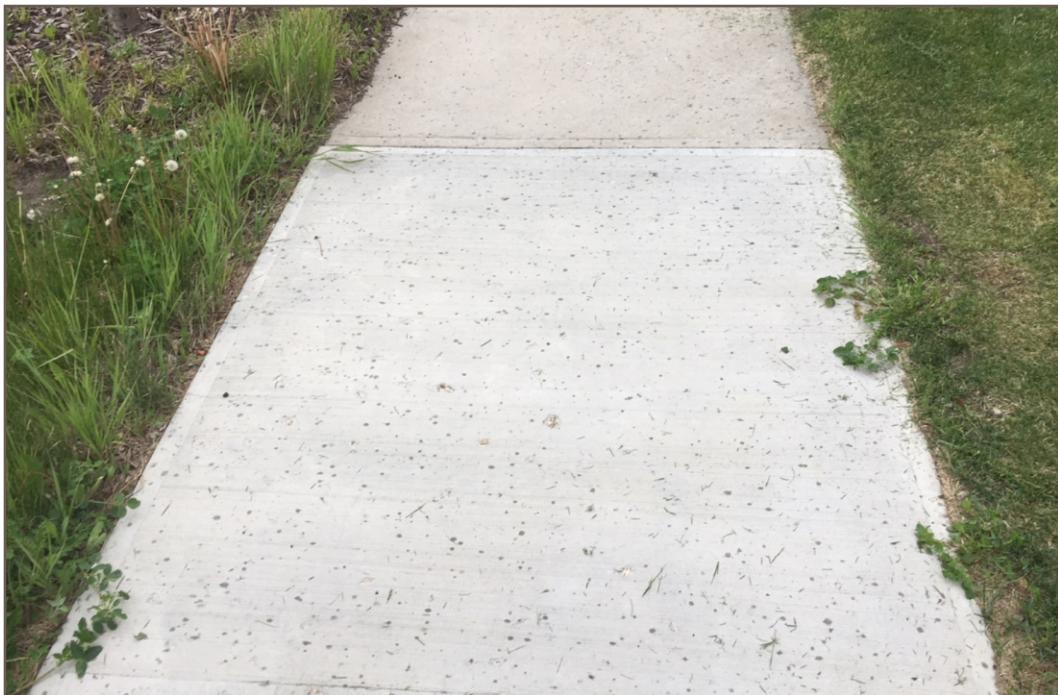
The concrete observed generally appeared in good conditions when compared to the fall of 2018 to the spring of 2019. It appears that only about half of the panels were replaced in 2018. Some of the finished surface comprised of rough texturing/aggressive booming. Some mortar flaking was observed from 2018 to 2019. About three panels appeared to have the top surface damaged (Photo 11). This may have been caused by chipping of ice by the residents causing indentations into the concrete. The damage does not appear to be chemical related.

Photo 11: Laurel. 2019 photo. Concrete possibly damaged by chipping of ice from surface.

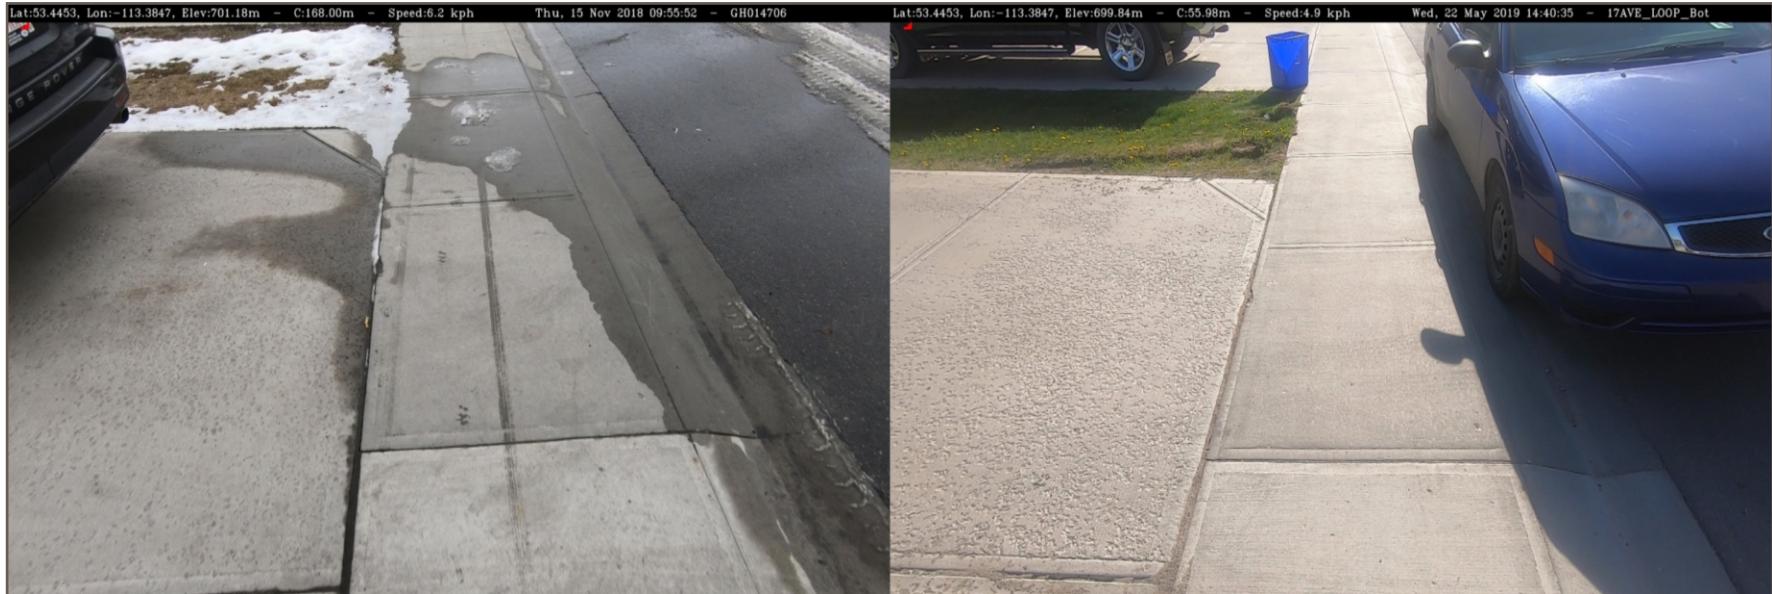
Some of the private driveways exhibited moderate to severe surface deterioration while the adjacent sidewalks were in good condition (Photo 12).

Photo 12: Laurel. 2018 photo on left, 2019 photo on right. Private driveway exhibiting significant damage while adjacent sidewalk is in good condition.
