CITY OF EDMONTON

STRATHCONA POOL (STR104) BUILDING CONDITION ASSESSMENT REPORT

SEPTEMBER 22, 2022

PROJECT NO.: 221-08057-00

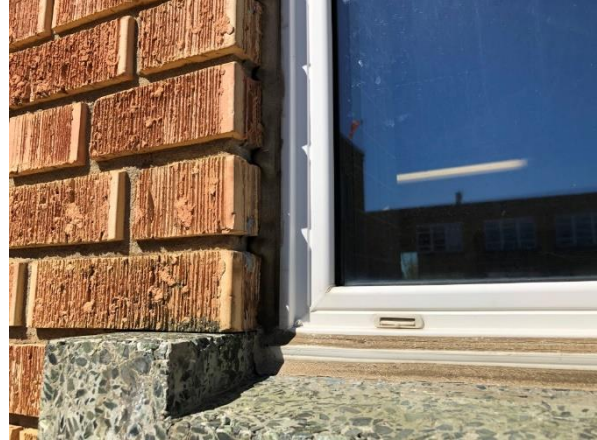
B2010.01.11 Joint Sealers**

Deficiency: Sealant is generally deteriorated, split, and crazed.

Recommendation: Lifecycle Replacement (2032)

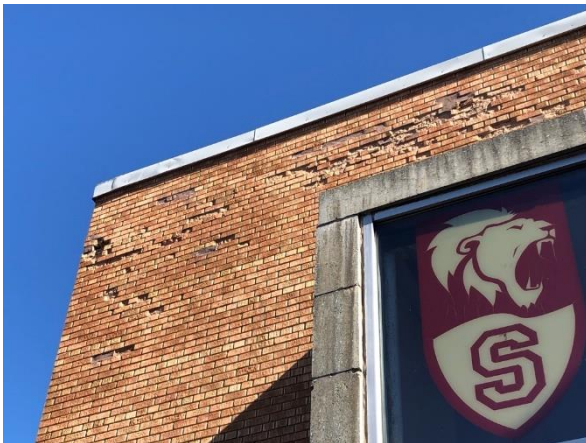
B2010.02.03.01 Clay Masonry Units* (Brick)

The exterior walls are clad with brick units face-sealed to a hollow clay tile backup wall. There is precast terrazzo framing surrounding the pool windows. There are spalling bricks along the upper walls largely located along the west wall and northwest corner, as well as above the staff entrance door at the northeast corner by the main pool entrance. Most of the spalling bricks have been fenced off from public access aside from the staff entrance on the north side. The area around the staff entrance is deemed to be potentially critical due to it being a safety concern. The entrance should either be closed, or have overhead protection provided until investigations and repairs are completed.

Areas where brick is damaged or missing will allow further water penetration into the cladding assembly. We expect that the overall brick cladding will continue to deteriorate at an accelerated rate particularly during freeze-thaw cycles if left unaddressed. This may lead to further migration of deteriorated locations, thus limiting access to the building. For this reason, we assess the overall cladding condition to be marginal, with the potential to become critical over the next couple of years.

Recommendation: Testing and repairs (2022)

The staff entrance should either be closed, or overhead protection provided until investigations and repairs are completed.

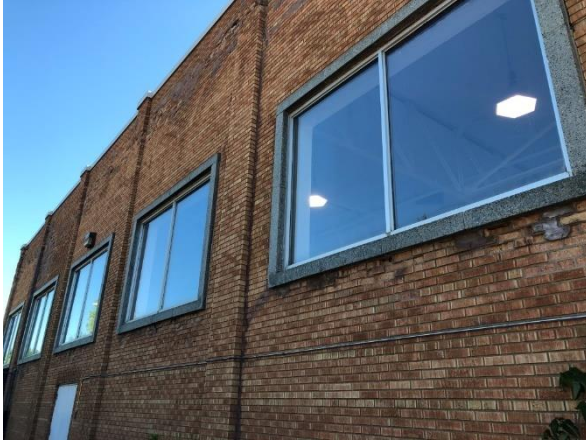
B2020.01.01.02 Aluminum Windows**

Deficiency: There are corrosion stains at the tops of some of the exterior window frames and condensation staining on the interior framing. Glazing seals appear deteriorated.

Recommendation: Lifecycle Replacement (2022)

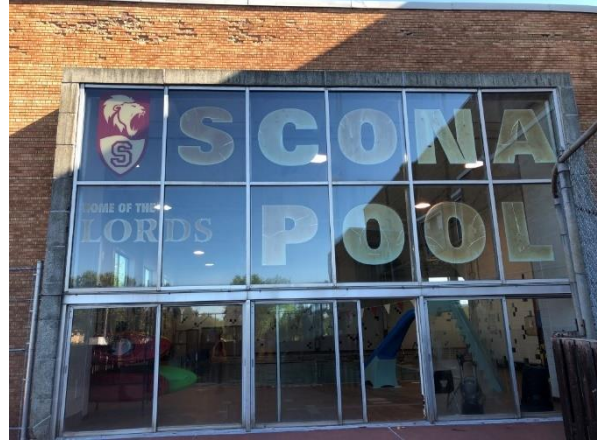
B2020.03 Glazed Curtain Wall**

Exterior windows in the pool area consist of double-glazed insulated glass units in aluminum frames. There is a glazed curtain wall at the south elevation sun deck entrance. We noted failed glazing seals with moisture in the IGU air spaces. There are failed and deteriorated glazing seals, surface corrosion staining at some exterior window frame headers, and the windows do not appear to be thermally broken.

Deficiency: We noted failed glazing seals with moisture in the IGU air space. The exterior aluminum frame finish is worn and faded.

Recommendation: Lifecycle Replacement (2022)

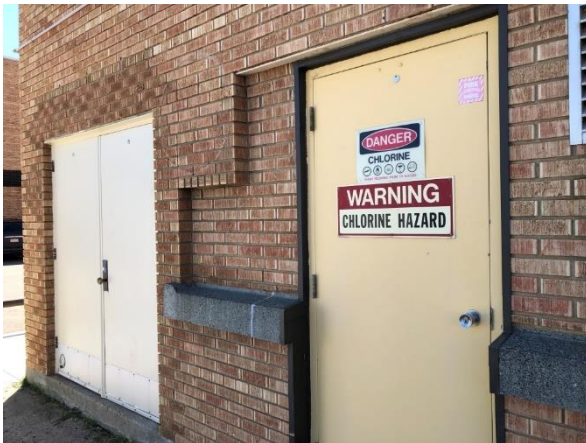
B2030.02.01 Metal Doors and Frames**

Deficiency: The doors have some flaking and peeling paint and surface corrosion on the frame and hardware.

Recommendation: Lifecycle Replacement (2022)

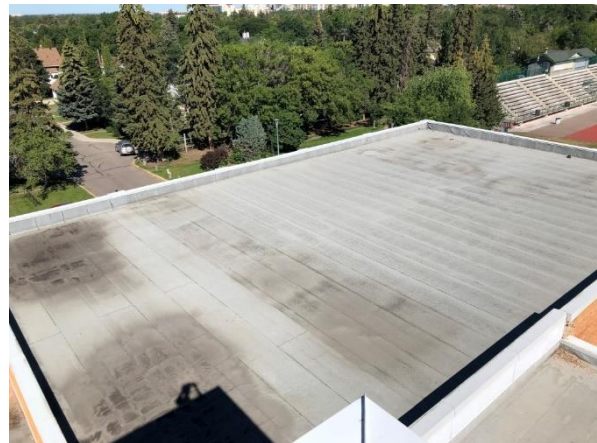
B3010.04.04 Modified Bituminous Membrane Roofing**

The pool has a three flat roof areas and one sloped roof area protected by a 2-ply modified bituminous membrane. Roof drainage is provided via internal drains. We noted areas of ridging, blisters, and tenting at parapet upturns on the northwest corner and south side of the pool roof. There is evidence of pooling water from observed debris build-up and multiple repair patches throughout the roof and evidence of water leakage northwest and southeast corners of the upper main pool roof.

Recommendation:

Repair (2022)

Lifecycle Replacement (2023)

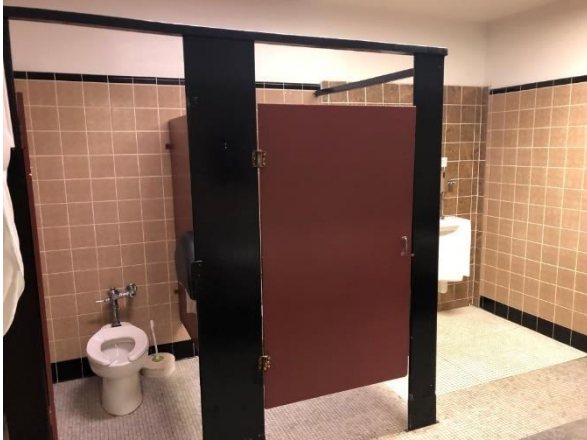
C1030.02.01 Metal Toilet Compartments**

Deficiency: No major issues noted or reported

Recommendation: Lifecycle Replacement (2045)

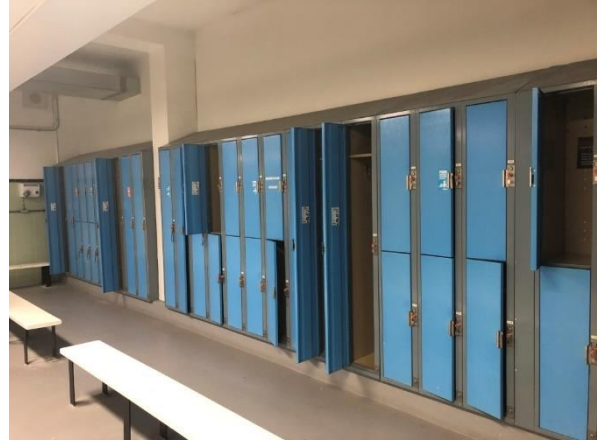
C1030.10.01 Metal Lockers**

Deficiency: No major issues noted or reported

Recommendation: Lifecycle Replacement (2025)

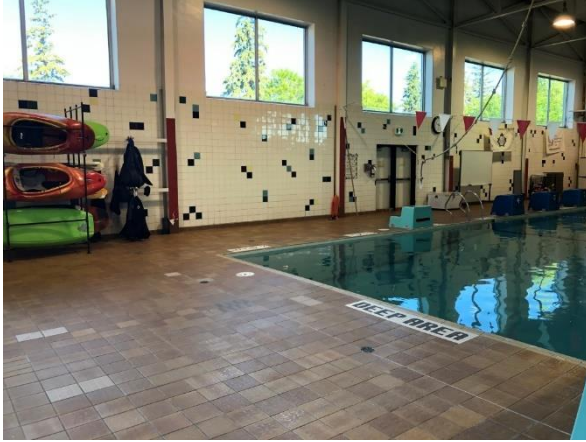
C3010.02.01 Tile Floor Finishes - Ceramic Tile**

Deficiency: No major issues were noted or reported. The tiles appear well-maintained.

Recommendation: Lifecycle Replacement (2025)

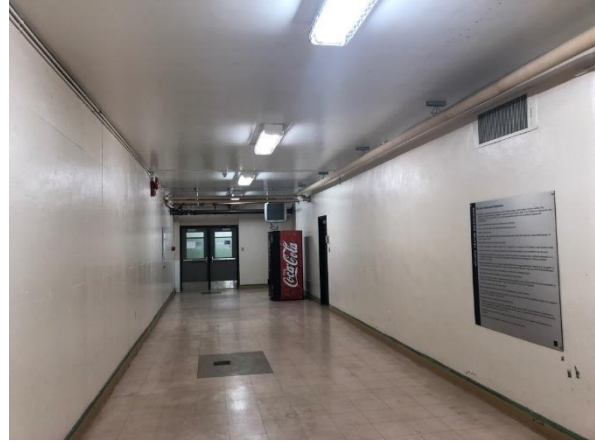
C3020.07 Resilient Flooring (Tile Flooring)**

Deficiency: The flooring is discoloured and has scuffs, marks, and scratches.

Recommendation: Lifecycle Replacement (2022)

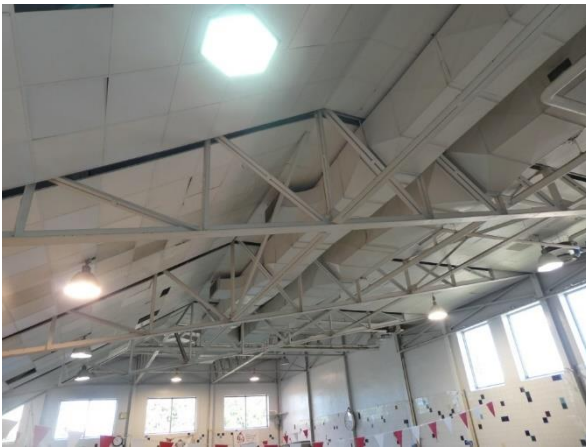
C3030.06 Acoustical Ceiling Treatment (T-Bar System - 1957)**

Deficiency: Acoustic tiles in the pool area have water stains and damages throughout. Localized tiles are also missing.

Recommendation: Lifecycle Replacement (2022)

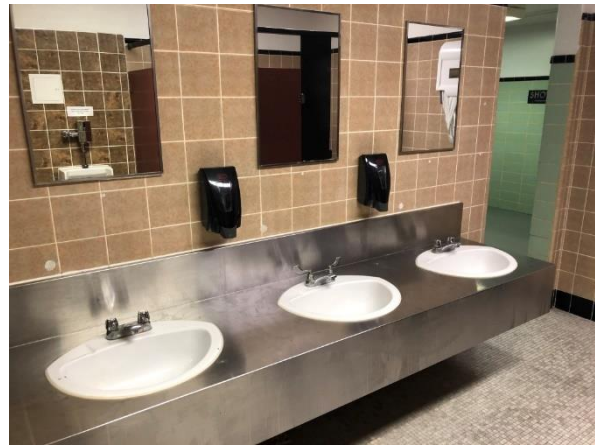
D2010.03 Lavatories (Enamel)**

Deficiency: No major issues were noted or reported. Lavatories appear outdated and past their expected service life.

Recommendation: Lifecycle Replacement (2022)

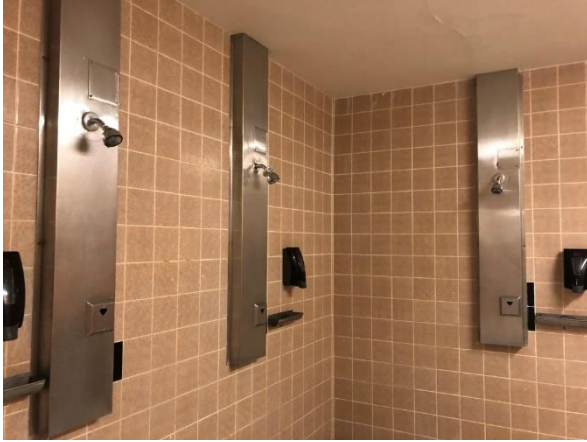
D2010.05 Showers**

Deficiency: No issues noted or reported

Recommendation: Lifecycle Replacement (2043)

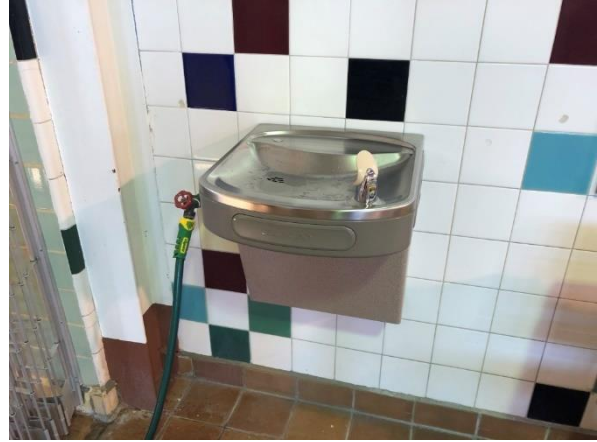
D2010.08 Drinking Fountains/Coolers**

Deficiency: No major issues noted or reported

Recommendation: Lifecycle Replacement (2039)

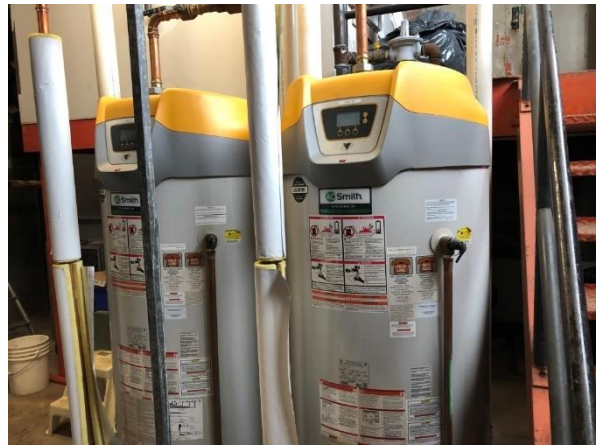
D2020.02.06 Domestic Water Heaters**

Deficiency: No major issues noted or reported

Recommendation: Lifecycle Replacement (2028)

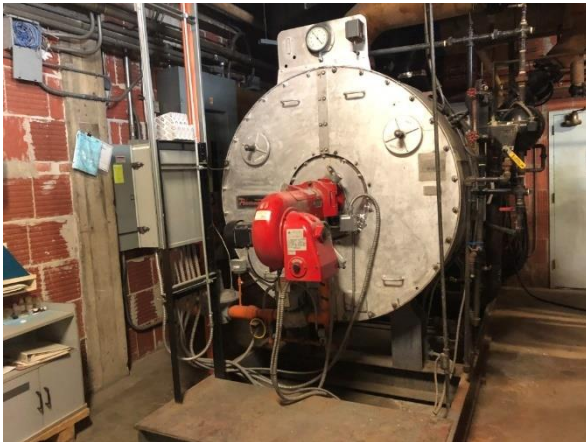
D3020.01.01 Heating Boilers and Accessories (Steam Boilers)**

The overall condition of the building mechanical systems is marginal; however, the condition of the pool process equipment is critical as the boiler and heat exchanger were not operational.

Deficiency: The boiler was not functional at the time of the visit as the heat exchanger was not operational.

Recommendation: Replace the boiler with separate boiler heating systems (2022)

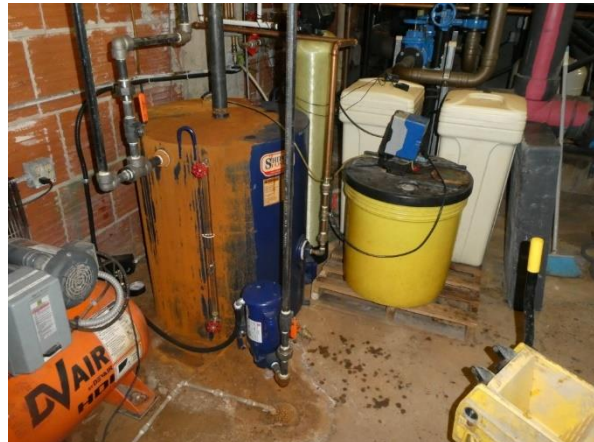
D3020.01.04 Water Treatment Equipment* (Steam Boilers)

Deficiency: System was not functional as the boiler was not functional.

Recommendation: We assume this will be replaced with the steam boiler (2022)

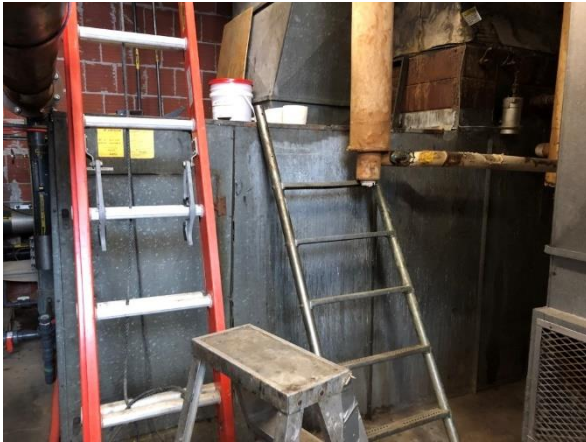
D3040.01.01 Air Handling Units (Mechanical Room AHU)**

Deficiency: AHU was functional at the time of the visit and periodically maintained according to the maintenance stickers. Casing is worn and dated. The AHU is past its expected service life and we expect it will require replacement within the next couple years.

Recommendation: Lifecycle Replacement (2023)

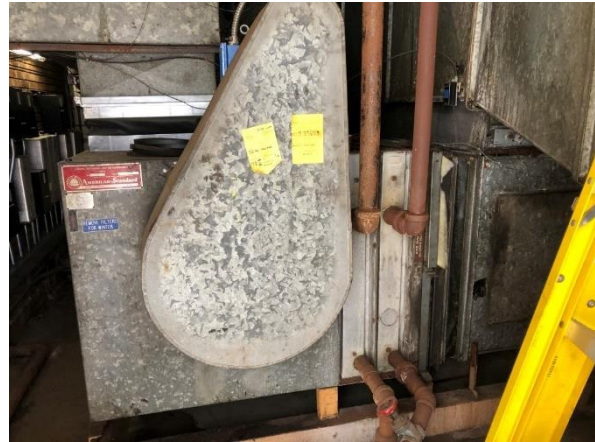
D3040.01.01 Air Handling Units (Pool AHU)**

Deficiency: AHU was functional at the time of the visit and periodically maintained according to the maintenance stickers. Casing is worn and dated. The AHU is past its expected service life and we expect it will require replacement within the next couple years.

Recommendation: Lifecycle Replacement (2023)

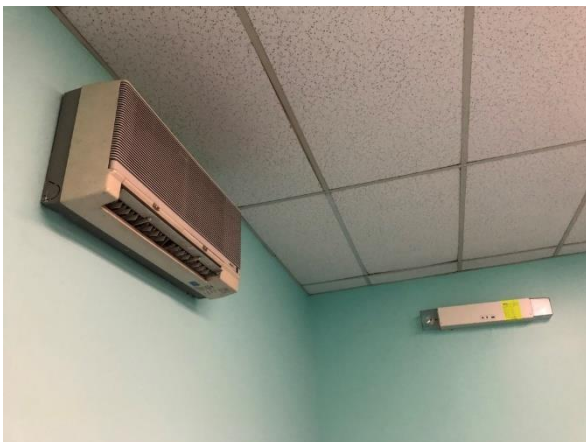
D3050.01.03 Packaged Terminal Air Conditioning Units**

Deficiency: No major issues noted or reported

Recommendation: Lifecycle Replacement (2025)

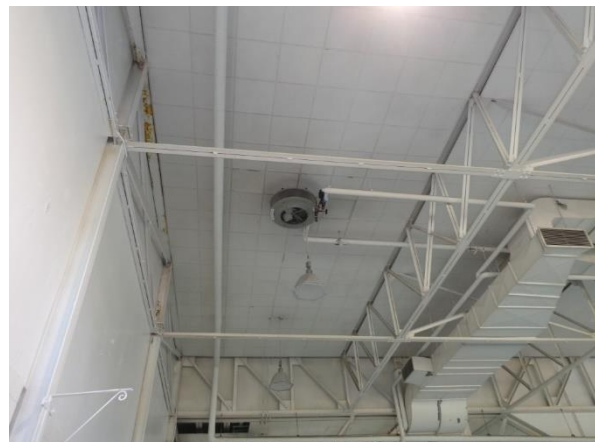
D3050.05.06 Unit Heaters**

Deficiency: No major issues noted or reported

Recommendation: Lifecycle Replacement.

Based on age, we expect these unit heaters will require replacement within the next two years and be individually replaced as they fail. (2023)

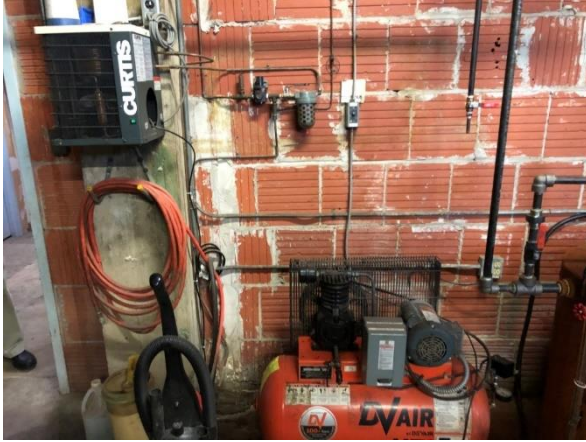
D3060.02.02 Pneumatic Controls**

Deficiency: No major issues noted or reported

Recommendation: Lifecycle Replacement (2047)

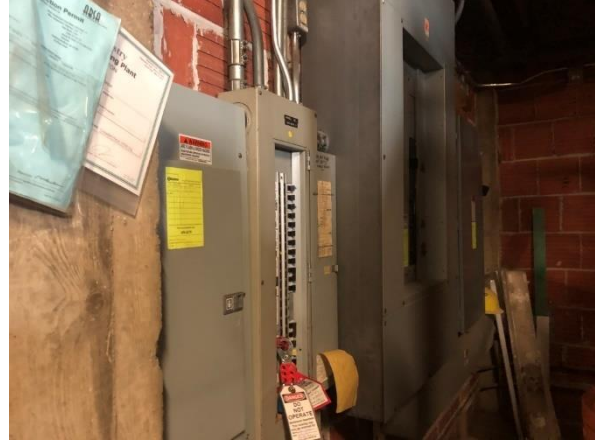
D5010.05 Electrical Branch Circuit Panelboards** (CDP)

Deficiency: No major issues noted or reported

Recommendation: Lifecycle Replacement (2025)

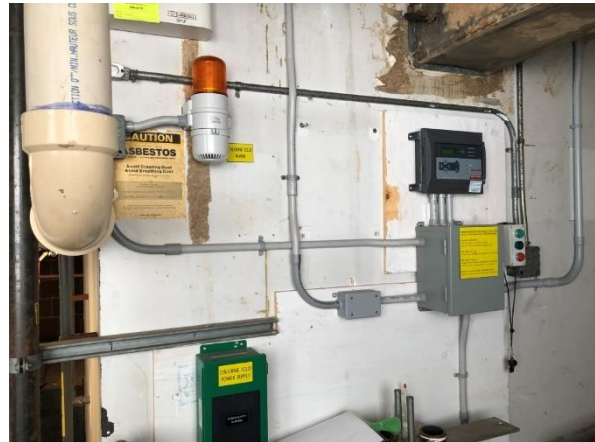
D5030.01.01: Gas Detection*

Deficiency: No major deficiencies noted or reported.

Recommendation: Lifecycle Replacement (2029)

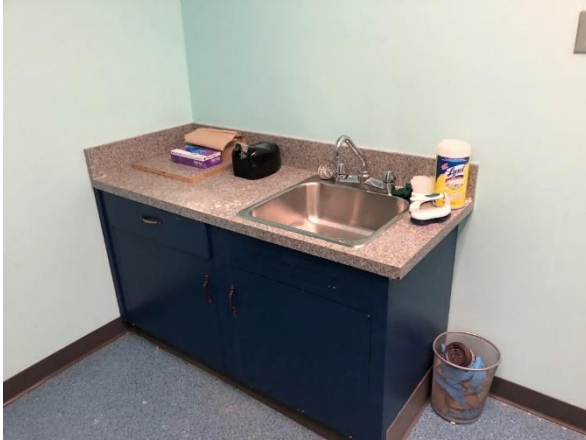
E2010.02.07: Kitchen Casework**

Deficiency: No major deficiencies noted or reported.

Recommendation: Lifecycle Replacement (2045)

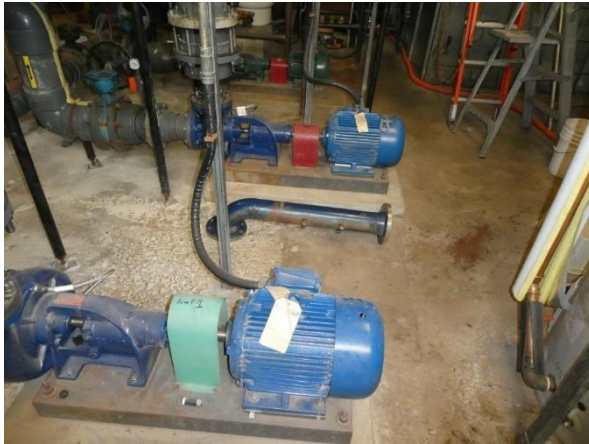
Aquatic Facilities* (Pool Pumps)

Deficiency: No issues were reported and none were noted.

Recommendation: Lifecycle Replacement (2048)

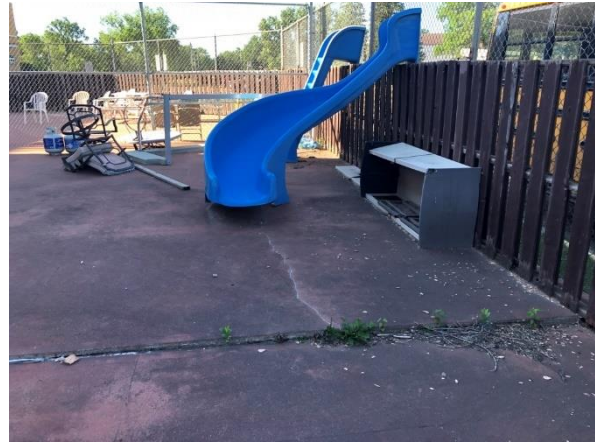
G2030.04 Rigid Pedestrian Pavement (Concrete Sun Deck)**

The exterior slab on the west side appears to be settling and moving, this is likely due to a combination of water ingress along the side of the building affecting the subgrade beneath these slabs along with the vegetation in the area. It is recommended to ensure water drains away from these slabs and not between the building and slab and ensure all vegetation between the building and slab is removed.

Deficiency: The sundeck has multiple cracks throughout and some panels have vertical differential settlement of two-inches, creating trip hazards.

Recommendation: Removing vegetation, mud-jacking, and recaulking (2022)
Lifecycle Replacement (2023)
