City of Edmonton

Edmonton City Centre Airport Phase II Environmental Site Assessment

AECOM

September, 2010

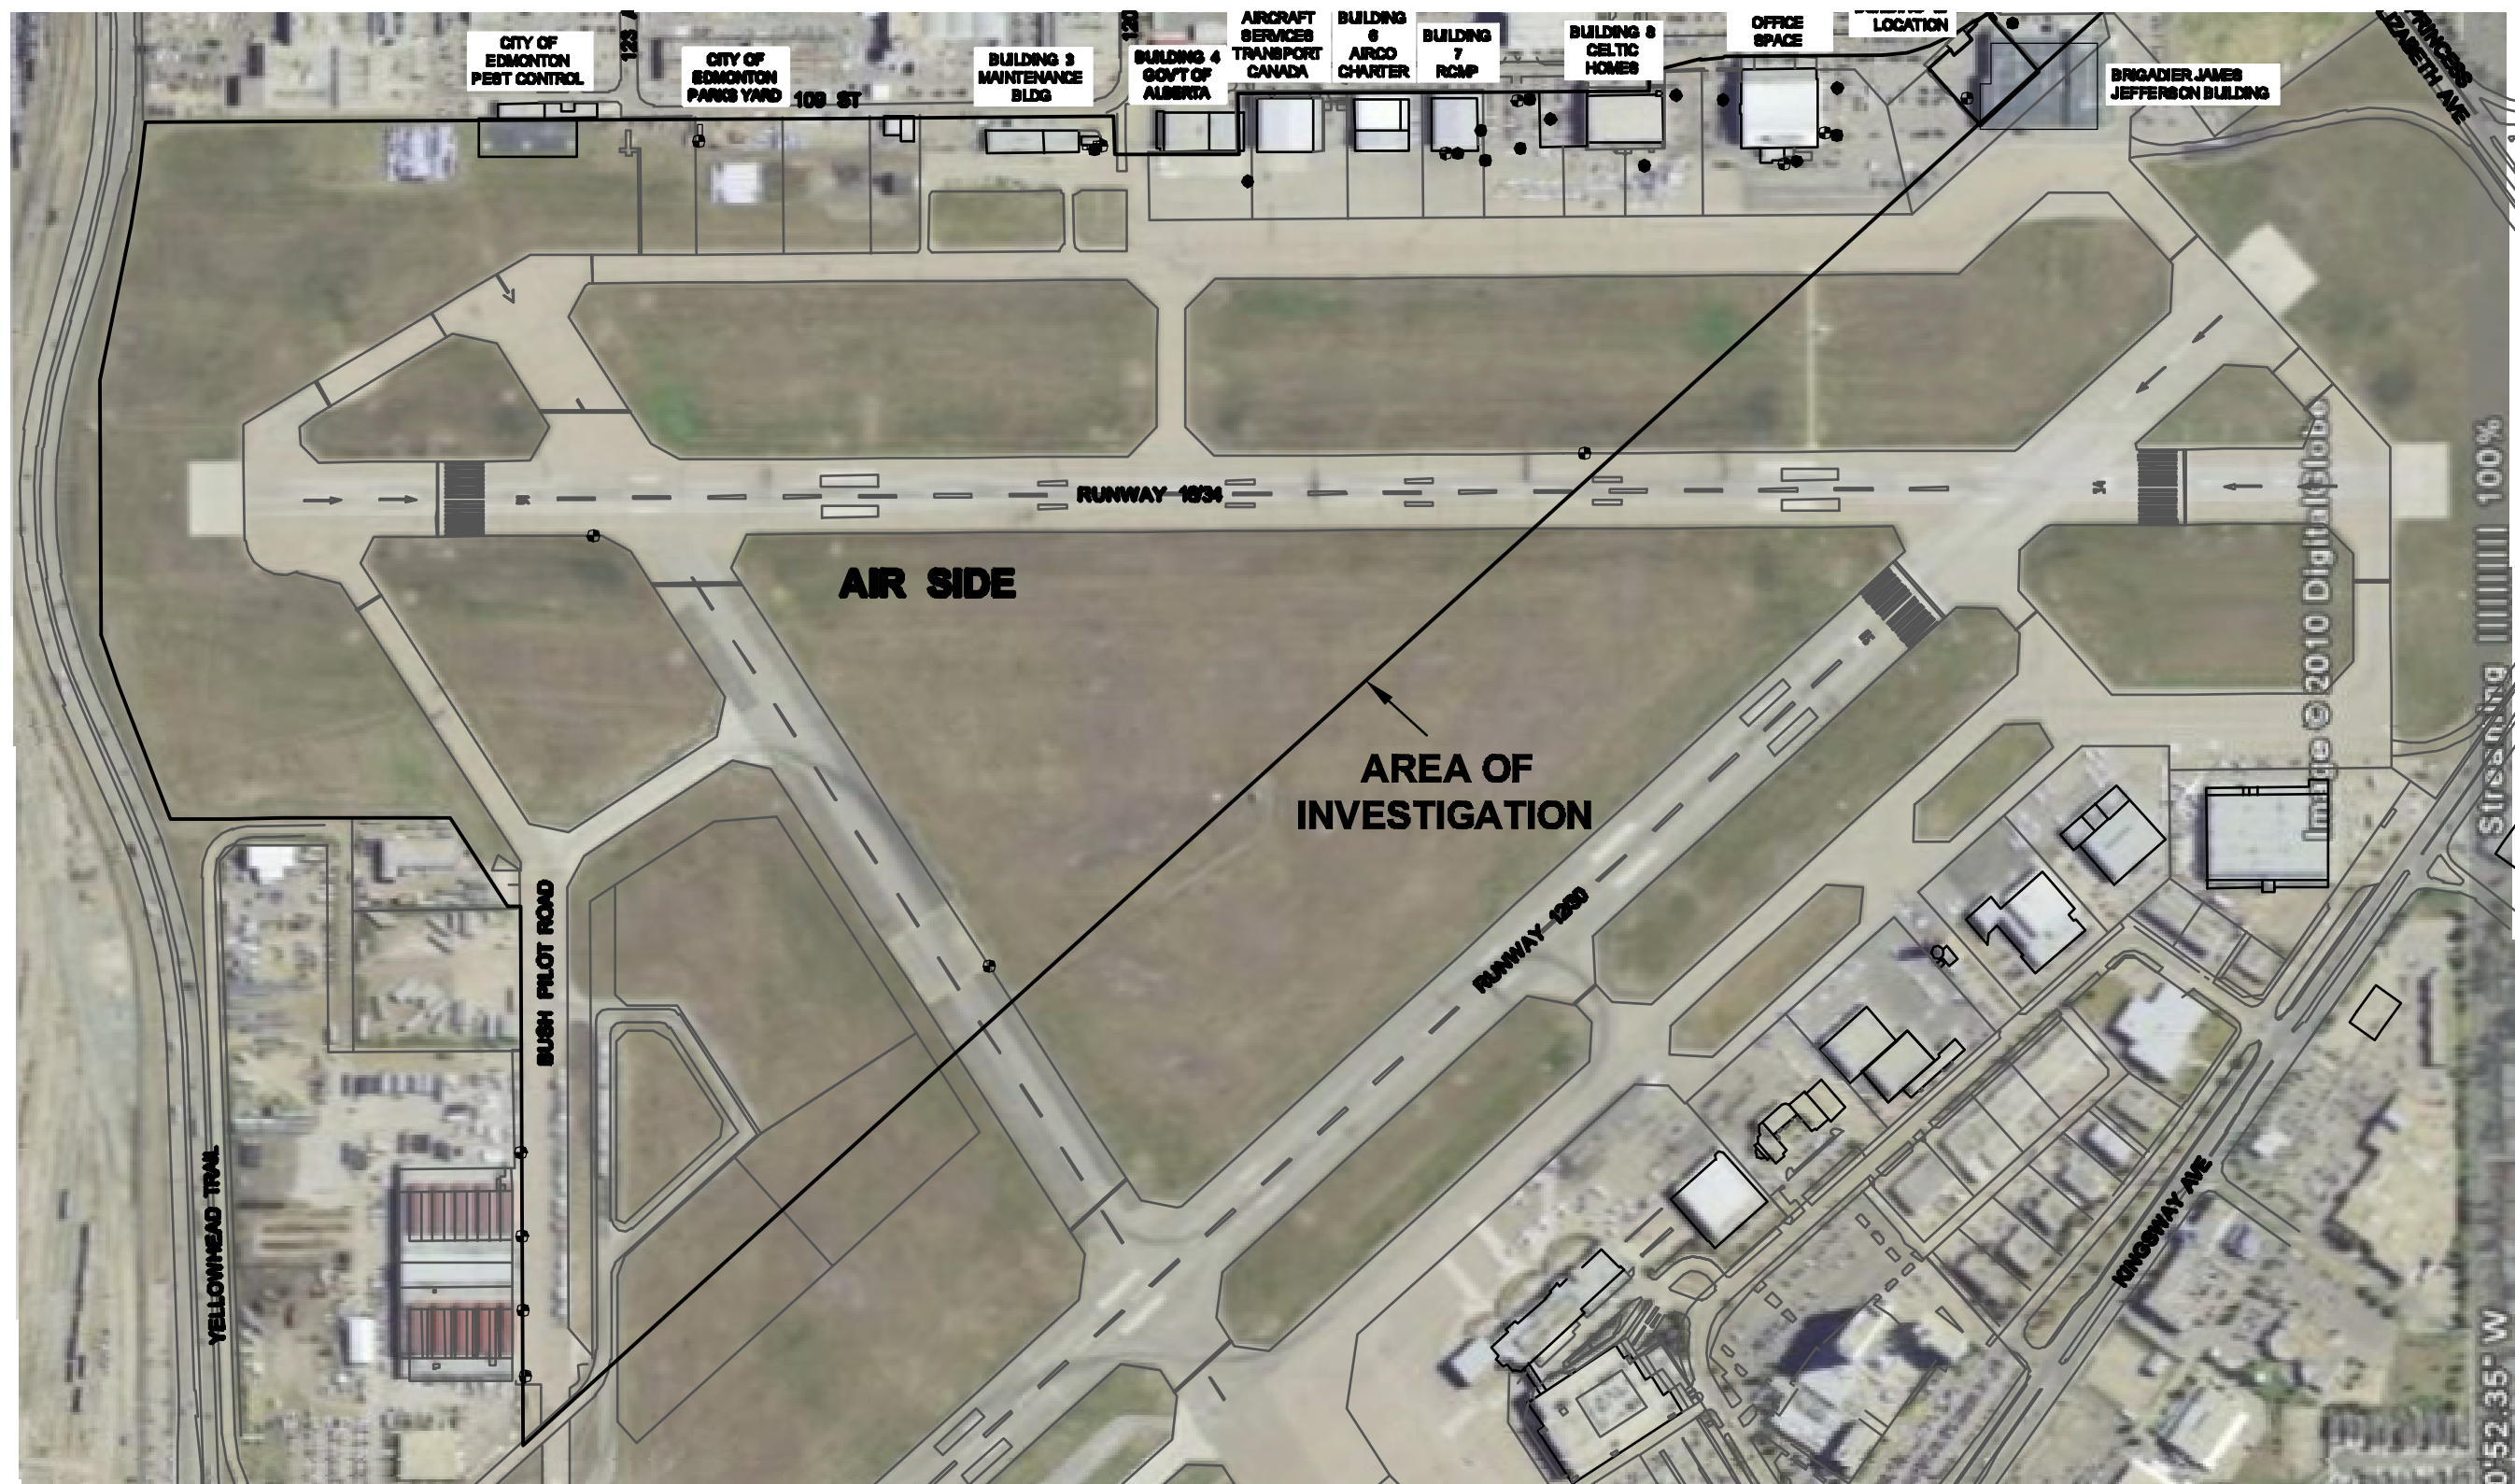
The City of Edmonton
Edmonton City Centre Airport, Edmonton, AB
Phase II ESA - Borehole & Monitoring Well Locations
Site Plan

The site is located in the ECCA of Edmonton, Alberta and occupies a total area of approximately 85 hectares. The site layout is depicted in Figure 2 in Appendix A. The assessment was centralized around the main runway (16/34), which runs north-south and is on the east side of the ECCA and includes the buildings situated along the east boundary of the airport. The west boundary of the assessment area was delineated by the intersection of 121 Street and Bush Pilot Road, running in a diagonal direction parallel to the west runway (12/30). Taxiways Charlie, Echo, Bravo and a portion of Delta were also assessed.

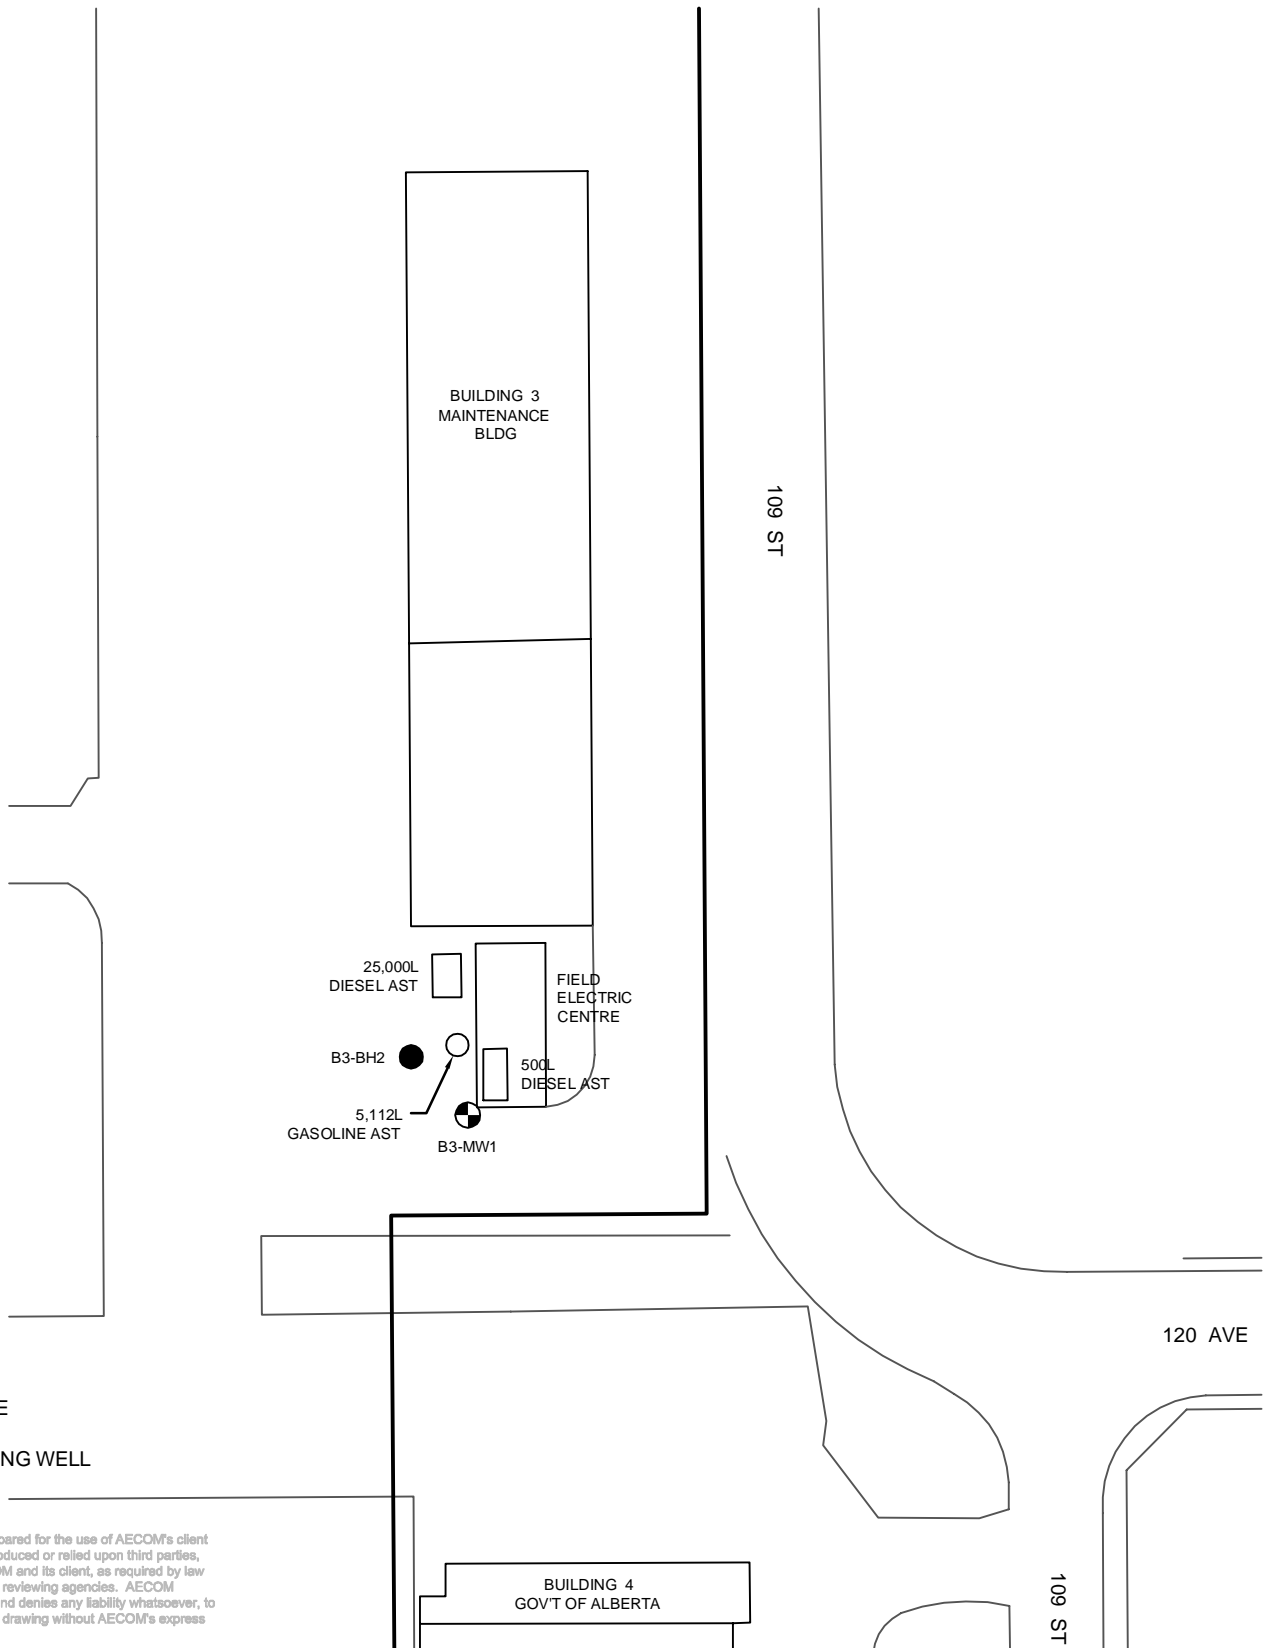
Figure 4

Two boreholes were advanced along the west and south limits of the December 1997 excavation, south of Building 3, as depicted in Figure 4. During the drilling event, elevated field readings and slight hydrocarbon odours were noted in B3-MW1 between 2.4 to 3.1 mBGS and in B3-BH2 between 1.8 to 2.5 mBGS.

- It is recommended that the petroleum hydrocarbon concentrations in the soil and groundwater exceeding the applicable criteria south of Building 3 be delineated. Once the area is delineated and operations have been decommissioned, the contaminated area should be remediated.

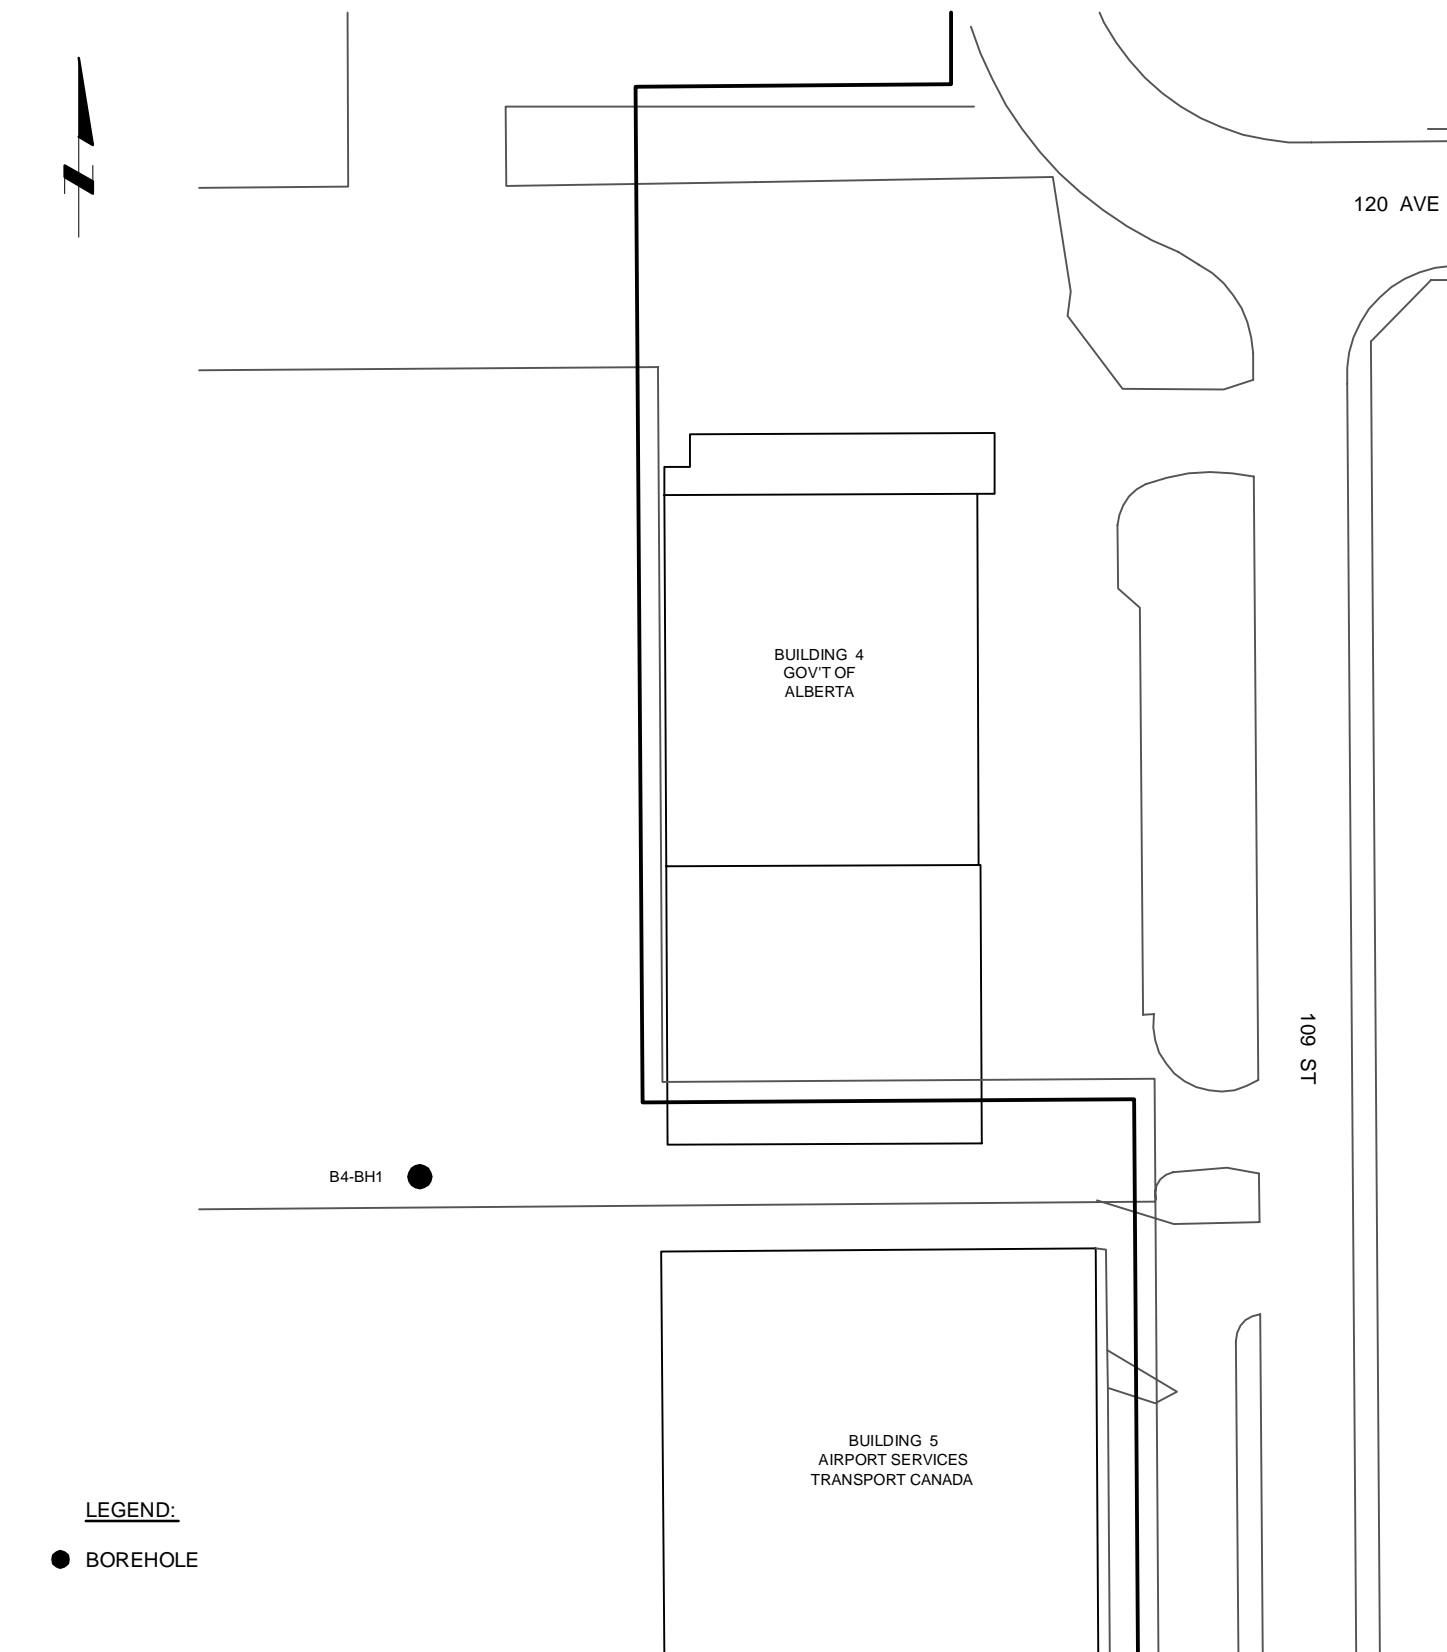
Figure 5

B4-BH1 was advanced south west of Building 4 in the vicinity of the 1998 investigation, as shown in Figure 5. There were no field observations of odour or staining in the soil during the drilling operation. A soil sample was collected from 0.76 m and 1.52 mBGS and submitted for petroleum hydrocarbon analysis. These depths were chosen because hydrocarbon concentrations in the soil collected during the previous investigation at these depths exceeded the current Tier 1 criteria. Table 6.18 presents the results of the analysis in comparison with the AB Tier 1 criteria.
