Wetland Monitoring

Edmonton Wetlands Workshop
December 4-5, 2013

Kennedale Wetland

KENNEDALE CONSTRUCTED WETLAND

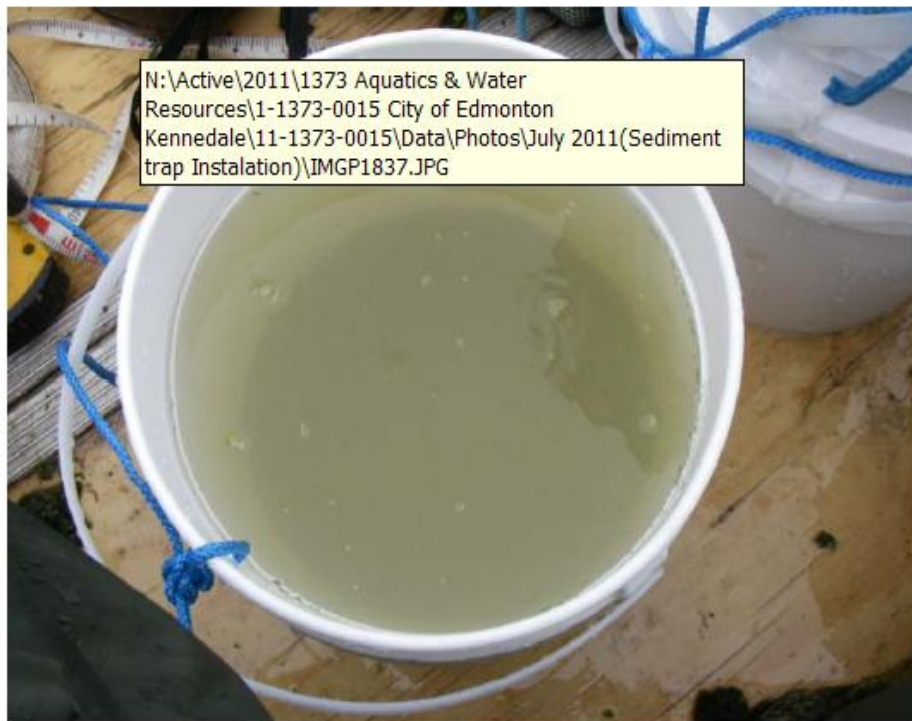
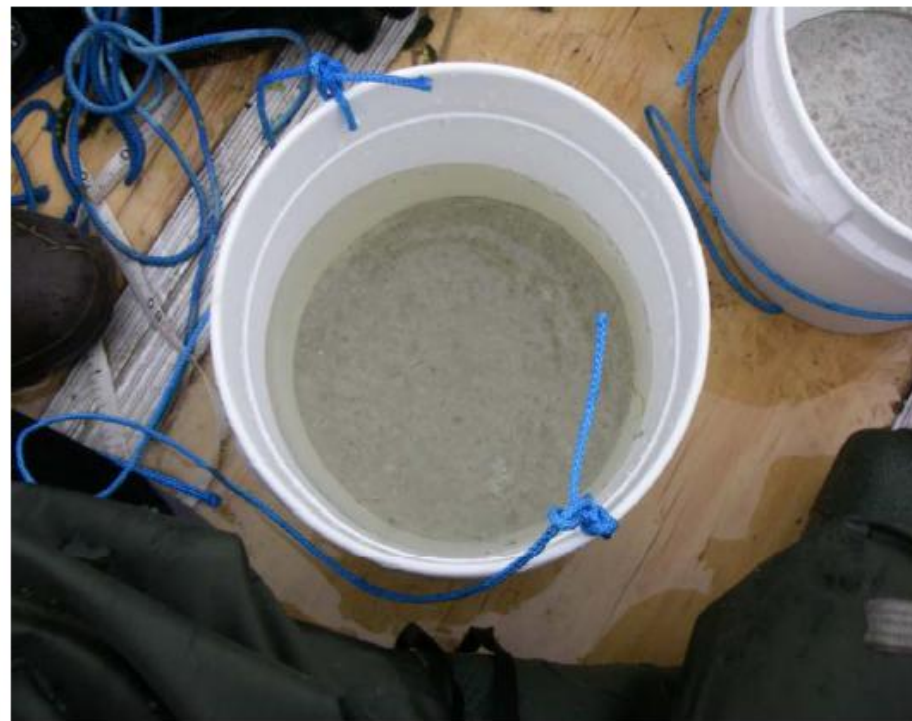
Figure F.4: Sediment traps consisting of plastic pails lined on the bottom with concrete during deployment. Pails were filled with water from the forebay and outlet pool to show the difference in turbidity during a prolonged rain event July 11, 2011

Forebay

Outlet Pool

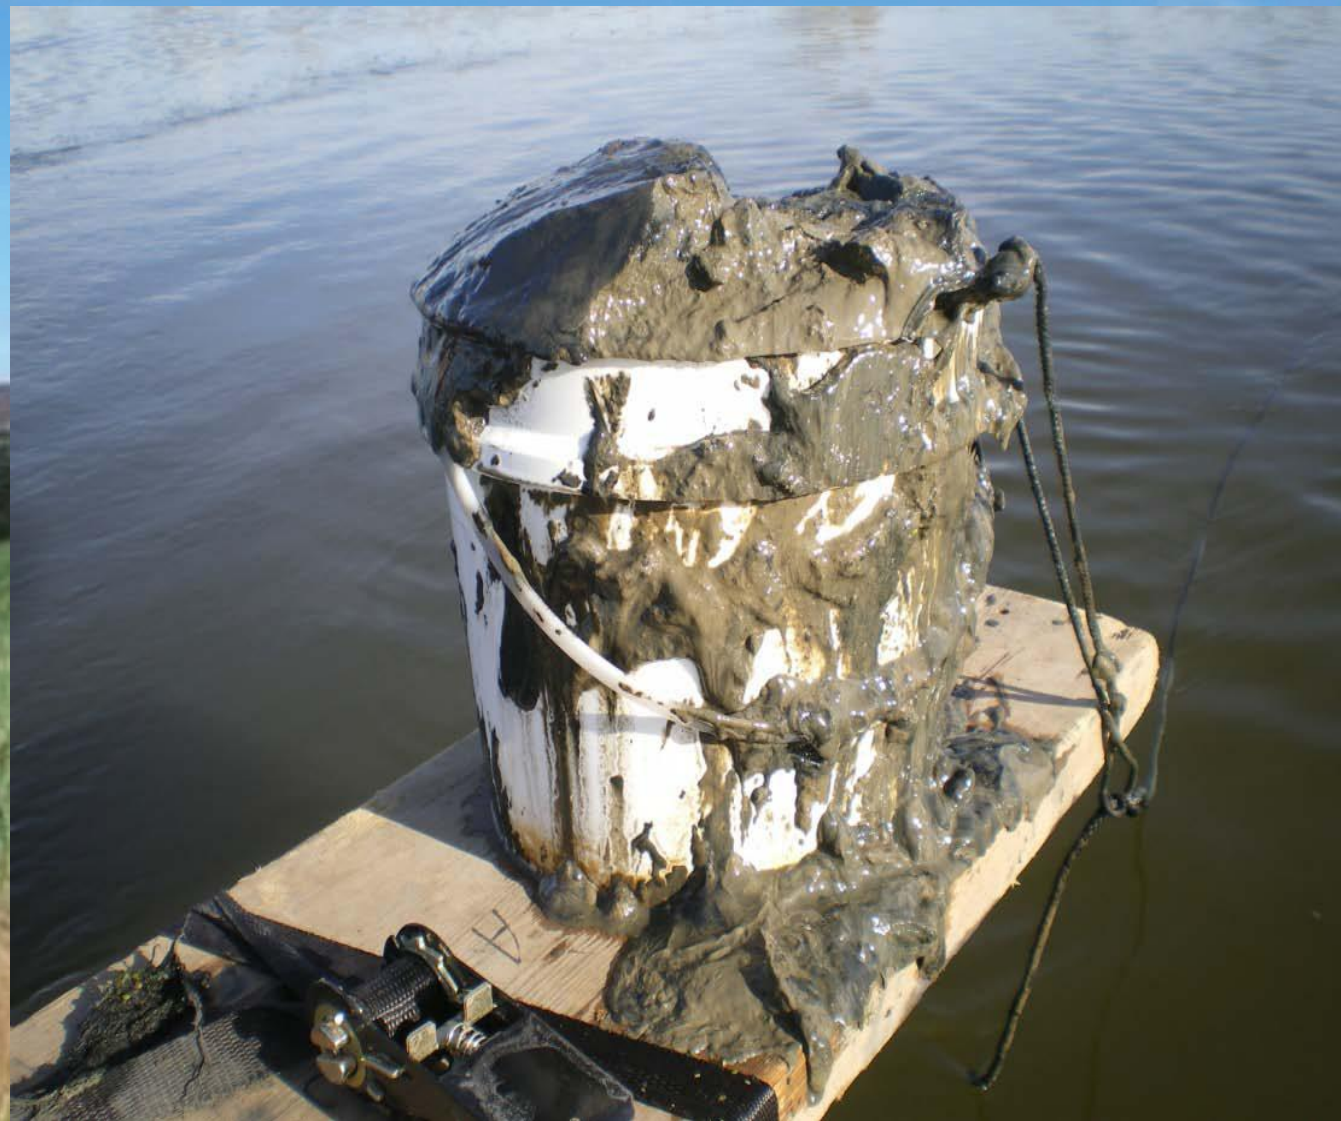
Sediment trap No. 4 retrieved from forebay – note clay/silt sediment and that pale is overfilled

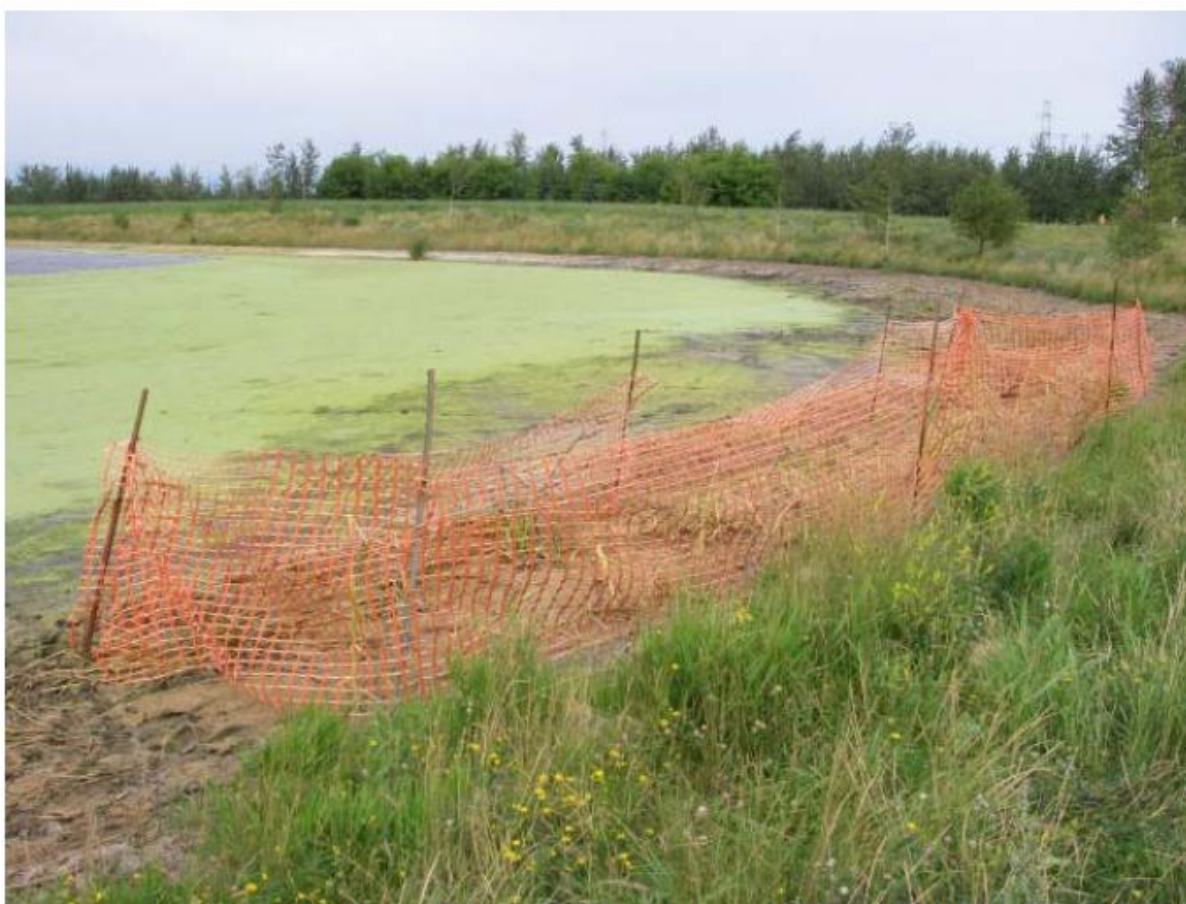
Plate 2. An area of new emergent plant installations along the shoreline on 17 August 2011.

- Lower the water level in late summer, fall and winter below NWL (0.40m below)
- Install additional wetland plants (plugs of common cattail and soft stem bulrush).
- Use snow fencing to protect the new plant installation
- Bring in wetland soil (organic soil and remnant plant material) from other wetland site in the City.

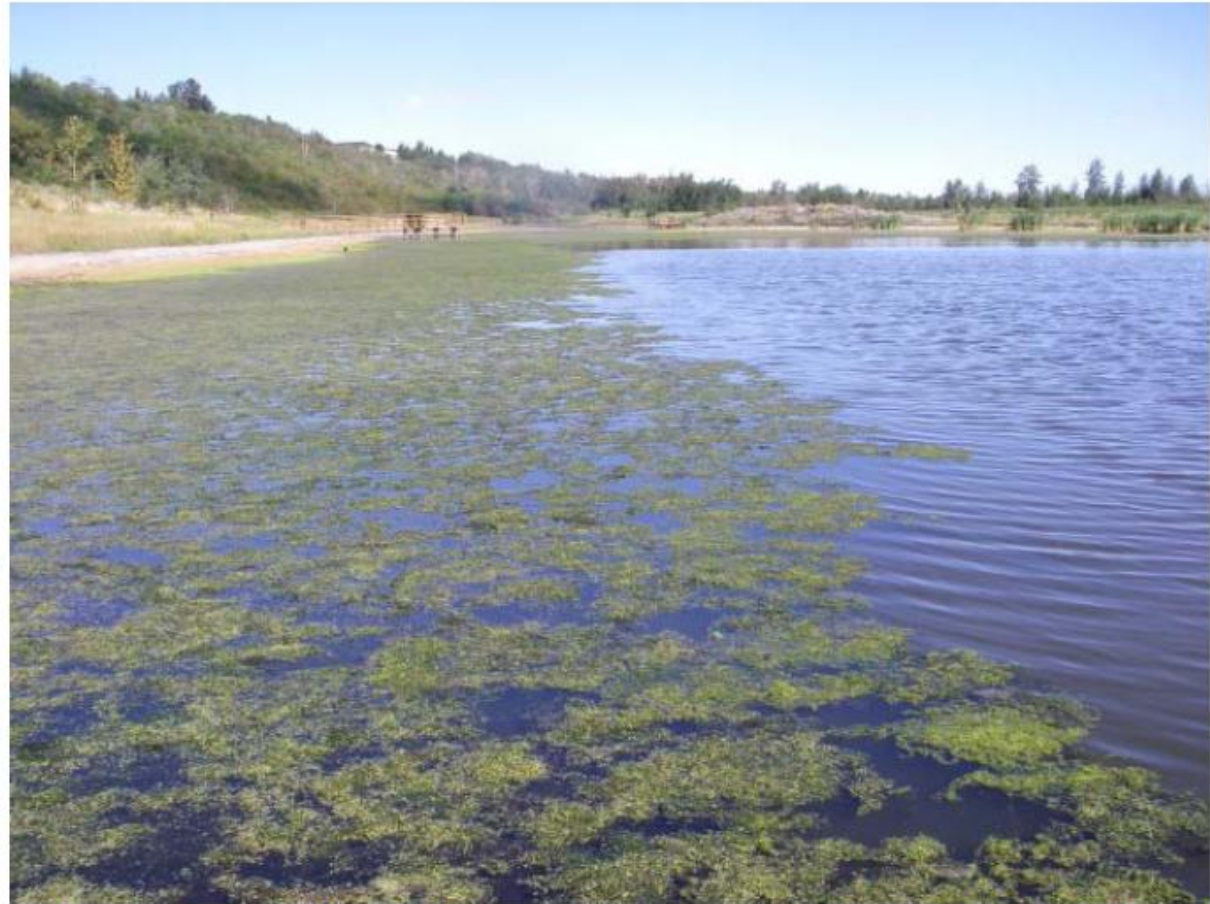
Plate 5. Submersed aquatic vegetation, duckweed and algae occur together along the shallow bench of the facility. The open water to the right is a result of deeper water (25 August 2011).

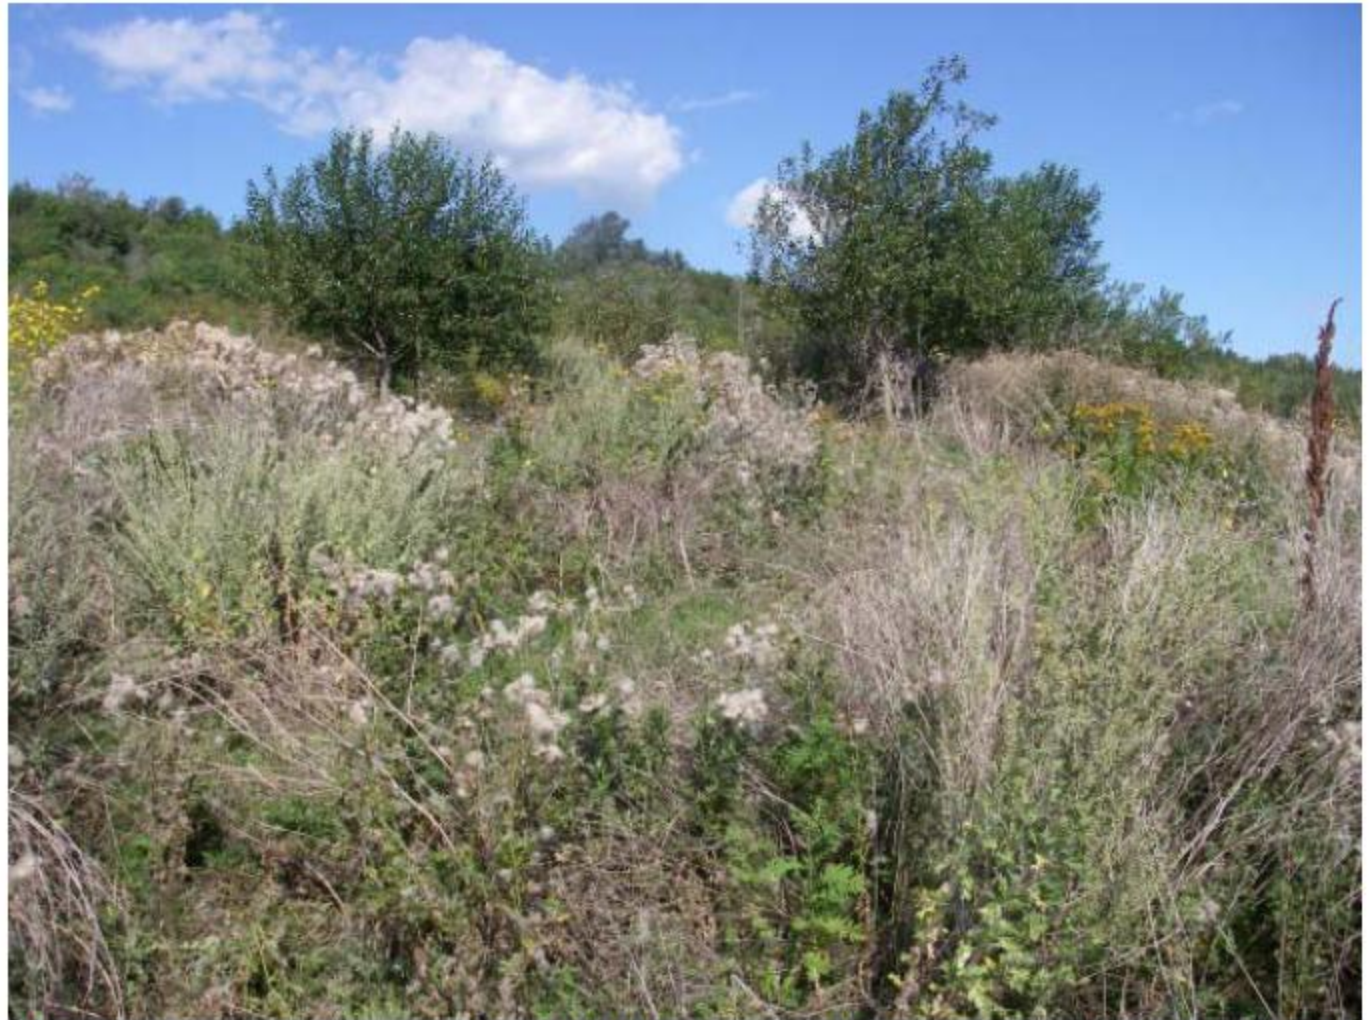
**Plate 7. Extensive weeds established near the north end of the island
(25 August 2011).**

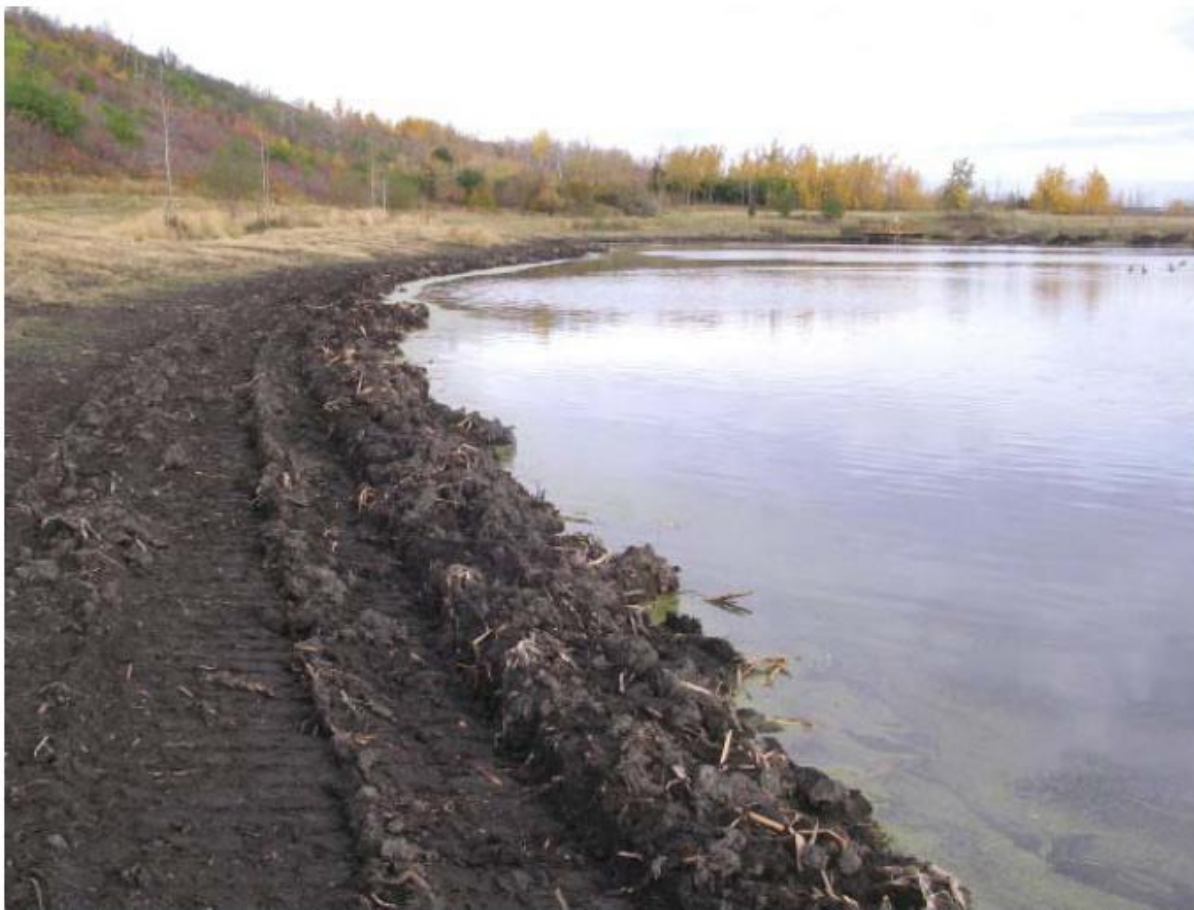
Plate 8. Original extent of wetland soils along the west shoreline on 13 October 2011.
