Environmental Noise Monitoring

91 Street Earth Berm Removal in Edmonton, Alberta

Prepared for the
City of Edmonton
Drainage Services Branch

aci Project #: 14-072
October 01, 2015

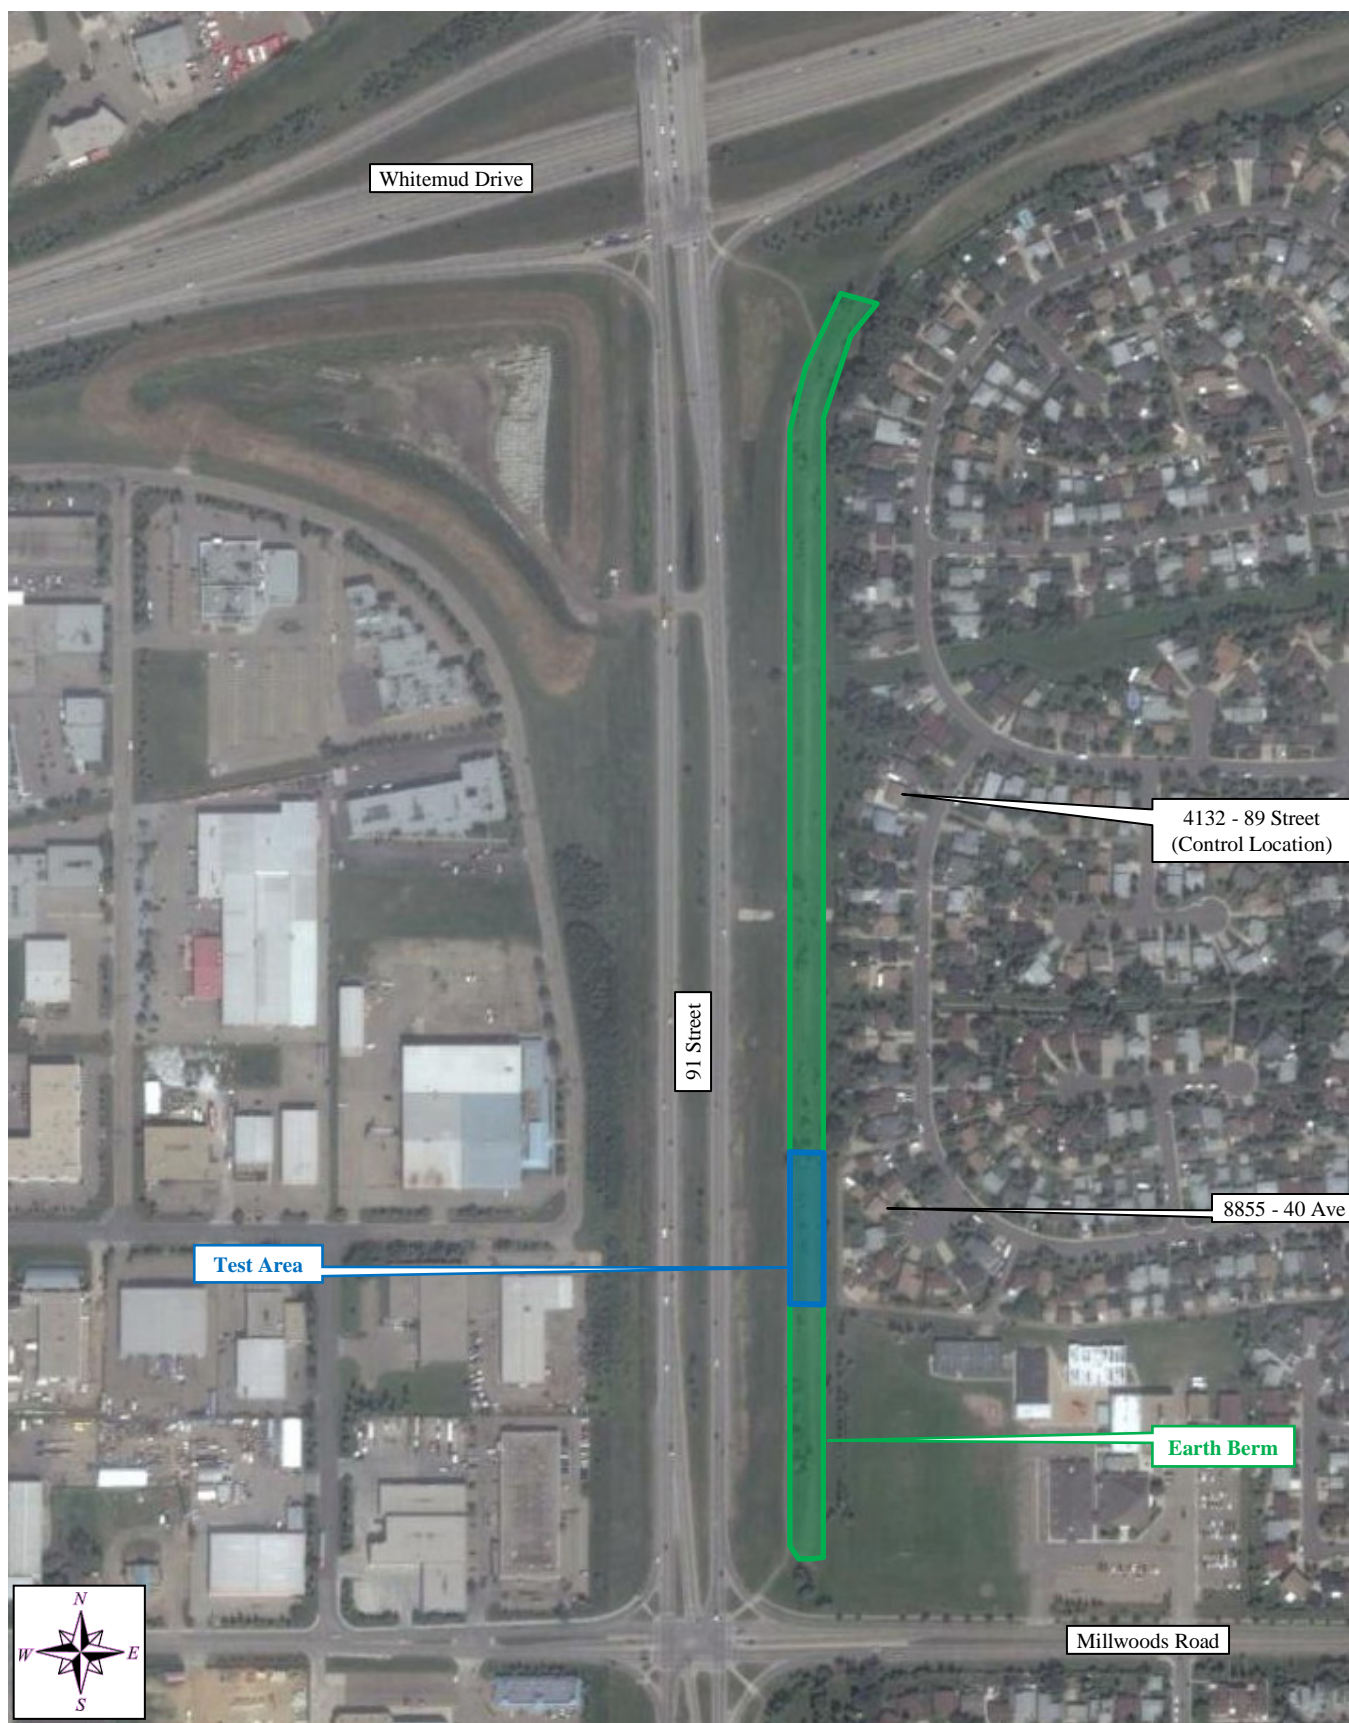
Figure 1. Study Area

The study area is located in the north Millbourne area of Edmonton, as shown in [Figure 1](#). The City of Edmonton Drainage Services is proposing to remove the existing earth berm located east of 91 Street to the north of Millwoods Road for the purposes of expanding the existing storm water management pond. The initial stage of the Project involved a test section with a portion of the earth berm removed and replaced with the vegetative style noise and visual barrier. As indicated in [Figure 2](#), the test section started at the south end from the alleyway to the south of 40 Avenue and spanned approximately 137 m to the north. This was directly behind the three houses in the cul-de-sac on 40 Avenue and 88 Street which back onto 91 Street.

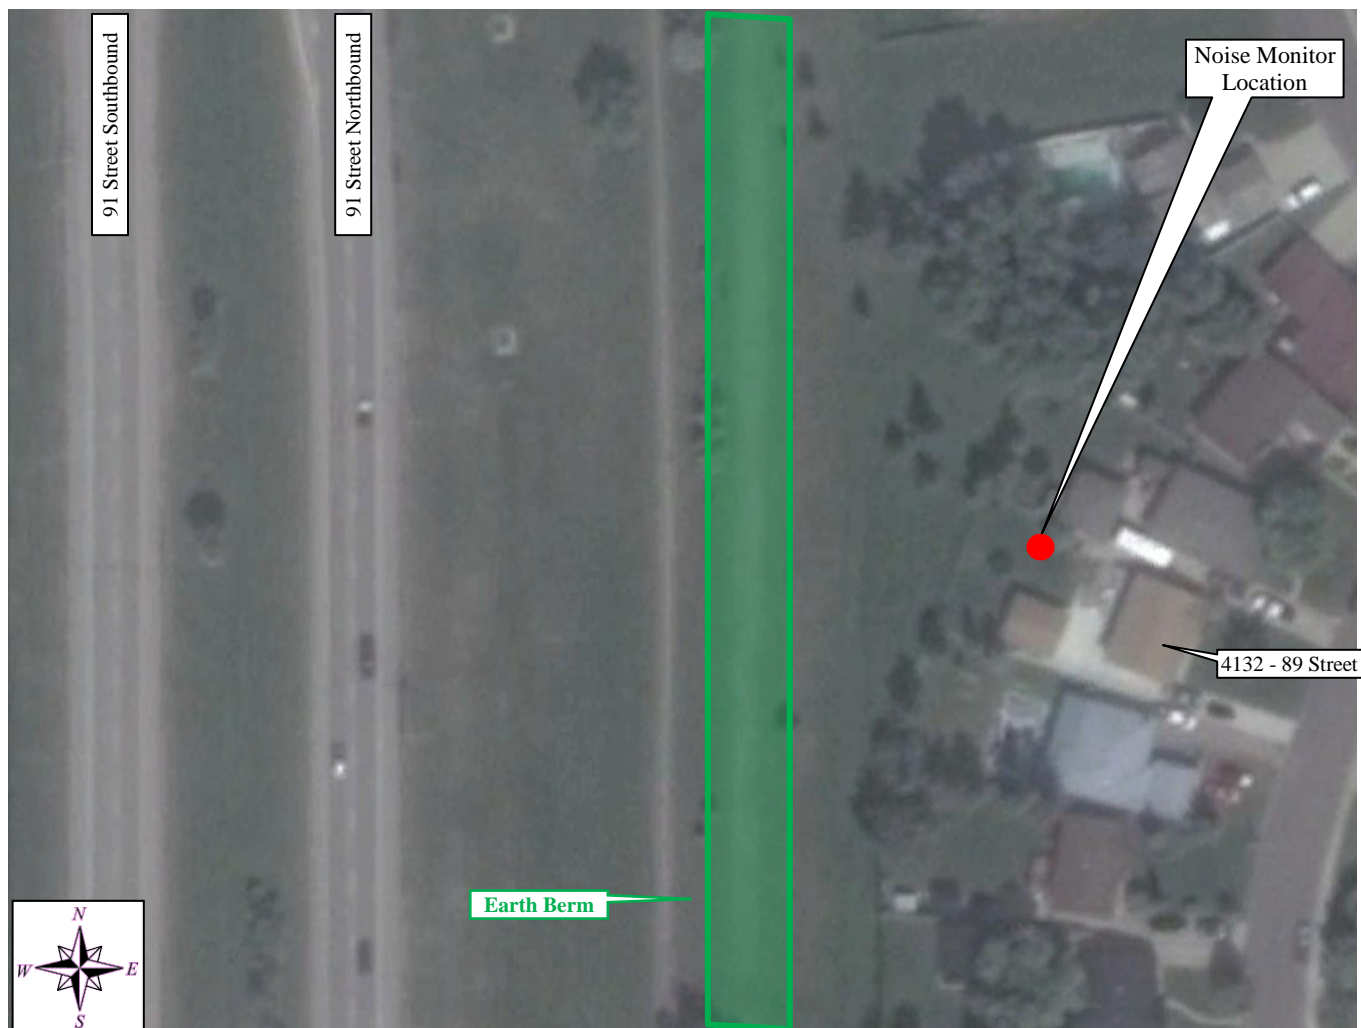
Figure 7. Noise Monitor Location at 4132 - 89 Street
