# CASE STUDY: EASTGATE YARD RAIN GARDEN

Location: Eastgate Yard, 9504 49 Street  
Construction Completed: 2015

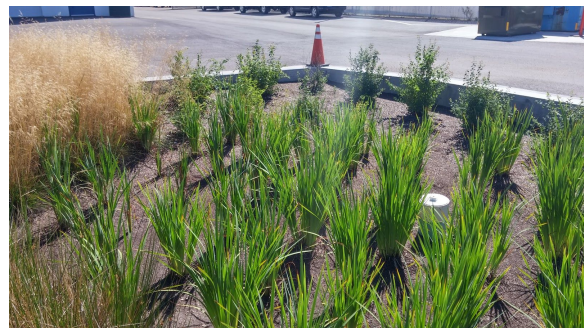
The rain garden continues to thrive in this location, with its plants growing well and ponding water draining away within less than 24 hours after rainfall.

*Thriving vegetation observed in the rain garden, Summer 2016.*
