BEAUMARIS LAKE OPEN SPACE

Preliminary Design Report

December 2018

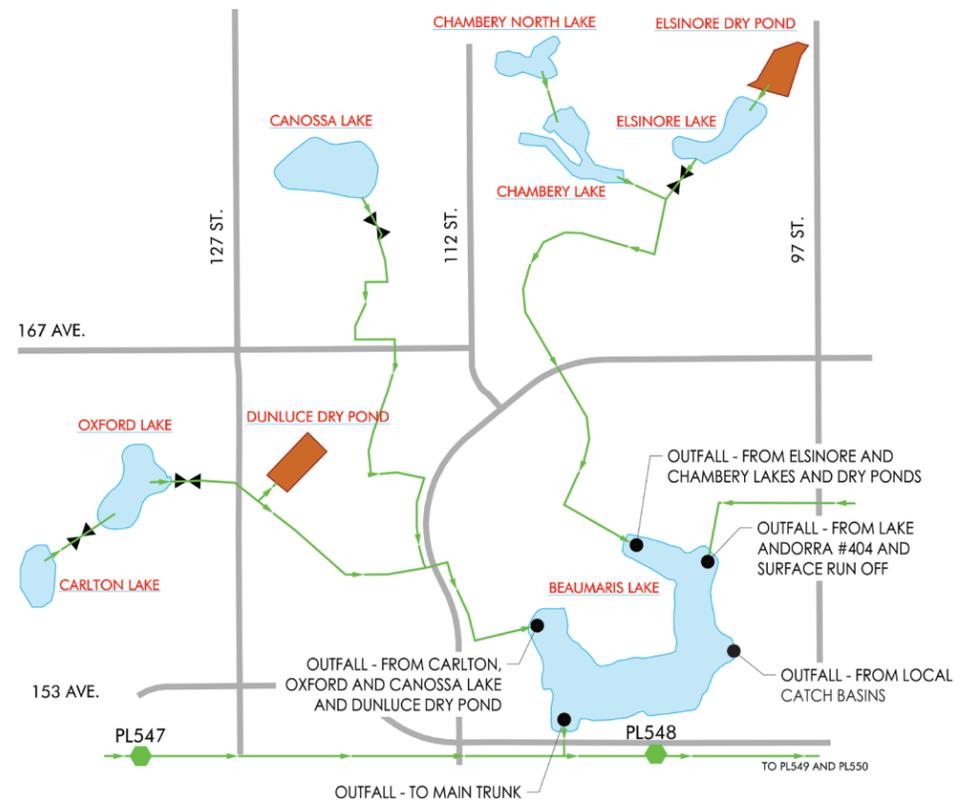
Located in north Edmonton, Beaumaris Lake is the oldest and largest storm water lake in the City. Opened in 1979, Beaumaris Lake is a well-loved destination for residents and visitors, displaying a panorama of marsh plant life, mature trees, birds, and wildlife. With approximately 2.5km of trails around the lake, it is a popular location for running, walking, cycling, and other methods of active transportation. The lake also serves a functional purpose, playing a key role in a much larger drainage network spread across northwest Edmonton (refer to Storm Water Network graphic, this page). Beaumaris Lake serves as the final collection point for surface water runoff from a series of stormwater lakes stretching from 135 Street to 97 Street and from Anthony Henday Drive to 153 Avenue.

Beaumaris Lake Storm Water Network

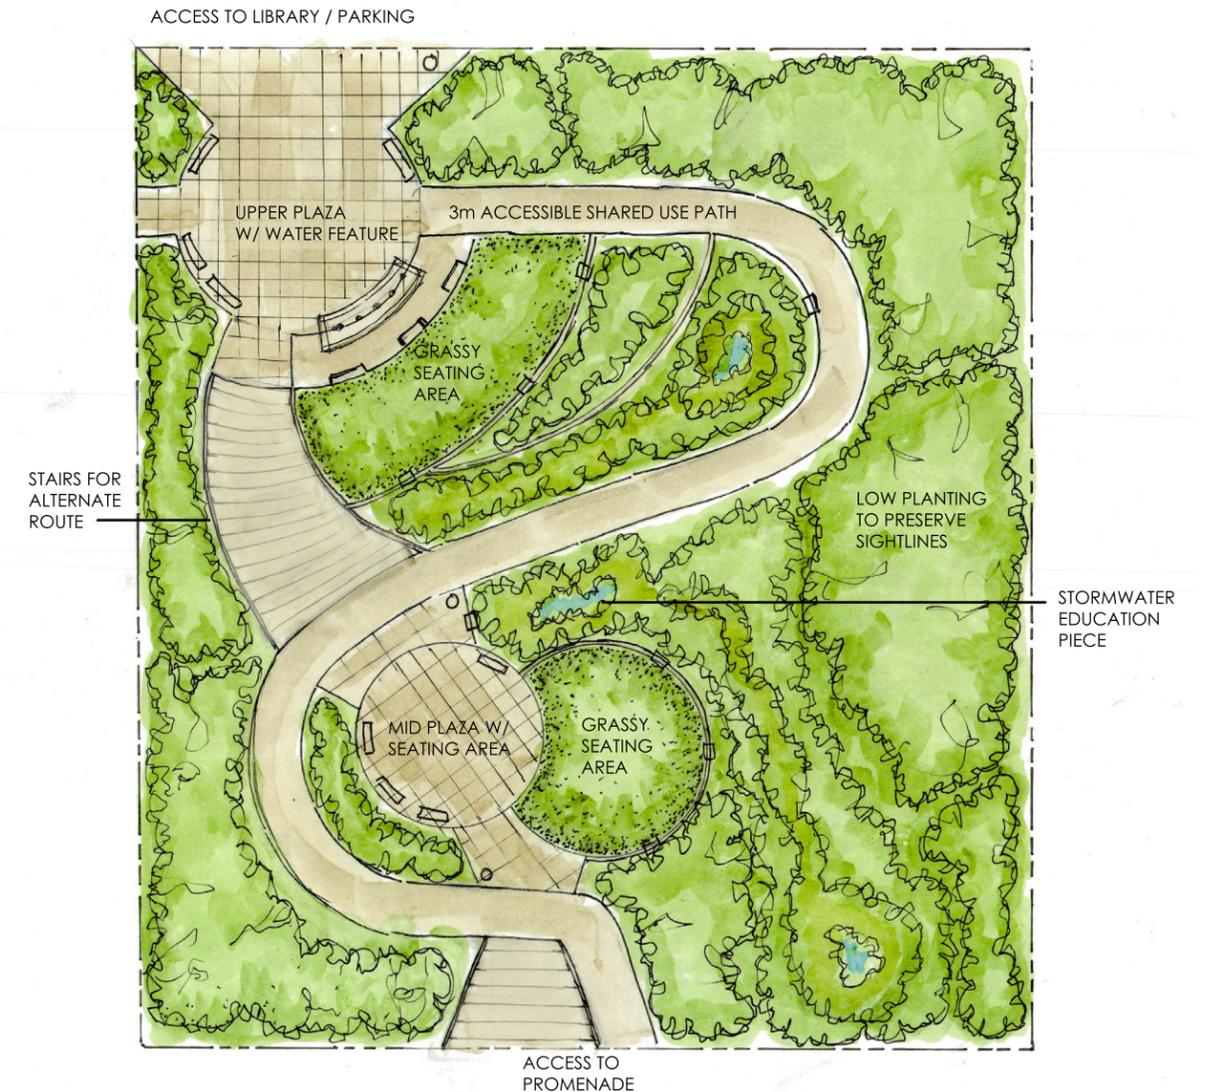
The final design includes a gentle, winding path to provide universal accessibility, as well as a wide staircase for a direct route to the promenade. Space is identified in the upper plaza for an interactive art or water feature, and several seating and resting areas are available in the upper, mid, and lower plazas. The upper and mid plazas both have adjacent open lawn areas, and interpretive rain gardens are included to showcase the importance of natural stormwater management.

West Park Preferred Concept Plan

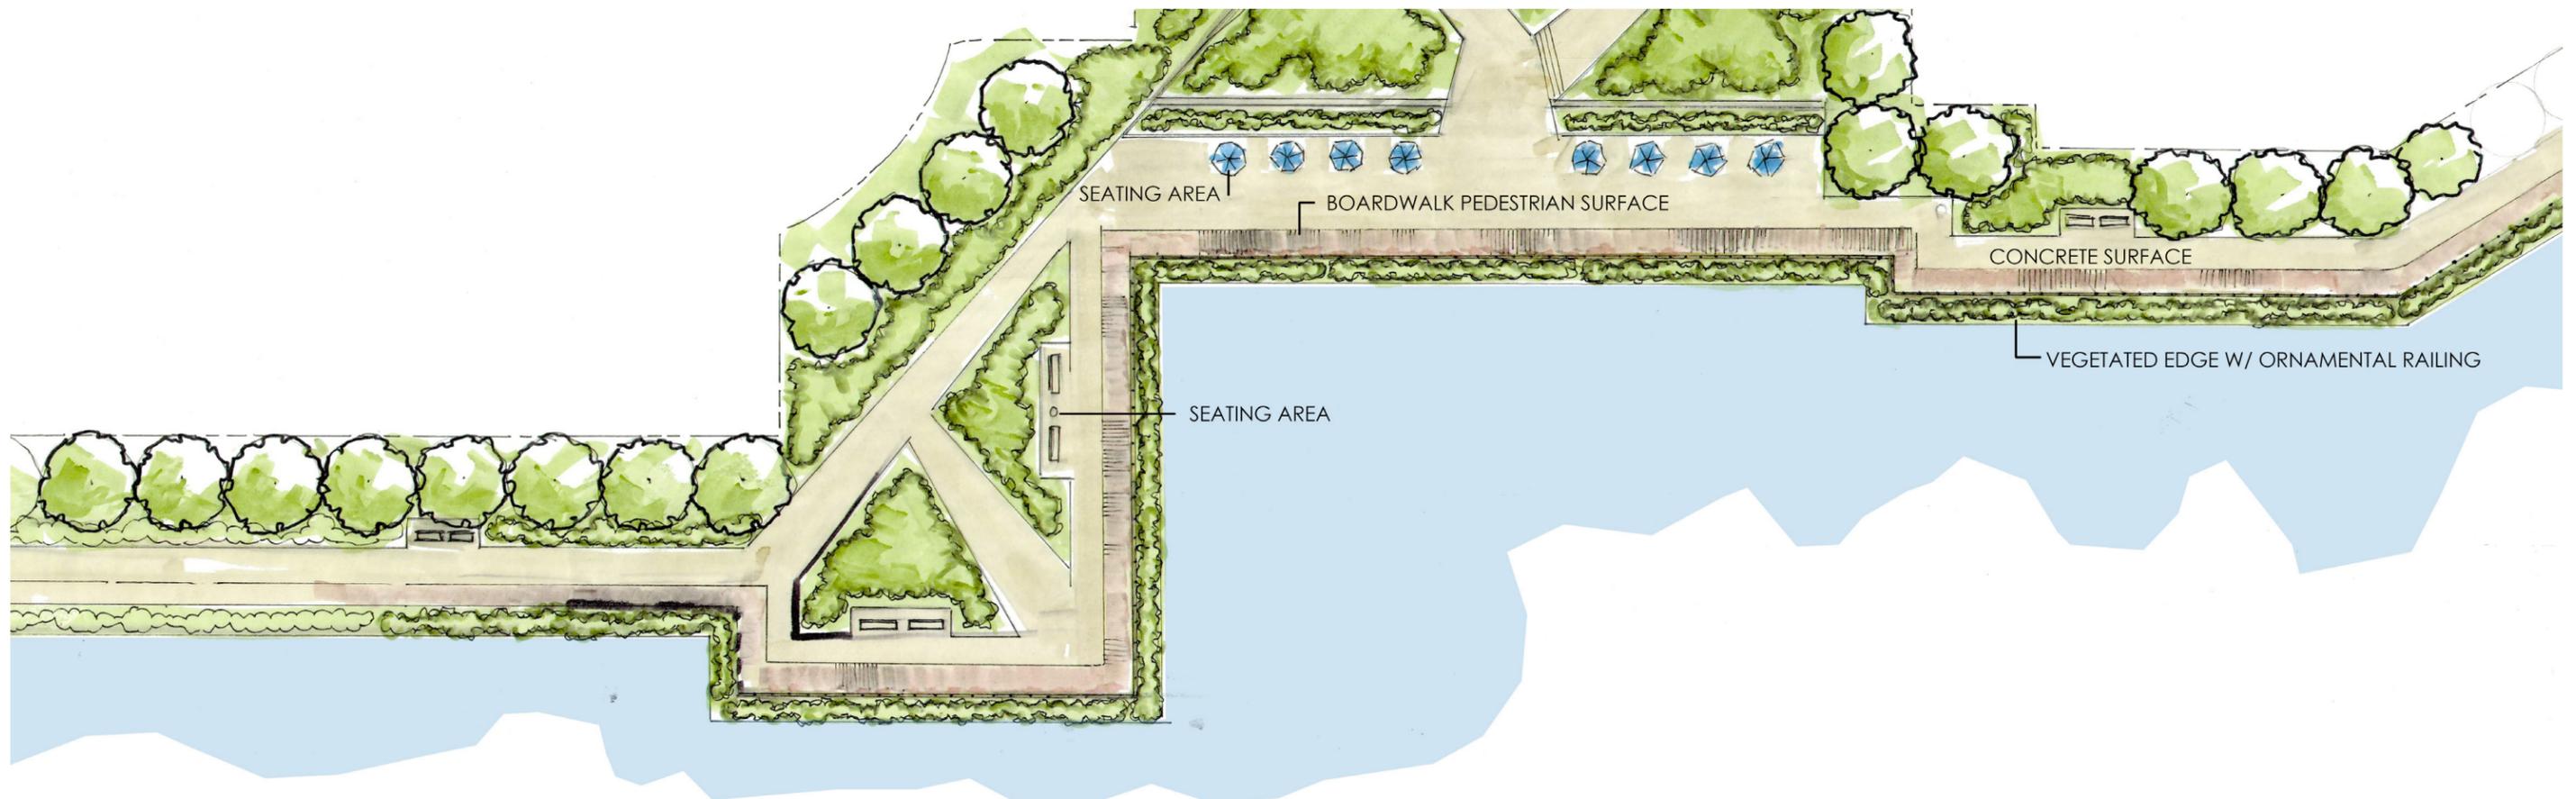
The design for the Promenade looks to balance the users in the Promenade area. A vegetated edge is added to the face of the Promenade wall, creating a softer edge around the lake front. The solid, concrete barrier will be removed, and replaced with a decorative railing to match the rest of the lake, and allow views through. The paving materials represent a separation between the various users on the Promenade. The boardwalk pavers represent the traditional use of wood decking along a waterfront promenade and the slow movement of people walking and resting. The concrete surface signals a faster movement area that can be used for cyclists. Due to the high volume of people using the promenade, signage could be used to differentiate between the areas to avoid conflict.

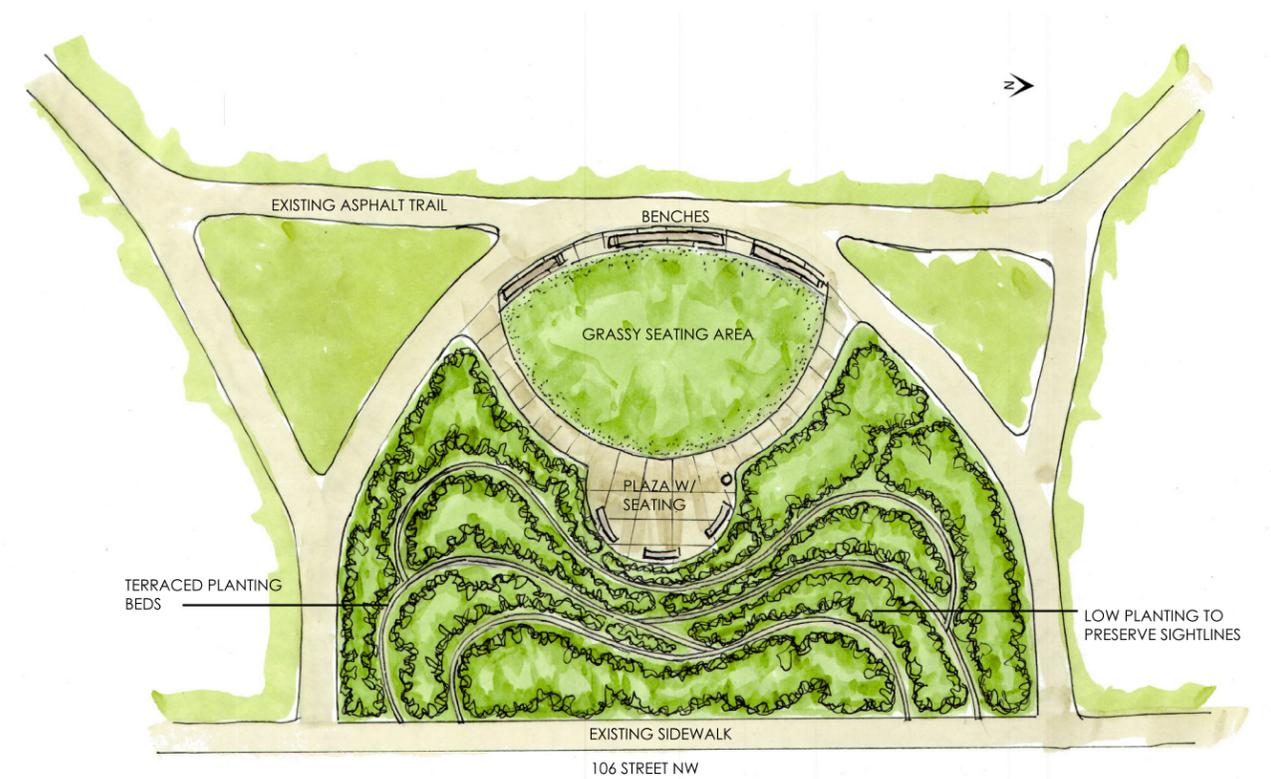
The community was interested in discouraging gathering close to the road, concentrating it on the lower level, adjacent to the shared use path. Views from the road will remain unobstructed, and site lighting has been design to increase visibility into the park.

East Park Preferred Concept Plan

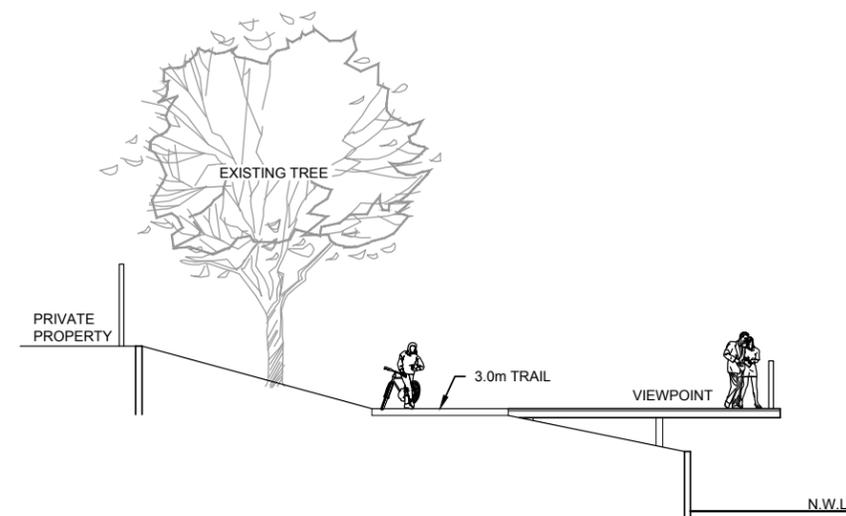
There are two existing viewpoints and three existing dock structures on Beaumaris Lake. The viewpoints were deemed to be in good condition, while the dock structures were very poor, with two of the three closed to public use. Due to their condition, user safety concerns, and EPCOR requirements, the docks are to be removed, and are proposed to be replaced with raised viewpoints, similar to the existing ones. The foundations for these viewpoints will be installed behind the existing lakeside walls, and the surface is designed to cantilever over the lake edge.

Typical Viewpoint Cross Section

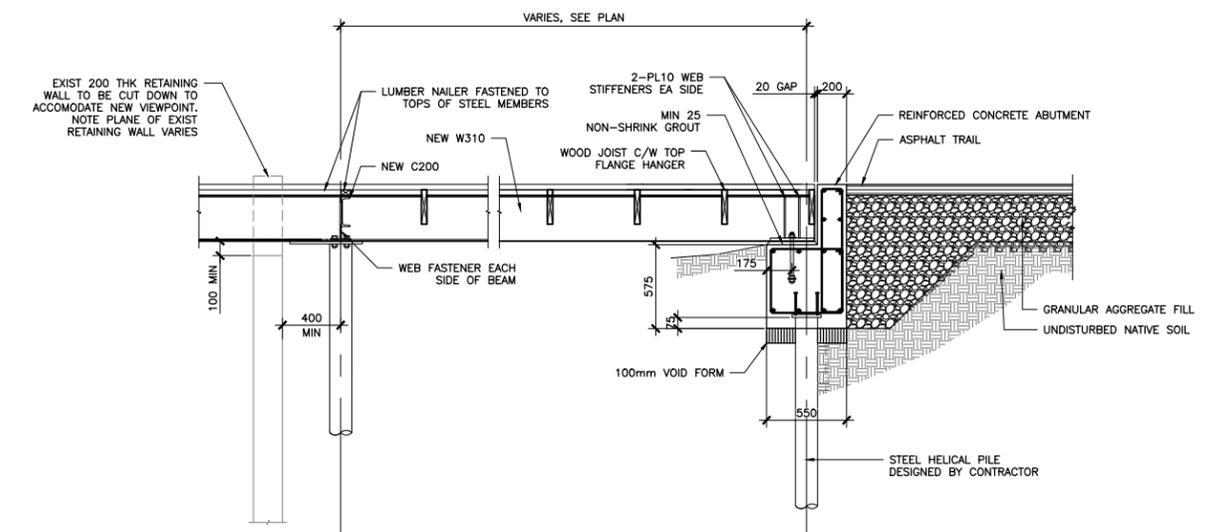
At Viewpoints 2 and 3 (refer to Project Context Map on Page 3 for locations), there are two tiers of existing lakeside retaining walls. The lower tier will remain as is, with the piles for the new viewpoints installed as described above. The upper wall extends approximately 1m above the existing grade and maintains the structural integrity of the upland trail and ground. The design for this is to cut the wall below grade and construct a new abutment atop the existing wall. This will maintain the integrity of the retaining wall, while allowing for the construction of the new viewpoint.

Altered Lakeside Retaining Wall Detail

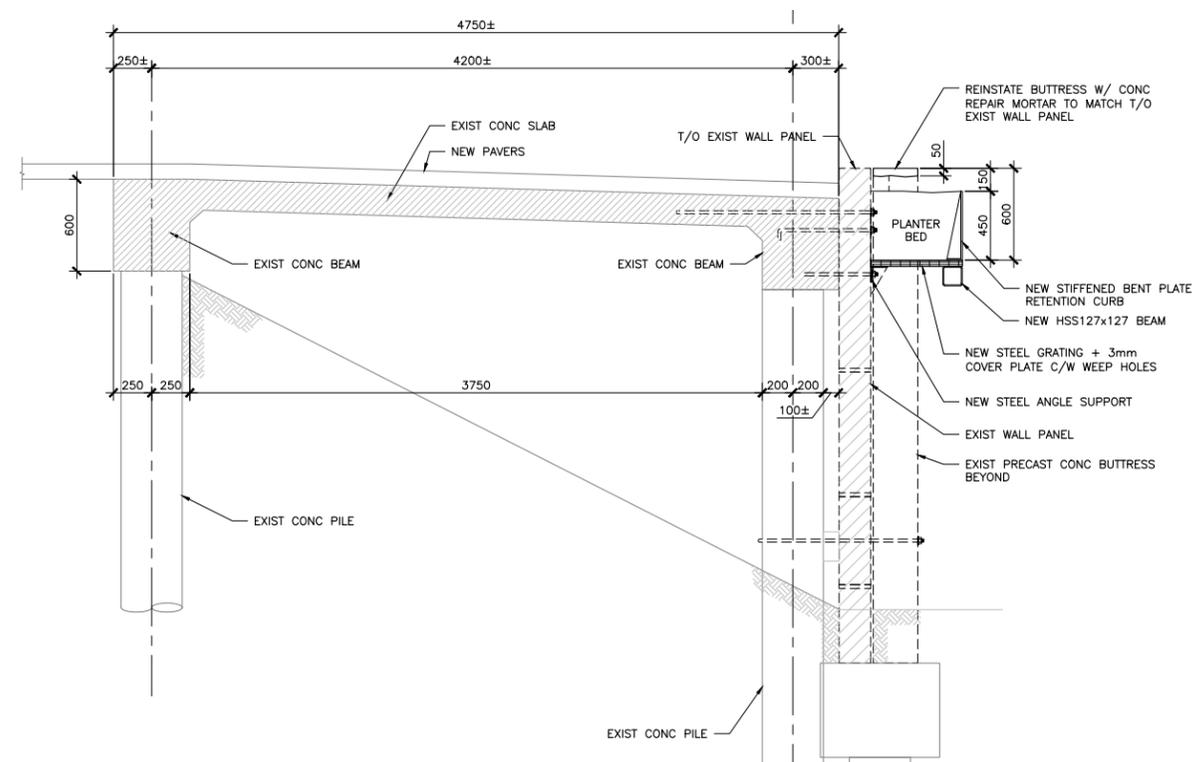
Proposed Cantilevered Planter Detail

The design of the cantilevered planters has evolved through the design phases in response to structural investigation, Operations feedback, and limitations in place from EPCOR. In concept design, the Promenade structure was proposed to be cut to accommodate the area required for soil and planting. Through further structural investigation, it was identified that this approach would not be achievable due to the hollow structure and the need to modify the piles holding up the existing slab. City Operations expressed their desire to be able to step onto the planters in order to maintain the plant material, so the first preliminary design of the cantilevered planters had piles extending into the lake in order to provide the structural support for maintenance workers. This design was not approved by EPCOR, as the intent for all new infrastructure was to stay out of the water. Therefore, the design was modified to remove the structural piles and span between the buttresses on the face of the pre-cast panels and anchor into the buttresses. The result of the planters will be a continuous soft edge around the lake, replacing the hard, utilitarian edge of the Promenade. The planting can also provide habitat for birds and water fowl found around the lake.

The cantilevered planting bed along the Promenade presents a unique maintenance situation. As noted in the Structural Engineering section, the design of the planters has evolved through the design phases. Although Operations desired the ability to step onto the planters, due to the limitations listed in the Structural Engineering section, the design could not allow for this. As a result, the design has the planters slightly below the surface of the promenade, and the proposed railing is set back from the edge to allow maintenance workers to work on the lake side of the railing and clean out the planters when needed. The proposed railing will be designed with tie-backs and to support the weight of the workers.

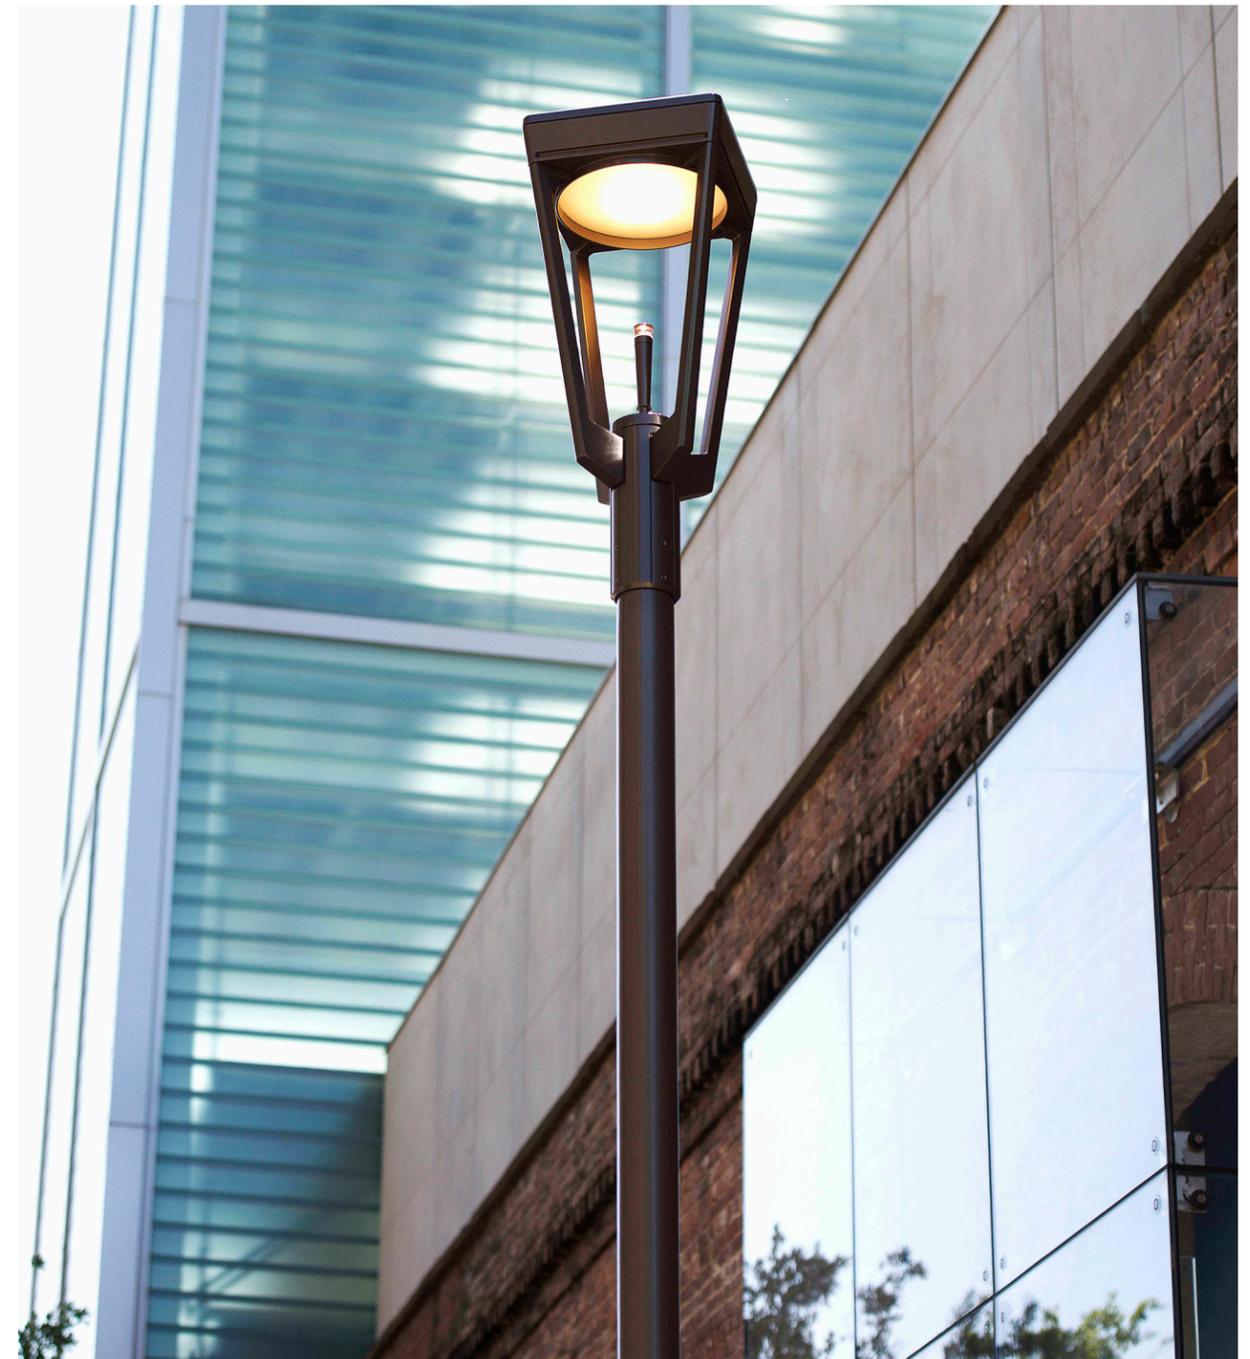
The scope identified for preliminary design was to remove all existing lighting, including concrete bases, abandon the existing power in place, and replace with new lighting along the trail and in the West and East Parks. After further consultation with the City's electrical engineering group, it was identified that the lighting within the project area, with the exception of the West Park, is currently an asset of EPCOR Distribution and will need to be transferred to City assets. The preliminary design has been updated to include new cabinets and meters to facilitate this transfer of assets, and drawings have been submitted to EPCOR for review. EPCOR is in the process of inspecting their assets around Beaumaris Lake in order to provide a plan on how best to service the metered cabinets. During Detailed Design, further coordination with EPCOR Distribution will need to take place to coordinate and finalize the electrical services and meter locations. Coordination with EPCOR during construction will also be needed for removal of the existing light poles, and installation of the cabinets and meters.

Ashbery Light Fixture - Landscape Forms

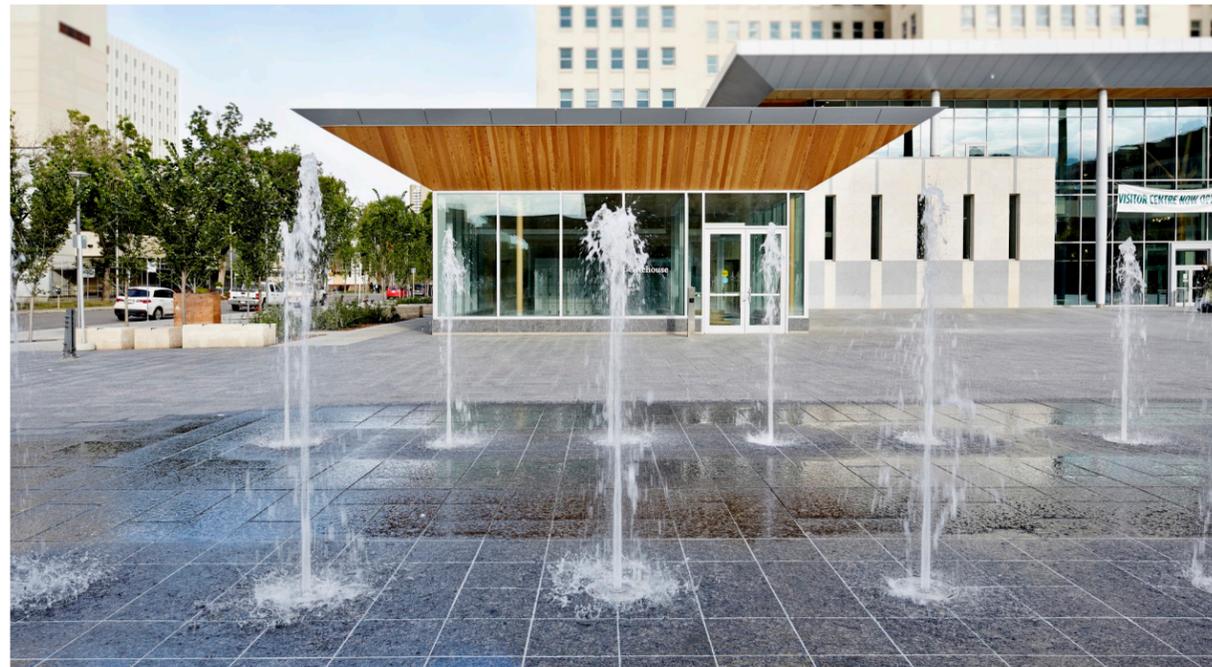
Water Feature Precedent Image

The water source of the interactive water feature will come from a 50mm (2") water service that will be brought in through an existing walkway easement west of the park space. This feature will consist of three low flow ground sprays, as well as a push button activator, which will control the use of the water feature. The water from the ground sprays will drain to the center of the plaza and be picked up by a 100mm drain pipe to daylight and be released into the first tiered bioswale planting bed.

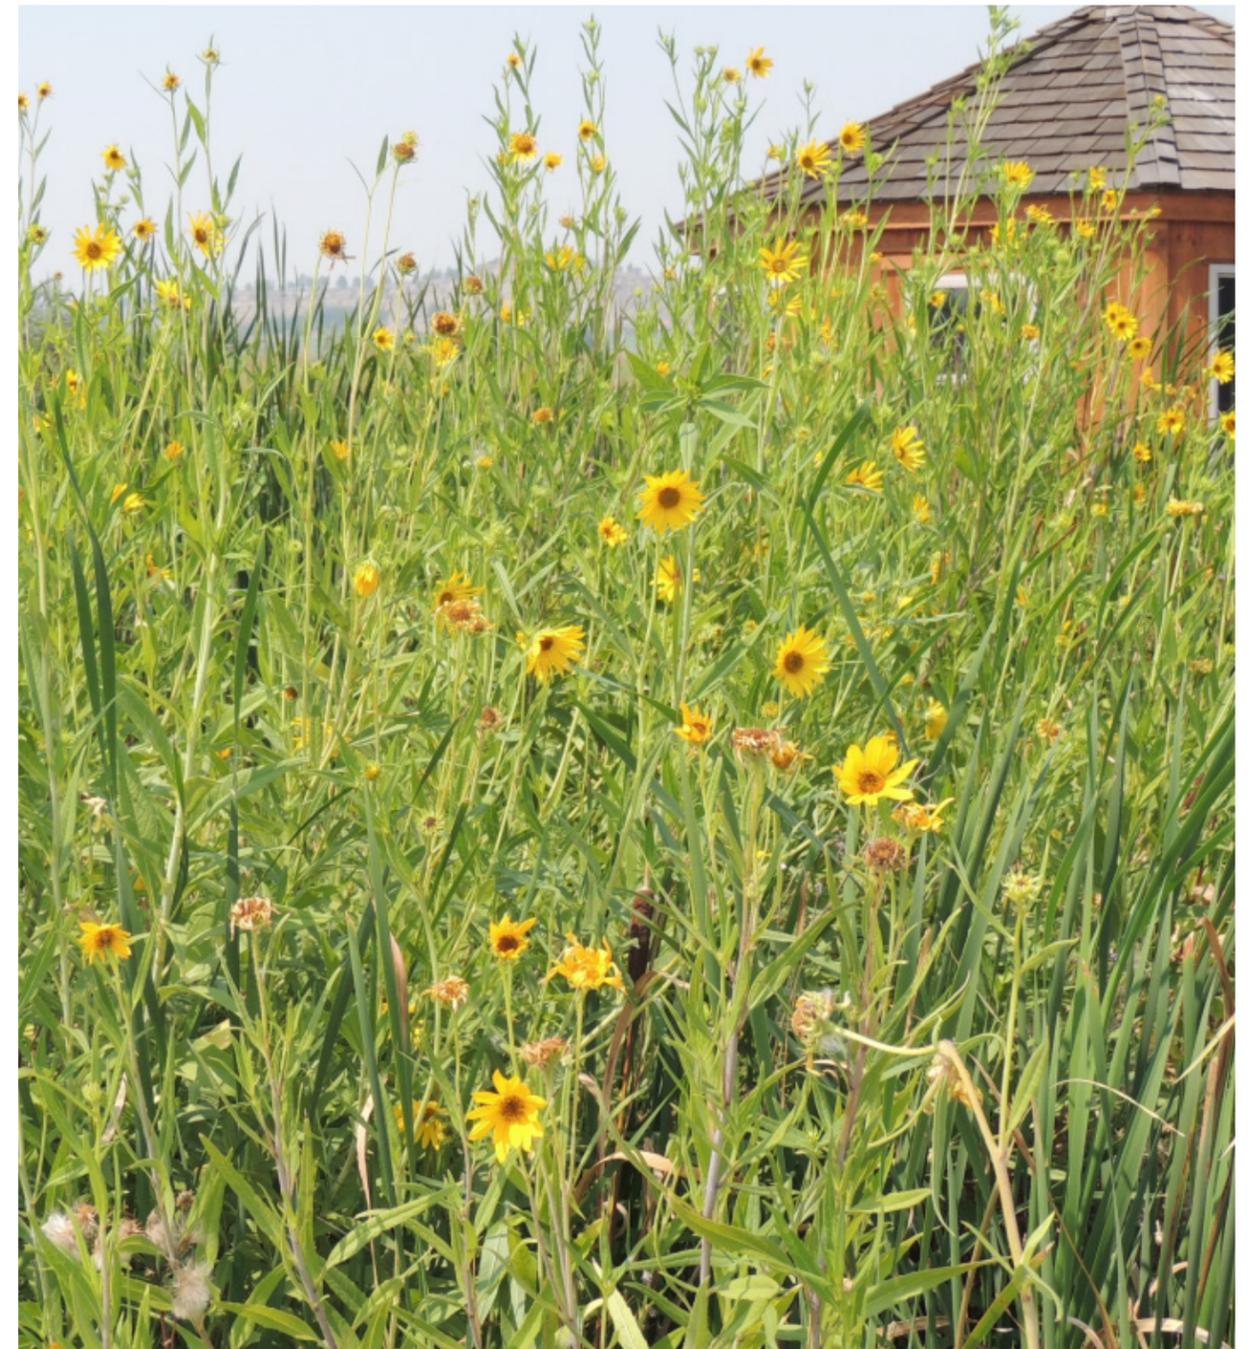
Since the costs associated with draining the interactive water feature into a sanitary line is not feasible within the budget of this project, the design intends to treat the greywater from the water feature with phytoremediation to ensure any contaminants that may be present will be filtered prior to the water entering into the stormwater management facility. The total length of planting features that the water will travel before it enters the storm water management facility is approximately 70m long. During this time much of the water will infiltrate through the soil and any excess will flow through to the storm water management facility.

Phytoremediation Plant Material Precedent Image
