Hawrelak Lake Water Quality Feasibility Study

City of Edmonton, Alberta, Canada

16 December 2020

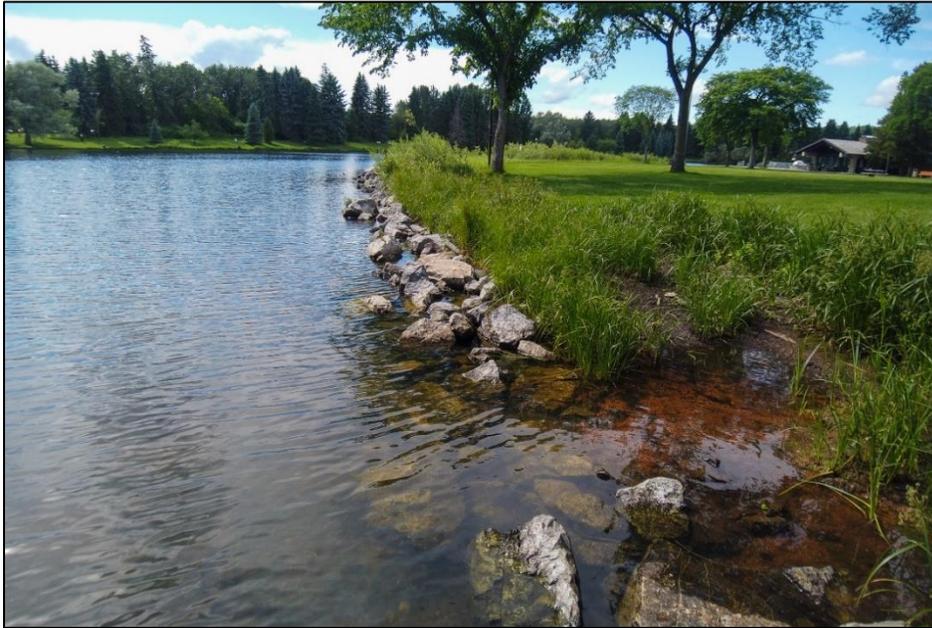
Figure 3. Hawrelak Lake east shore, with riprap and a narrow, unmowed strip of vegetation

- There is a narrow, vegetated buffer along much of the lake edge, but little emergent vegetation. Photos taken on July 31, 2020, illustrate conditions at the lakeshore (Figures 3-8).
- The small pond and stream that drain to the lake are filled with lake water from a pump near the pavilion; the pump is managed by the City of Edmonton. The pond and stream are used as interpretive features by a volunteer organization.

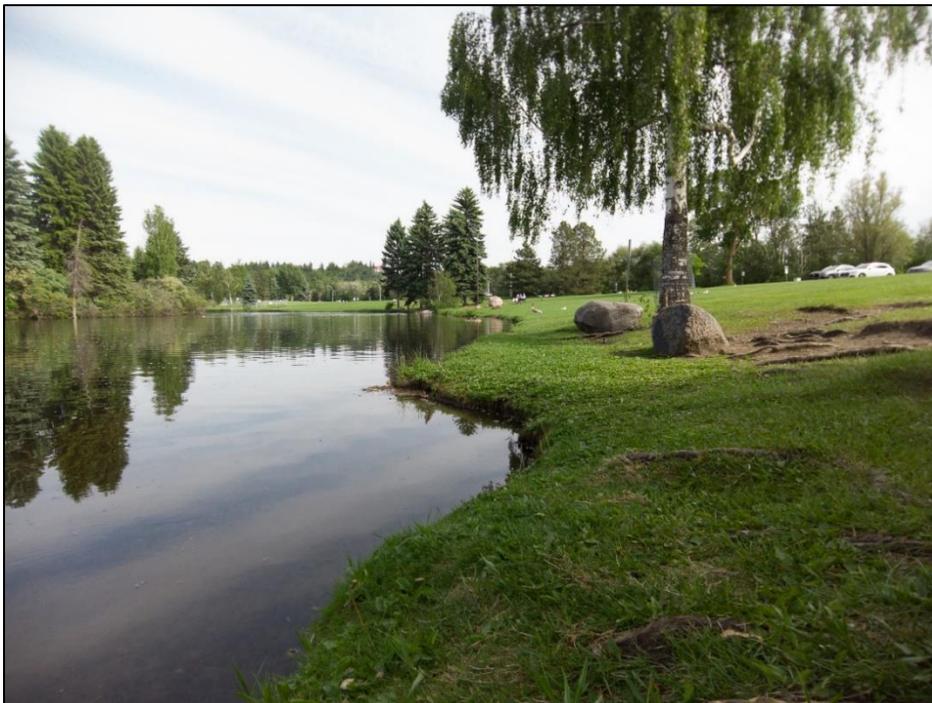
Figure 4. Hawrelak Lake north shore, west of beach, with turf mowed to water

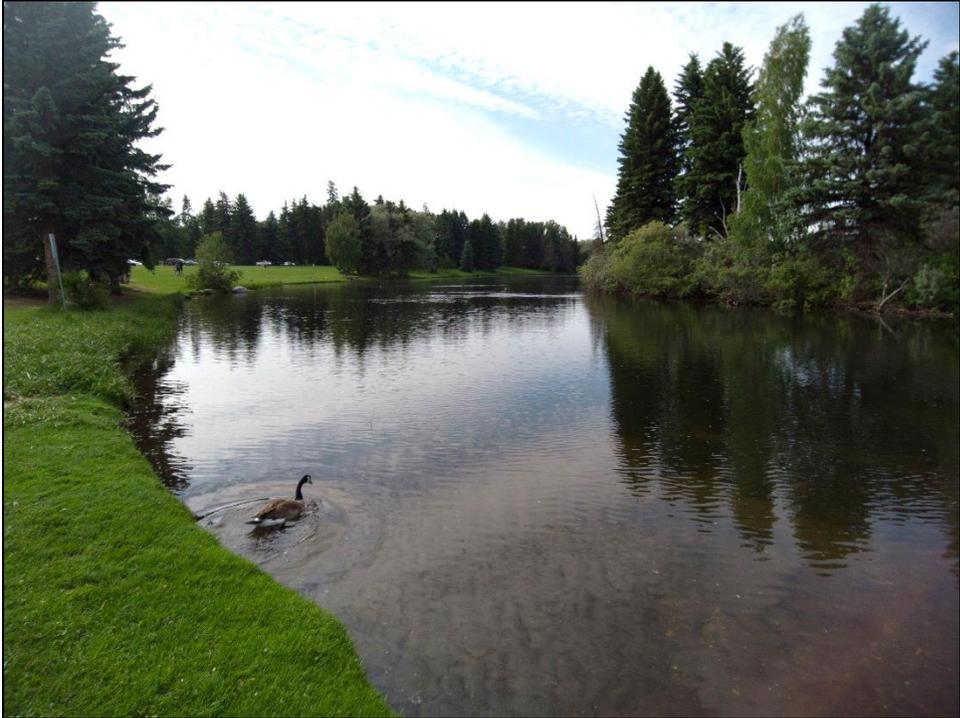
Figure 5. Hawrelak Lake north shore, with turf mowed to water's edge

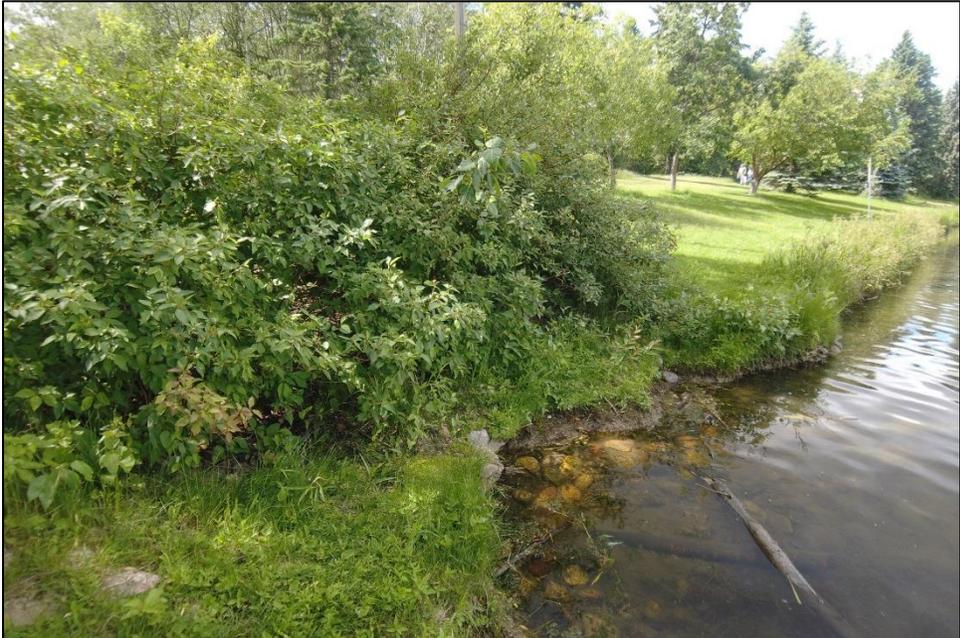
Figure 6. Hawrelak Lake west shore at river water outfall, with narrow, unmowed strip of vegetation

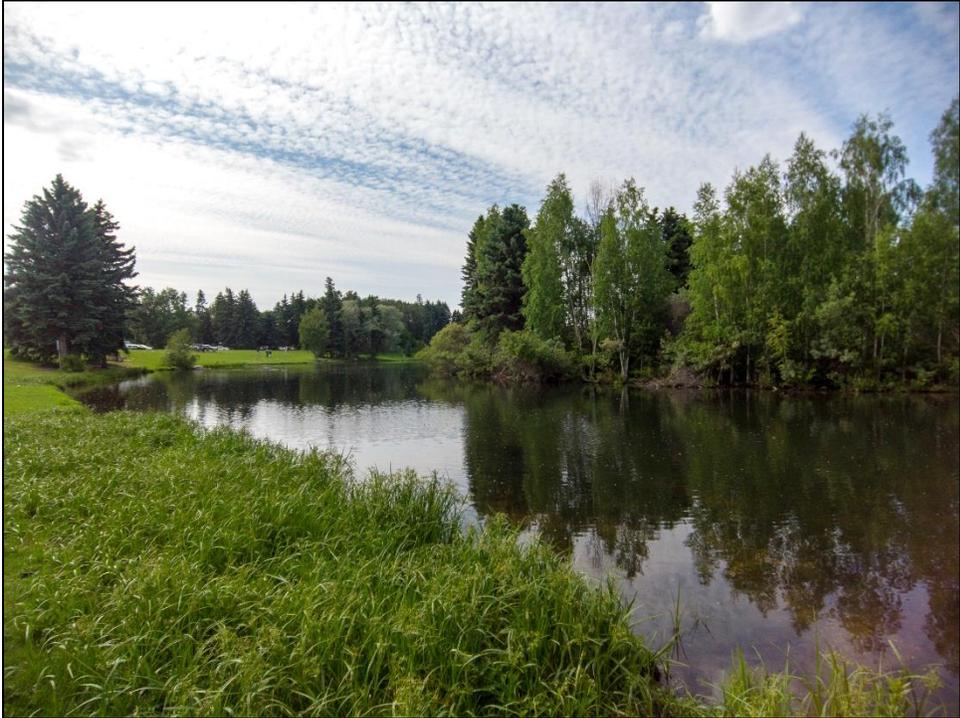
Figure 7. Hawrelak Lake west shore, with small patch of native bulrushes, a marsh plant

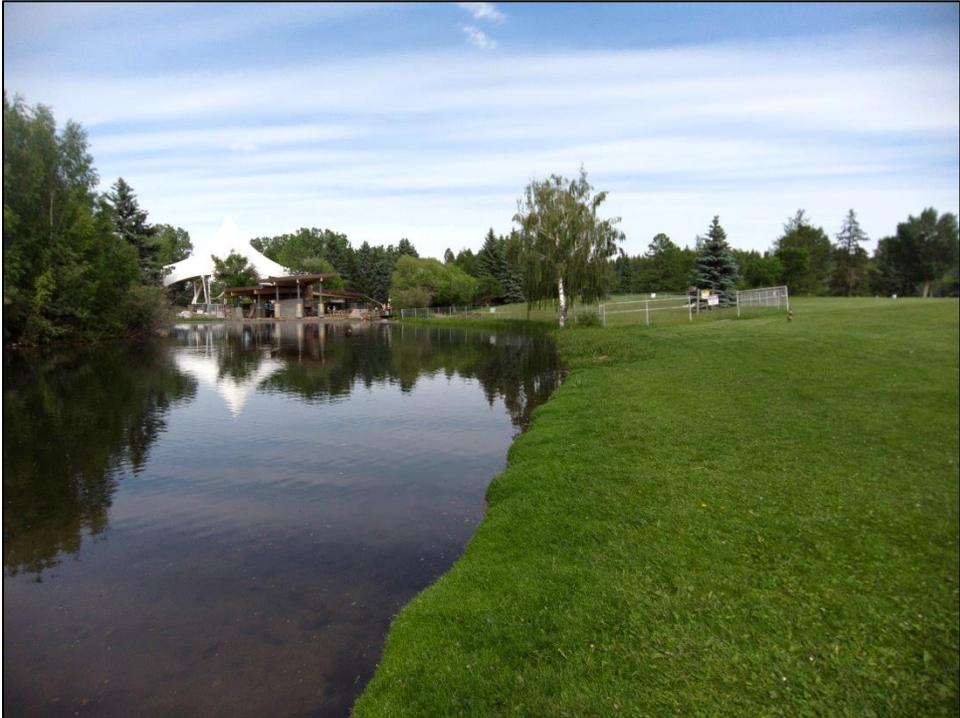
Figure 8. Hawrelak Lake south shore, with turf mowed to water's edge

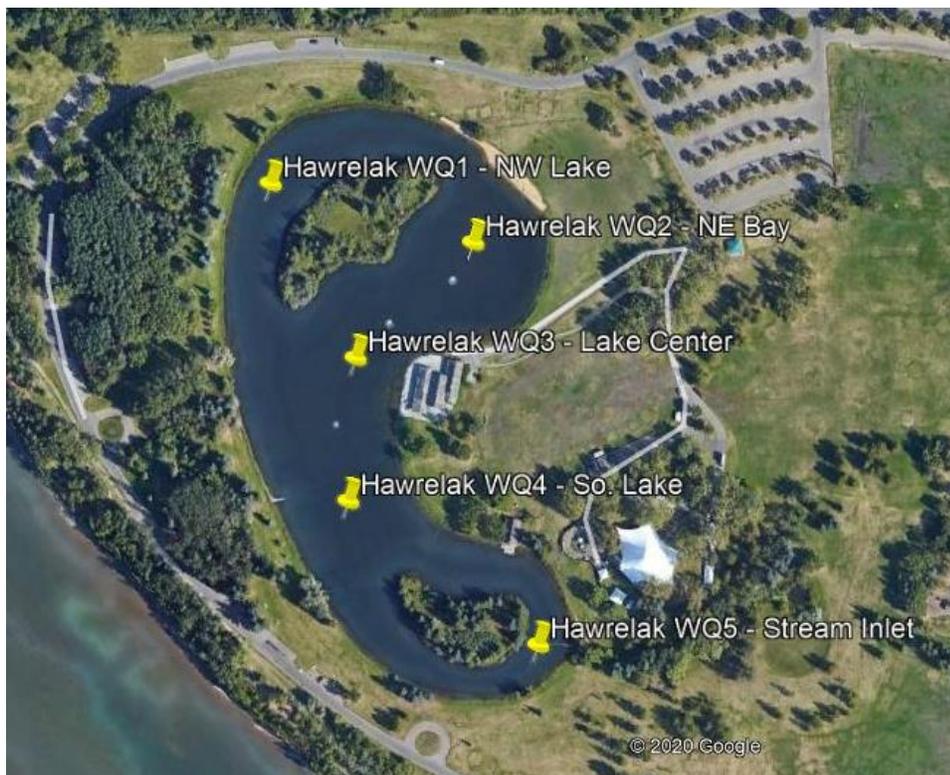
Figure 9. Hawrelak Lake water quality sampling locations, 2020

City staff began sampling water quality in the lake shortly after the master planning process began in spring 2020. Five sampling locations were chosen to represent different sections of the lake (Figure 9). Two samples were taken each month, beginning June 18 and ending October 14, 2020, after which ice formed, preventing water quality sampling. (Water quality sampling will begin again at ice-out in March or April and continue through June 2021 to complete a year's sampling.)

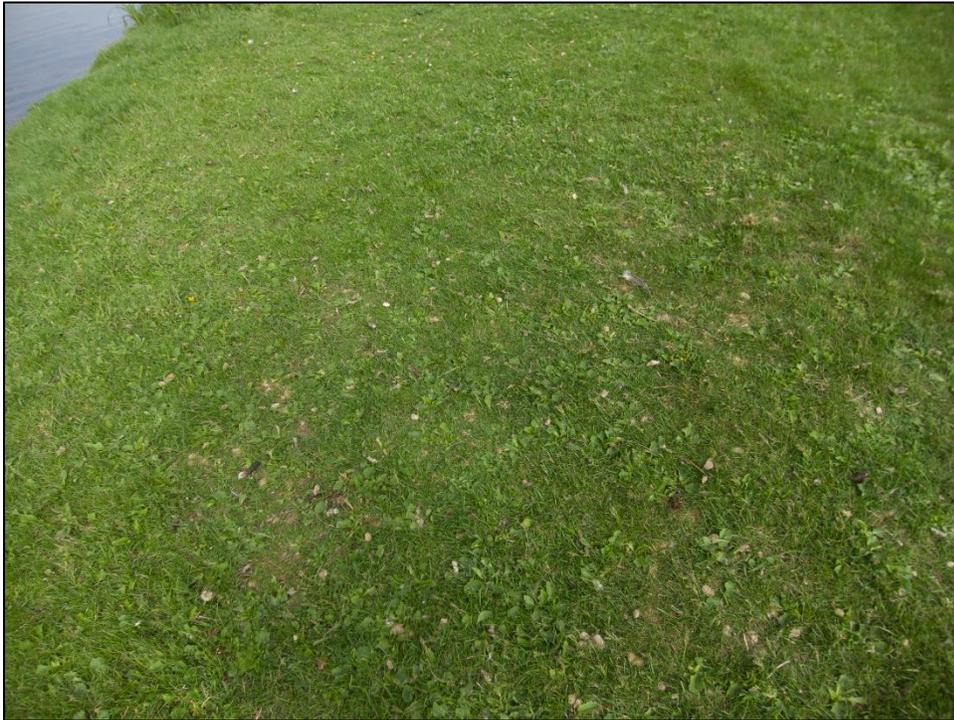
Figure 12. Hawrelak Lake south shore, with evident high density of goose droppings

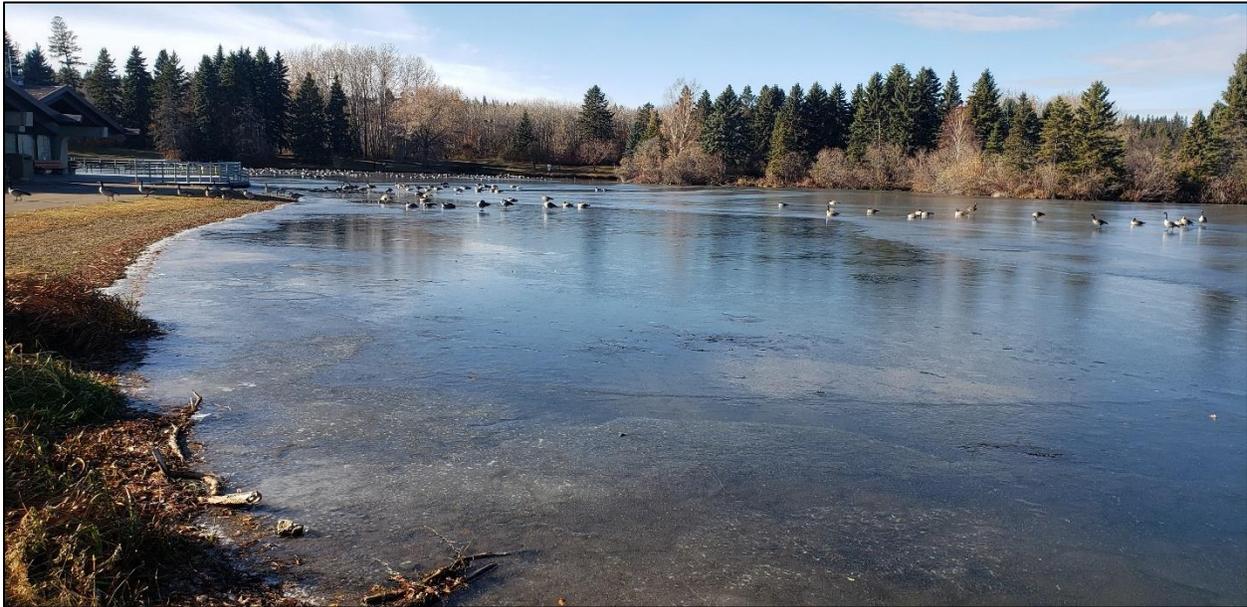
Figure 14. Geese (150-200) on Hawrelak Lake ice, October 5, 2020

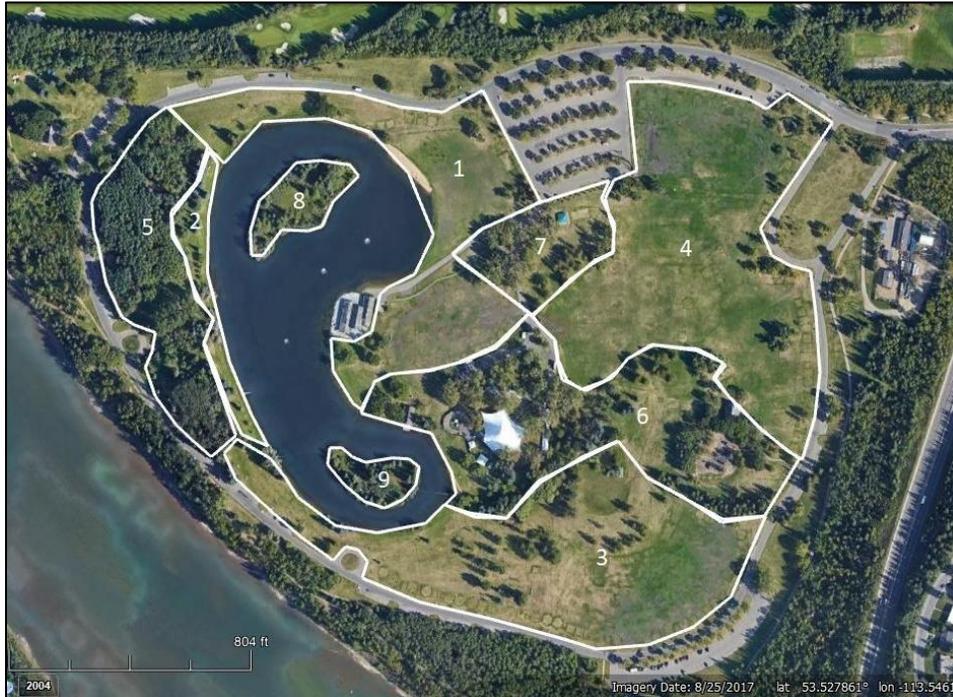
Figure 17. Hawrelak Lake Park soil sampling areas (1-9)

Soils were tested to determine character and bulk density, which can influence water quality. Appendix 2 presents the Soil Analysis Summary for the project. Nine soil testing areas of similar vegetation cover were sampled in July 2020 for chemical constituents and bulk density (Figure 17).

The total phosphorus and Kjeldahl nitrogen levels in all areas greatly exceeded typical levels in soils (Table 3, Appendix 2). This suggests the soil is a potential source of soluble phosphorus and nitrogen, which could be borne to the lake in shallow groundwater, assuming the lake's clay liner is breached or that groundwater movement is lateral rather than vertical. Sand-clay percentages indicate the soils are clay loams to loams. The dry bulk density (0.65 to 0.95), however, was consistent with loam soils.

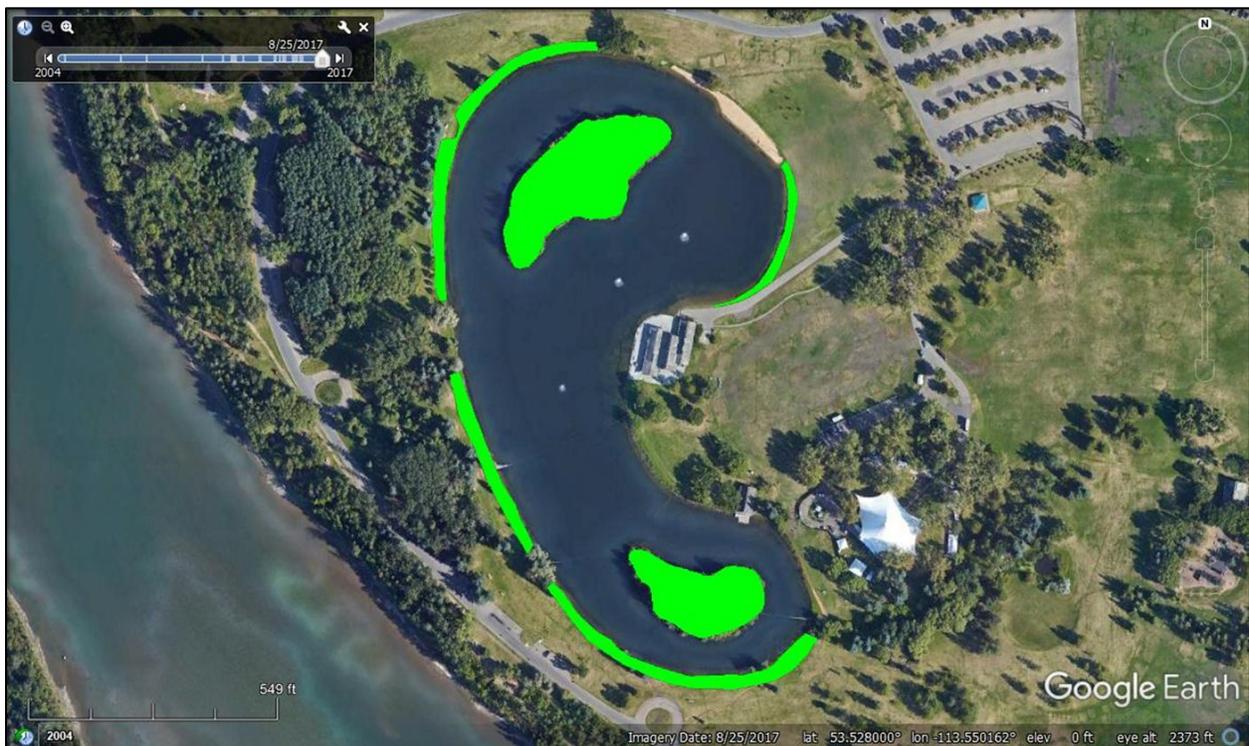
Figure 21. Potential island plantings and 25-ft buffer (emergent plants are lakeward of the buffer)

- **Plant emergent vegetation in water.** In this BMP, a mix of native aquatic species is installed as live plants, from the water's edge generally out to 3 feet. Chlorination for ITU events will not affect the vegetation if plant species are chosen for chlorine tolerance. A dense emergent planting will discourage goose nesting at the shoreline. The public reaction to taller vegetation around the lakeshore will dictate feasibility.

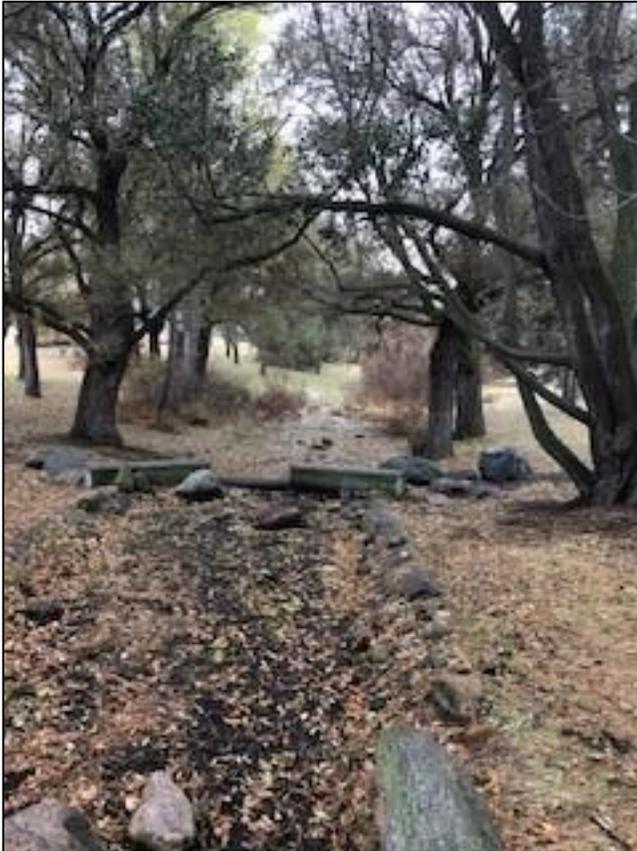
Figure 22. Shaded stream corridor near the southeast corner of the lake

- **Re-landscape and dredge the pond and stream area.** If the pond-stream system harbors bacteria, and if the bacteria are not killed in winter when water is no longer pumped from the lake to the pond, exposing the pond bottom and streambed to ultraviolet radiation in sunlight could kill bacteria in the sediment. The stream, however, is shaded, reducing the amount of sunlight reaching it (Figure 22). Measures to expose the stream to sunlight would include selectively thinning the tree canopy and understory and planting trees away from the stream to compensate for canopy loss. Dredging the pond and stream of sediment could remove that potential source of bacteria. This work could be incorporated into landscaping plans for the Pavilion and vicinity. Before proceeding, the presence and abundance of bacteria in the pond bottom and streambed sediments should be evaluated.

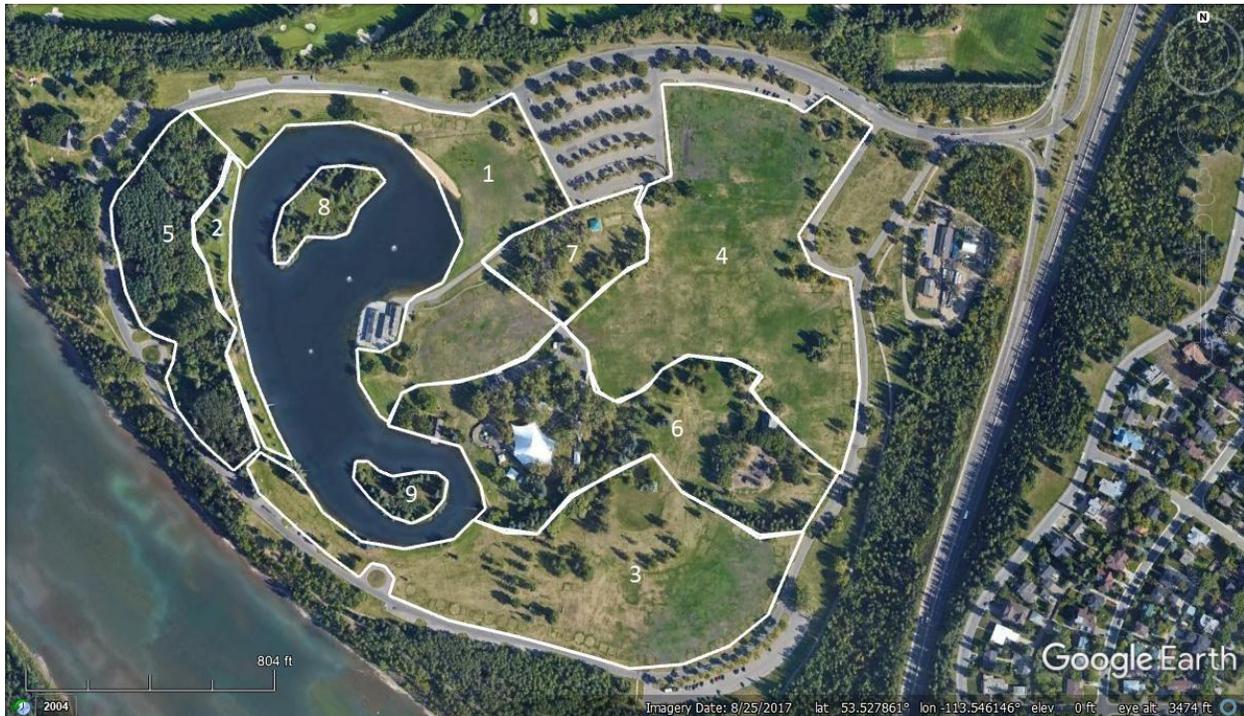
Figure 1. Soil sampling areas at Hawrelak Park

City staff with AES guidance gathered soil samples from Hawrelak Park to understand the constituents and character of soils and their potential effect on the water quality of Hawrelak Lake. Two soil samples from the top 10cm of the soil profile were obtained and combined for analysis in each of nine soil sampling areas at Hawrelak Park (Figure 1). Soil samples were taken in July, 2020. Soil bulk density samples also were obtained in each of the soil sampling areas in the same time period.

The soil samples were analyzed for constituents and character. The total phosphorus and Kjeldahl nitrogen levels in all soil sampling areas greatly exceeded typical levels in soils (Table 1). The sand-clay percent on average type the soils as clay loams, tending towards loams.
