NHC Ref. No.1004400

3 June 2020

**Re:** Touch the Water Promenade and North Shore Promenade – Final Report  
Hydrotechnical Assessment

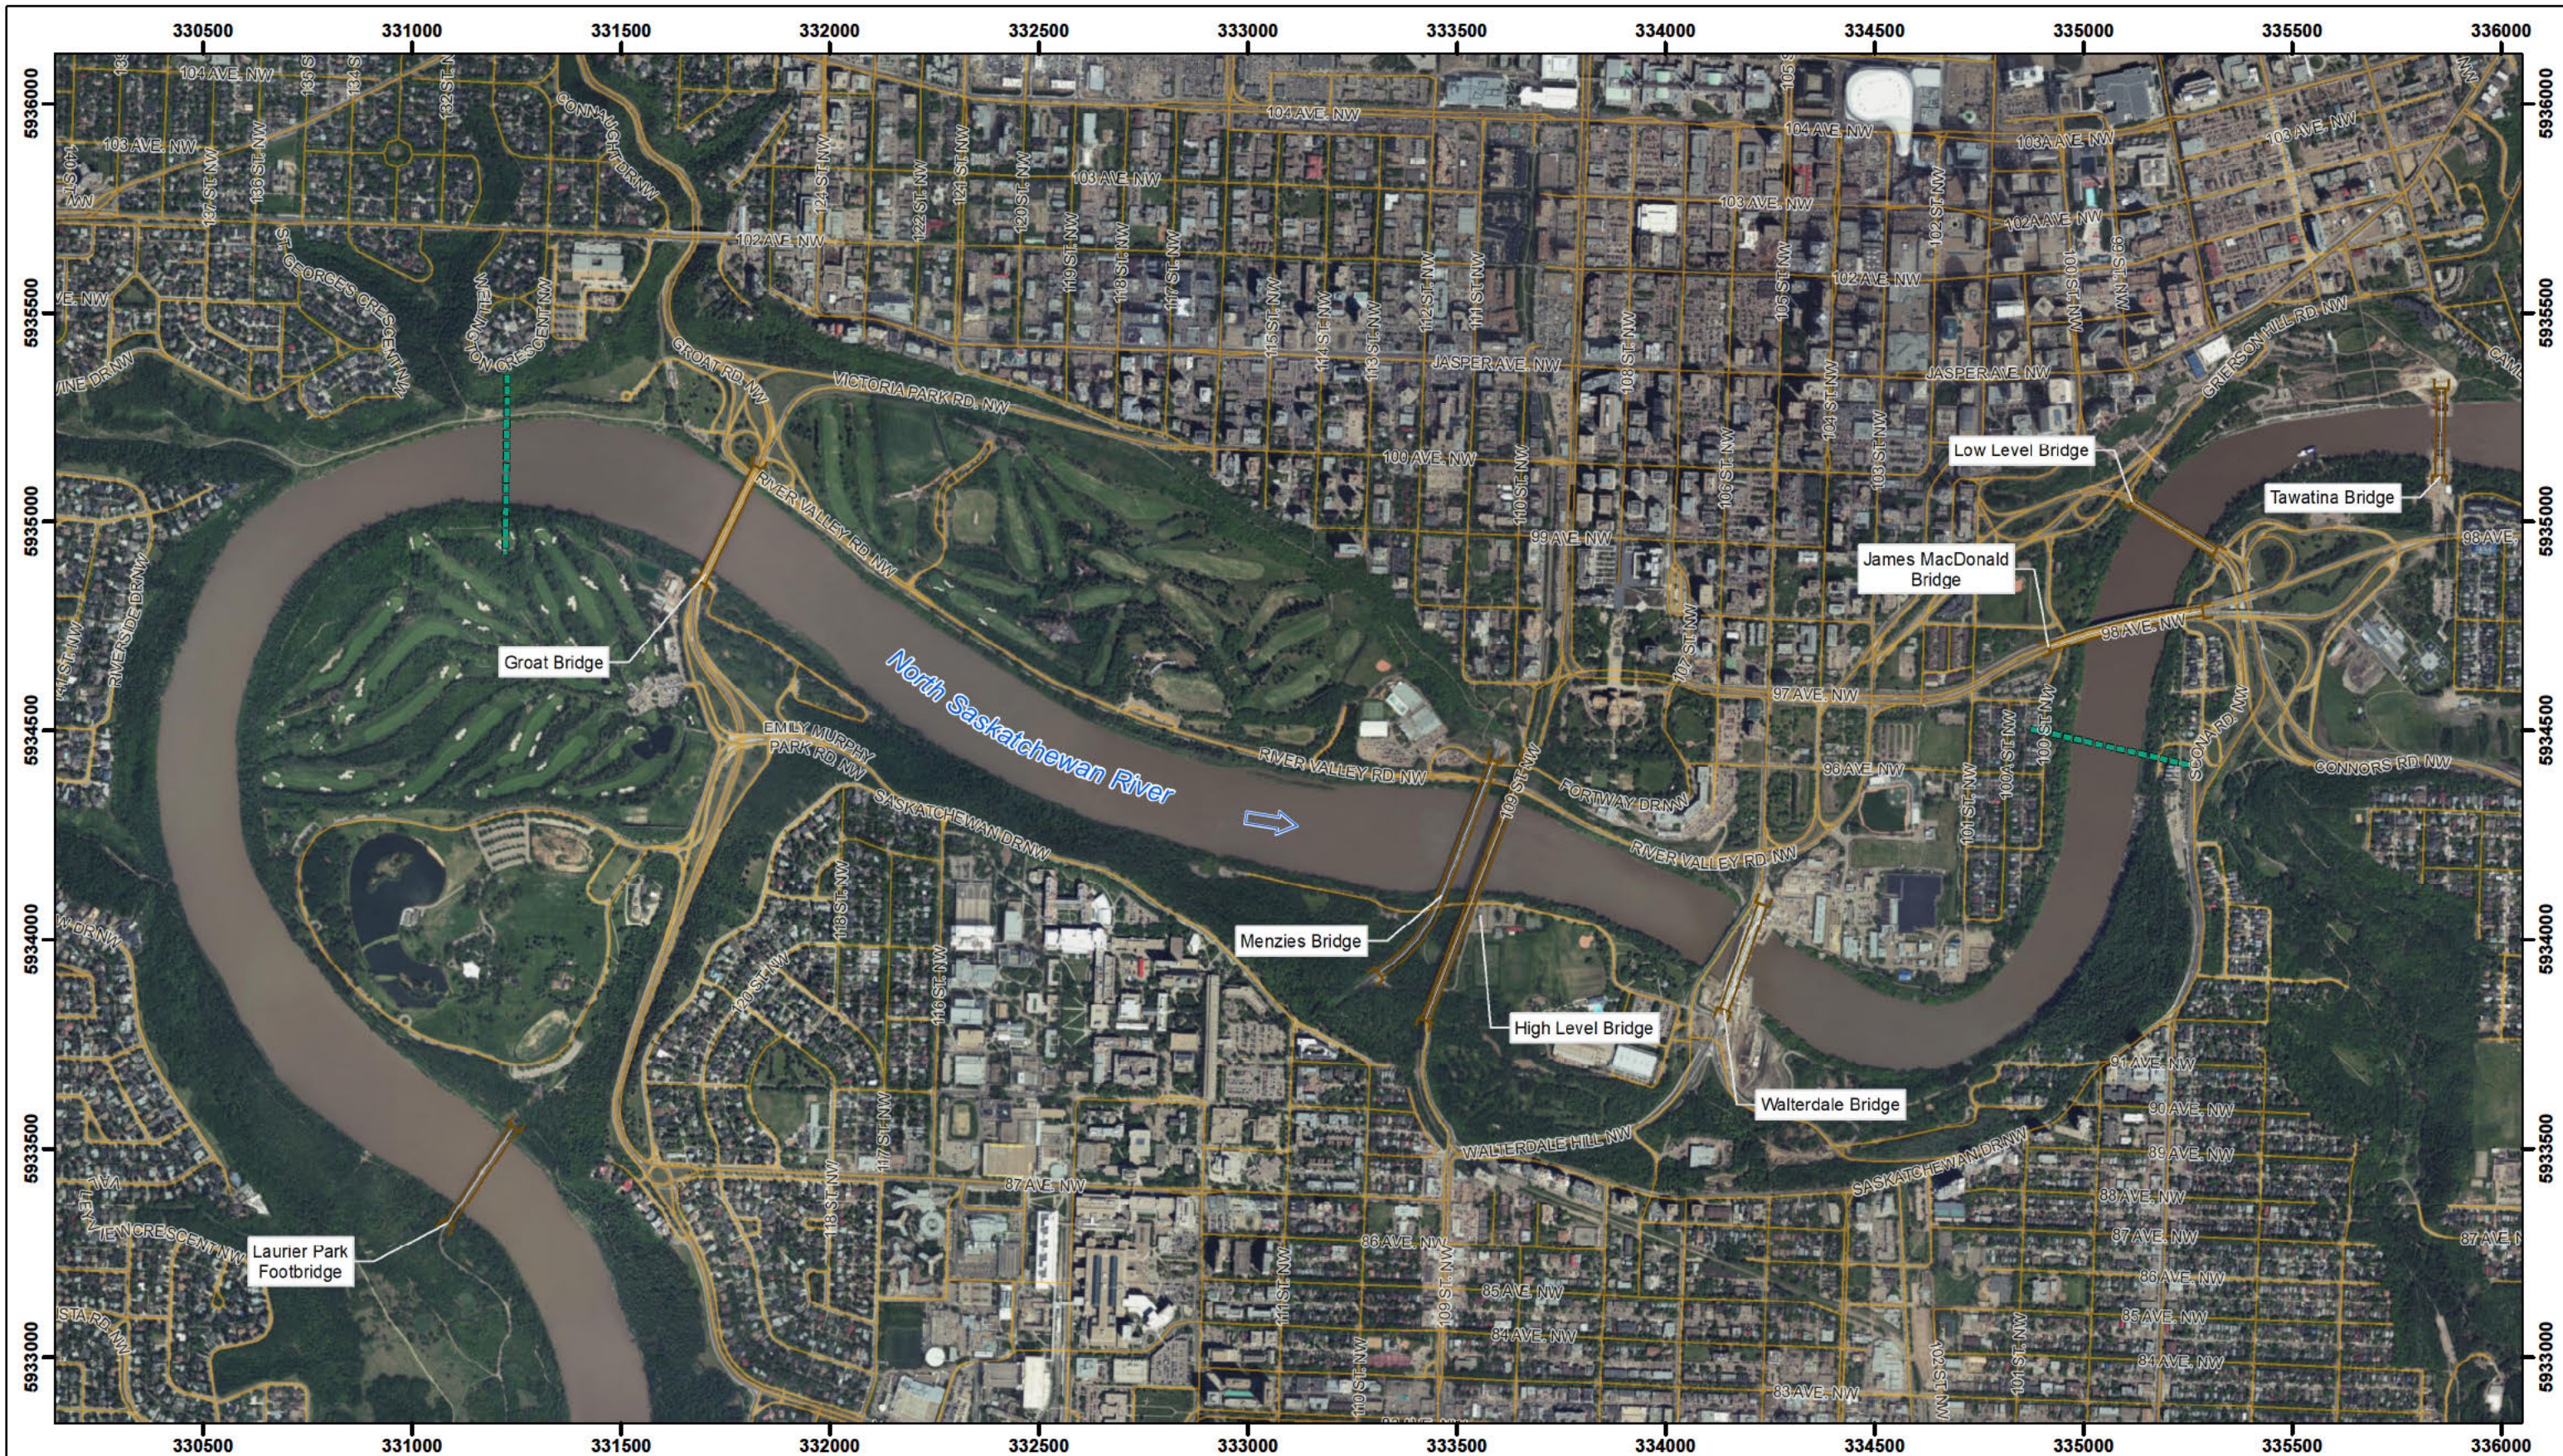
**FIGURE 2-1**

**Figure 2-1** shows the locations of the North Shore Promenade and Touch the Water Promenade, which is south of downtown Edmonton. The North Saskatchewan River generally flows east in the vicinity of the project.

**SITE PLAN**

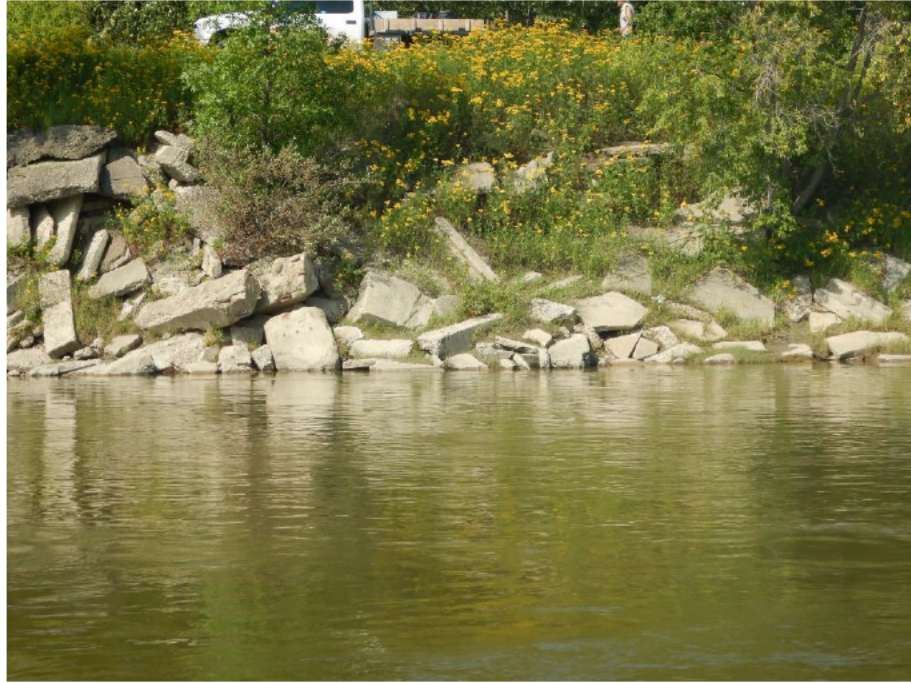
1) Looking at concrete bank armoring upstream of Groat Road Bridge.

- 1. Replace existing concrete block armouring upstream of Groat Road Bridge. The recommended replacement would be rock riprap with bioengineering features.**
- 2. All features on the bank should be assessed for erosion potential and potential mitigation measures should be incorporated.**

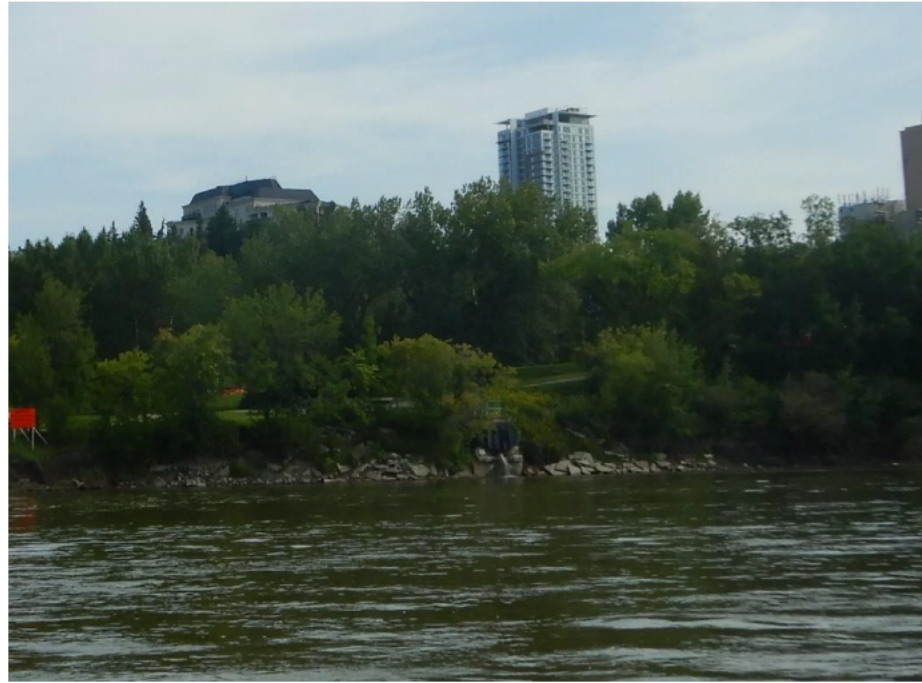
2) Looking at existing outfall on left bank upstream of Groat Road Bridge.

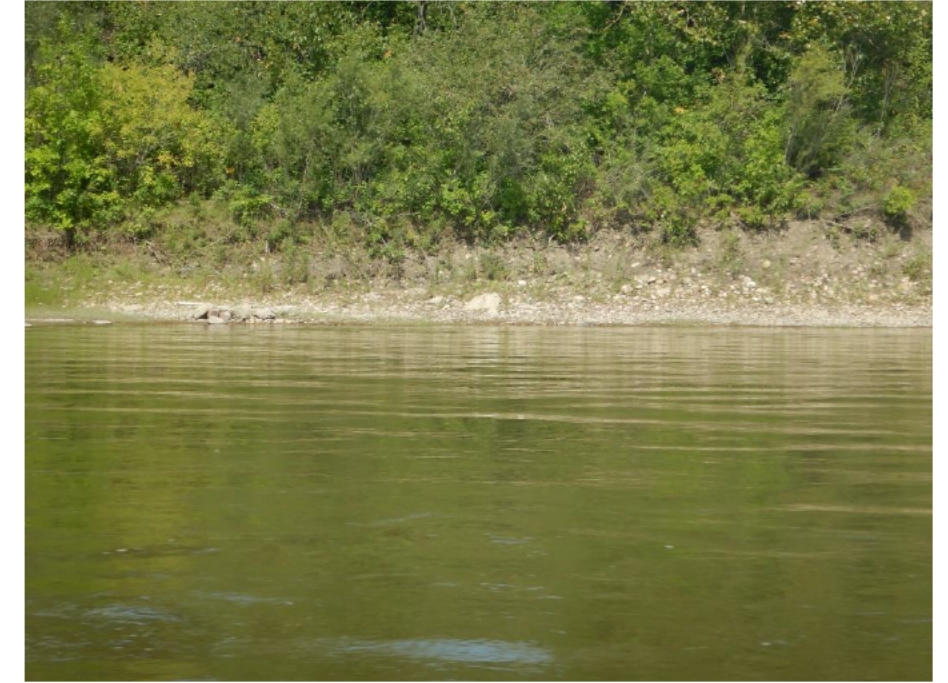
3) Looking at left bank downstream of Groat Road Bridge.

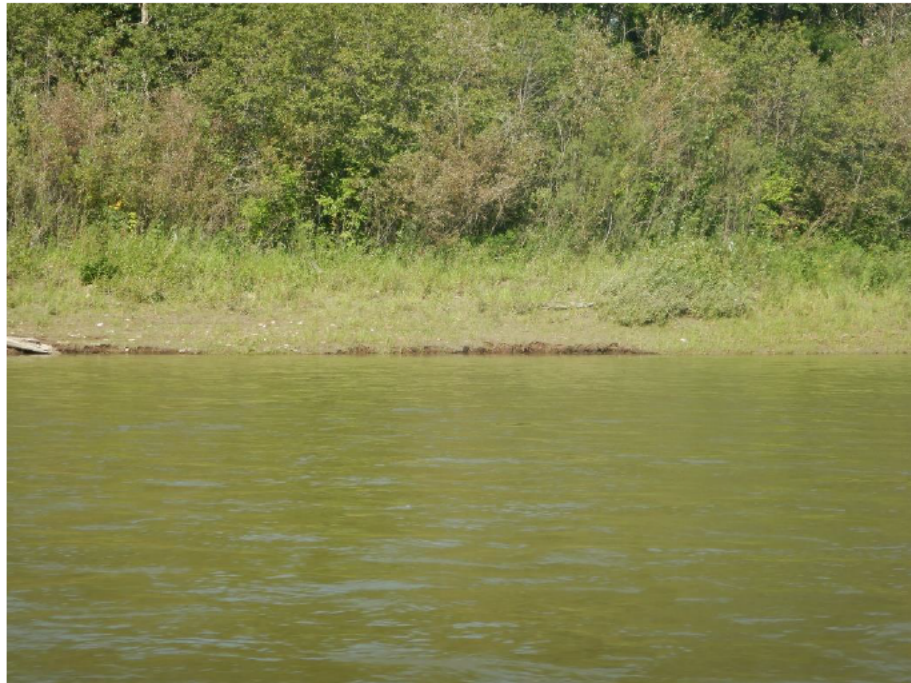
4) Looking at left bank between Groat Road and Menzies Bridge.

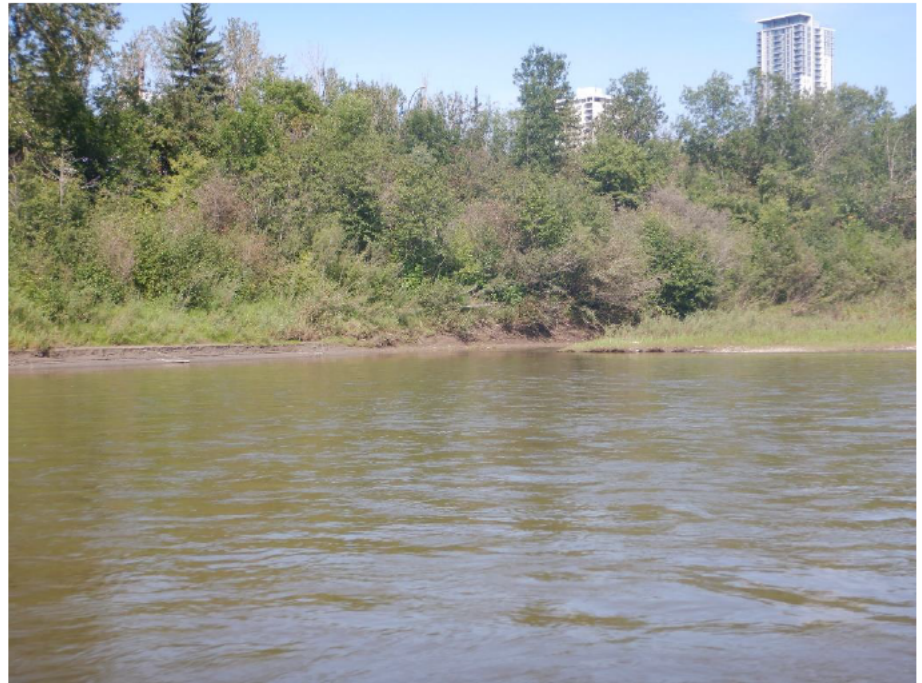
5) Looking at upstream end of island on left bank.

The existing island had been a stable natural feature on the river over the last sixty years based on the historical air photo assessment so during lower flows this feature could be accessed by the public safely. Downstream of the Walterdale bridge, natural fine sediment deposition has occurred on the left bank forming a small natural beach.

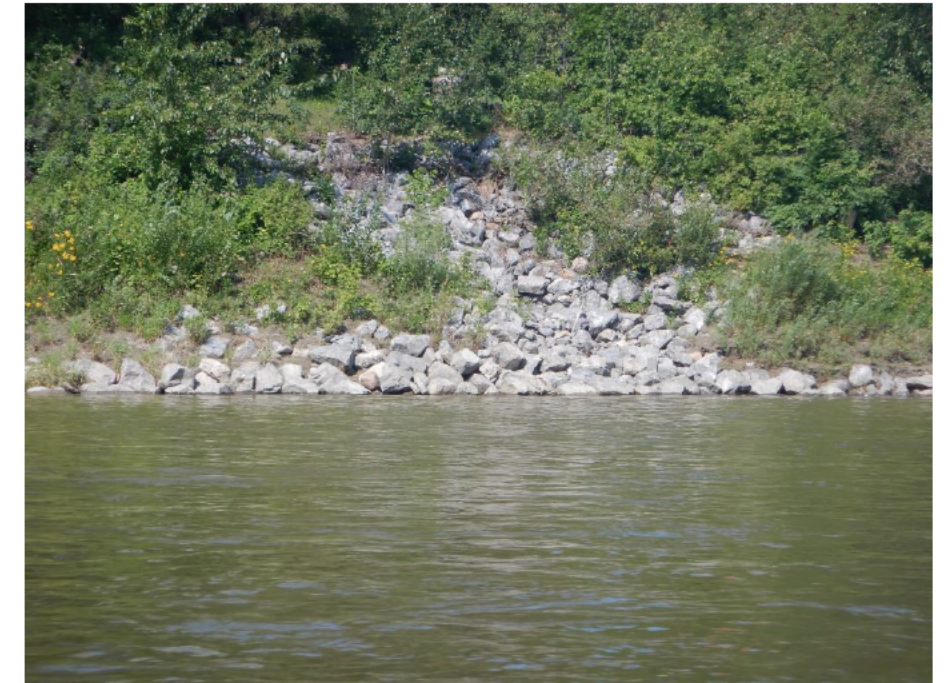
6) Looking at existing outfall on left bank upstream of Menzies Bridge.

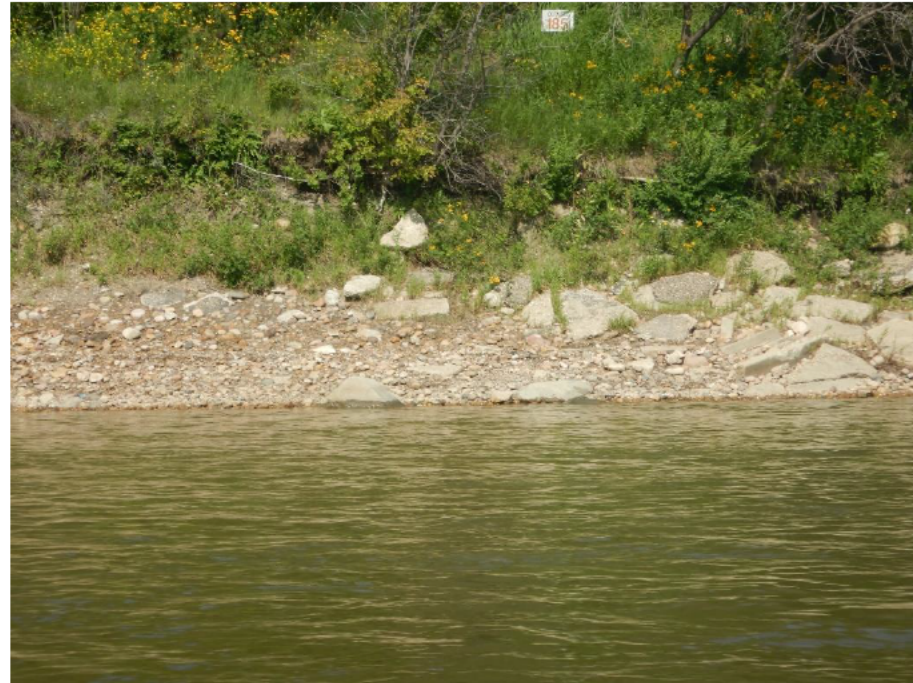
7) Looking at concrete bank armoring downstream of High Level Bridge.

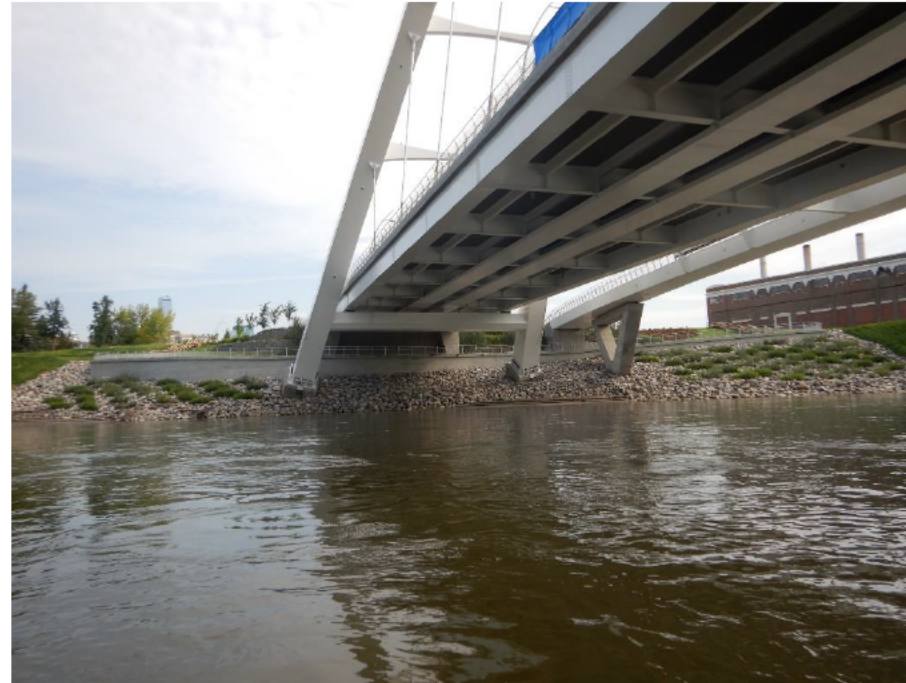
8) Looking at vegetated riprap on left bank at Walterdale Bridge.

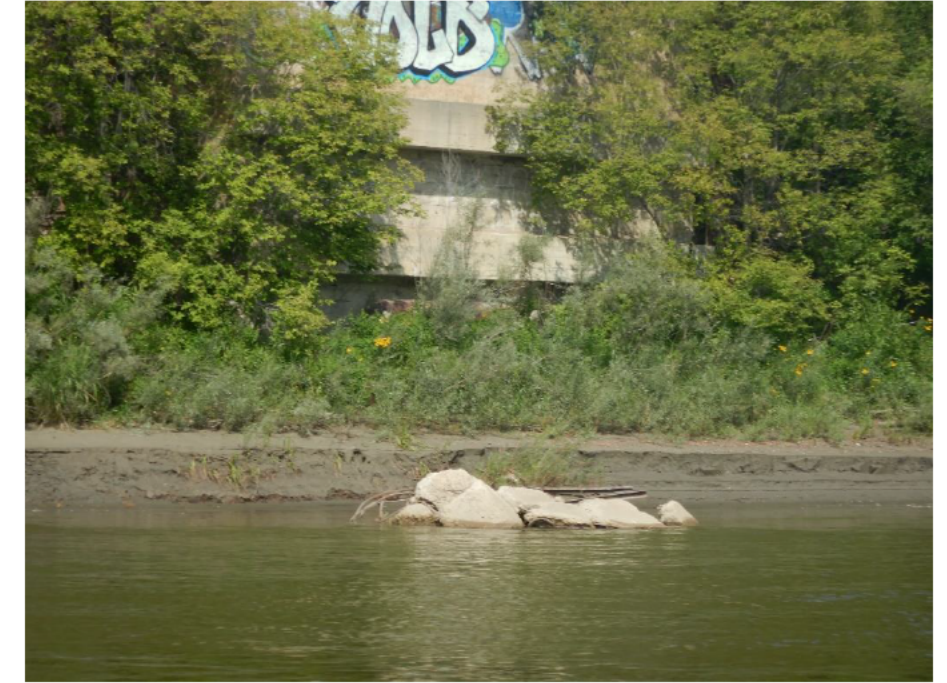
9) Looking at left bank downstream of Walterdale Bridge.

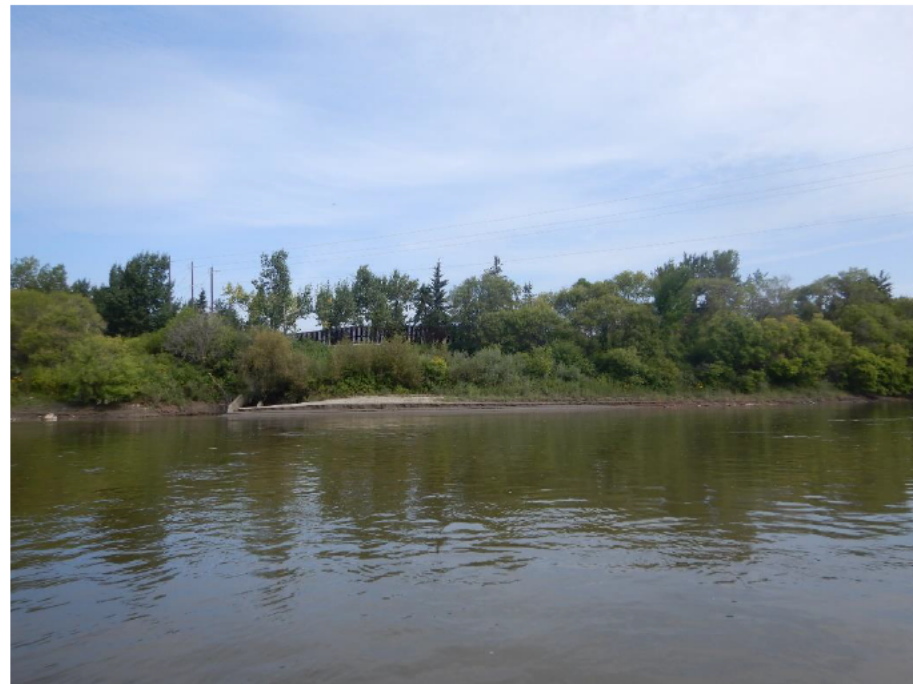
10) Looking at left bank downstream of Walterdale Bridge.

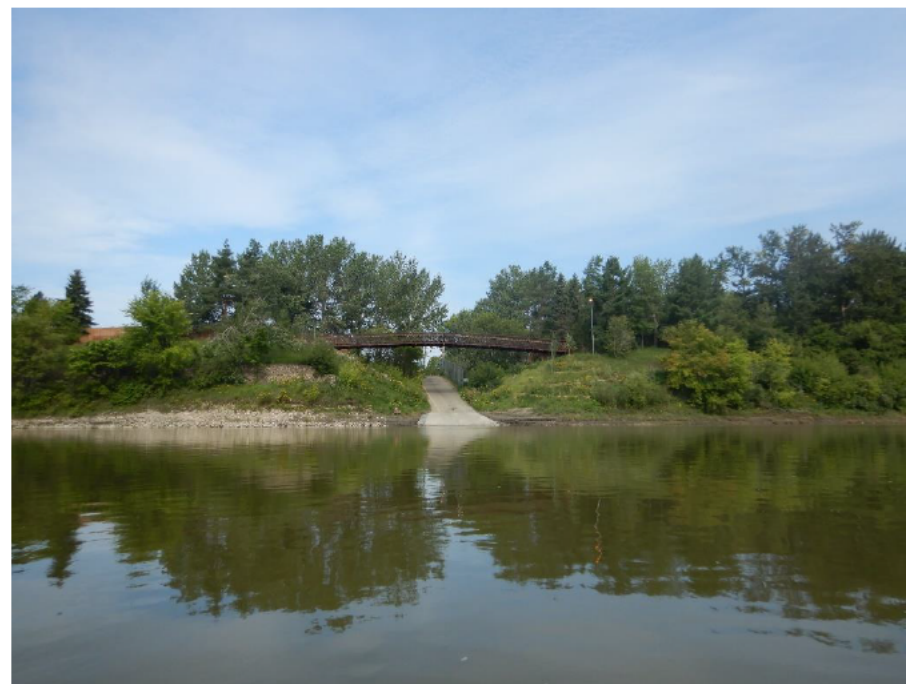
11) Looking at existing boatlaunch on left bank.

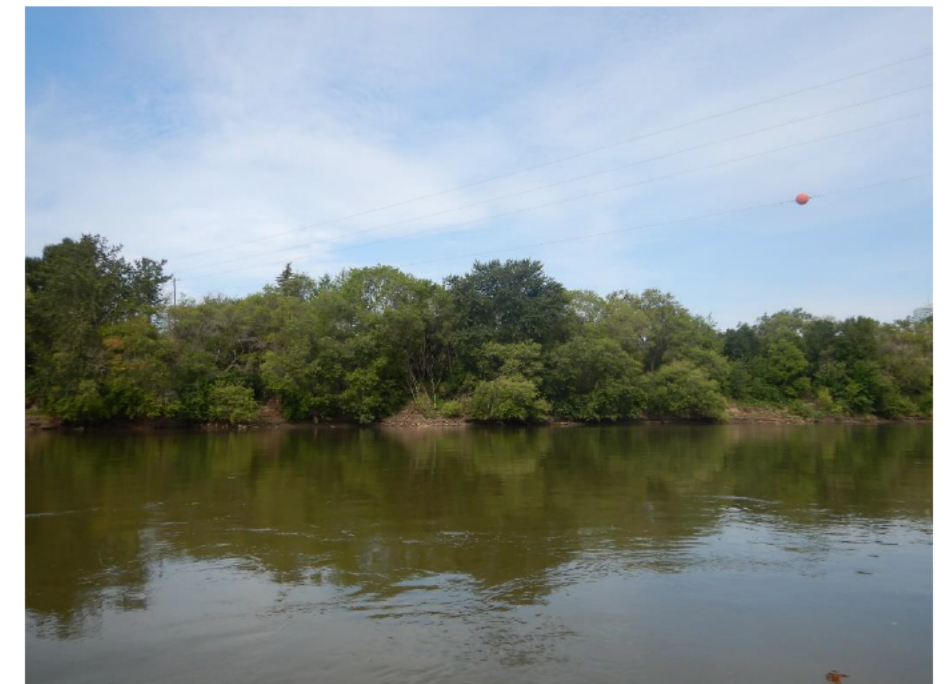
12) Looking at left bank at the downstream end of the project area .

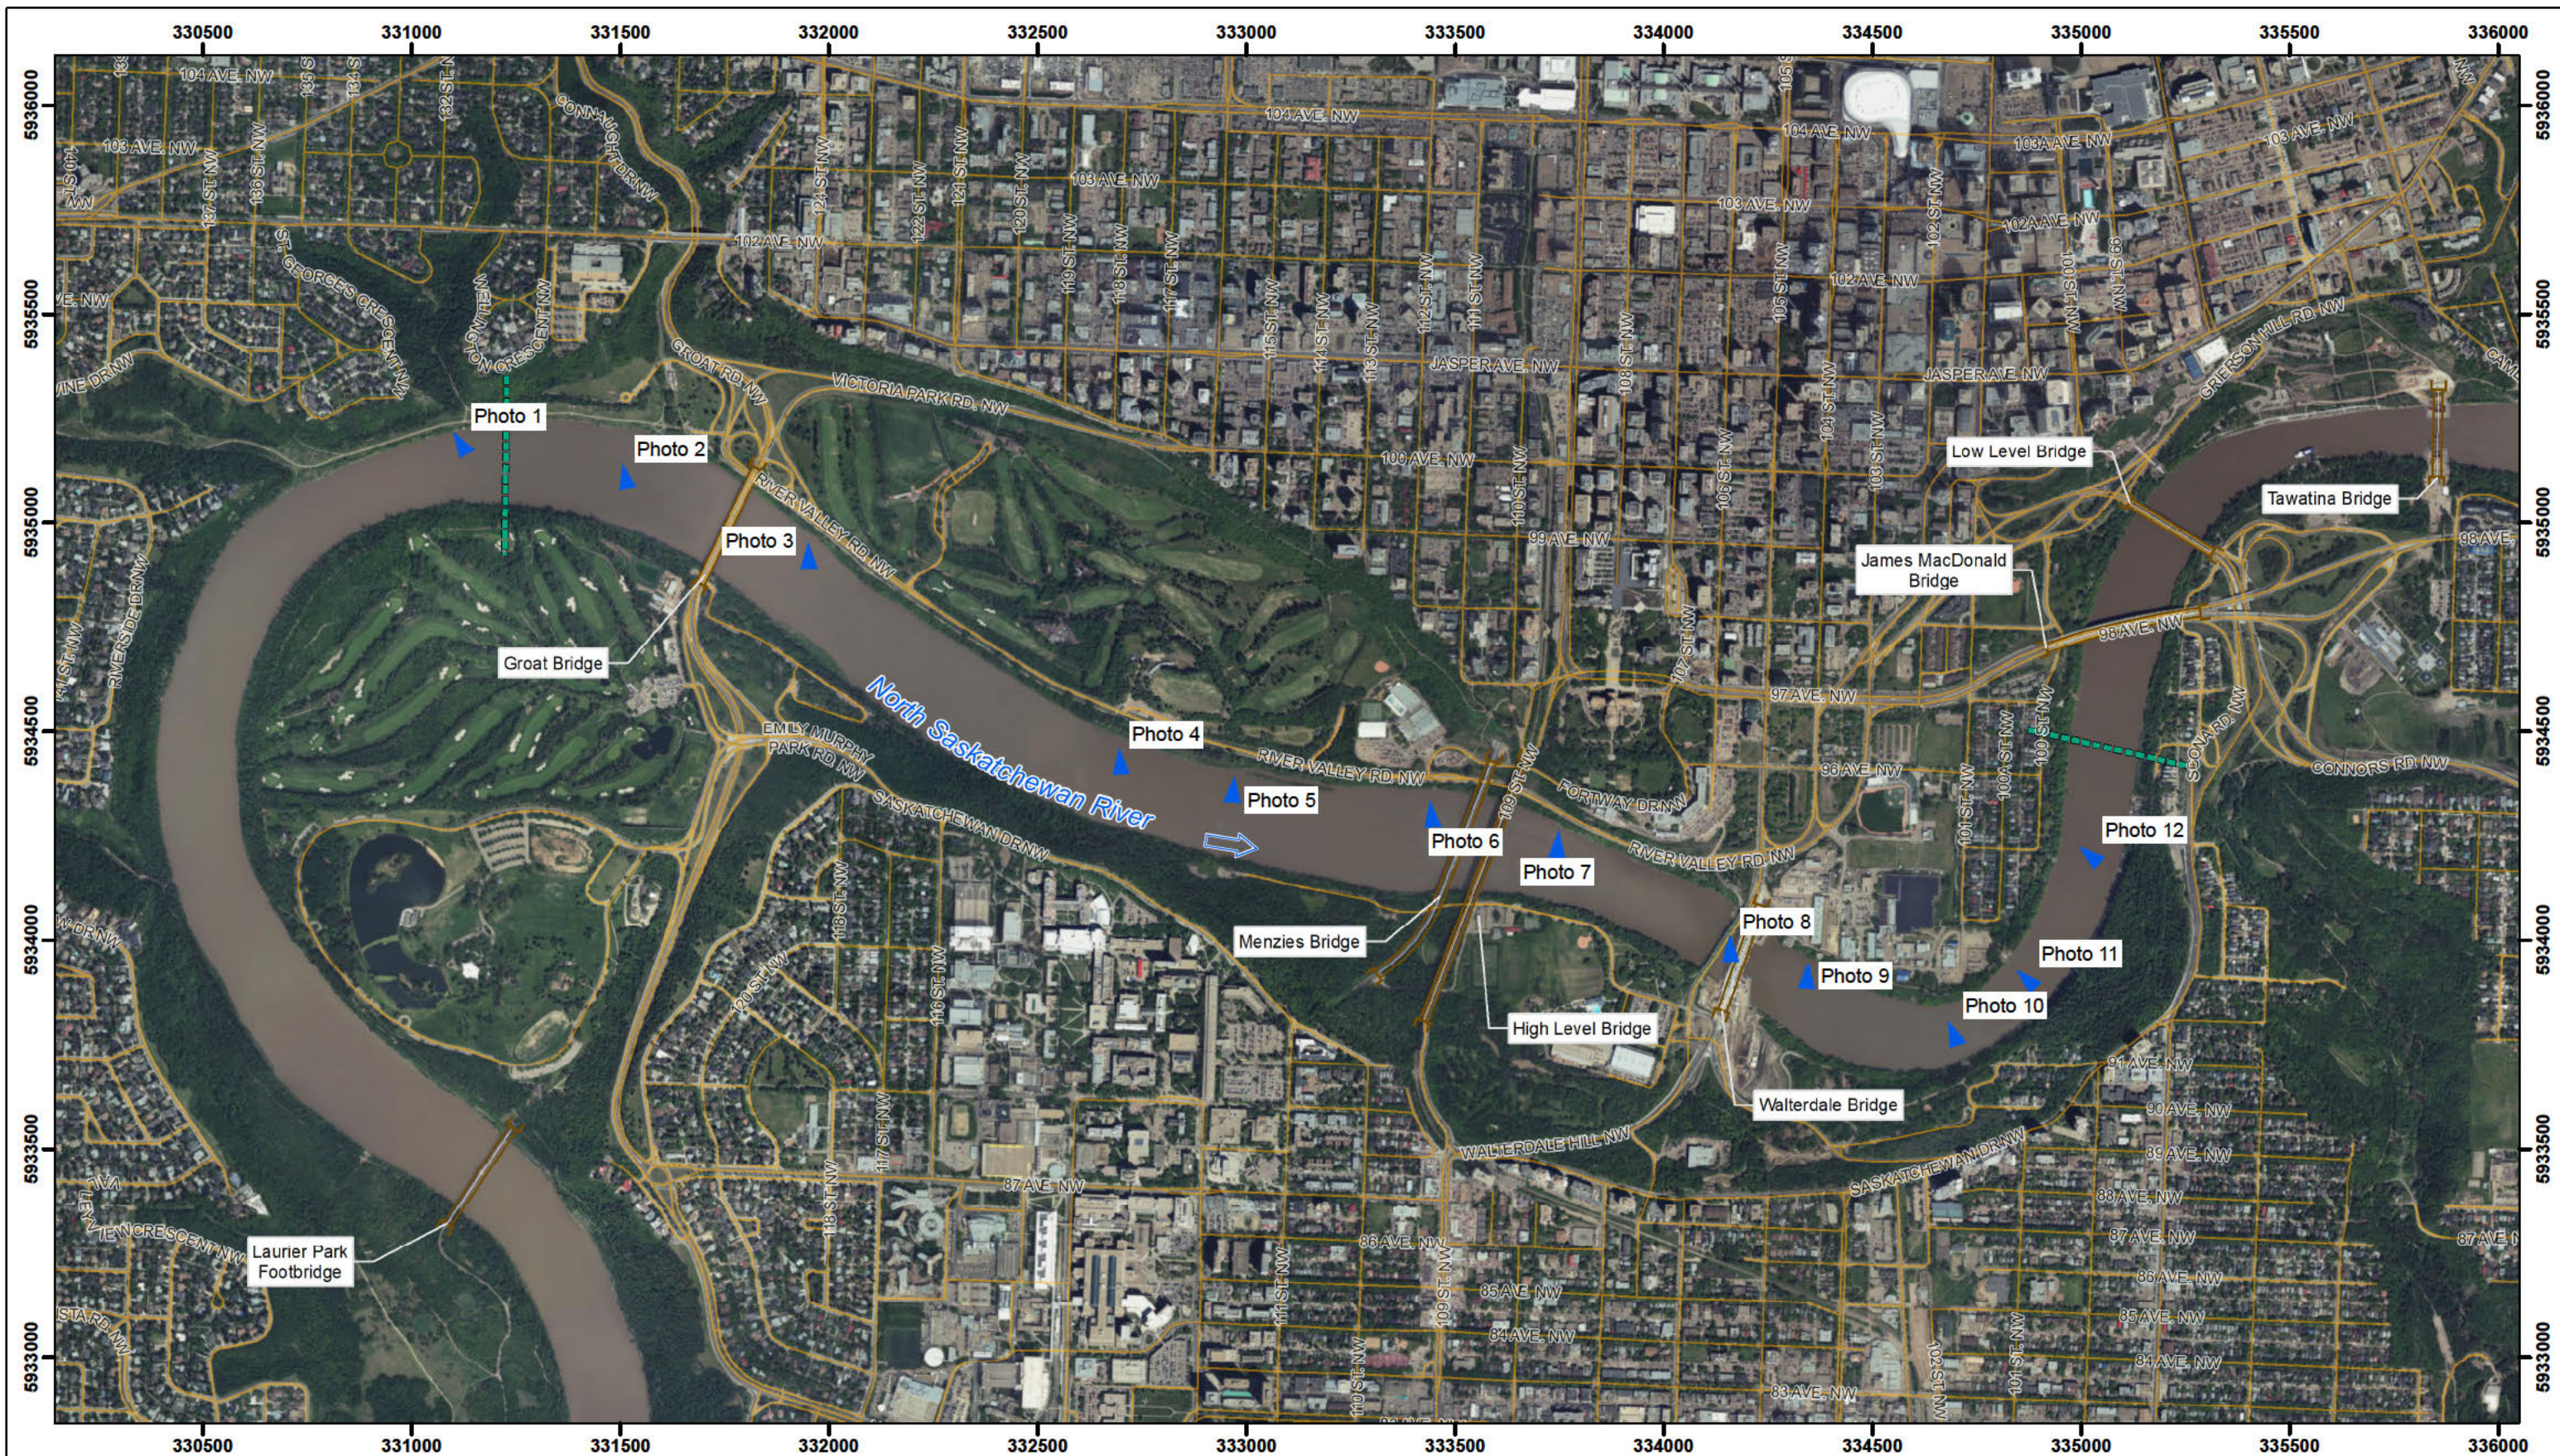
**FIGURE 2-4**

**PHOTO LOCATIONS**

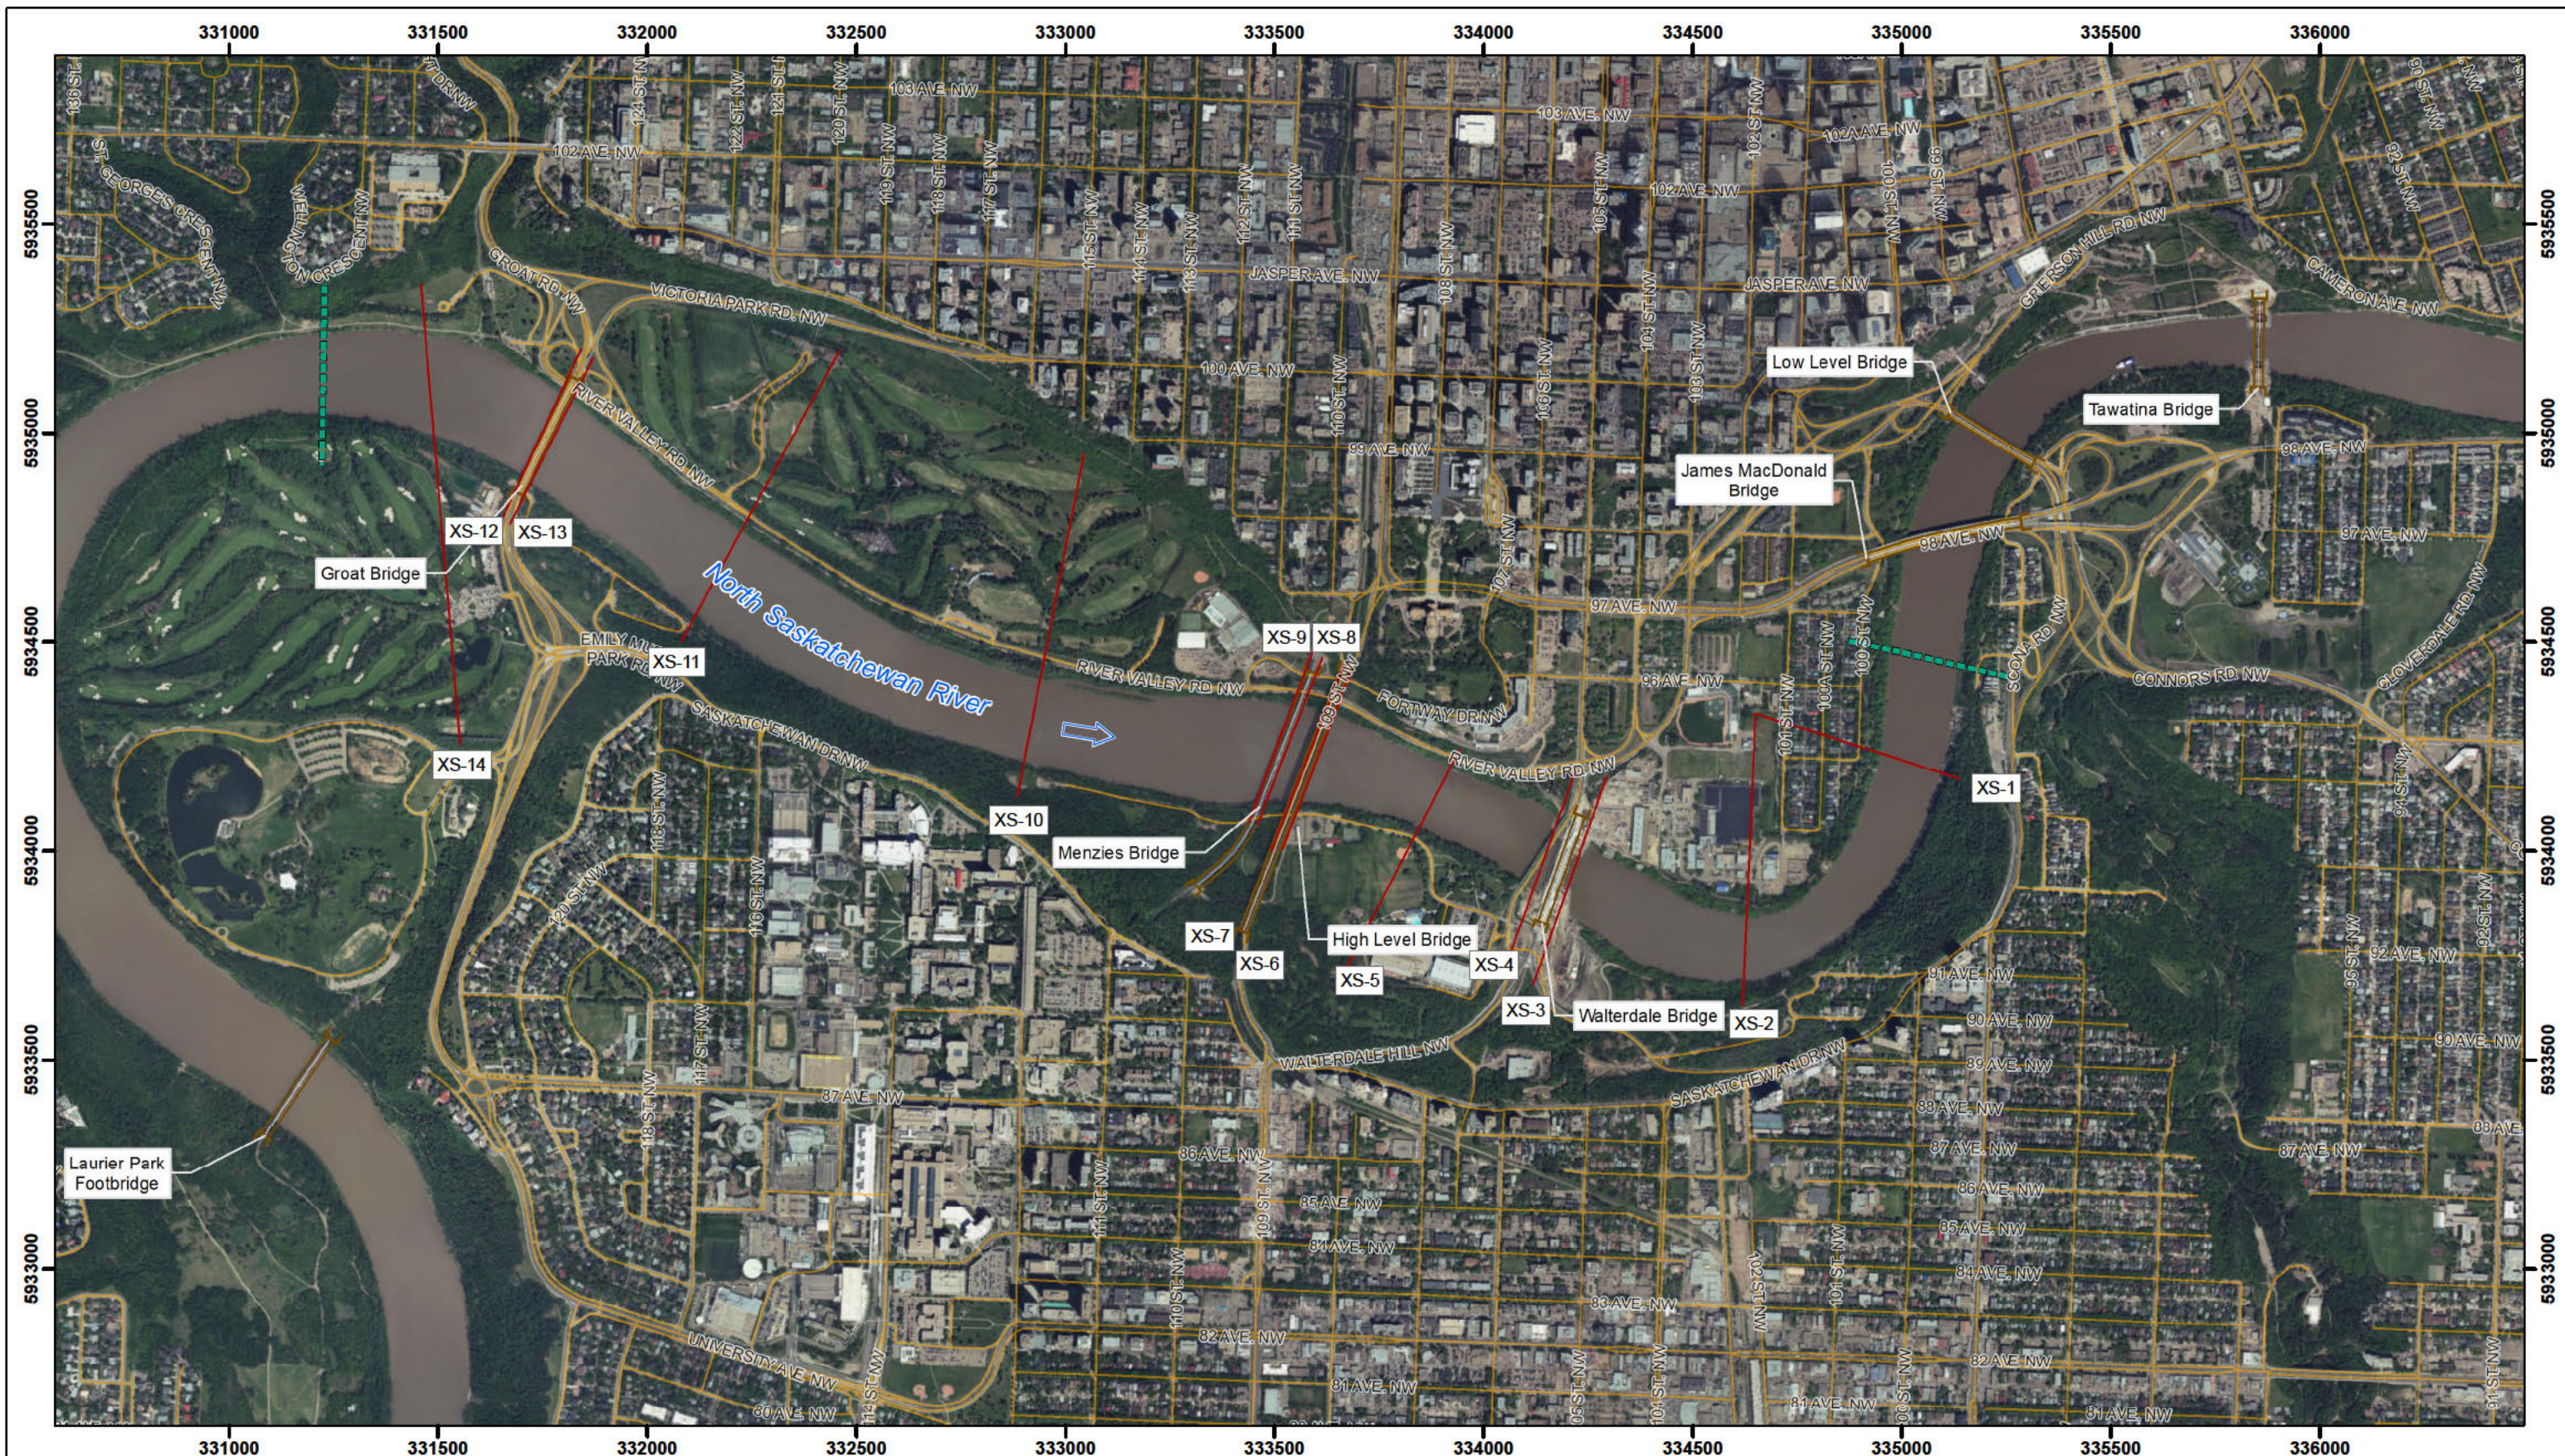
**FIGURE 4-1**

A one-dimensional model (HEC-RAS) was developed using NHC's survey data, lidar (provided by Dub) and bridge data obtained from Alberta Transportation. **Figure 4-1** shows the locations of the cross sections used in the hydraulic model. HEC-RAS is a one-dimensional hydraulic model that is the industry standard for hydraulic analysis. Data from previous floodplain studies were utilized to incorporate the bridge features into the hydraulic models. The local downstream channel gradient was based on local survey data, Alberta Transportation bridge files and data from Kellerhals et al. (1972). Manning's 'n' roughness values of 0.031 and 0.06 were selected for the river bed and bank, respectively. The Manning's "n" roughness and downstream boundary conditions were calibrated for this reach based on high water marks from the 1986 and 1982 floods. The roughness selected is consistent with site observations, air photos, satellite images and recommended values listed in Chow (1959).

**CROSS SECTION LOCATIONS**

Water levels along the entire reach for 2-, 5-, 10-, 25-, 50-, and 100-year return periods have been determined and are provided in **Appendix A. Figure 4-1** shows the locations of the referenced cross sections.

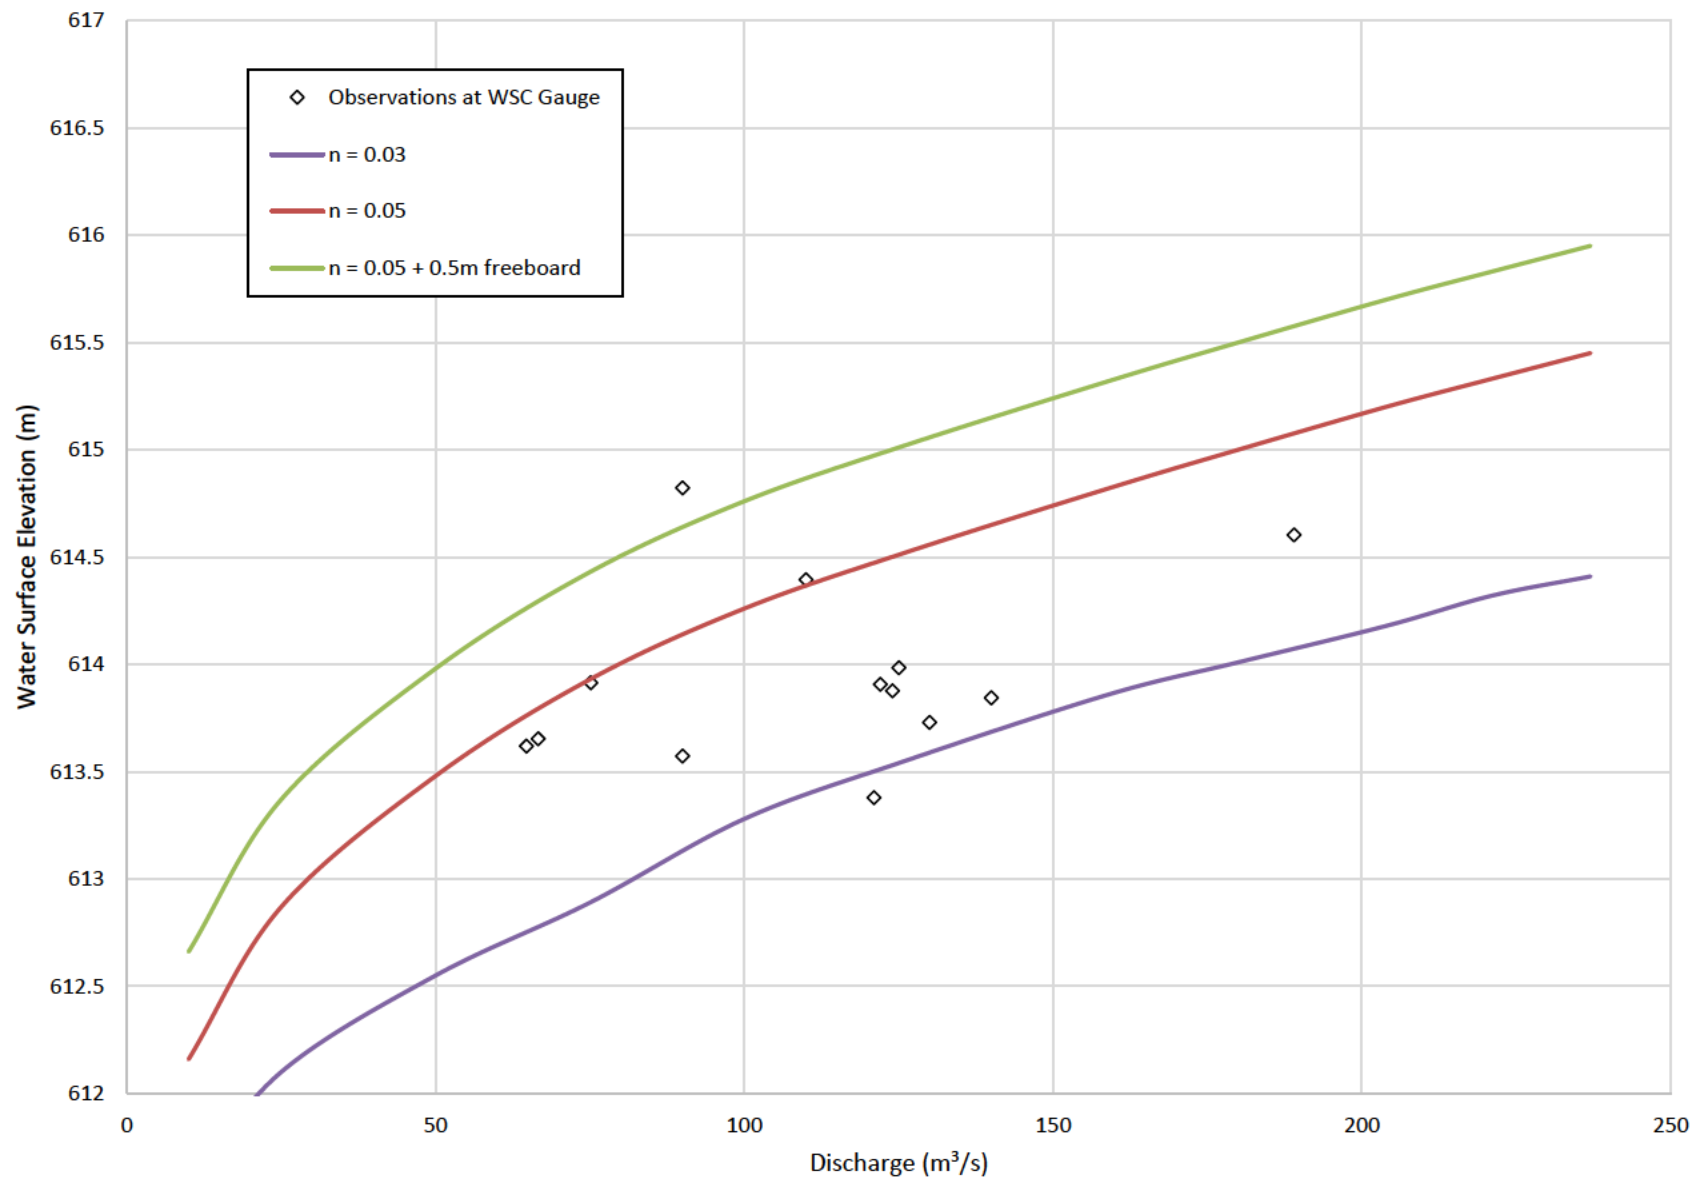
Freeze-up ice levels were modeled in the HEC-RAS model to provide top of ice levels for various return periods. The WSC gauge provides water level and discharge records from between 1999 and 2015. The relationship between freeze-up water discharge and water level are illustrated in **Figure 4-2**. This relationship between discharge and water level depend on various parameters including discharge, ice thickness, and ice roughness so the data plotted in **Figure 4-2** is quite variable.

**FREEZE-UP RATING CURVE**

The HEC-RAS model was extended downstream of the WSC gauge using geometry data from the previous floodplain study. The freeze-up water level from the WSC gauge was used to calibrate the ice jam parameters in the HEC-RAS model. The downstream end of the ice jam was established near the end of the model domain and ice jam profiles were calculated throughout the reach. A range of discharges were modeled so an ice jam rating curve could be developed. This rating curve was compared to observed data at the WSC gauge. The analysis assumed a typical freeze-up ice thickness of 0.6 m.

Two typical early winter under ice roughness' ( $n = 0.03$  and  $n = 0.05$ ) were modeled and compared to the measurements at the WSC gauge. It was found that a roughness of 0.03 did not adequately envelope the WSC data, however the roughness of 0.05 enveloped most of the data points. HEC-RAS is unable to simulate ice cover consolidation, so a freeboard of 0.5 m was added to the ice levels to account for this. Once calibrated, the ice jam model was run for the freeze-up discharges to determine the top of ice throughout the model domain.
