NHC Ref. No.1004400

3 June 2020

**Re:** Touch the Water Promenade and North Shore Promenade – Final Report  
Hydrotechnical Assessment

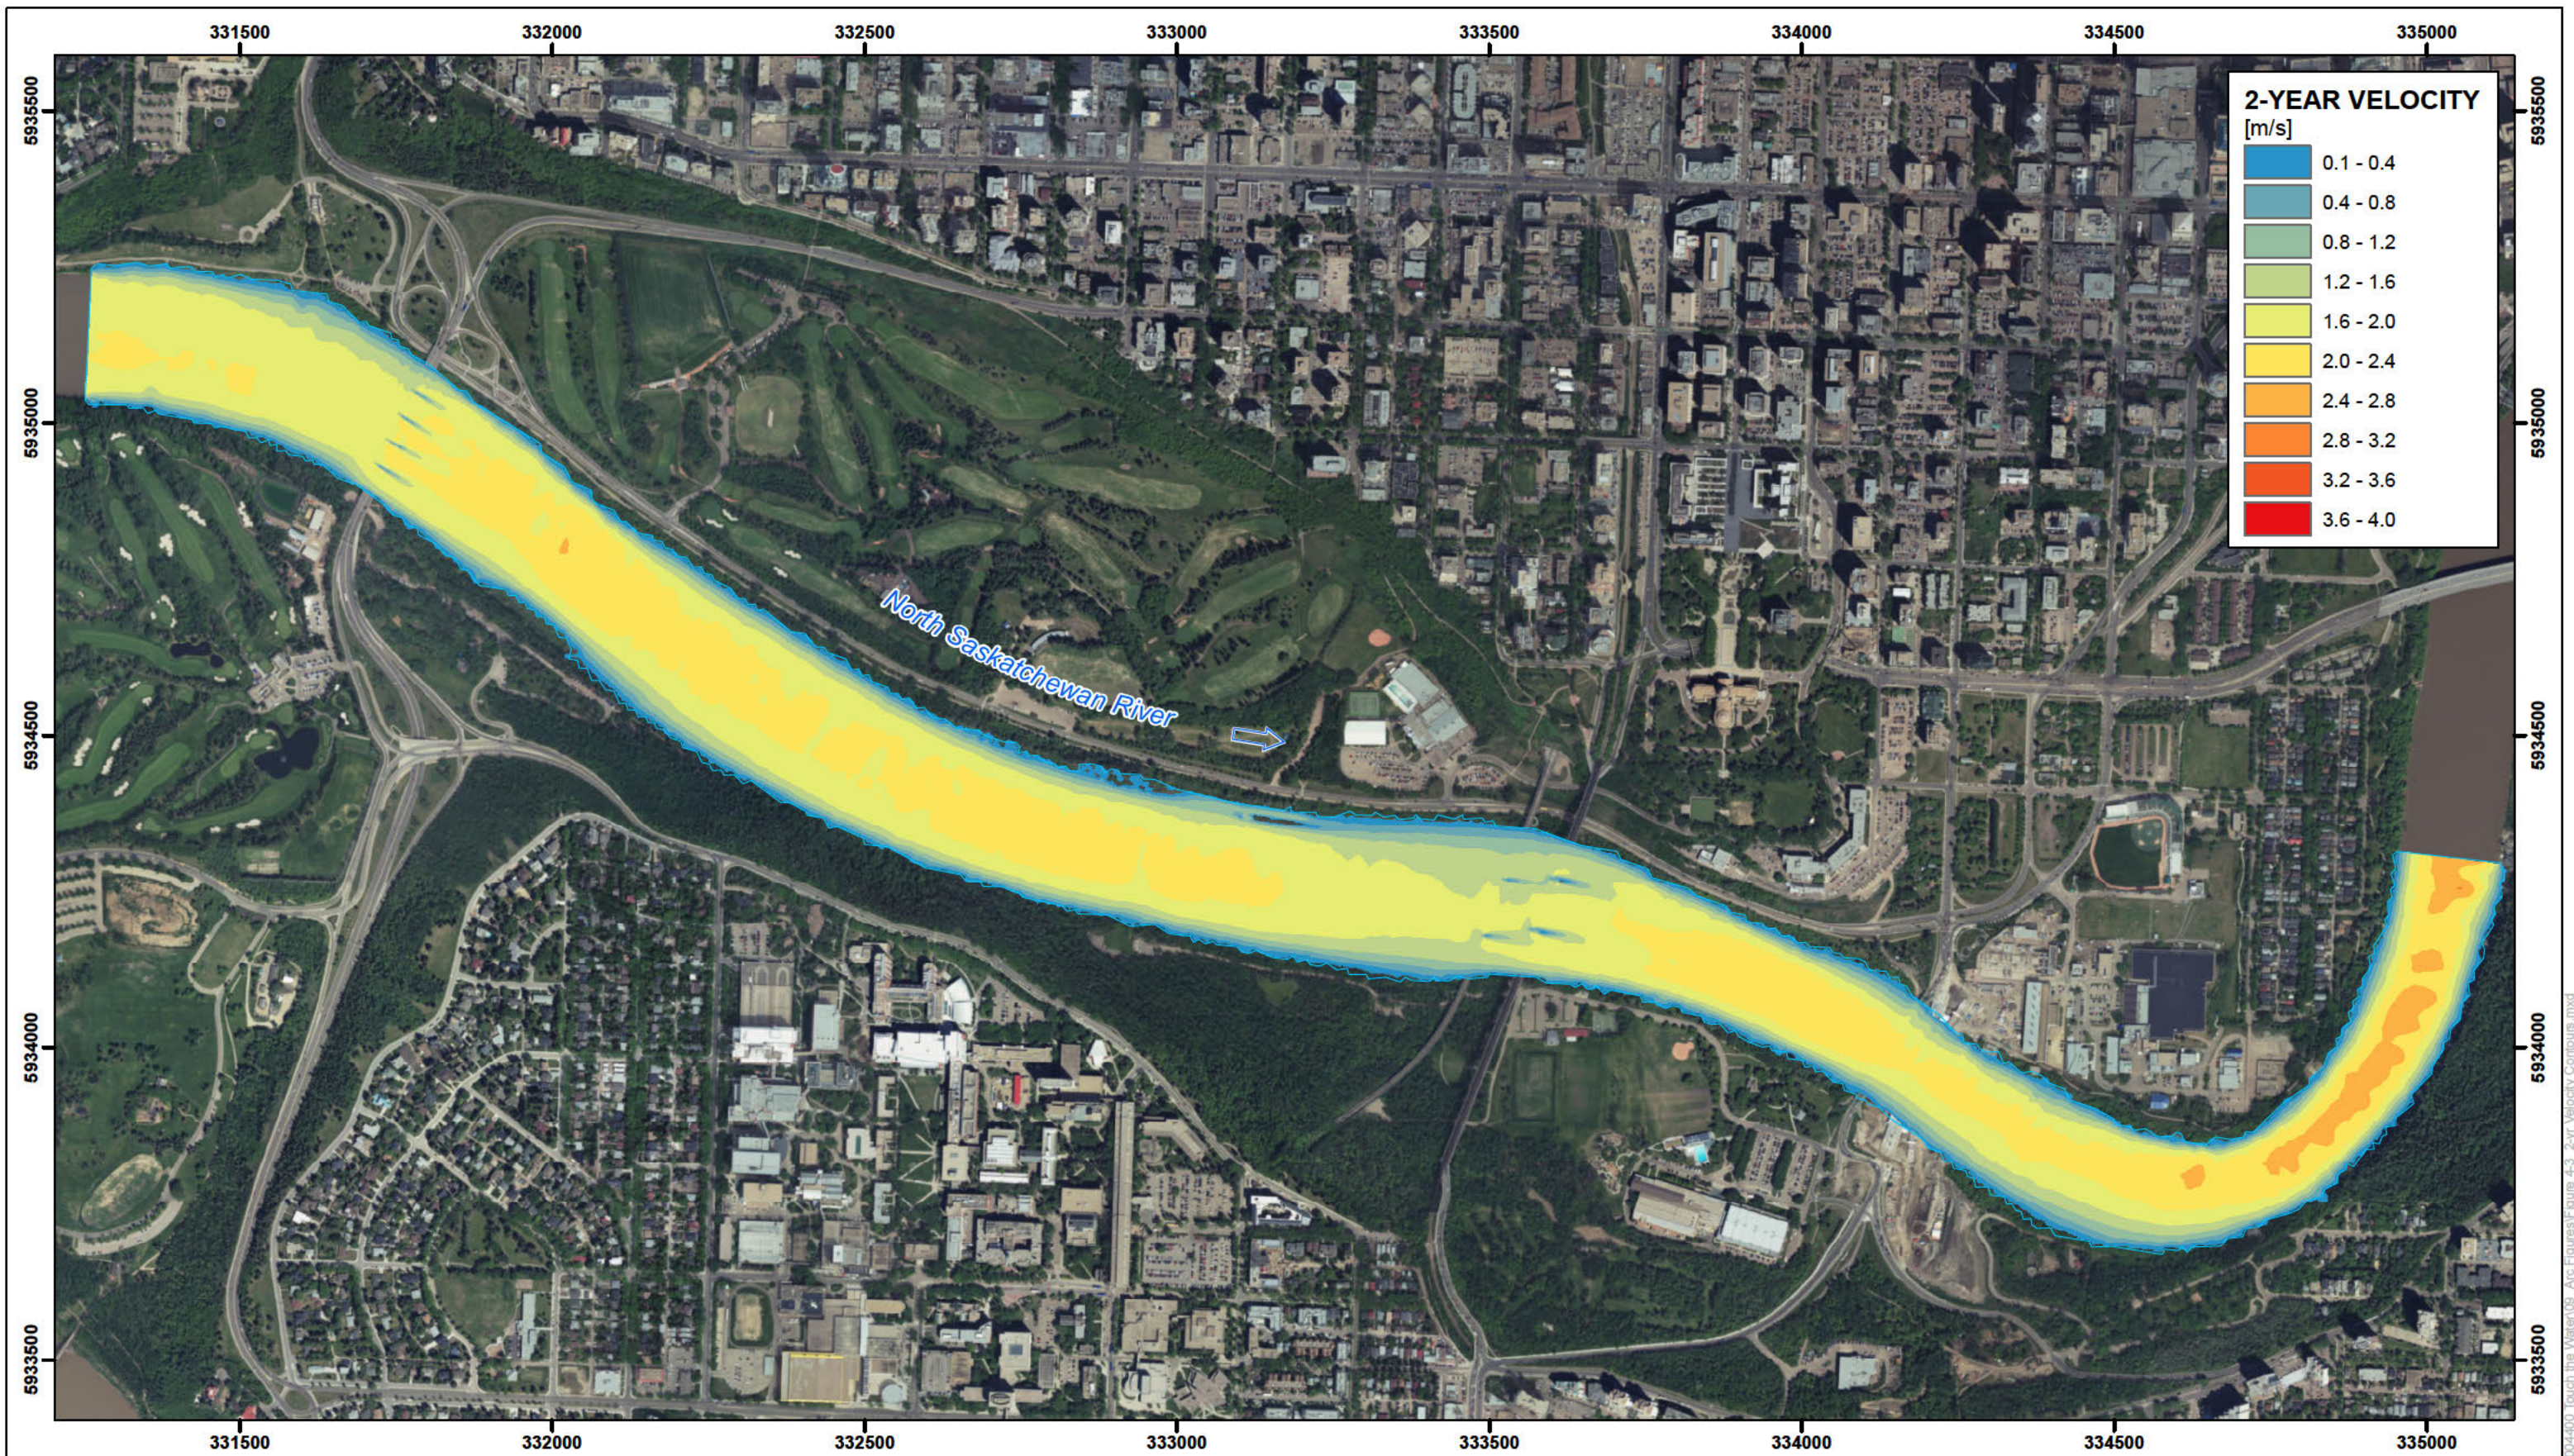
**FIGURE 4-3**

**Figure 4-3** to **Figure 4-8** show the velocity distributions and extents of inundation in the North Saskatchewan River during a 2-, 5-, 10-, 25-, 50-, and 100-year flood peaks, respectively.

1. Basemap: Esri World Imagery (2015).
2. 2-year peak discharge of 1270 cms modelled using TELEMAC2D.
3. Inundation extents are shown in blue.

**2-YEAR VELOCITY CONTOUR**

Based on the velocity contour maps, the locations of greatest potential for erosion on the left bank are upstream of the Groat Road bridge and between the High Level Bridge and the Walterdale Bridge.

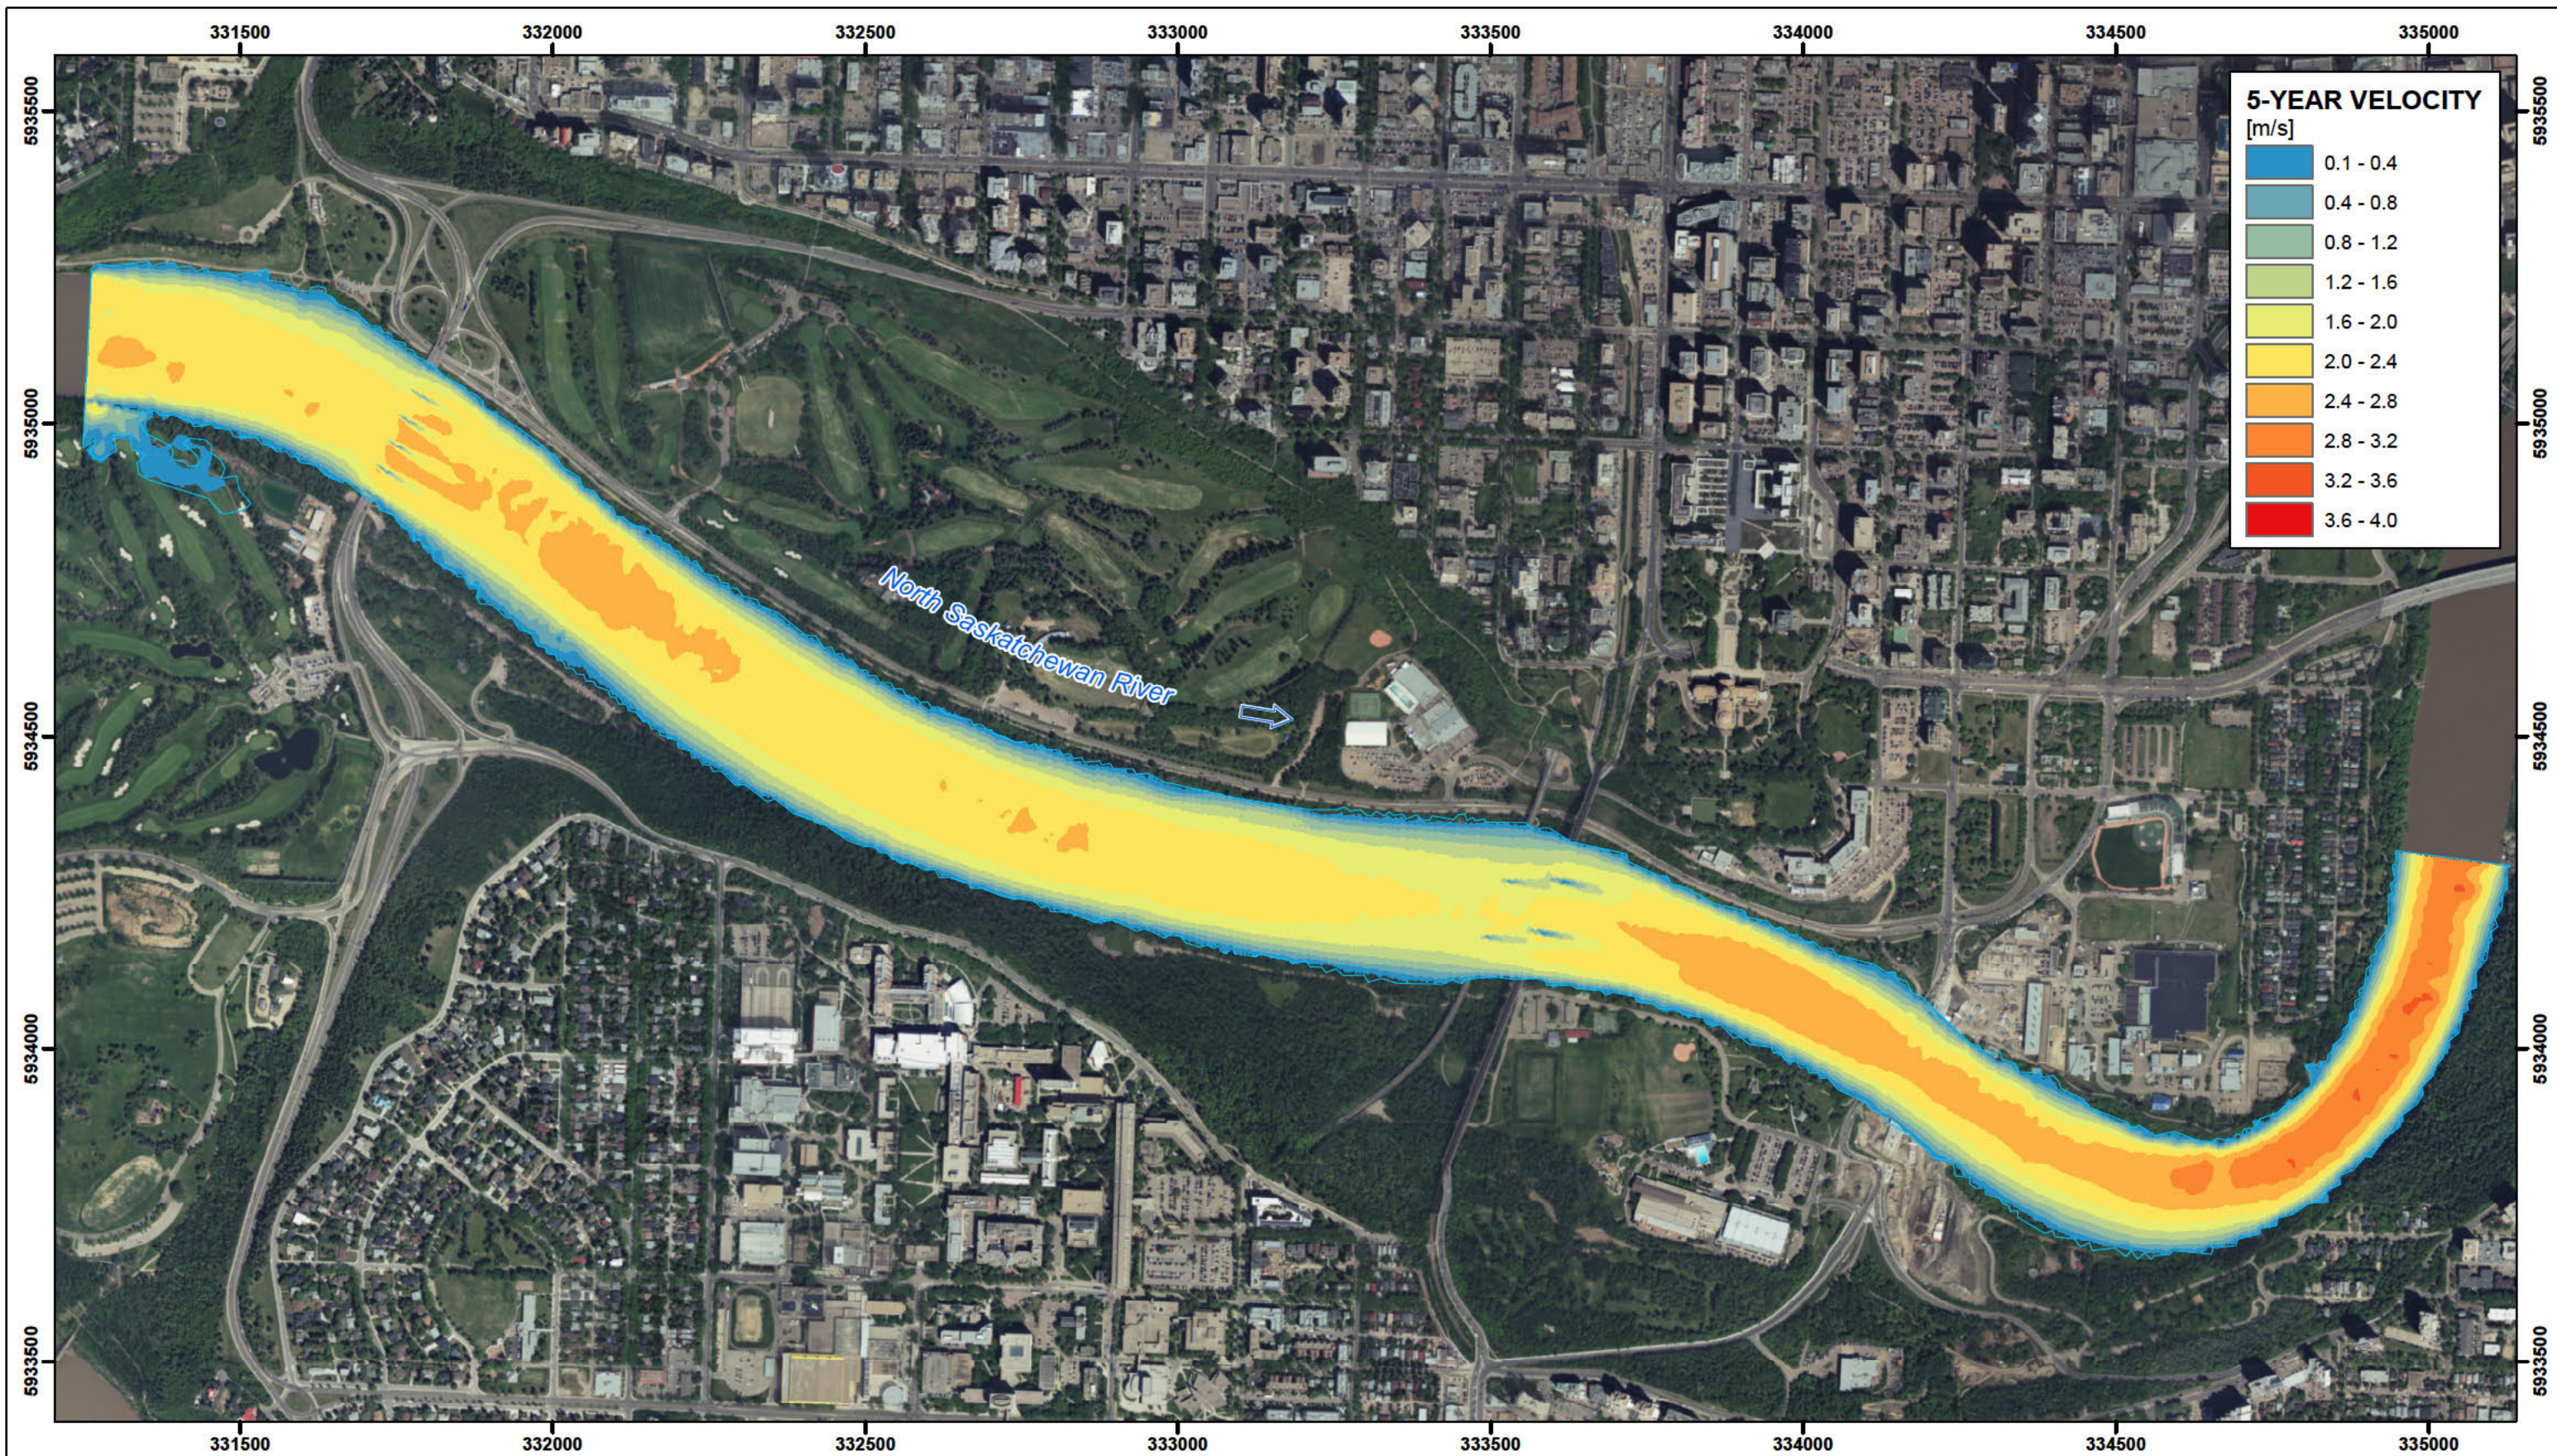
**FIGURE 4-4**

1. Basemap: Esri World Imagery (2015).
2. 5-year peak discharge of 2230 cms modelled using TELEMAC2D.
3. Inundation extents are shown in blue.

**5-YEAR VELOCITY CONTOUR**

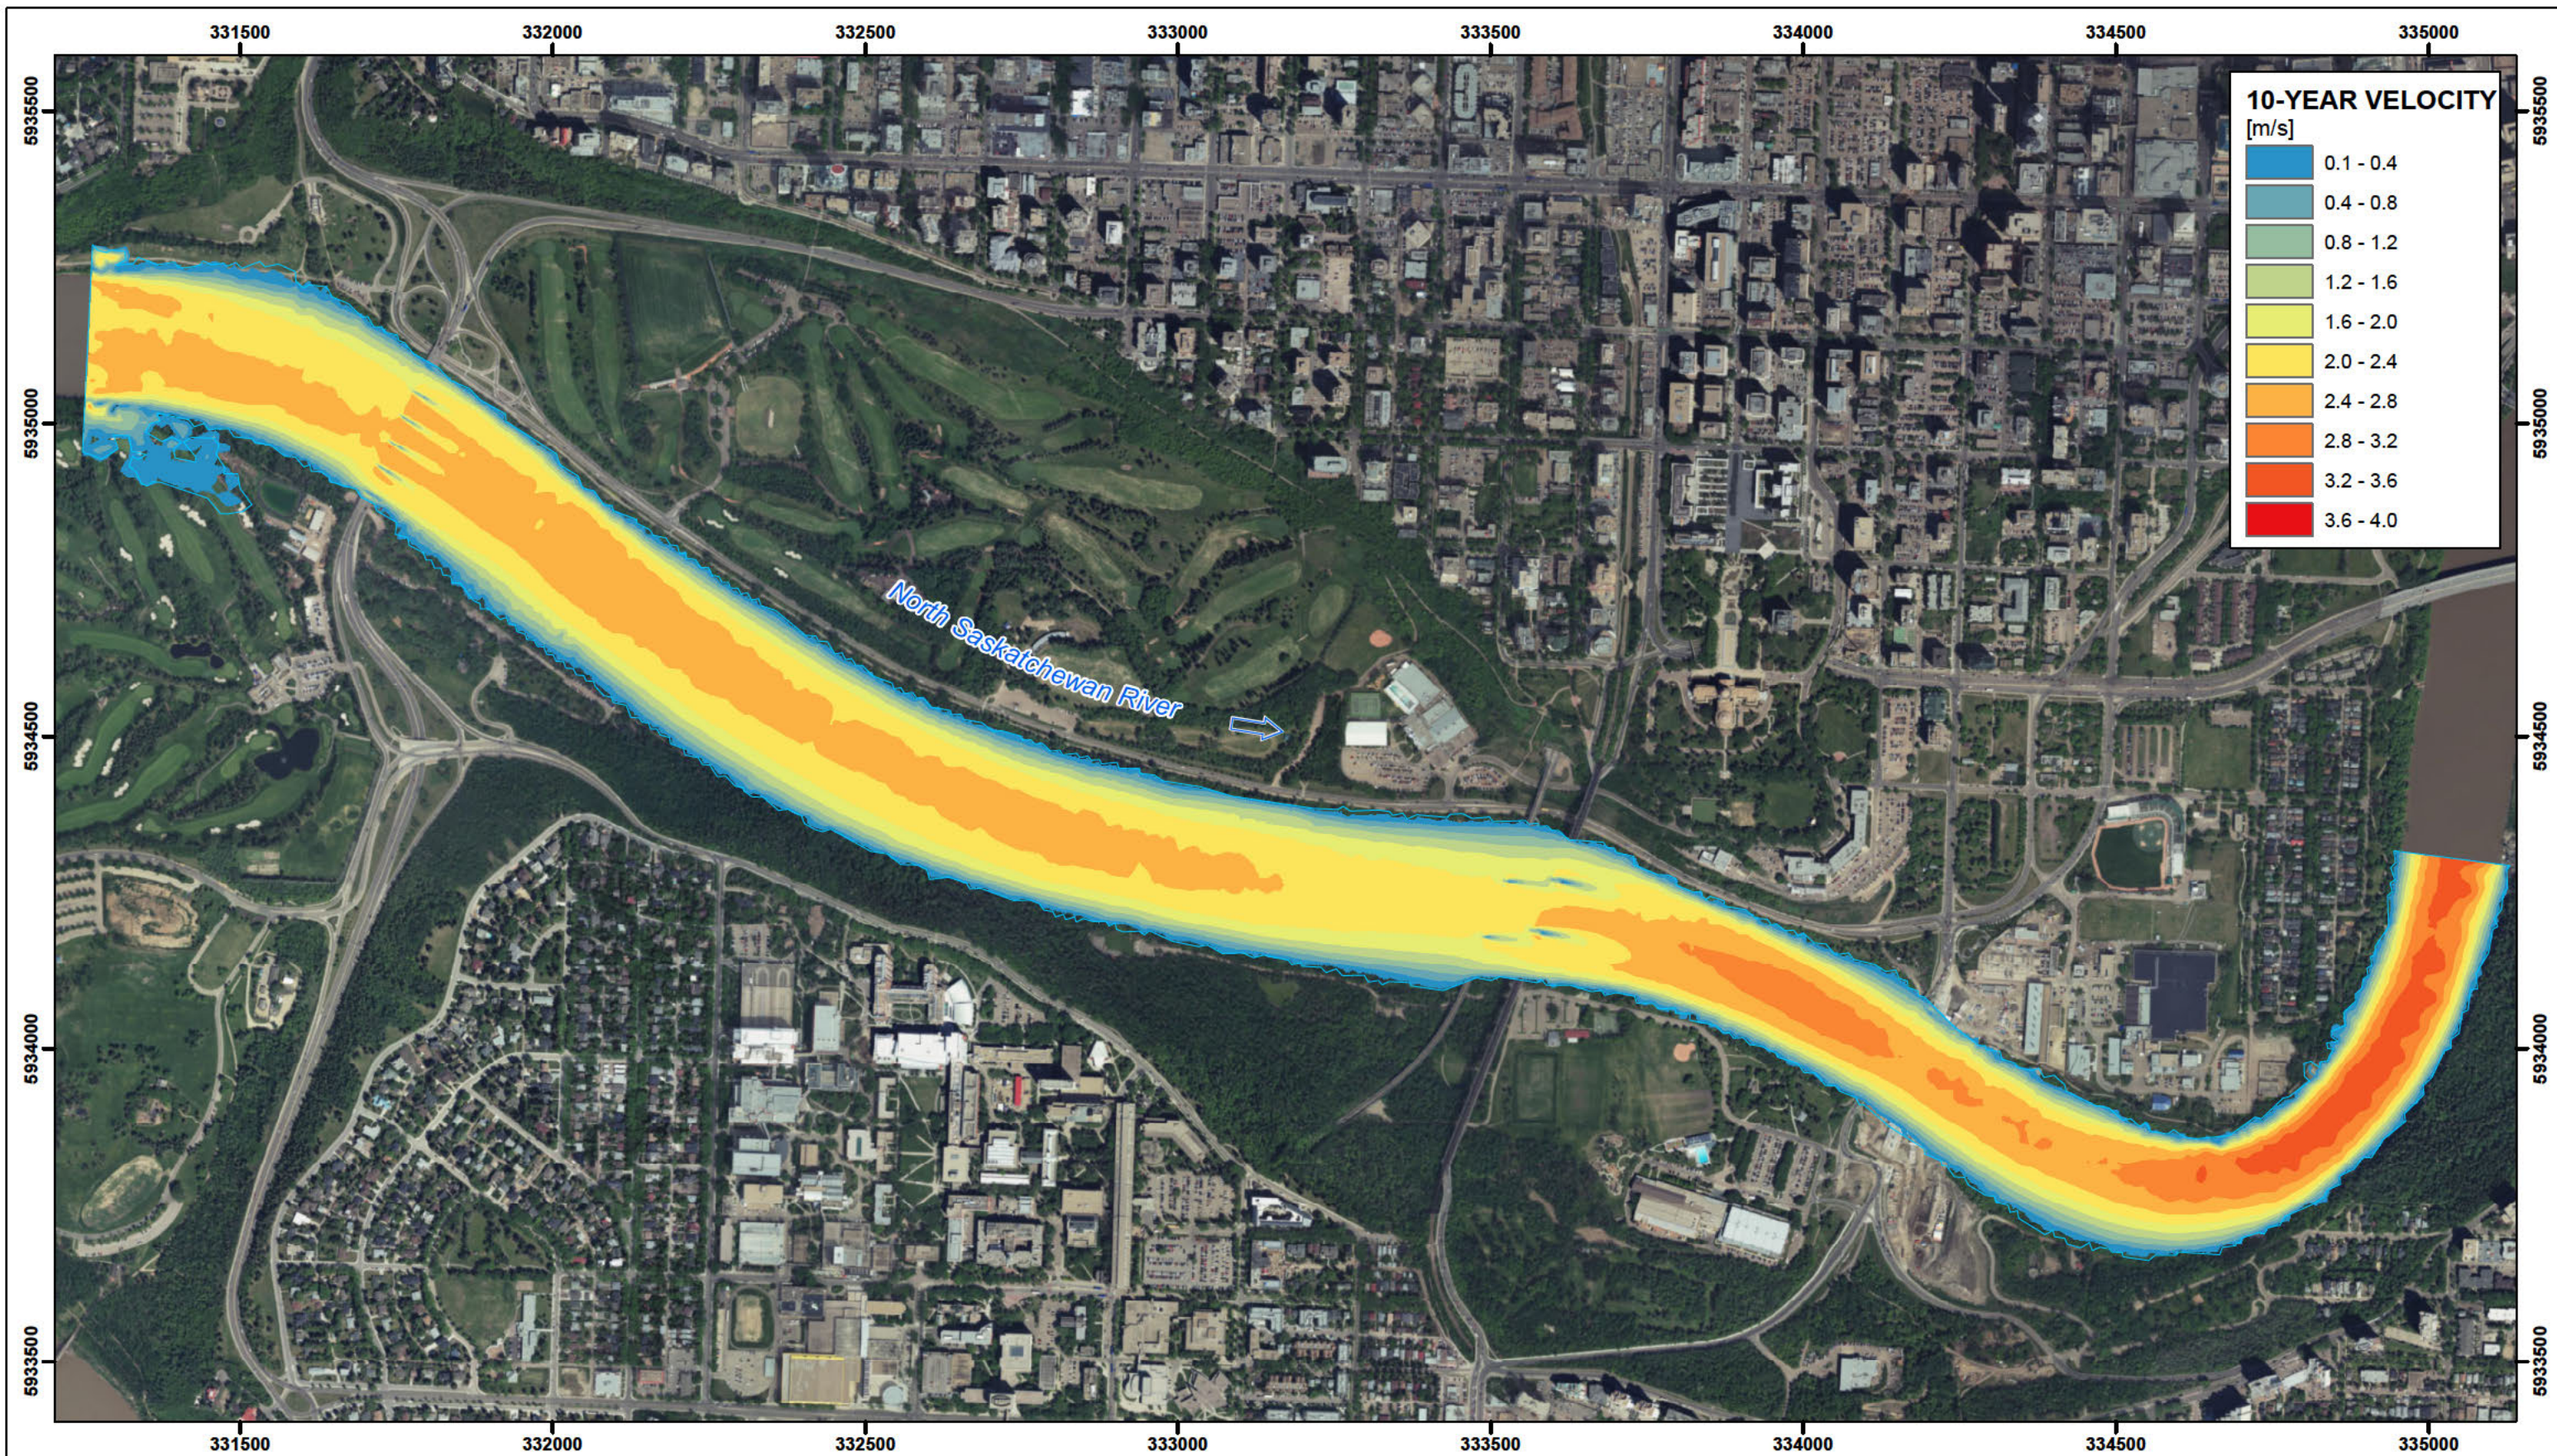
**FIGURE 4-5**

- Notes:**
1. Basemap: Esri World Imagery (2015).
  2. 10-year peak discharge of 2940 cms modelled using TELEMAC2D.
  3. Inundation extents are shown in blue.

**10-YEAR VELOCITY CONTOUR**

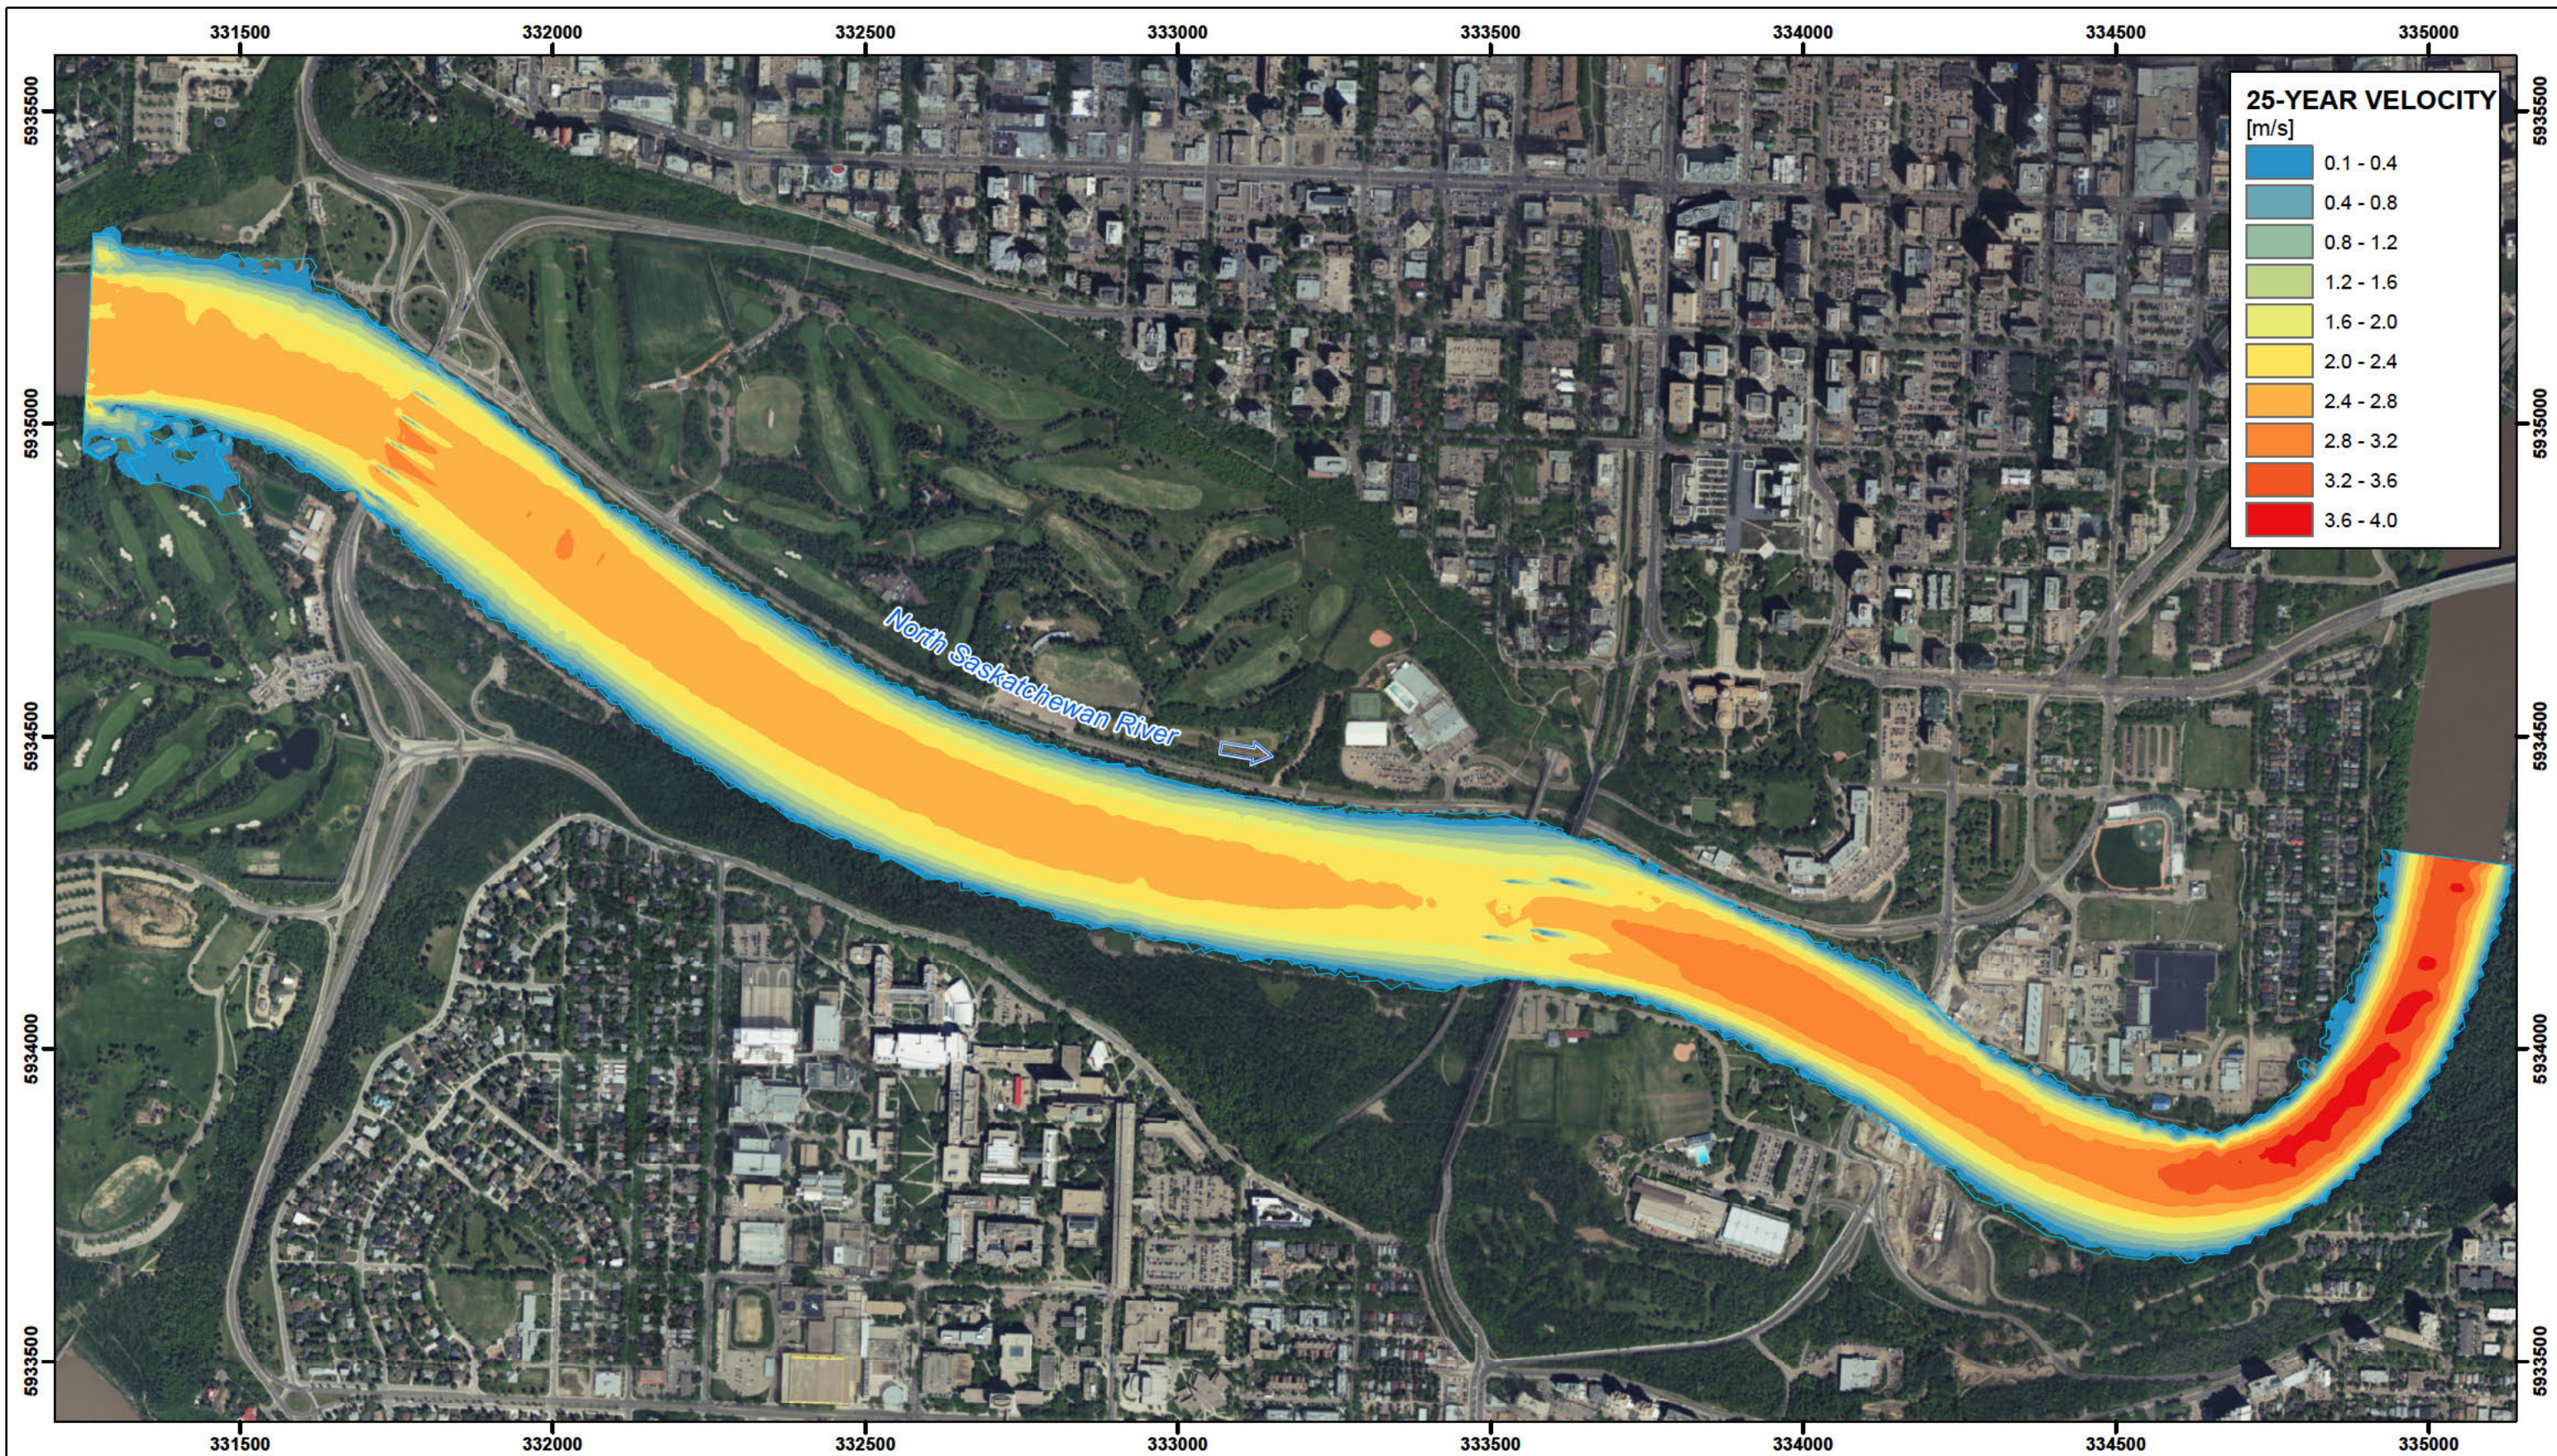
**FIGURE 4-6**

1. Basemap: Esri World Imagery (2015).
2. 25-year peak discharge of 3870 cms modelled using TELEMAC2D.
3. Inundation extents are shown in blue.

**25-YEAR VELOCITY CONTOUR**

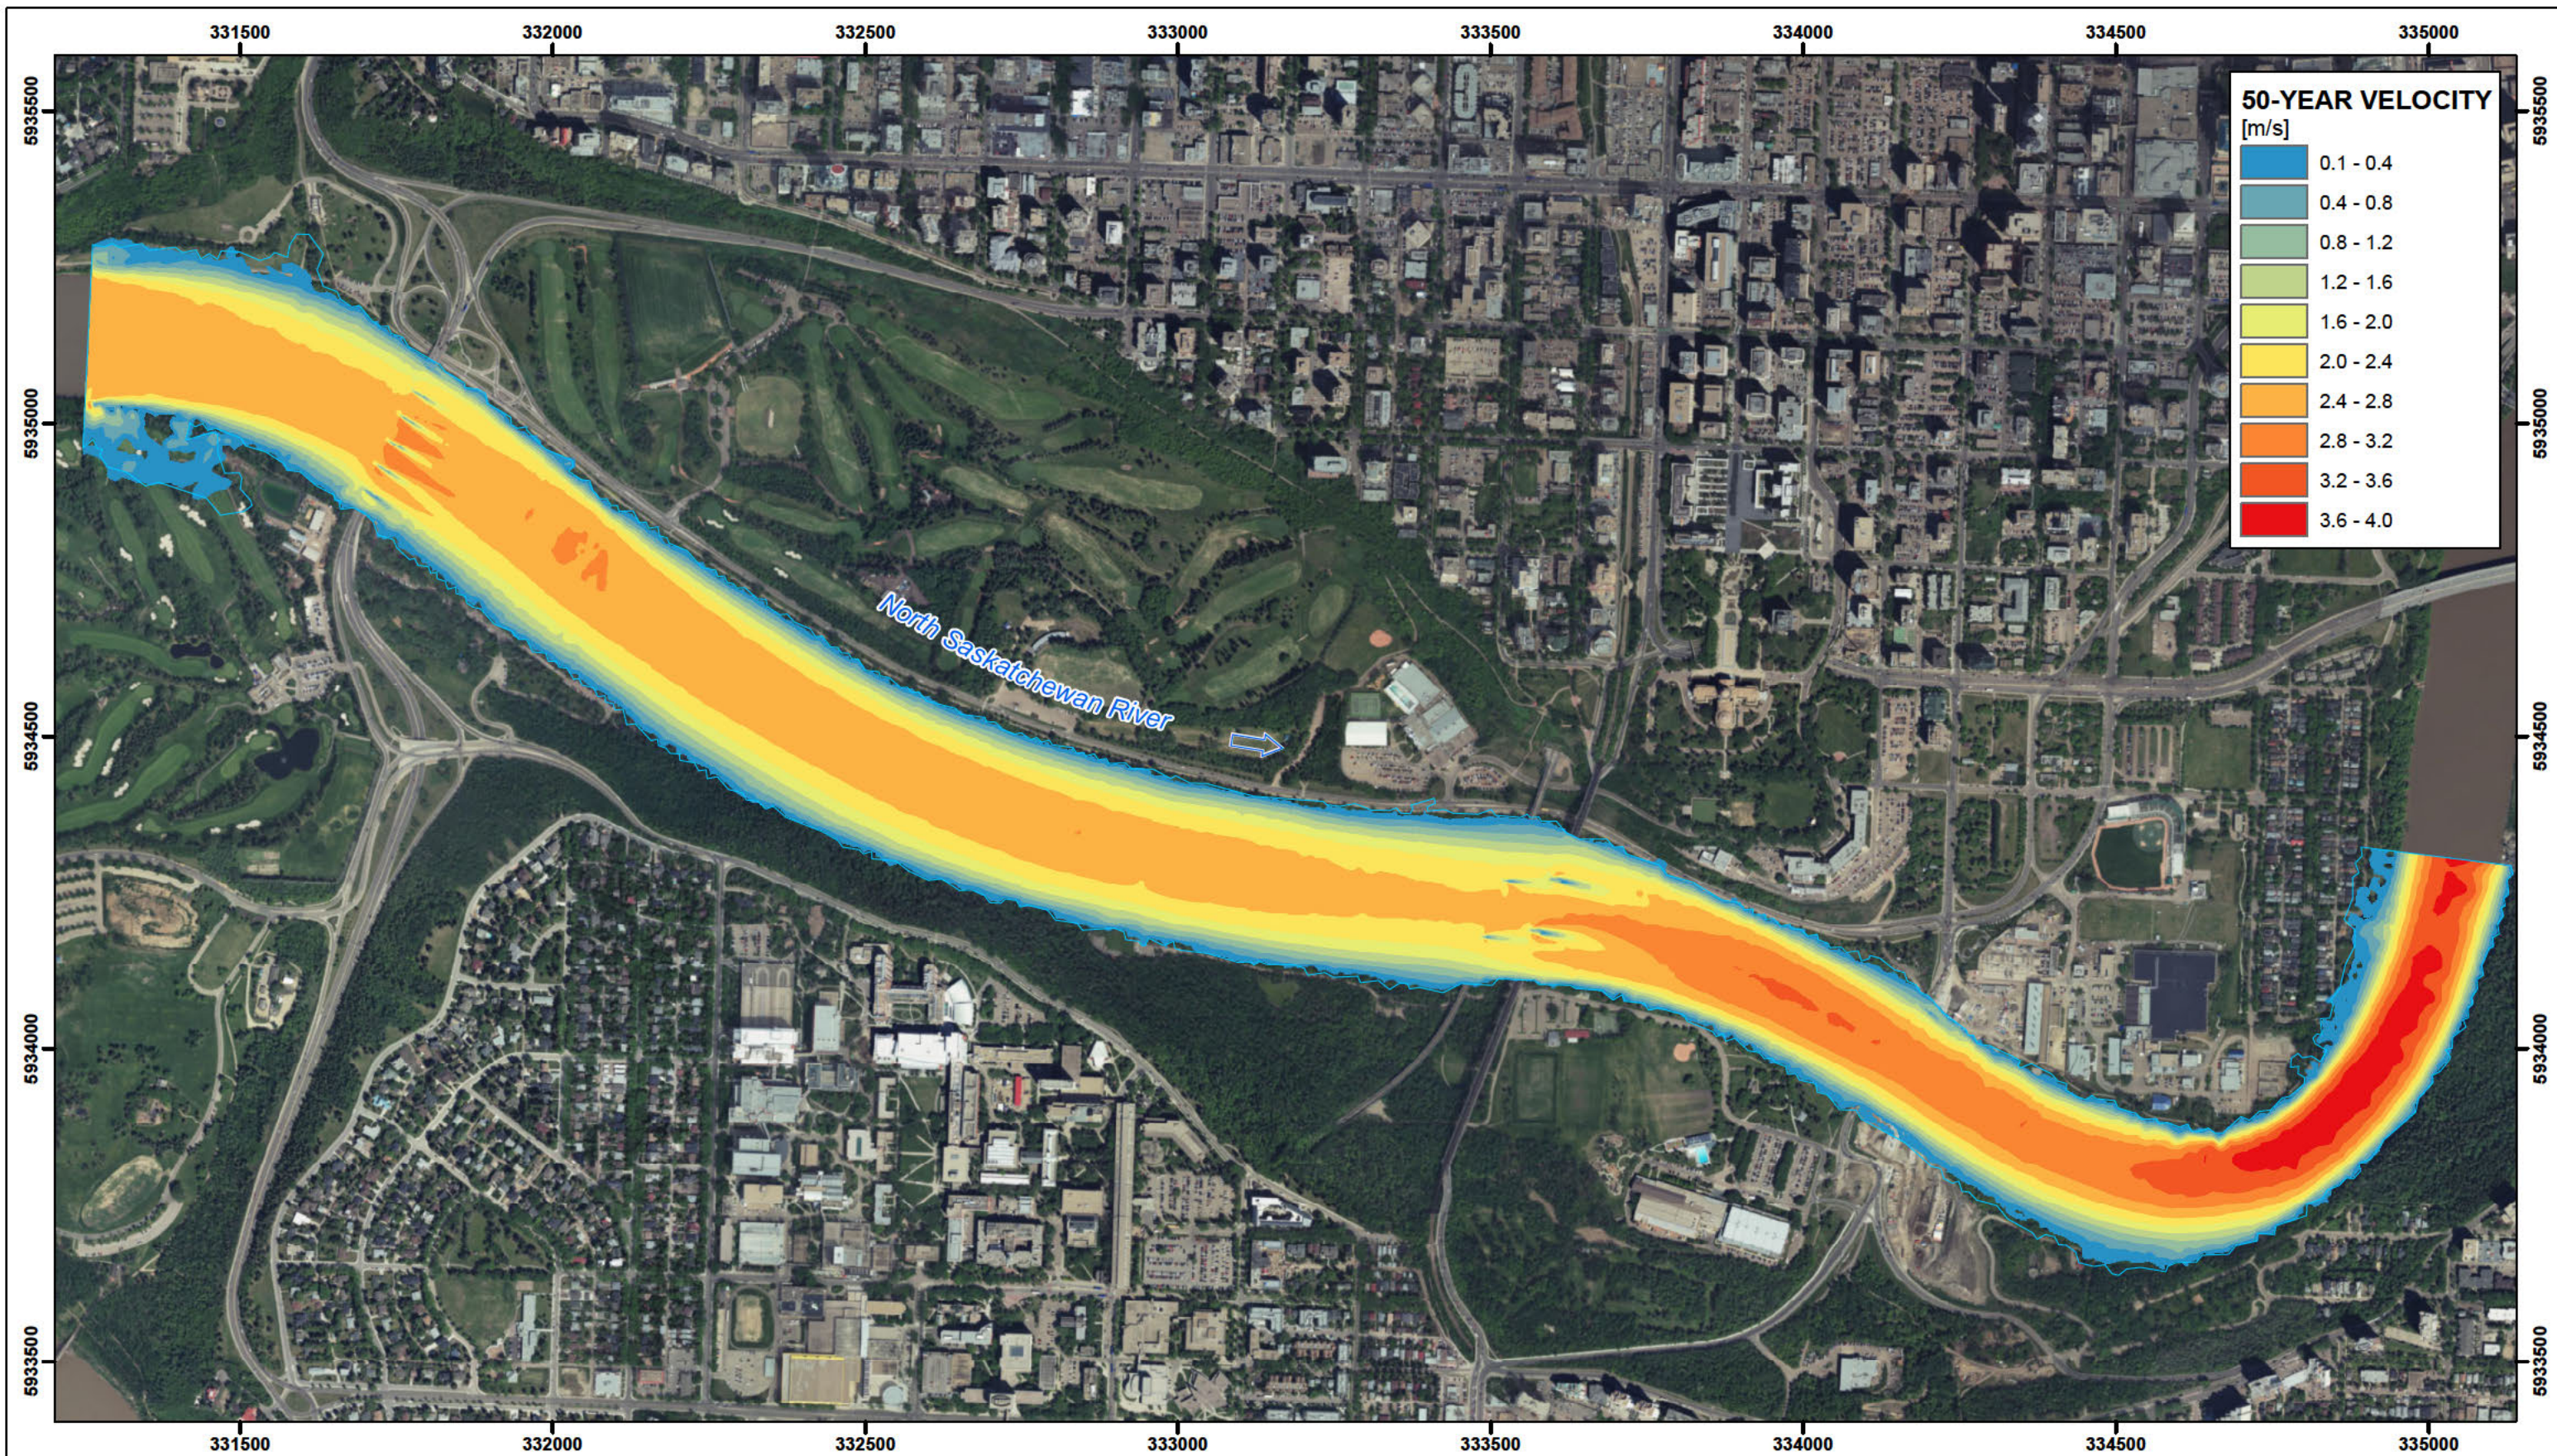
**FIGURE 4-7**

- Notes:**
1. Basemap: Esri World Imagery (2015).
  2. 50-year peak discharge of 4570 cms modelled using TELEMAC2D.
  3. Inundation extents are shown in blue.

**50-YEAR VELOCITY CONTOUR**

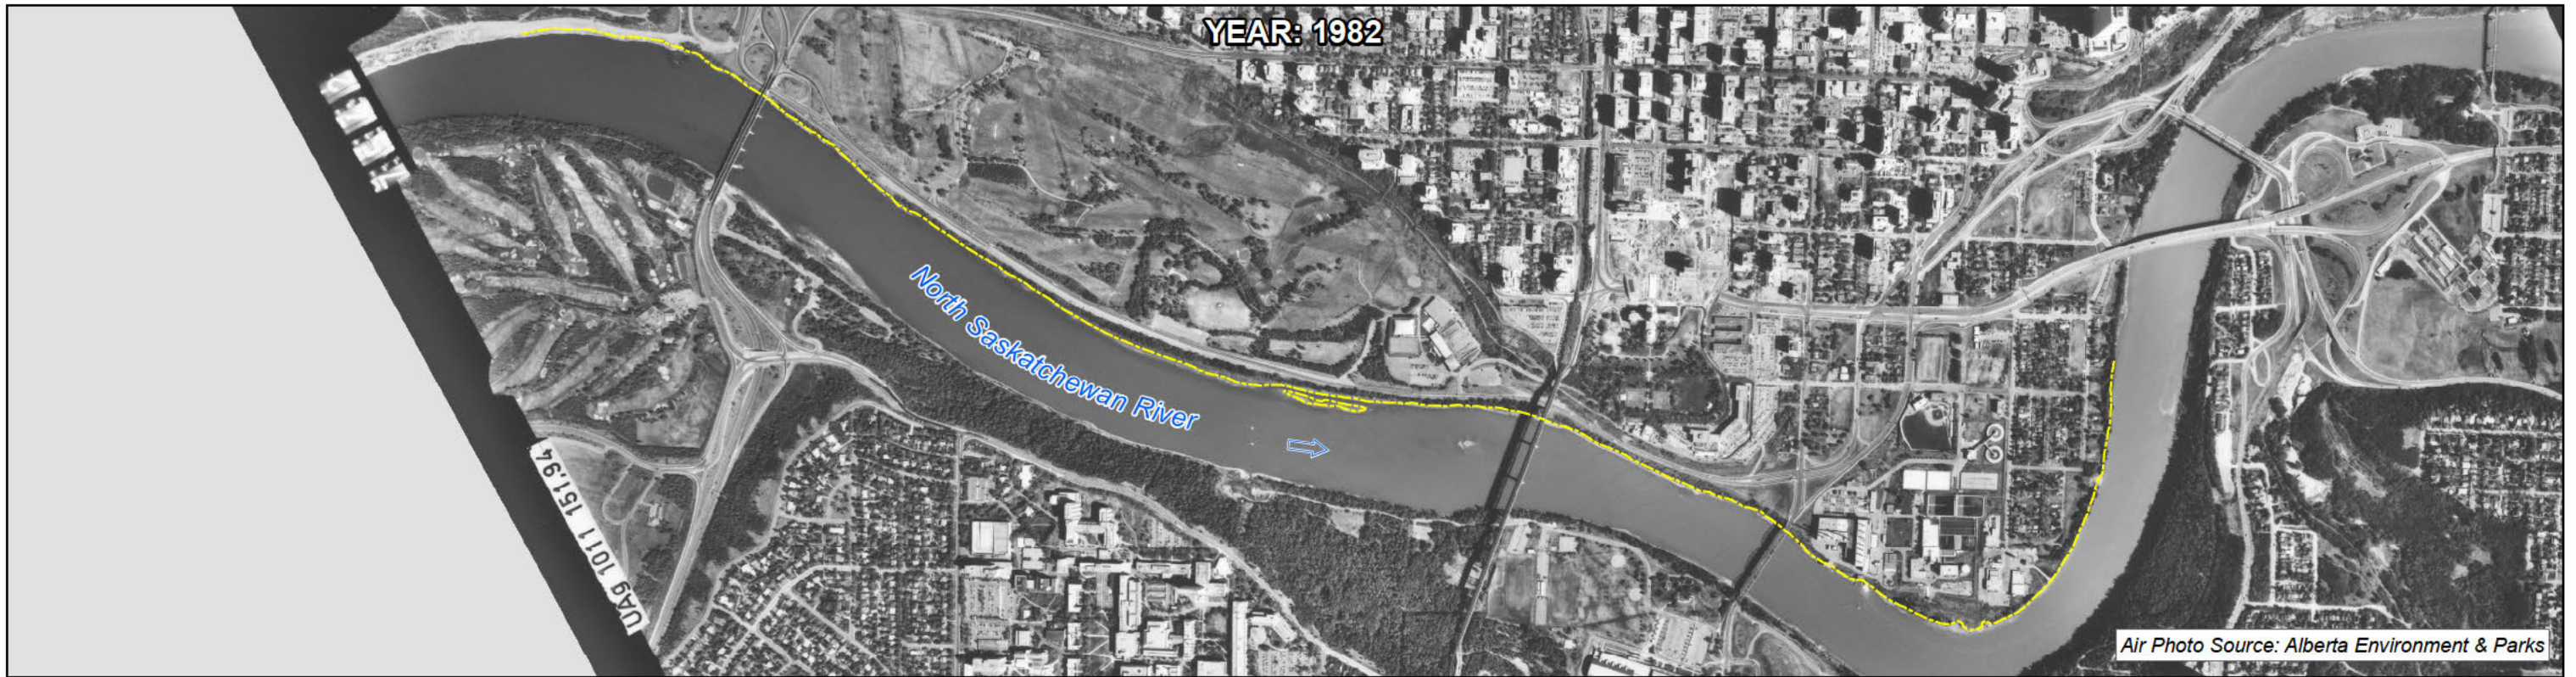
**FIGURE 5-1**

Touch the Water Promenade and  
North Shore Promenade  
Hydrotechnical Assessment  
**HISTORICAL AIR PHOTO  
ANALYSIS**

The North Shore Promenade and the Touch the Water Promenade are both located along the left bank of the North Saskatchewan River. The stability of the left bank was assessed based on historical air photos and field observations. Historical air photos were obtained from AEP to assess the rates of erosion on the left bank of the river. Photos from 1962, 1982, 2001 and recent satellite imagery from 2015 were analyzed. **Figure 5-1** and **Figure 5-2** show the georeferenced air photos. **Figure 5-3** shows the approximate location of the bank delineated on each air photo. The bank lines were overlaid on a single image to illustrate the lateral stability of the left bank along the reach. Given that there is no consistent trend in bank position over time, much of the differences are likely due to distortion and scale effects.

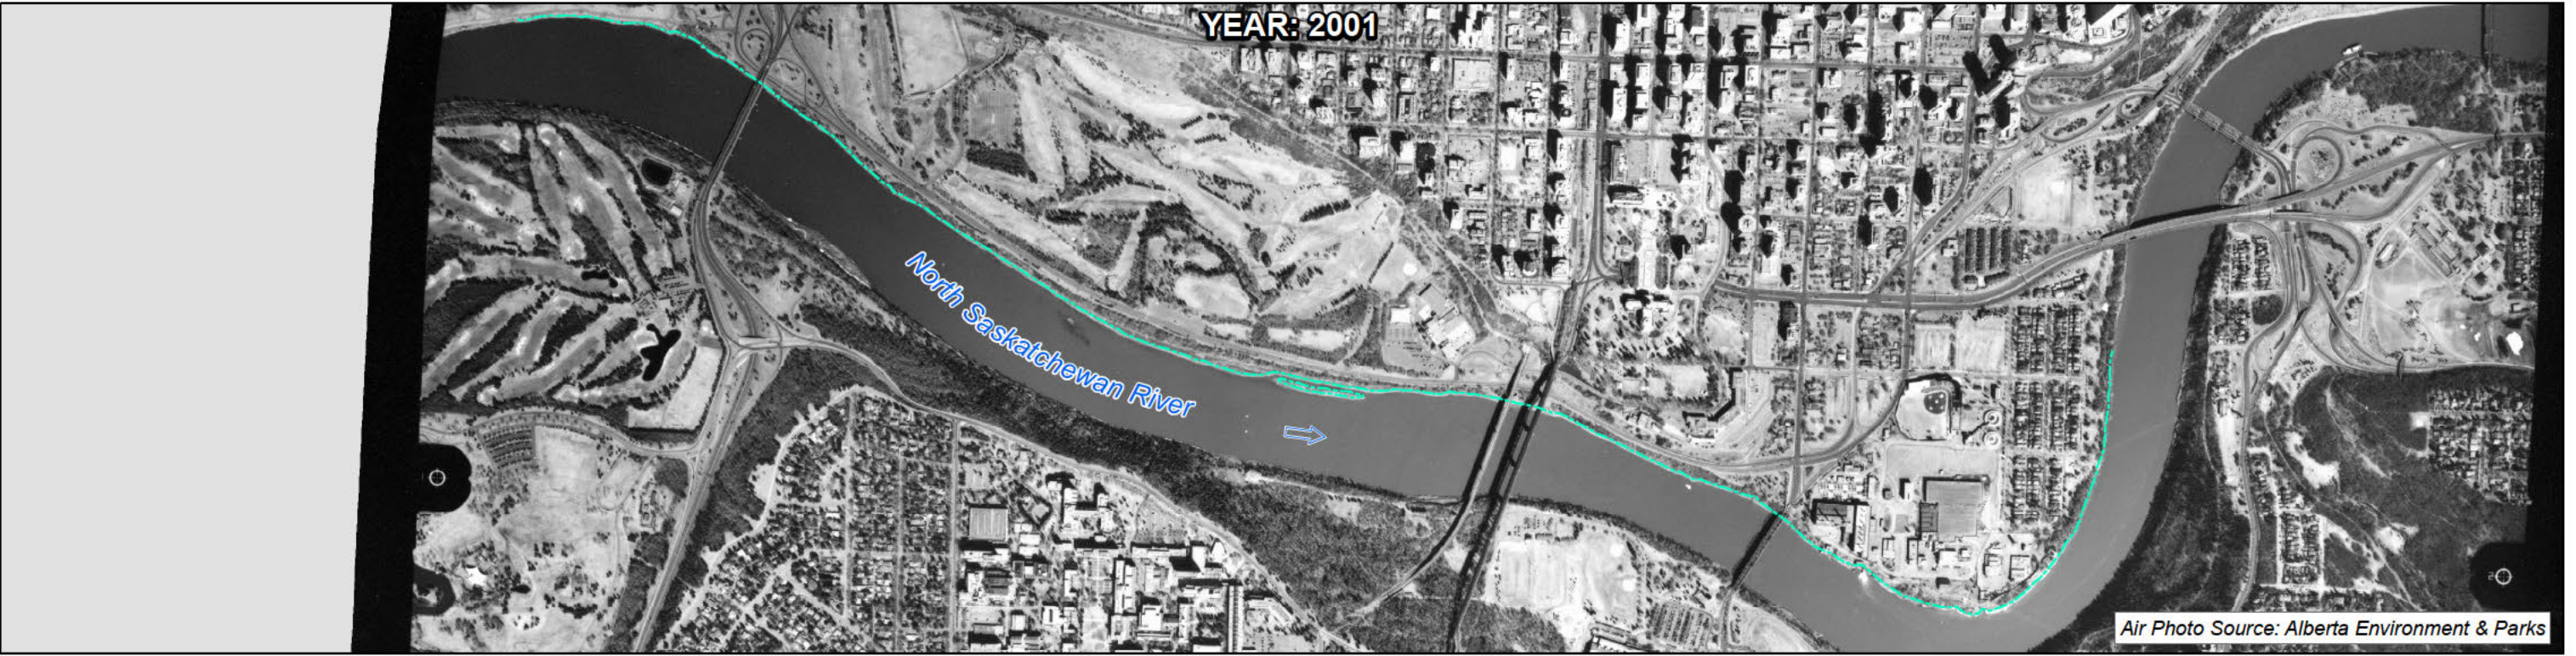
**FIGURE 5-2**

**HISTORICAL AIR PHOTO  
ANALYSIS**
