NHC Ref. No.1004400

3 June 2020

**Re:** Touch the Water Promenade and North Shore Promenade – Final Report  
Hydrotechnical Assessment

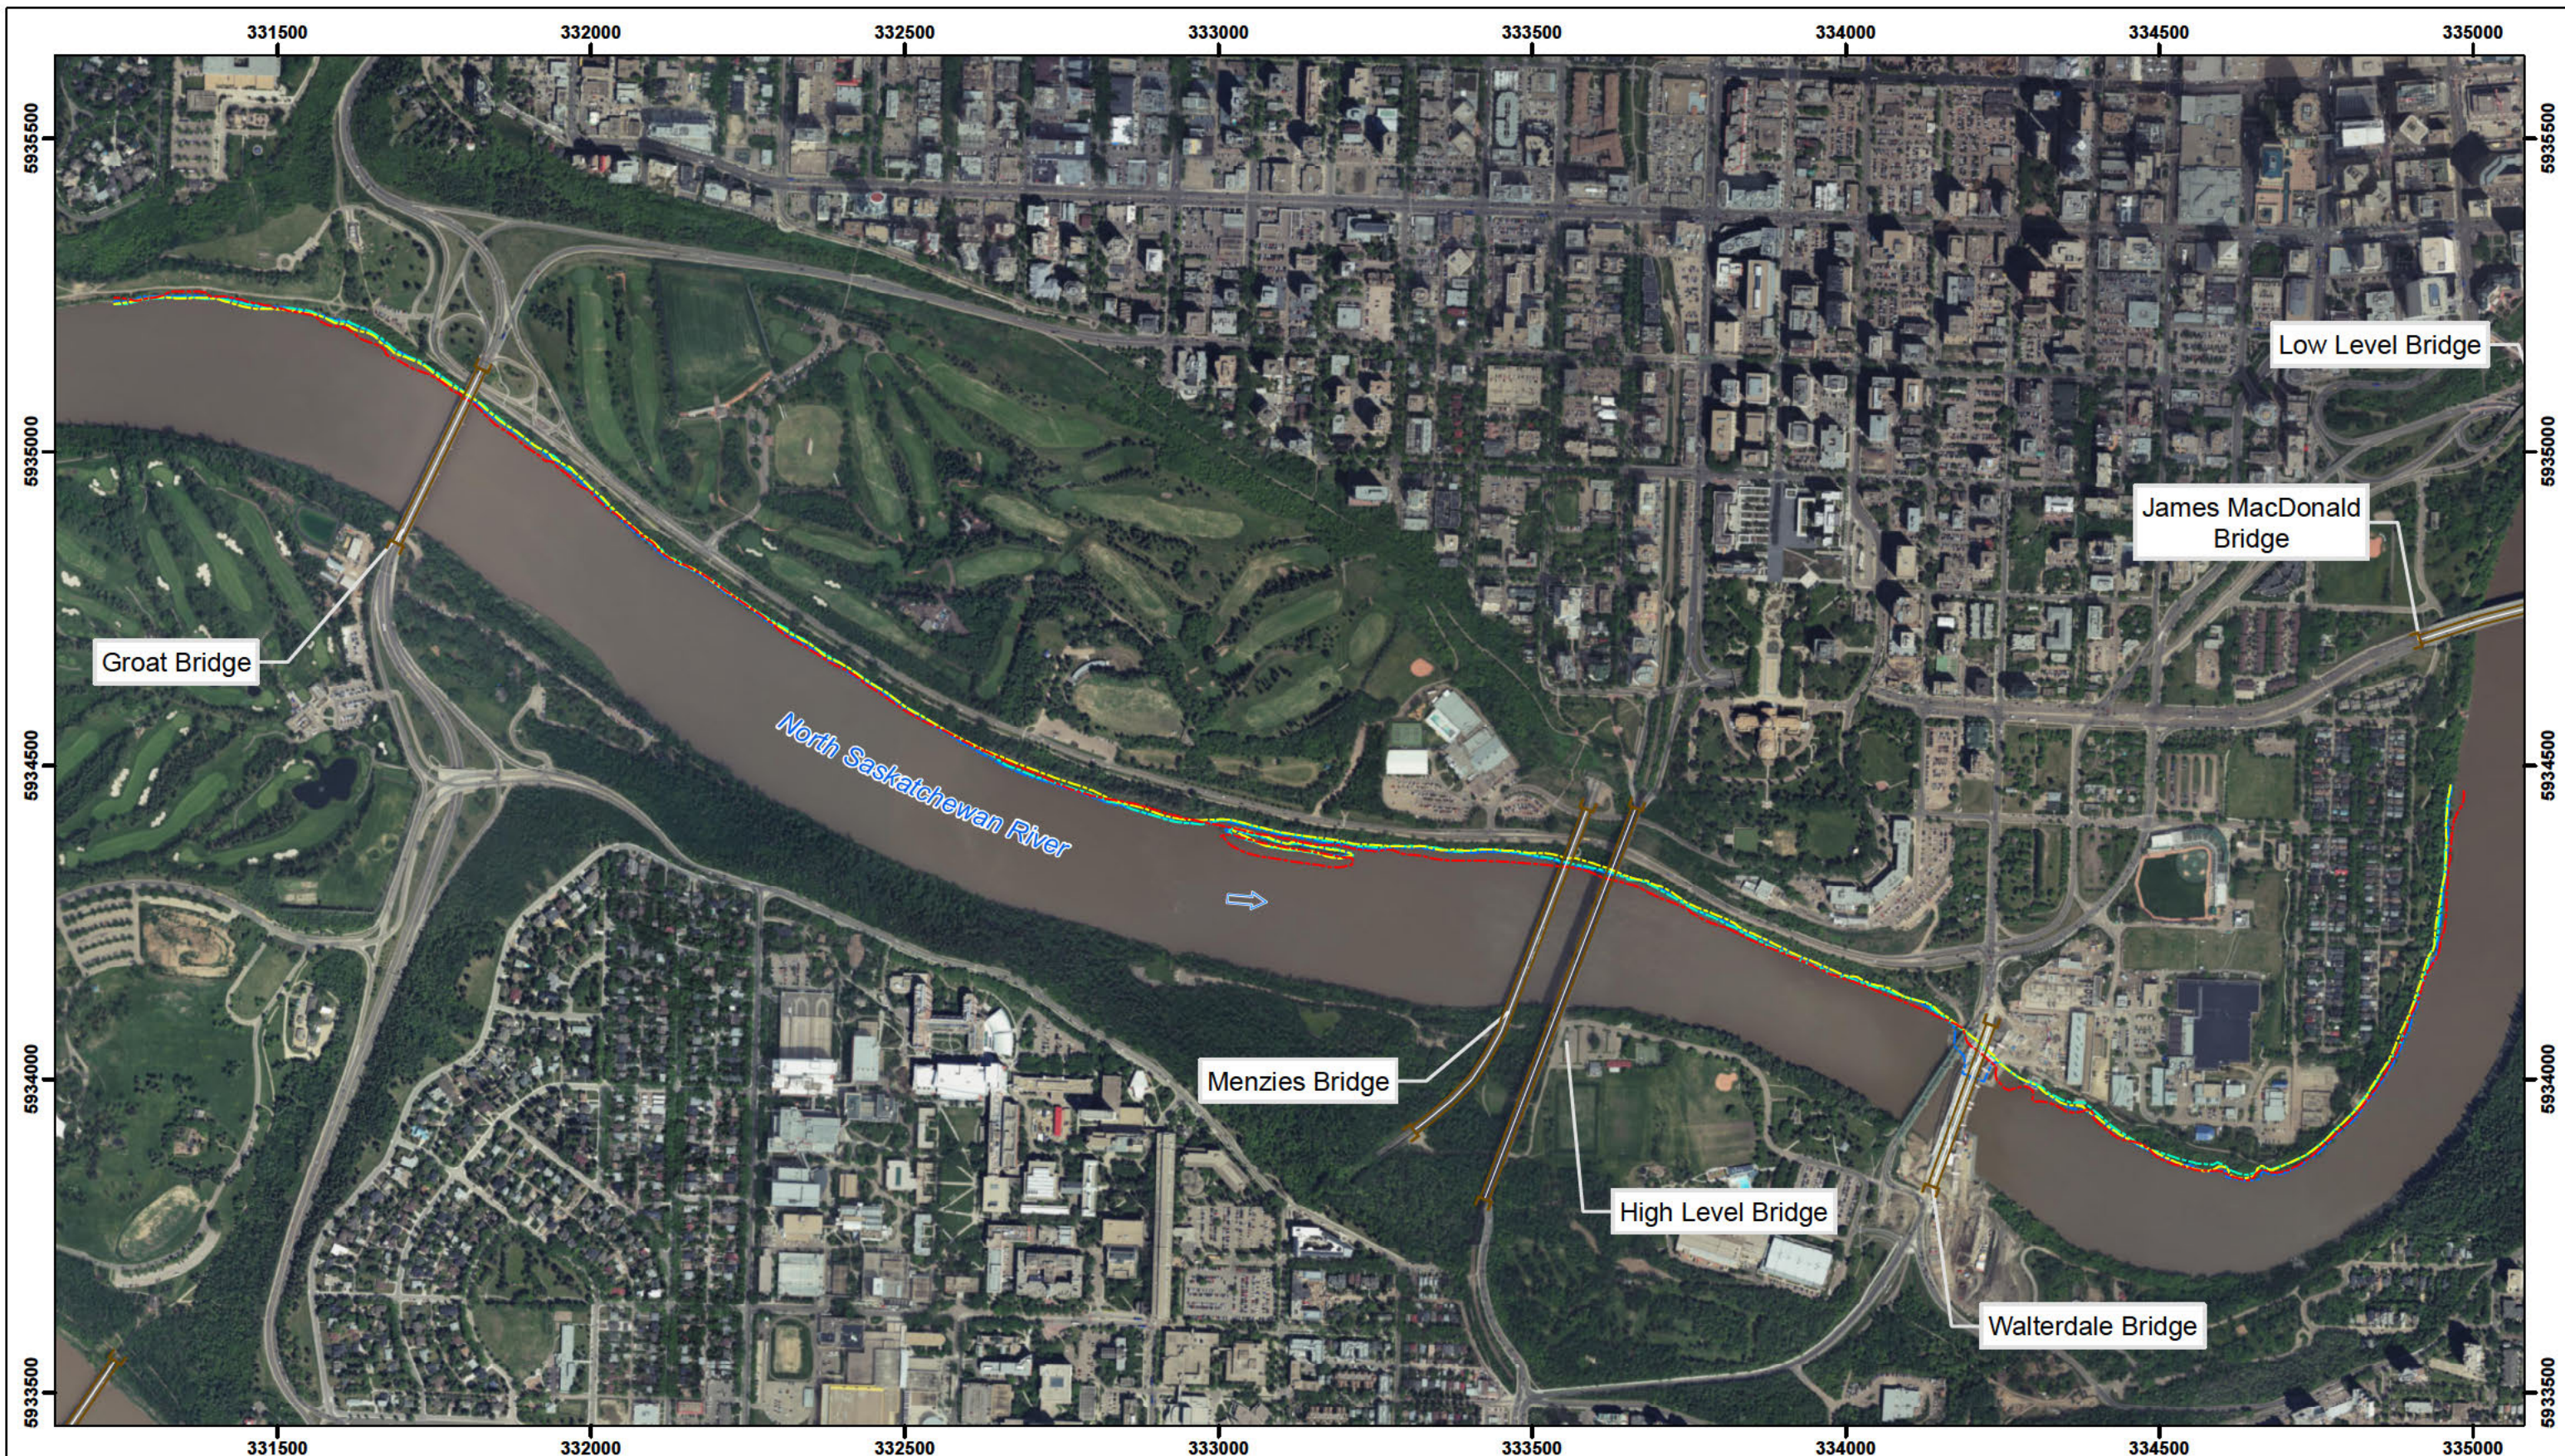
**FIGURE 5-3**

**BANKLINE**

- 1962
- 1982
- 2001
- 2015

**LATERAL STABILITY ANALYSIS**

The North Shore Promenade and the Touch the Water Promenade are both located along the left bank of the North Saskatchewan River. The stability of the left bank was assessed based on historical air photos and field observations. Historical air photos were obtained from AEP to assess the rates of erosion on the left bank of the river. Photos from 1962, 1982, 2001 and recent satellite imagery from 2015 were analyzed. **Figure 5-1** and **Figure 5-2** show the georeferenced air photos. **Figure 5-3** shows the approximate location of the bank delineated on each air photo. The bank lines were overlaid on a single image to illustrate the lateral stability of the left bank along the reach. Given that there is no consistent trend in bank position over time, much of the differences are likely due to distortion and scale effects.

In general, the left bank of the North Saskatchewan River is not susceptible to significant bank erosion. The historical air photo analysis of the reach shows that over the last approximately 60 years that the left bank has remained relatively stable. Upstream of the Groat Road Bridge, the left bank may be susceptible to some erosion because it is located on the outside of a meander. There is some existing bank protection in the form of broken concrete at the toe of the bank in this area. This bank protection is keeping the bank stable and more resistant to erosion. Dub has indicated that the existing concrete blocks armouring this bank should be replaced with an alternative material on this section of the river. Between the Groat Road Bridge and the High Level Bridge, the channel is fairly straight with the left bank being on the inside of a mild meander. The left bank is well vegetated and therefore appears to be stable. At the toe of the slope, some deposition of fine sediment was observed. The standard procedure is to use rock riprap as protection as it is a proven robust material and is durable over time. Other options for bank protection
