City of Edmonton

2019-3585

Rainbow Valley Bridges Renewal & Widening Terwillegar Drive Stage 2 Upgrades Environmental Impact Assessment

JANUARY 2022

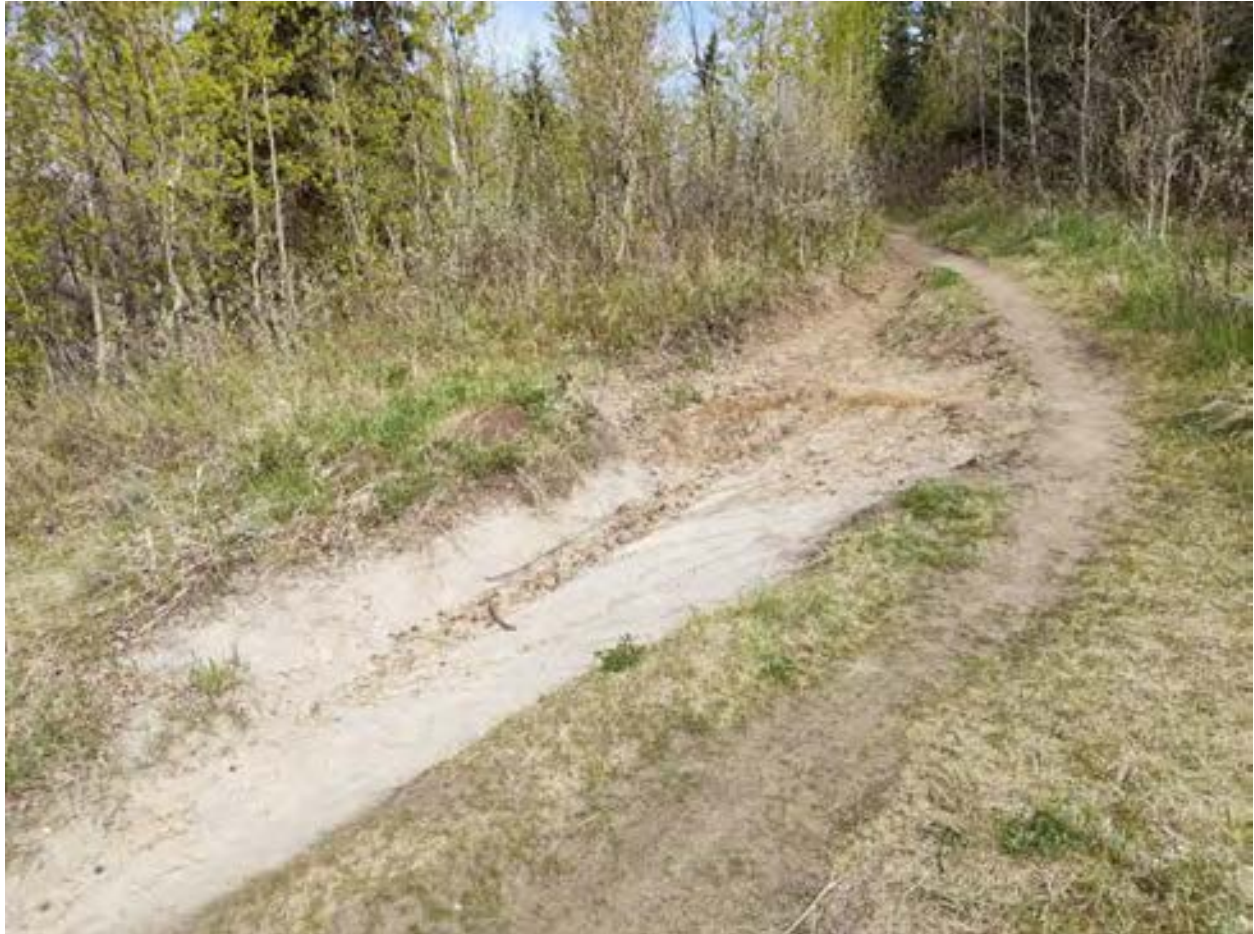
Figure 13. The single, small patch of exposed bedrock found northeast of the Rainbow Valley Bridges. Note ironstone horizon near the top of the exposure. The patch was likely exposed through erosion of the footpath across it.

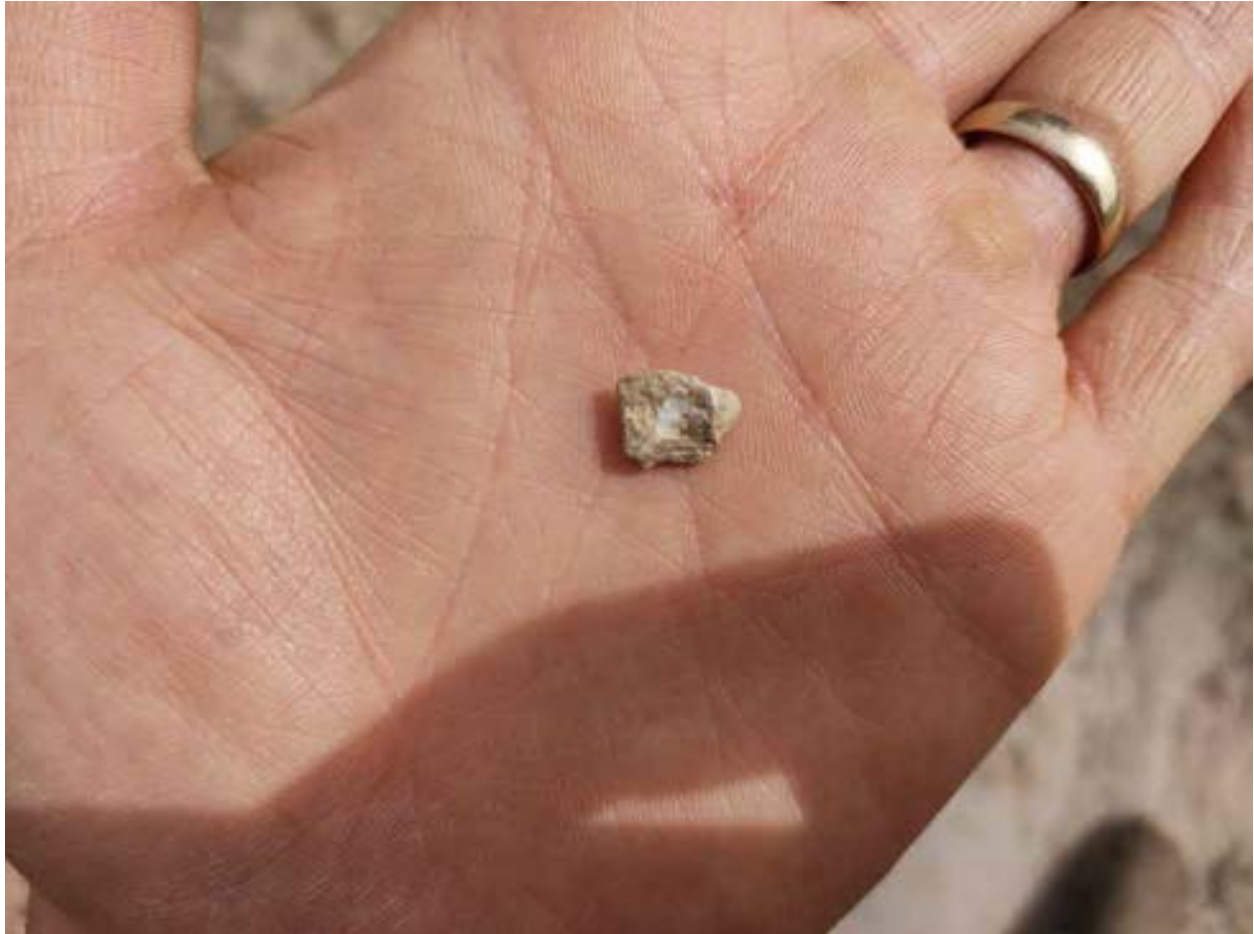
Figure 15. Possible fragment of an ornithischian tooth found at the exposure in Figure 13.

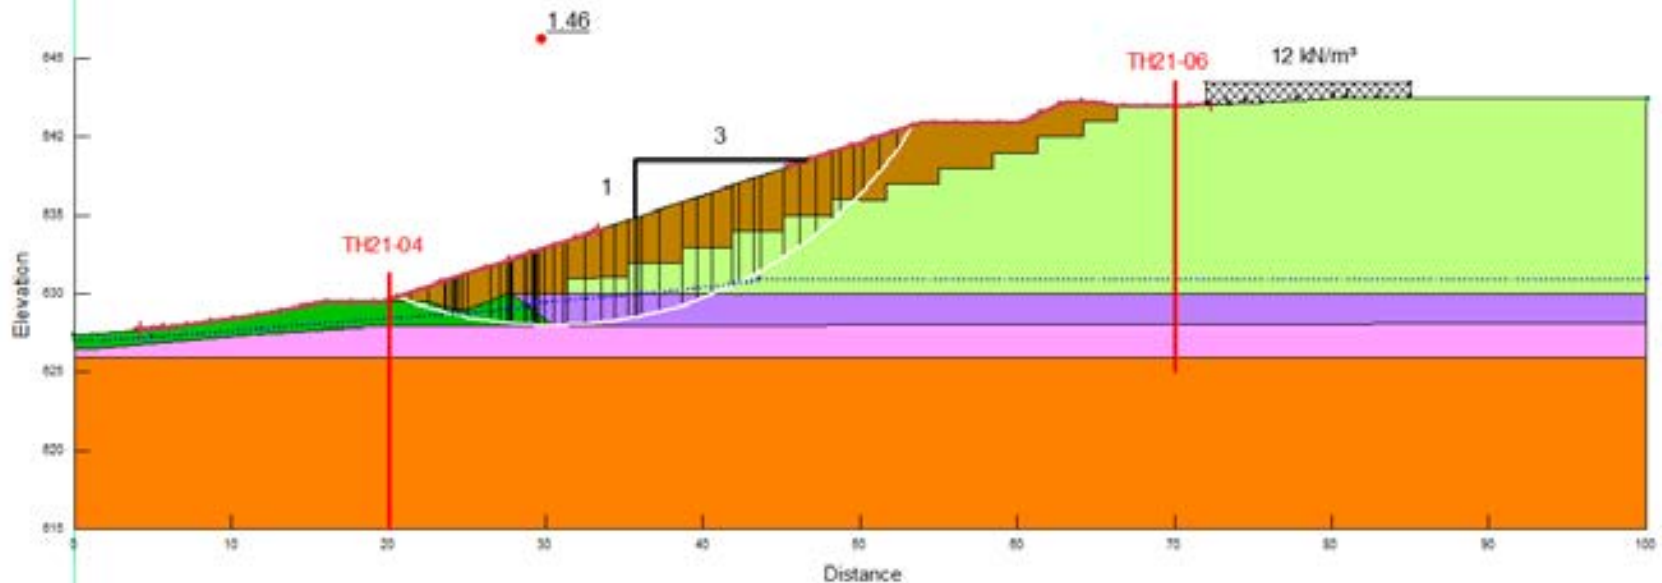
Color	Name	Material Model	Unit Weight (kN/m ³)	Effective Cohesion (kPa)	Effective Friction Angle (°)	Phi-B (°)	Piezometric Line	B-bar	Add Weight
Green	Clay Fill	Mohr-Coulomb	19	5	20	0	1	0.4	No
Pink	Clay Shale	Mohr-Coulomb	20	10	25	0	1	0.6	No
Purple	Clay Shale and Sandstone Fill	Mohr-Coulomb	20	10	22	0	1	0.4	No
Light Green	Existing Fill	Mohr-Coulomb	19	10	20	0	1	0.4	No
Brown	New low to medium plastic Clay Till Fill	Mohr-Coulomb	19	5	28	0	1	0.2	Yes
Orange	Sandstone	Bedrock (Impenetrable)					1	0	No

Figure E2: Section E1-E1' – Short Term Conditions

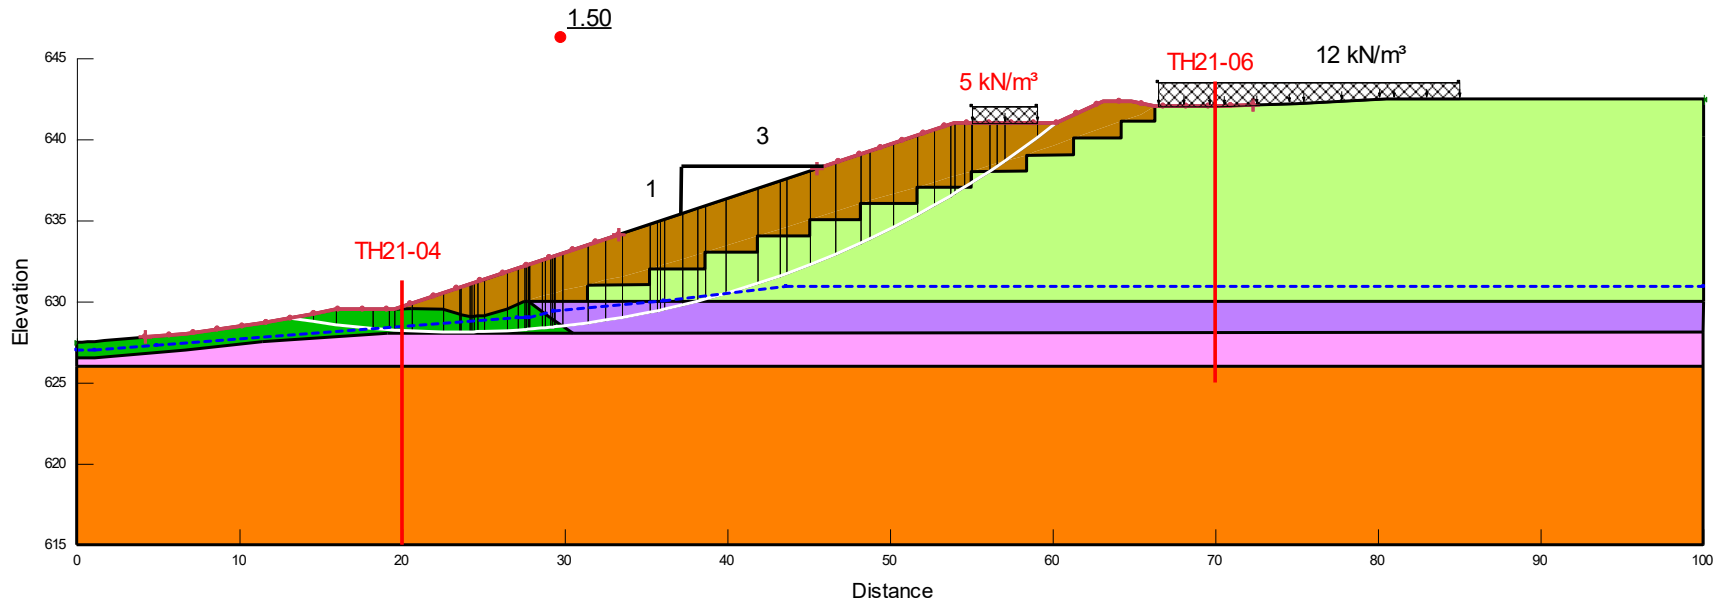
Color	Name	Material Model	Unit Weight (kN/m ³)	Effective Cohesion (kPa)	Effective Friction Angle (°)	Phi-B (°)	Piezometric Line
Green	Clay Fill	Mohr-Coulomb	19	1	20	0	1
Pink	Clay Shale	Mohr-Coulomb	20	10	25	0	1
Purple	Clay Shale and Sandstone Fill	Mohr-Coulomb	20	5	22	0	1
Light Green	Existing Fill	Mohr-Coulomb	19	5	20	0	1
Brown	New low to medium plastic Clay Till Fill	Mohr-Coulomb	19	5	28	0	1
Orange	Sandstone	Bedrock (Impenetrable)					1

Figure E3: Section E1-E1' – Long Term Conditions

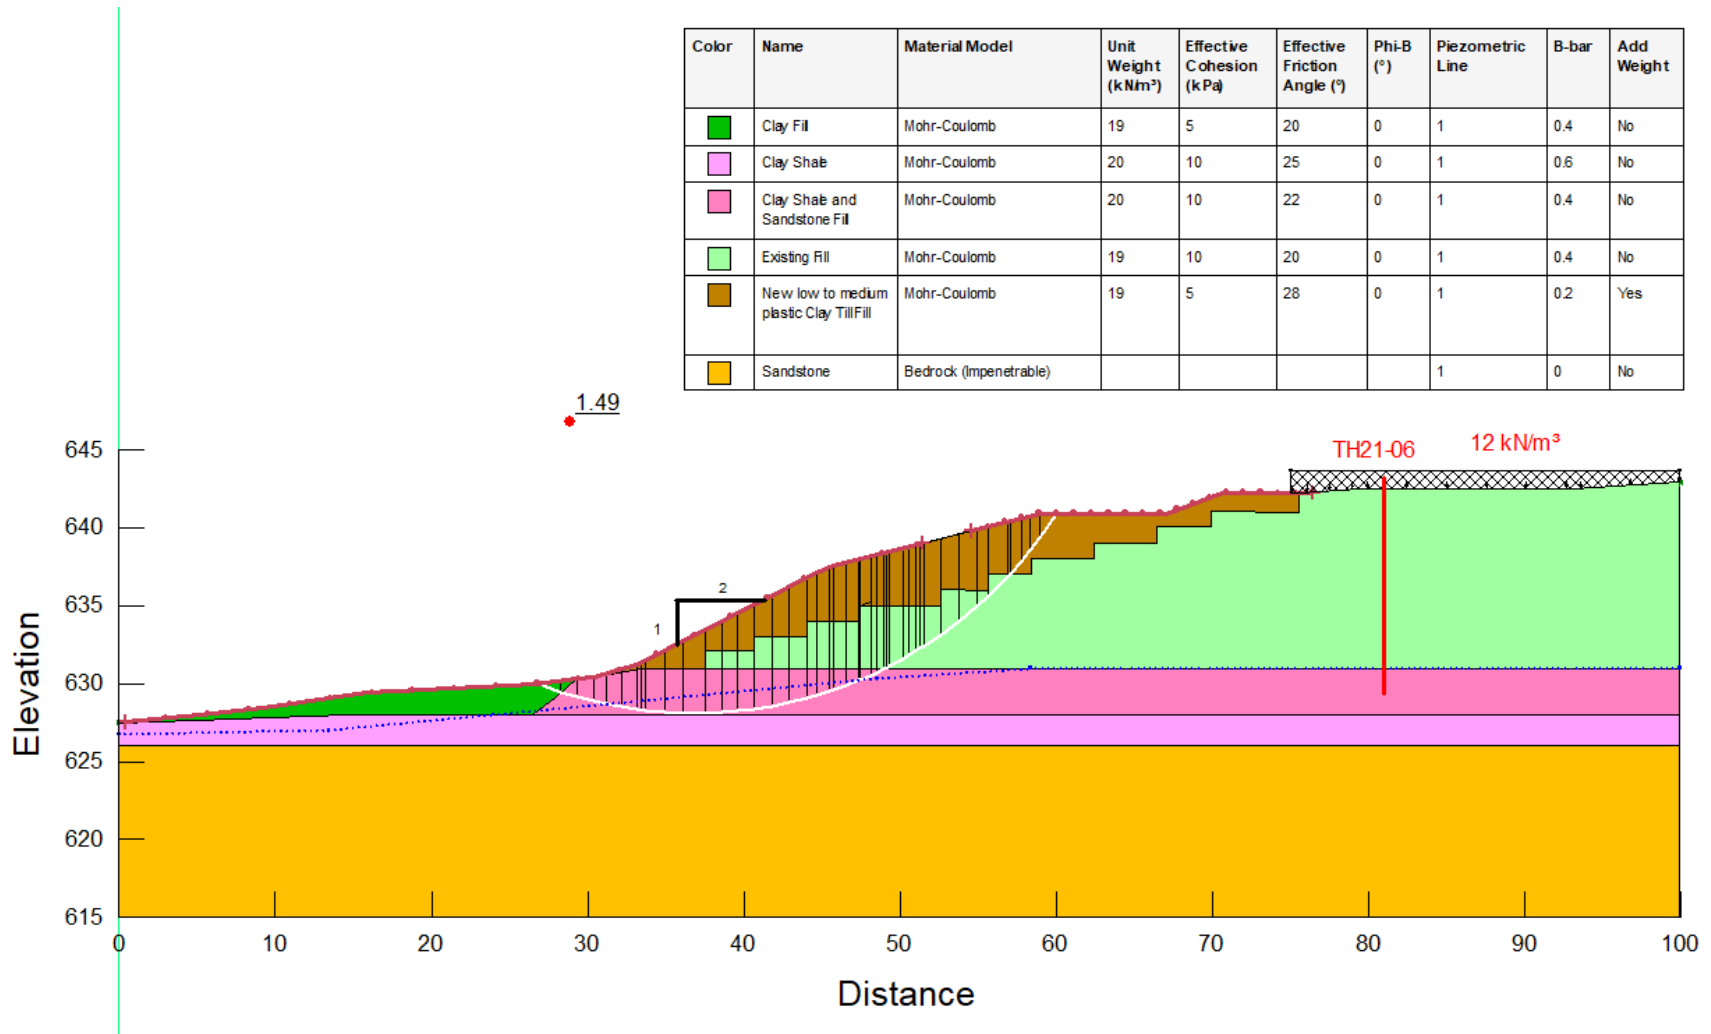
Figure E11: Section E4-E4' – Short Term Conditions

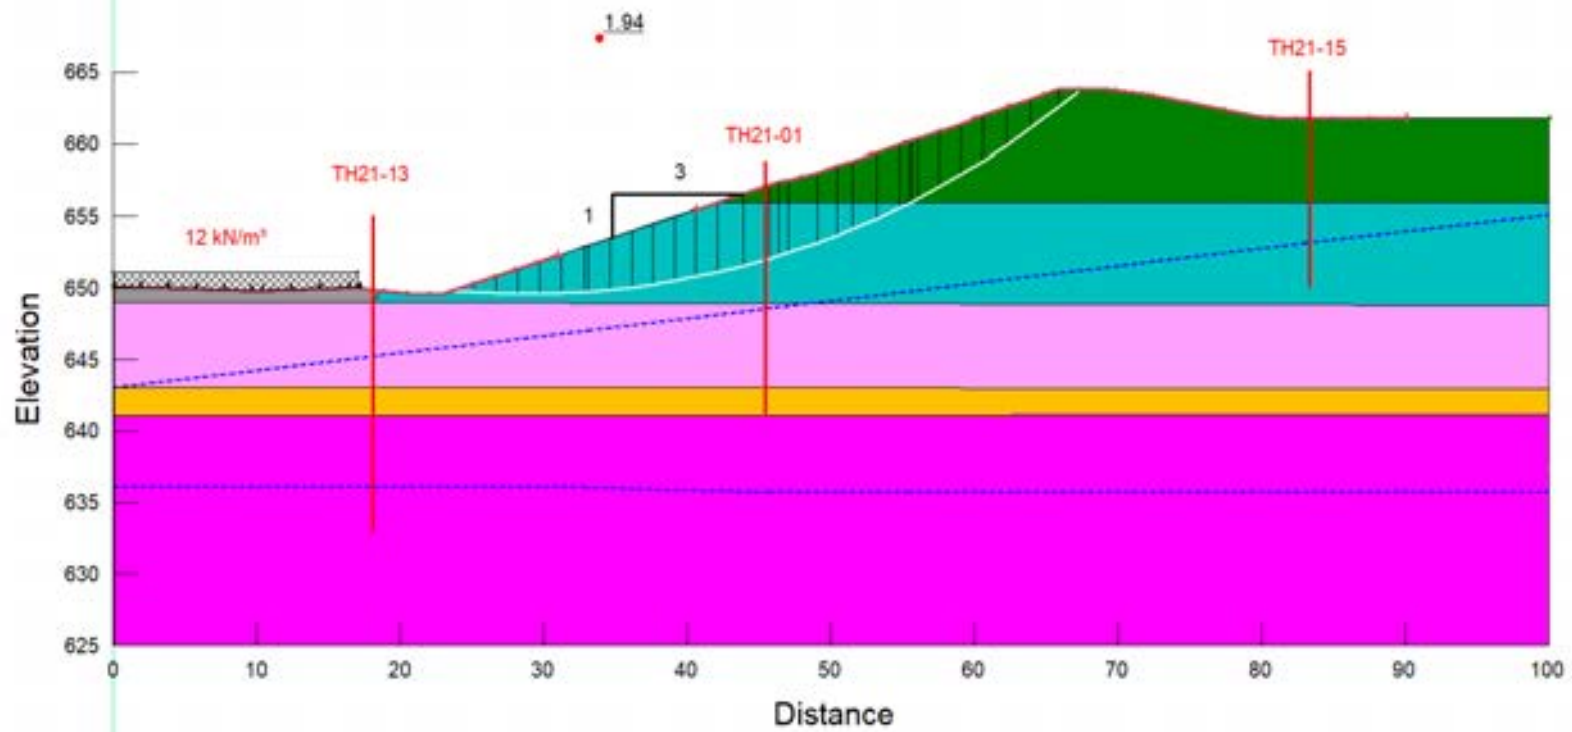
Color	Name	Material Model	Unit Weight (kN/m ³)	Effective Cohesion (kPa)	Effective Friction Angle (°)	Phi-B (°)	Piezometric Line
Green	Clay	Mohr-Coulomb	19	3	23	0	2
Pink	Clay Shale	Mohr-Coulomb	20	10	25	0	2
Magenta	Clay Shale (2)	Mohr-Coulomb	20	10	25	0	1
Cyan	Clay Till	Mohr-Coulomb	19	5	28	0	2
Grey	Gravel and Sand Fill	Mohr-Coulomb	21	0	35	0	2
Yellow	Sandstone	Bedrock (Impenetrable)					2

Figure E14: Section W1-W1' – Cut Slope

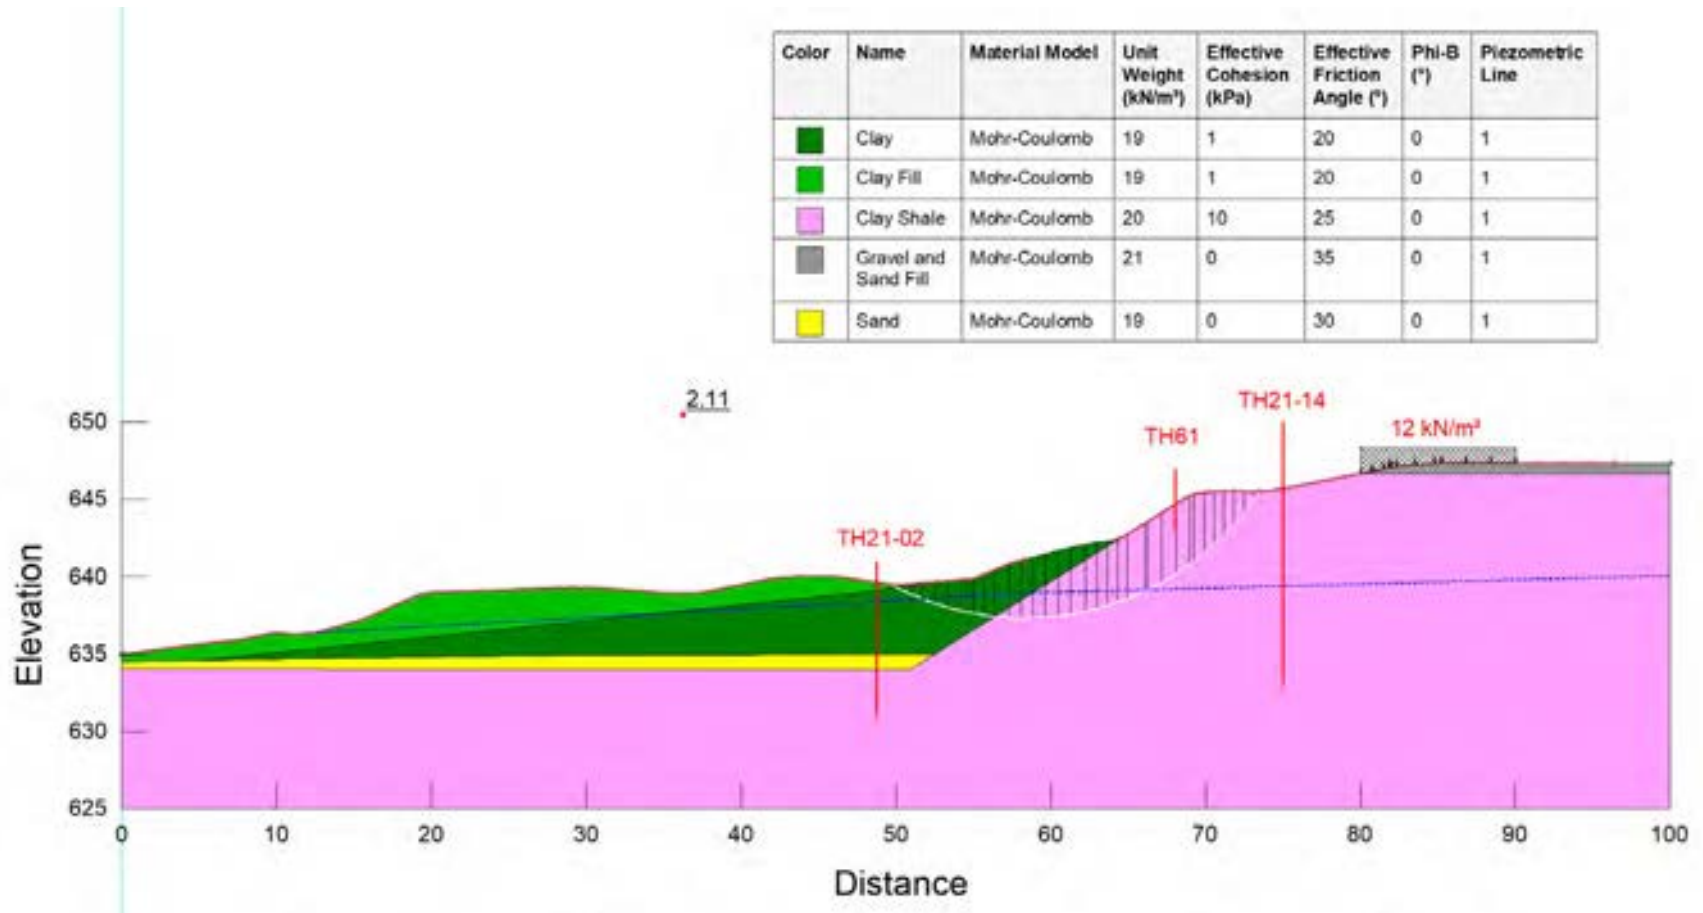
Figure E15: Section W2-W2' – Existing Conditions

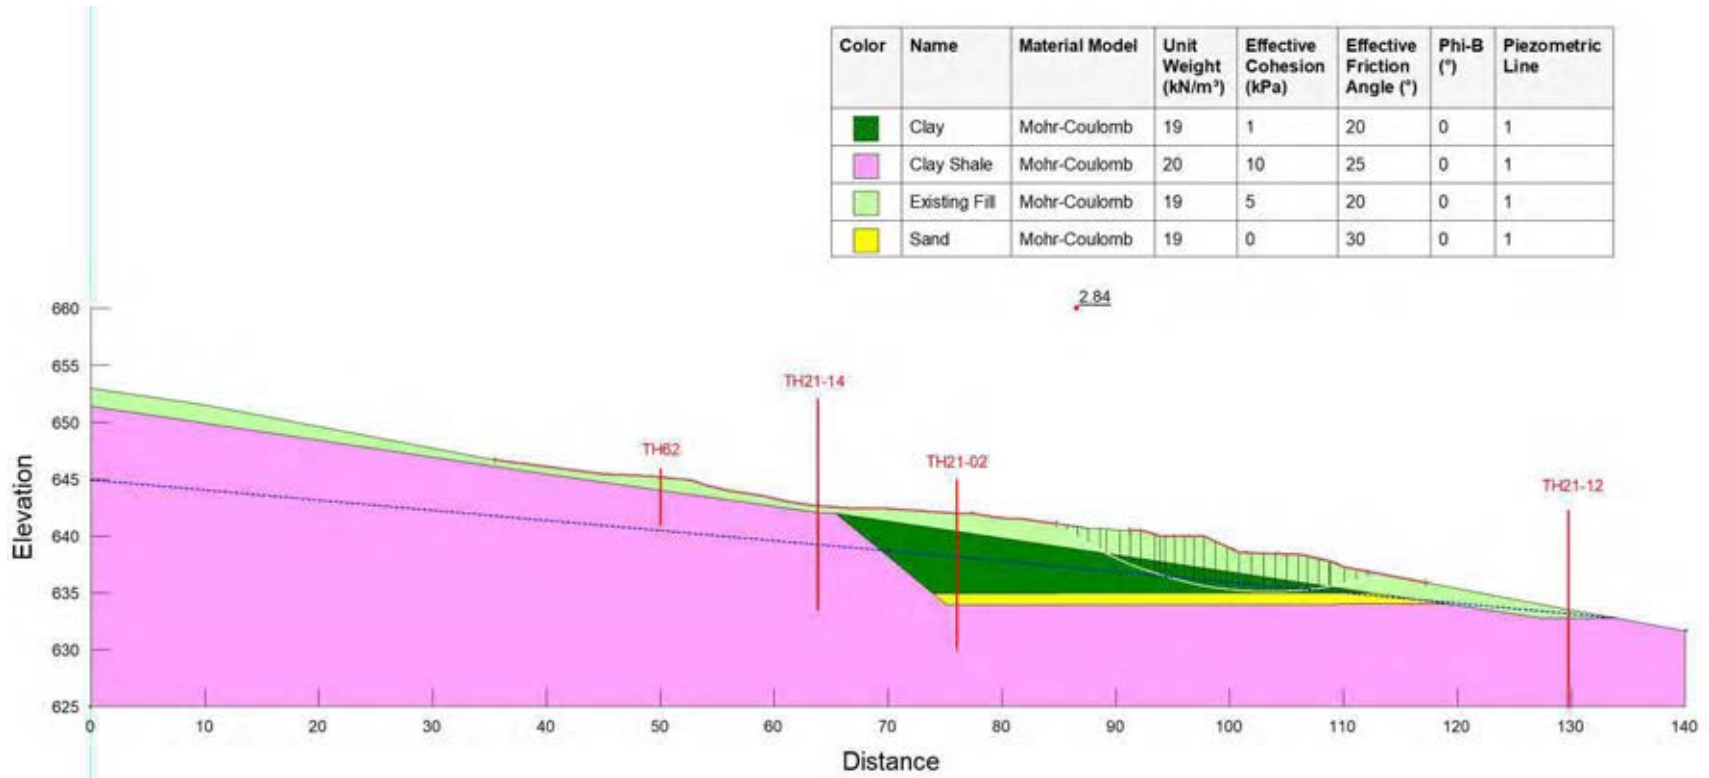
Figure E18: Section W3-W3' – Existing Conditions

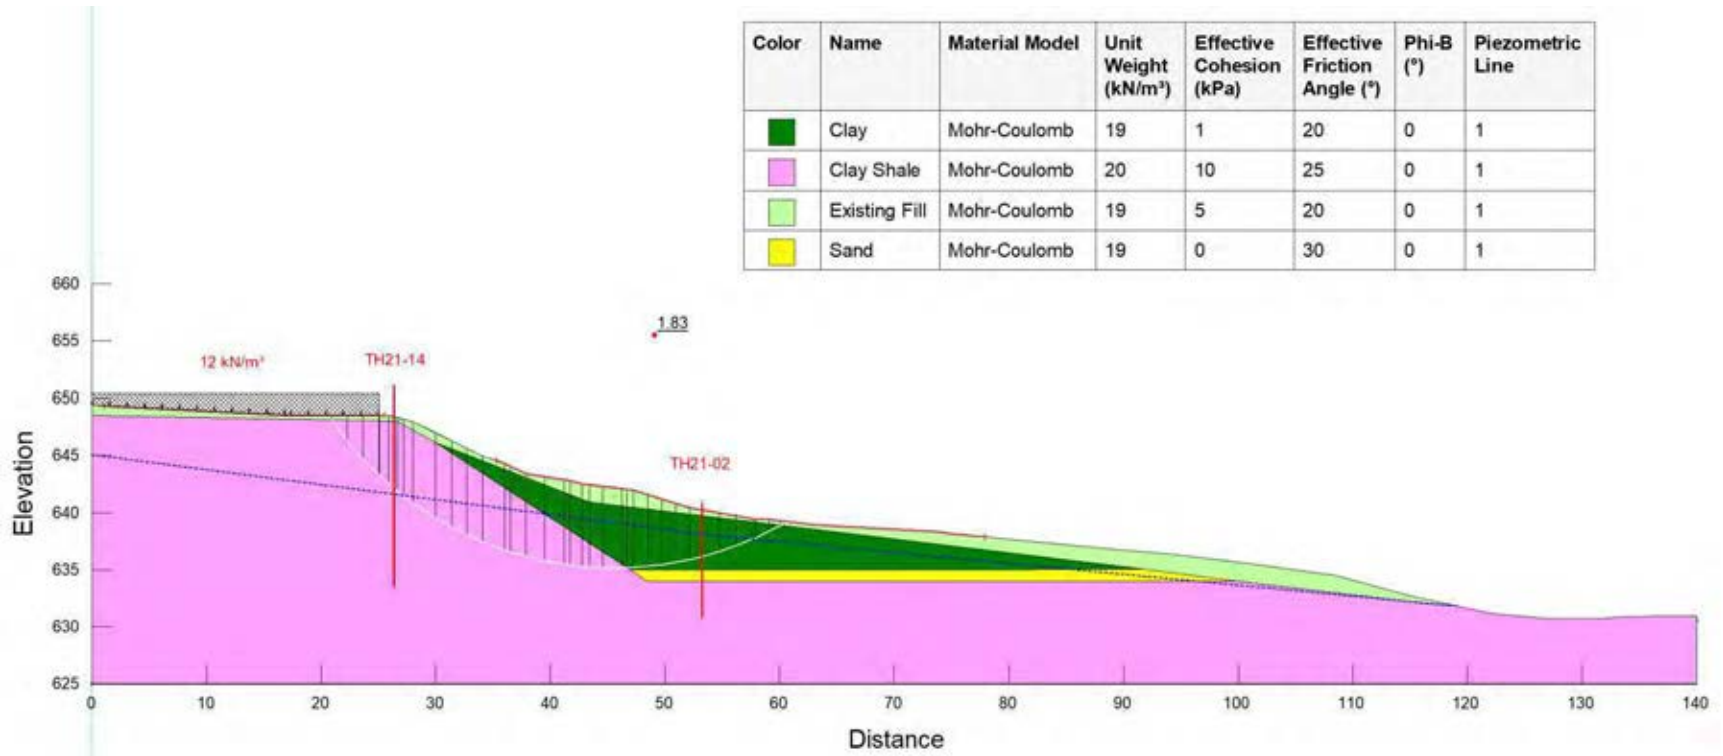
Figure E21: Section W4-W4' – Existing Conditions

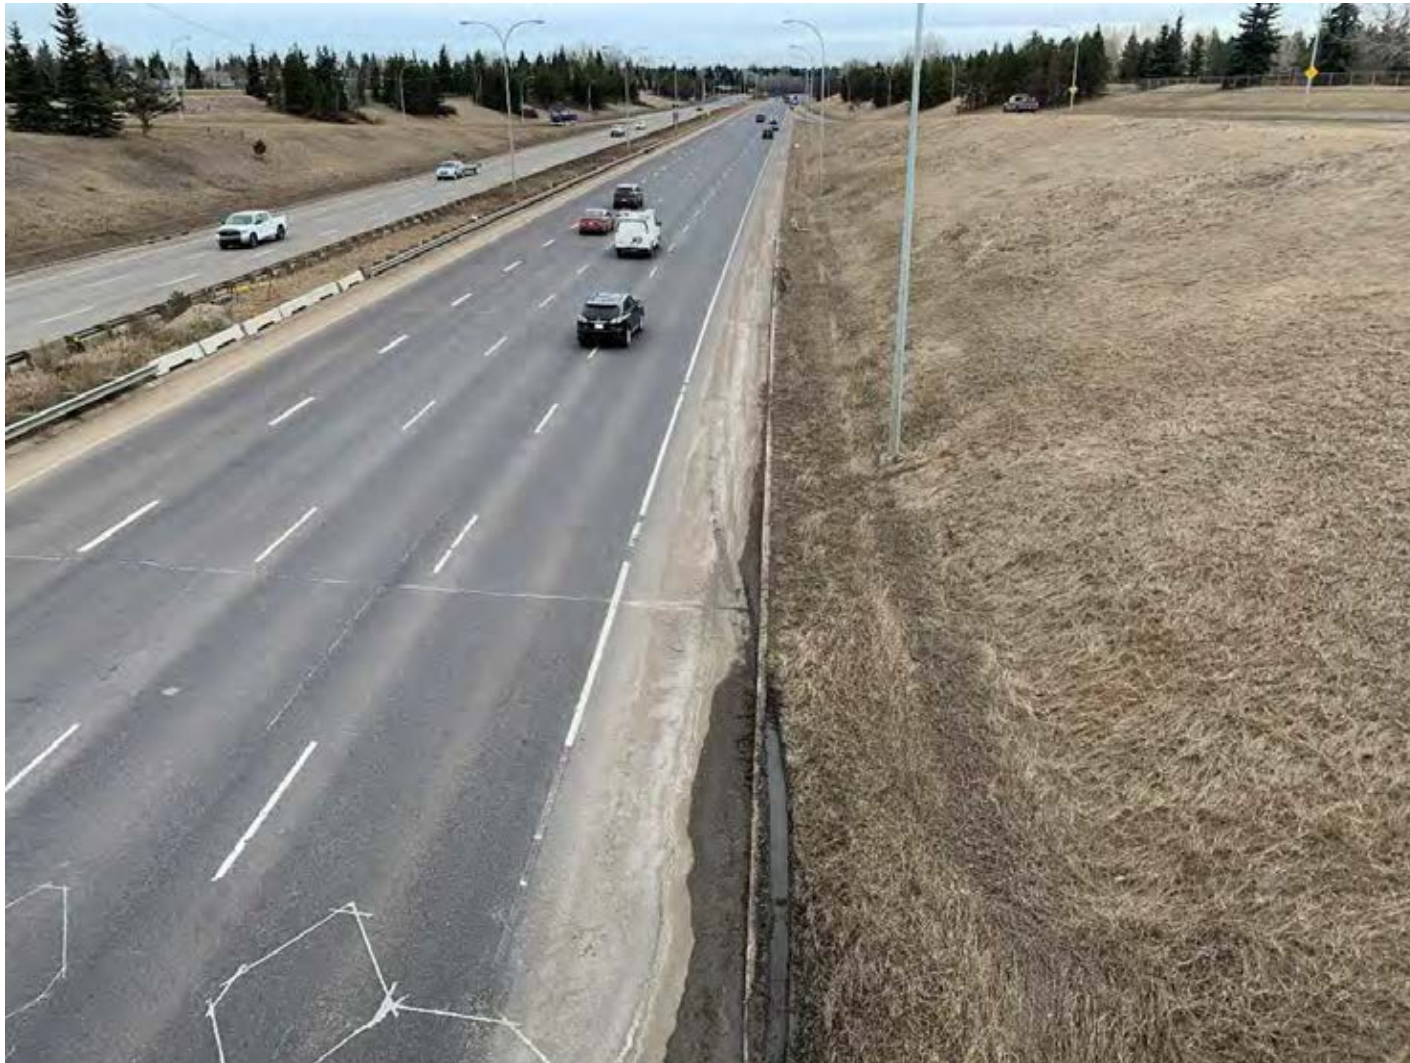
Photograph 3 – Facing north from 53 Avenue bridge, salt staining on WMD. April 22, 2020.

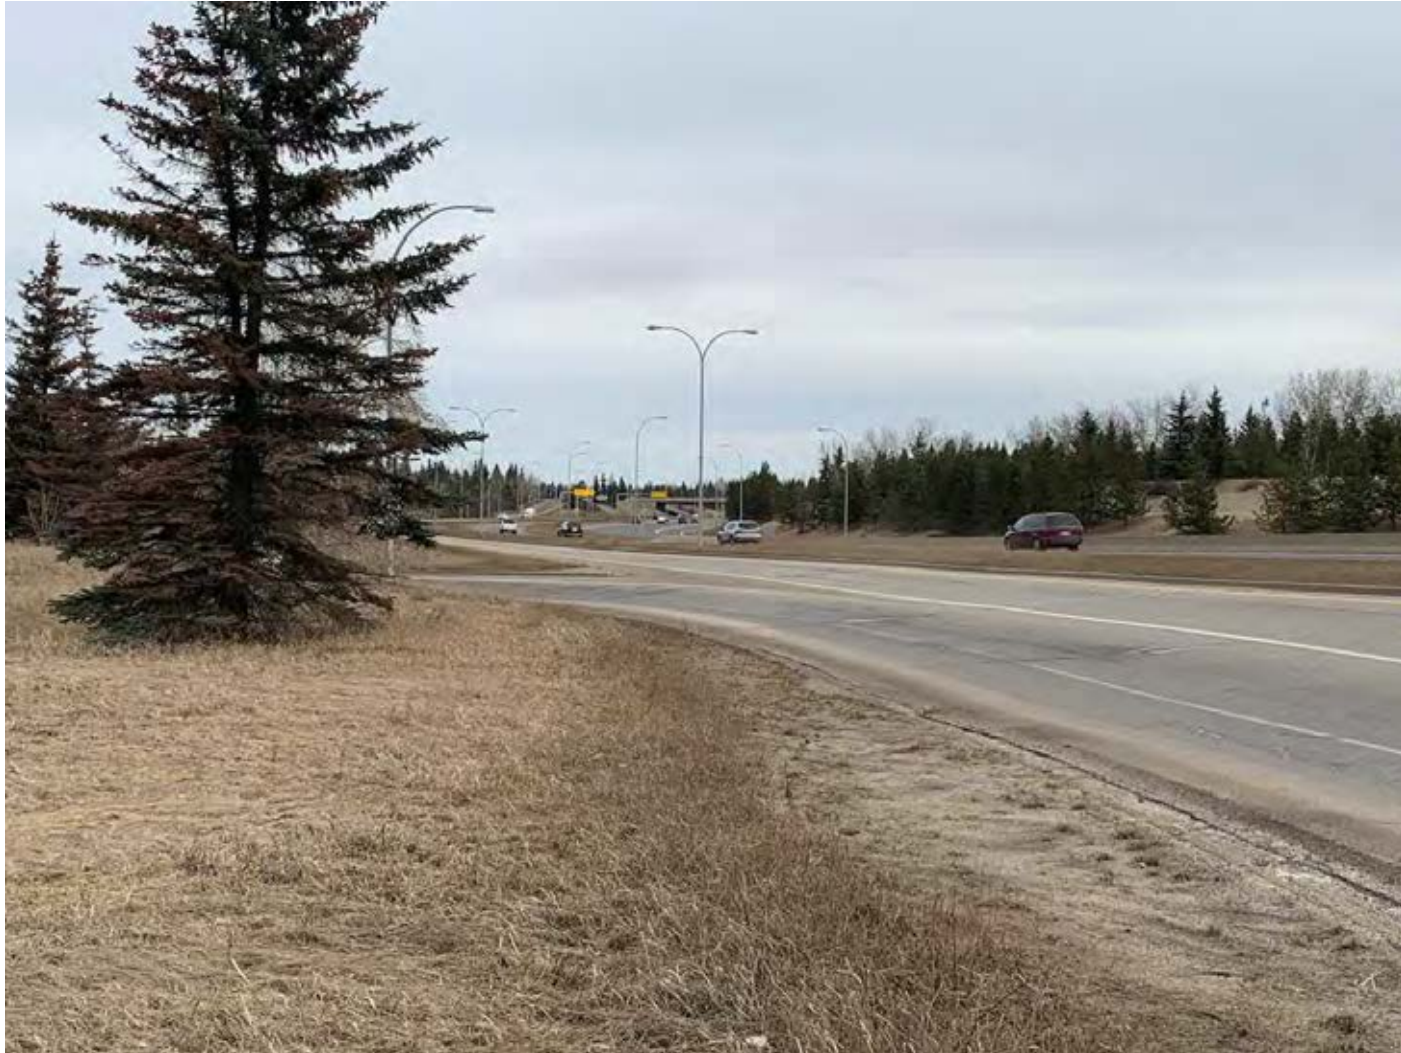
Photograph 4 – Facing northwest from WMD-Terwillegar Drive interchange, salt staining and non-vegetated area along southbound Terwillegar Drive. April 22, 2020.

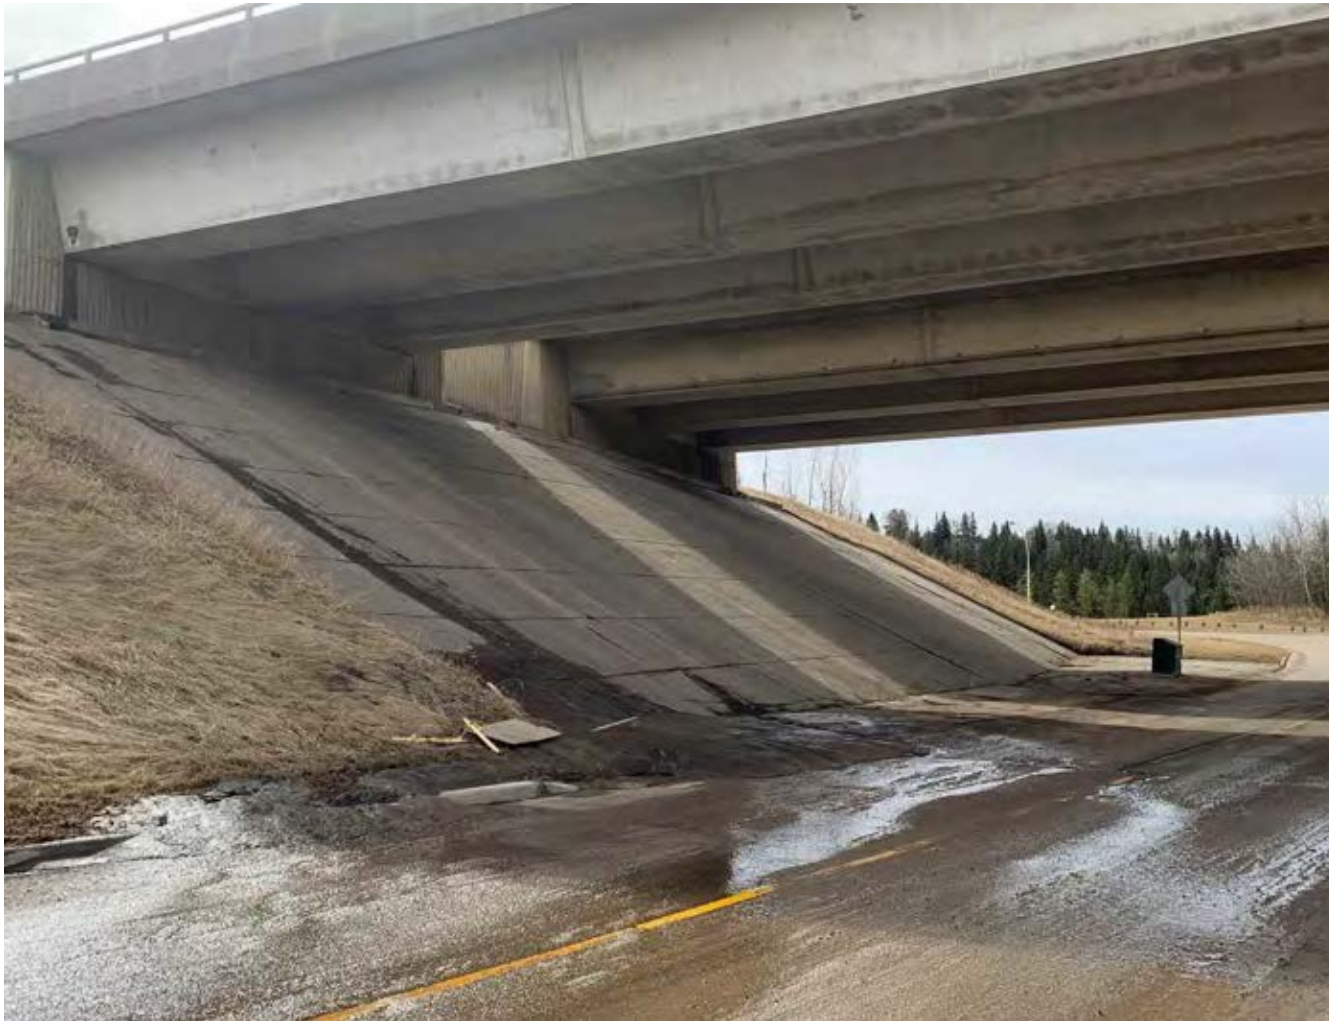
Photograph 7 – Facing southeast toward RVB, catch basin, box containing gravel, and cracks in lower concrete.
April 22, 2020.

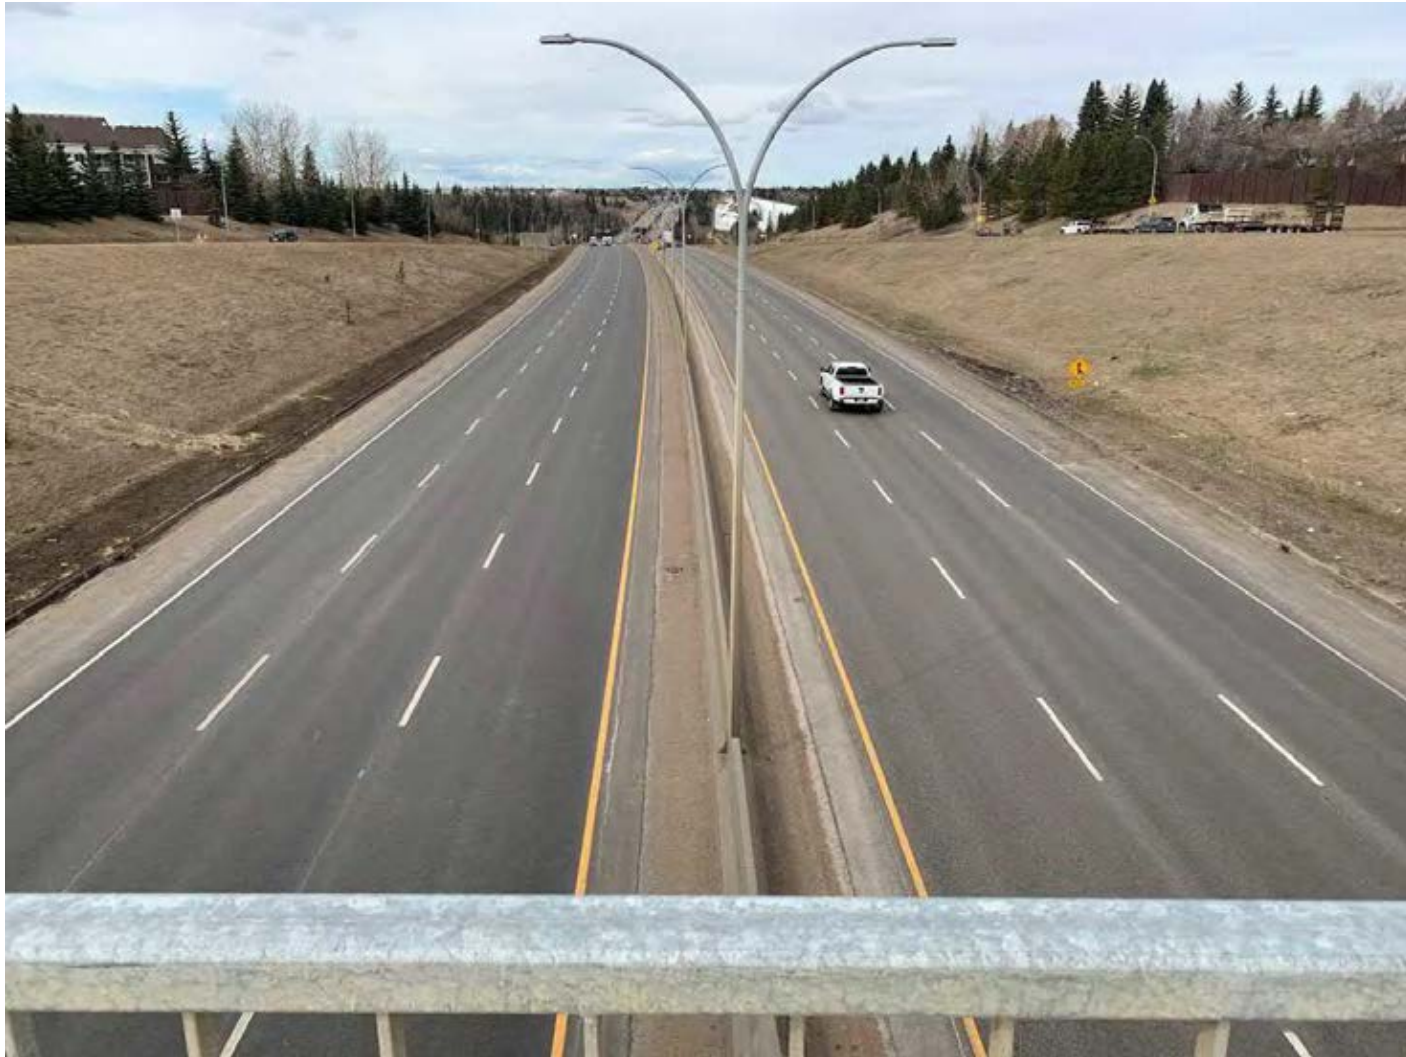
Photograph 9 – Facing west from 122 Street Bridge, salt staining on WMD. April 22, 2020.

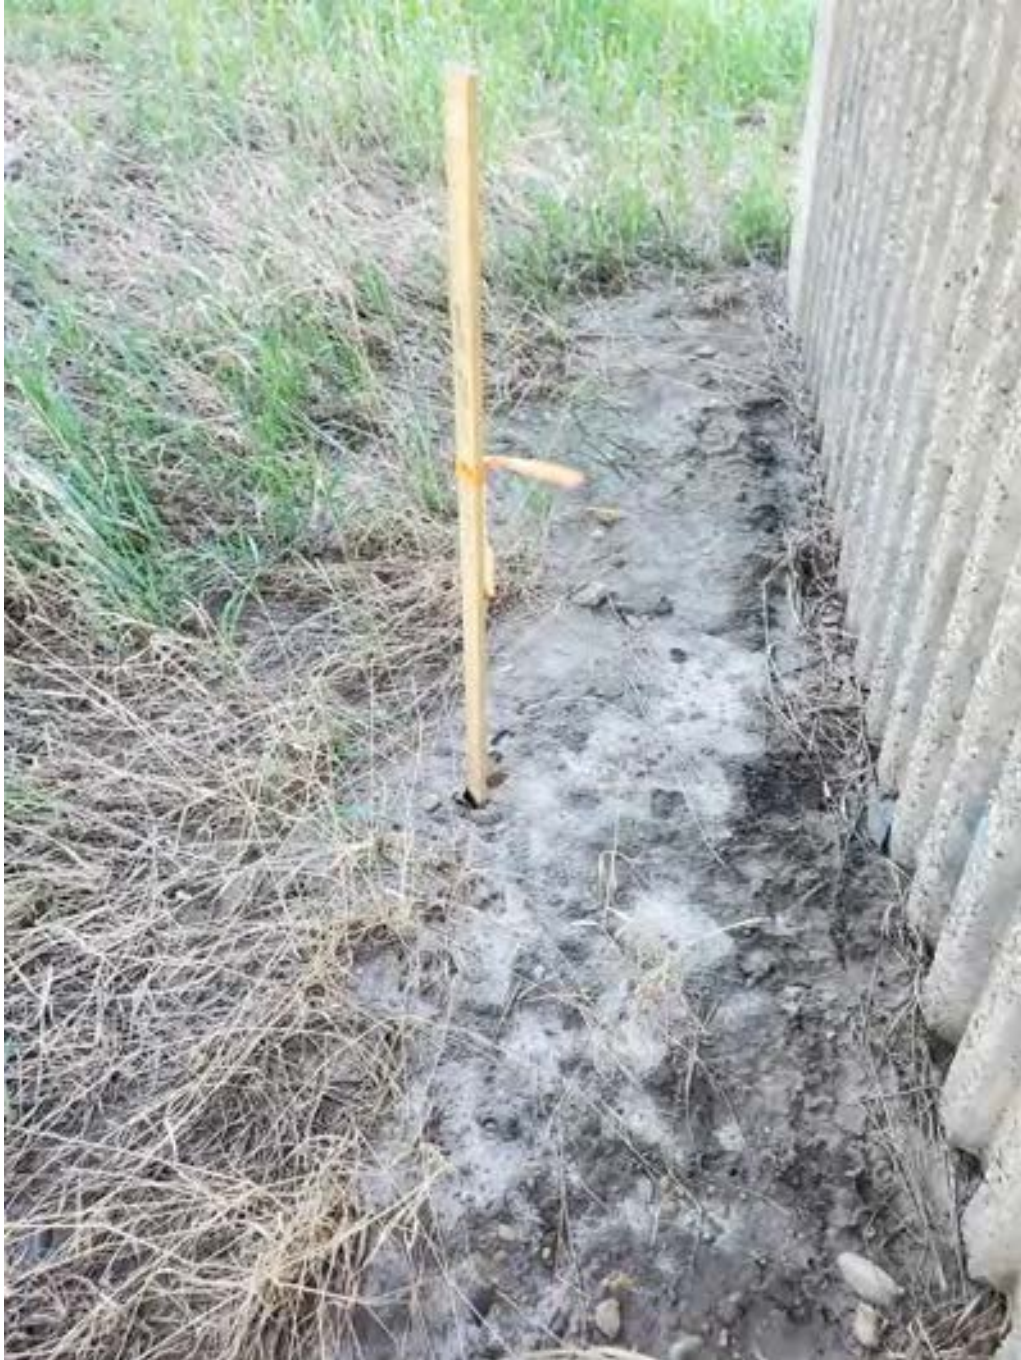
Photograph 3 – Salt staining at 21HA19, adjacent to pier below Rainbow Valley Bridges.
June 4, 2021.

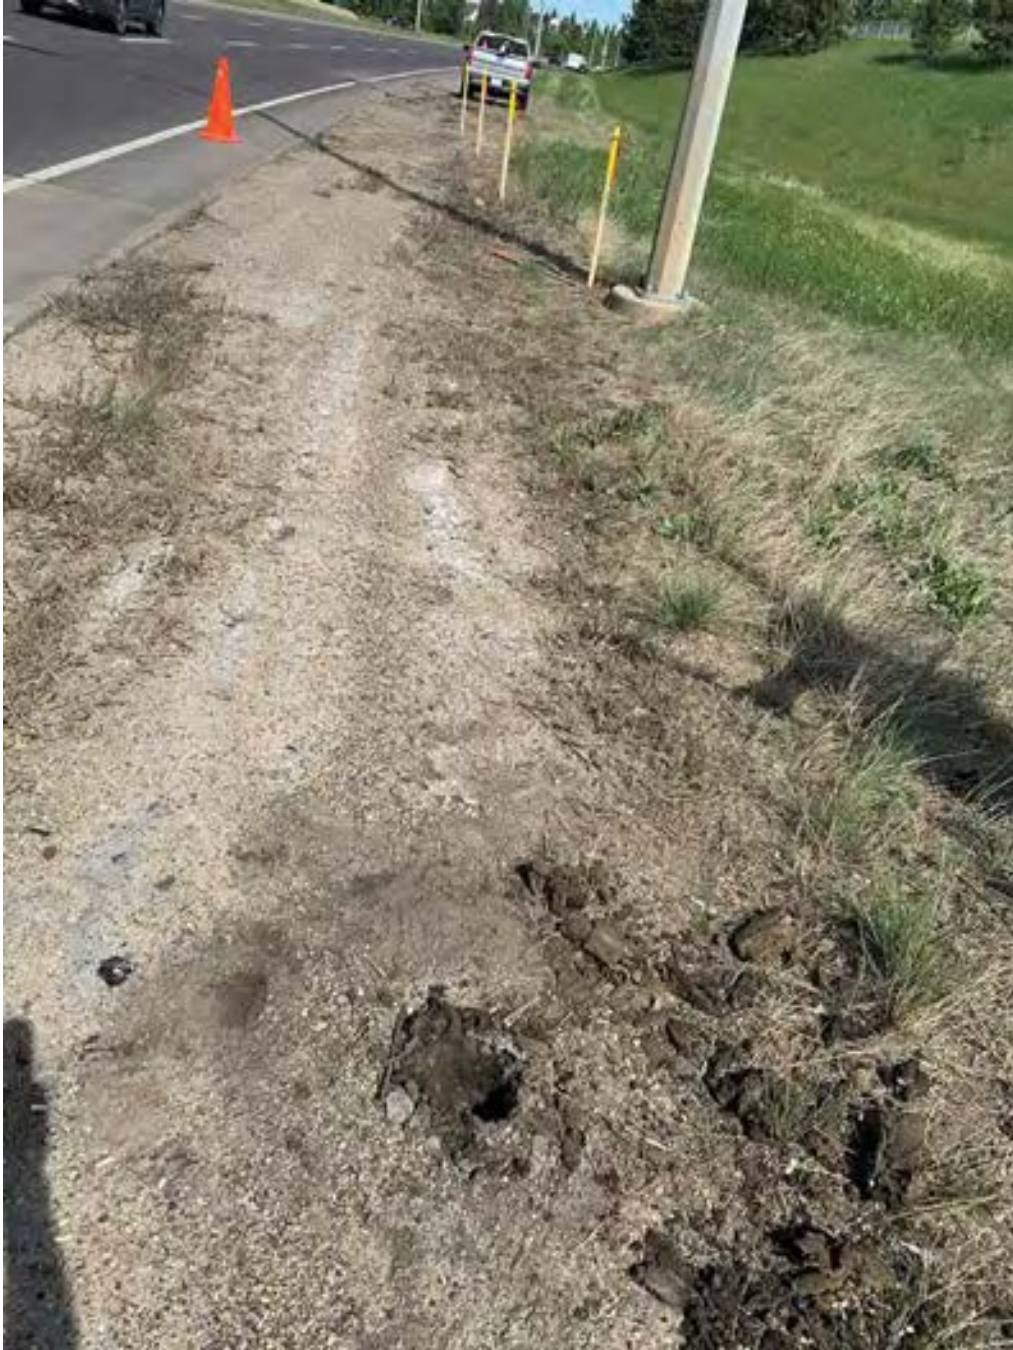
Photograph 5 – Salt staining at 21HA24 location, facing north along Whitemud Drive.
June 2, 2021.

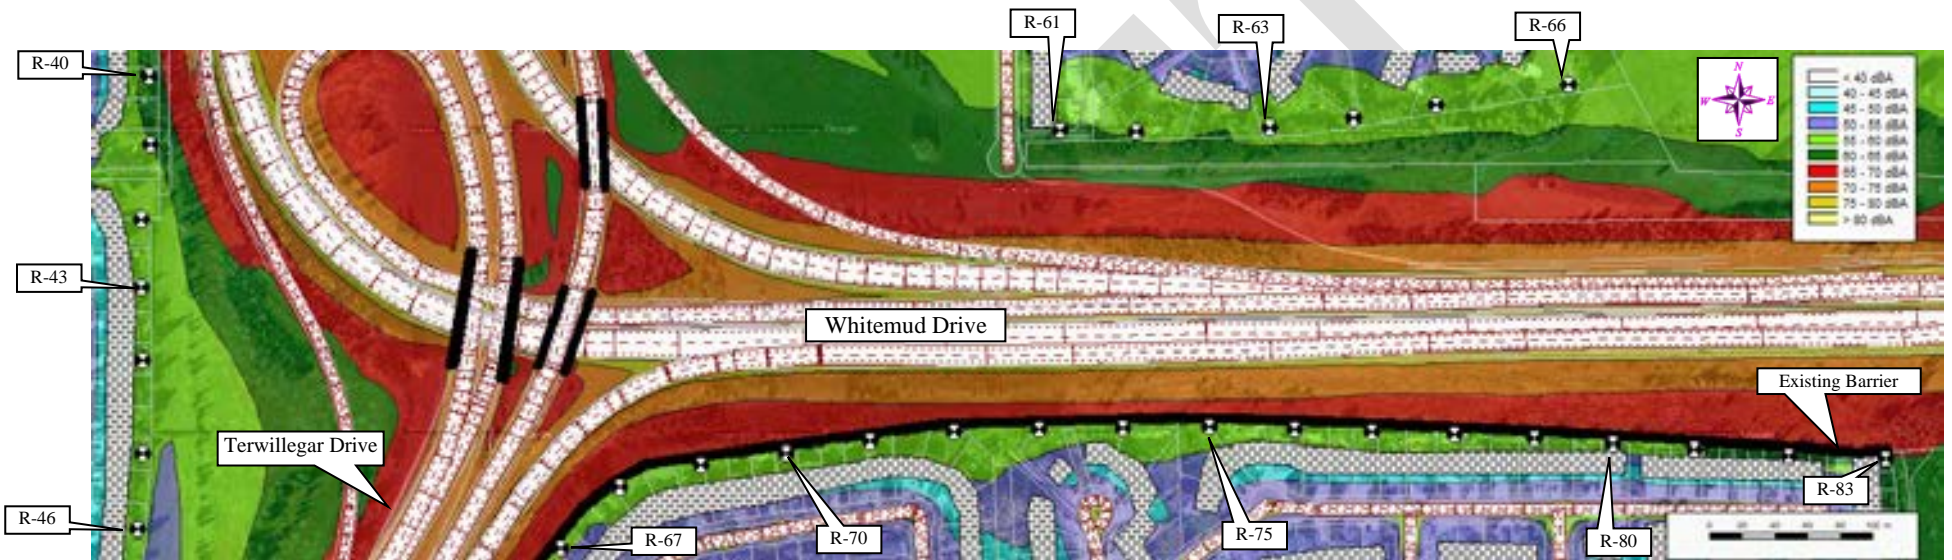
Figure 15d. Future Conditions L_{eq24} Sound Levels (East of Terwillegar Drive)
