**Environmental Impact Assessment
Pursuant to Bylaw 7188
for
Valley Line West Light Rail Transit (LRT)
Activities Near MacKinnon Ravine**

Final Report

**LRT Delivery
Integrated Infrastructure Services
Edmonton, Alberta**

**Spencer Environmental
Management Services Ltd.
Edmonton, Alberta**

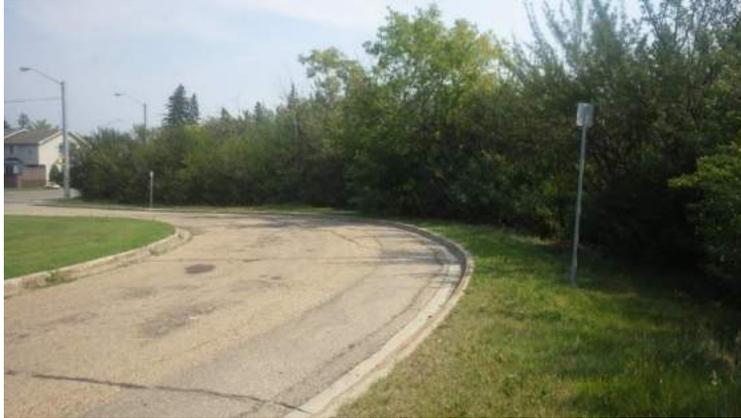
Plate 1. View to northeast of plant community adjacent the bus turnaround. Non-Forested Community – Caragana, Steep Slopes (NF.1).

In the study area, the non-forested caragana community was documented on the north side of Mackinnon Ravine, along the southeast edge of the bus turnaround and extending northeast to SPR and continuing east along SPR (Plate 1). Common caragana dominated with frequent Manitoba maple and occasional aspen. The understorey comprised grasses including abundant smooth brome and abundant quack grass (both exotic) and frequent Kentucky bluegrass.

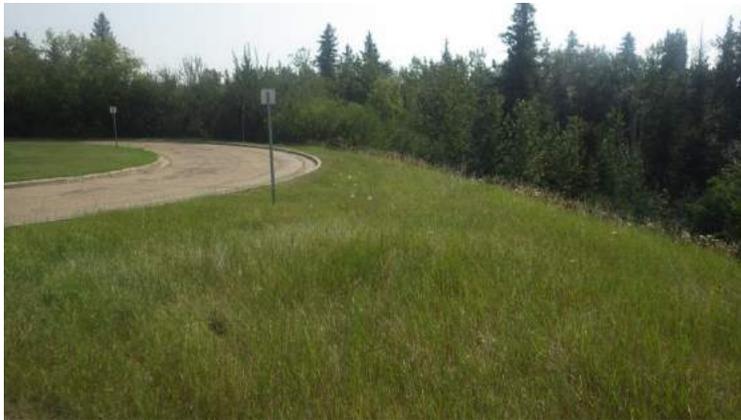
Plate 2. Distant view to southeast of plant community on far steep slope below bus turnaround. Non-Forested – Smooth-Brome, Steep Slopes (NF.6).

This plant community was present along the steep upper slope of MacKinnon Ravine extending from 149 Street east to the bus turnaround, below the narrow manicured area at the top of slope (Plate 2). Some localities supported inclusions of sapling and young *Populus sp.* stands invading the brome community from downslope (Plate 3). Kentucky bluegrass dominated along with smooth brome and quackgrass (both exotic) with abundant crested wheatgrass (exotic). Frequent regenerating white spruce were observed on the outside margin of this community as it transitioned to the adjacent forested area (outside of core study area) (Plate 4).

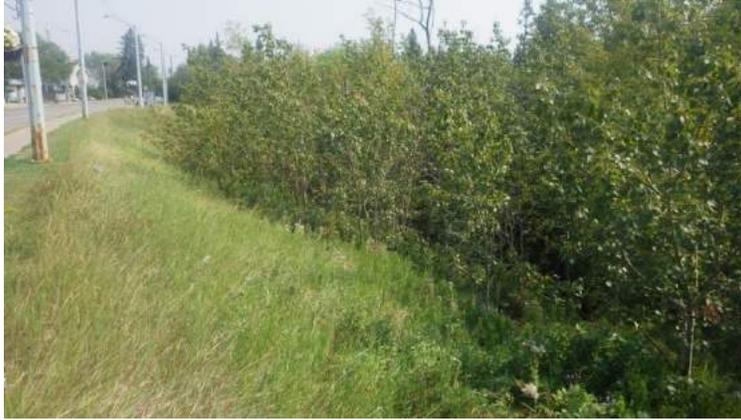
Plate 3. View to east along south side of SPR with *Populus* sp. Inclusions. Non-Forested – Smooth-Brome, Steep Slopes (NF.6).

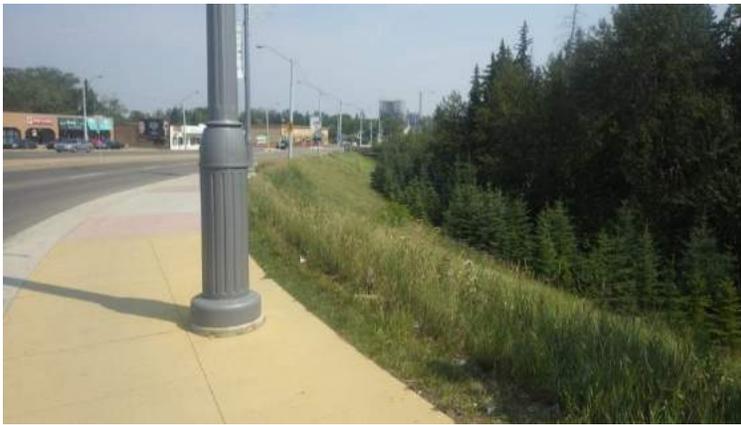
Plate 4. View to east along south side of SPR with white spruce sapling regeneration. Non-Forested – Smooth-Brome, Steep Slopes (NF.6).

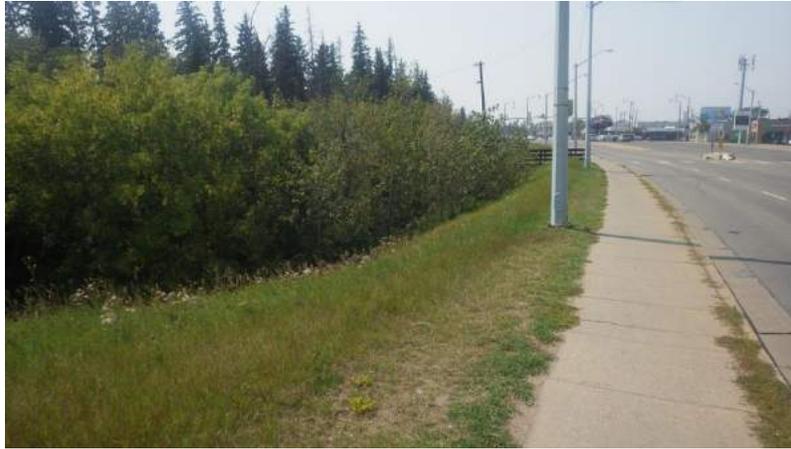
**Plate 5. View to west of narrow mowed strip adjacent SPR sidewalk.
Manicured (M).**

Manicured areas are those subject to regular mowing or maintenance and or supporting landscaping trees. They are characterized by grassy areas and planted trees, as well as areas where the original cover has been maintained but severely thinned. Manicured areas were present in the roadway ROW in a very narrow strip adjacent SPR and the sidewalk along the top-of-slope of MacKinnon Ravine (Plates 5 & 6). This area was dominated by maintained Kentucky bluegrass, smooth brome and crested wheatgrass with occasional Manitoba maple and jack pine.

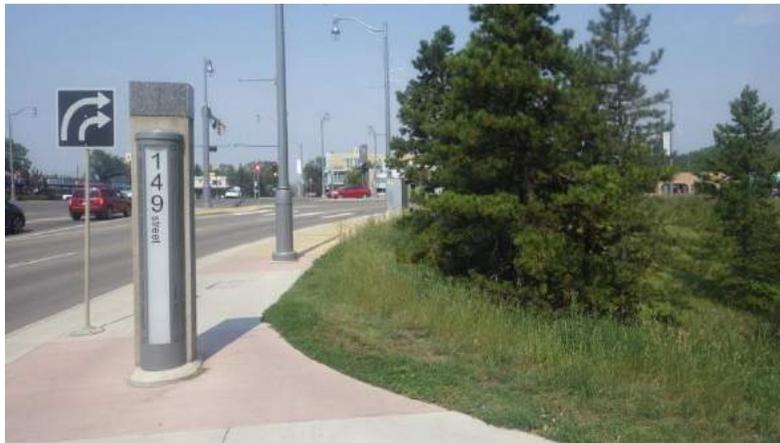
**Plate 6. View to north of planted trees adjacent 149 Street sidewalk.
Manicured (M).**

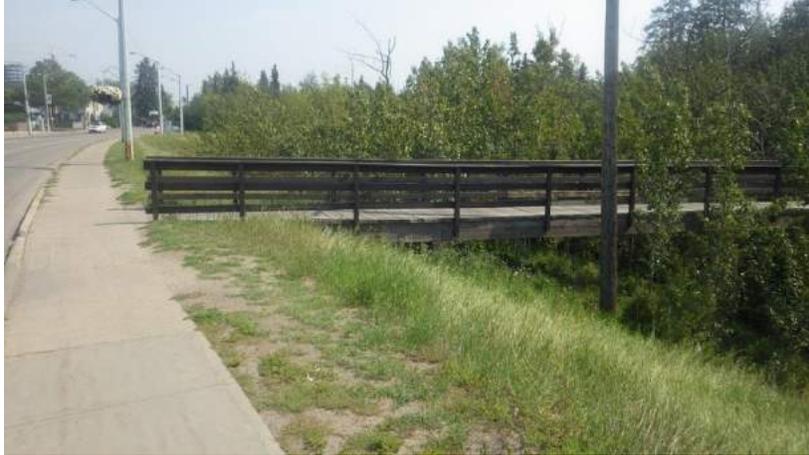
Plate 7. View to the east of northern terminus and end of first span of existing pedestrian trestle bridge.

Because the existing pedestrian trestle bridge that crosses MacKinnon Ravine at this location directly terminates at the south edge of the existing sidewalk, the north end of that footbridge must also be modified (Figure 10, Appendix A; Plates 7, 8, 9). The bridge work is very localized and is expected to be straightforward. The bridge work details will be finalized by the Proponent, but it appears that the first span would be affected (approximately 5.5 m long), and the northernmost abutment supporting the first span would need to be replaced. The trestle bridge would be marginally shorter and stringers of the first span would need to be cut. The last City bridge report indicated the pedestrian bridge to be in good condition (Marzan, *pers. comm.*). The bridge work would be located within MacKinnon Ravine.

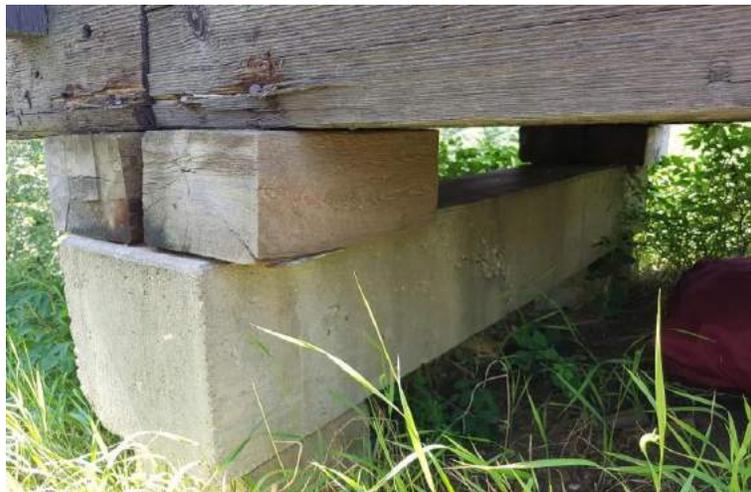
Plate 8. End of first span and associated foundation near northern terminus of existing pedestrian trestle bridge.

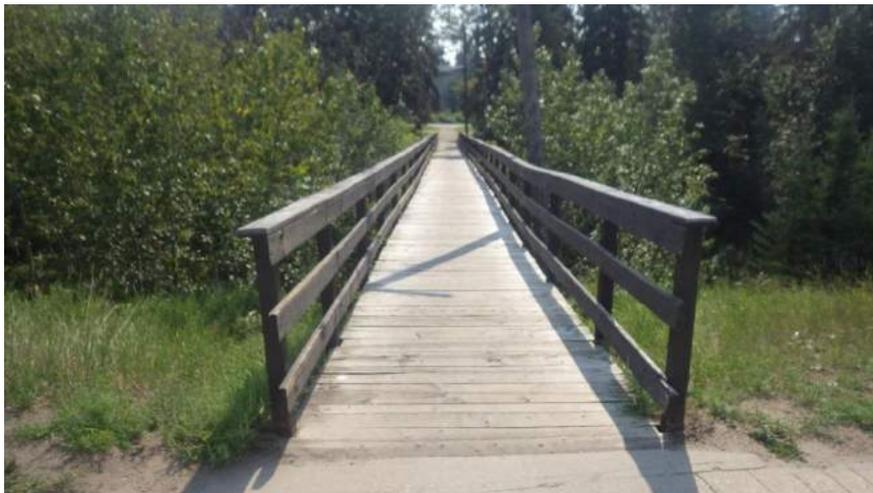
Plate 9. View to the south of northern terminus of existing pedestrian bridge.

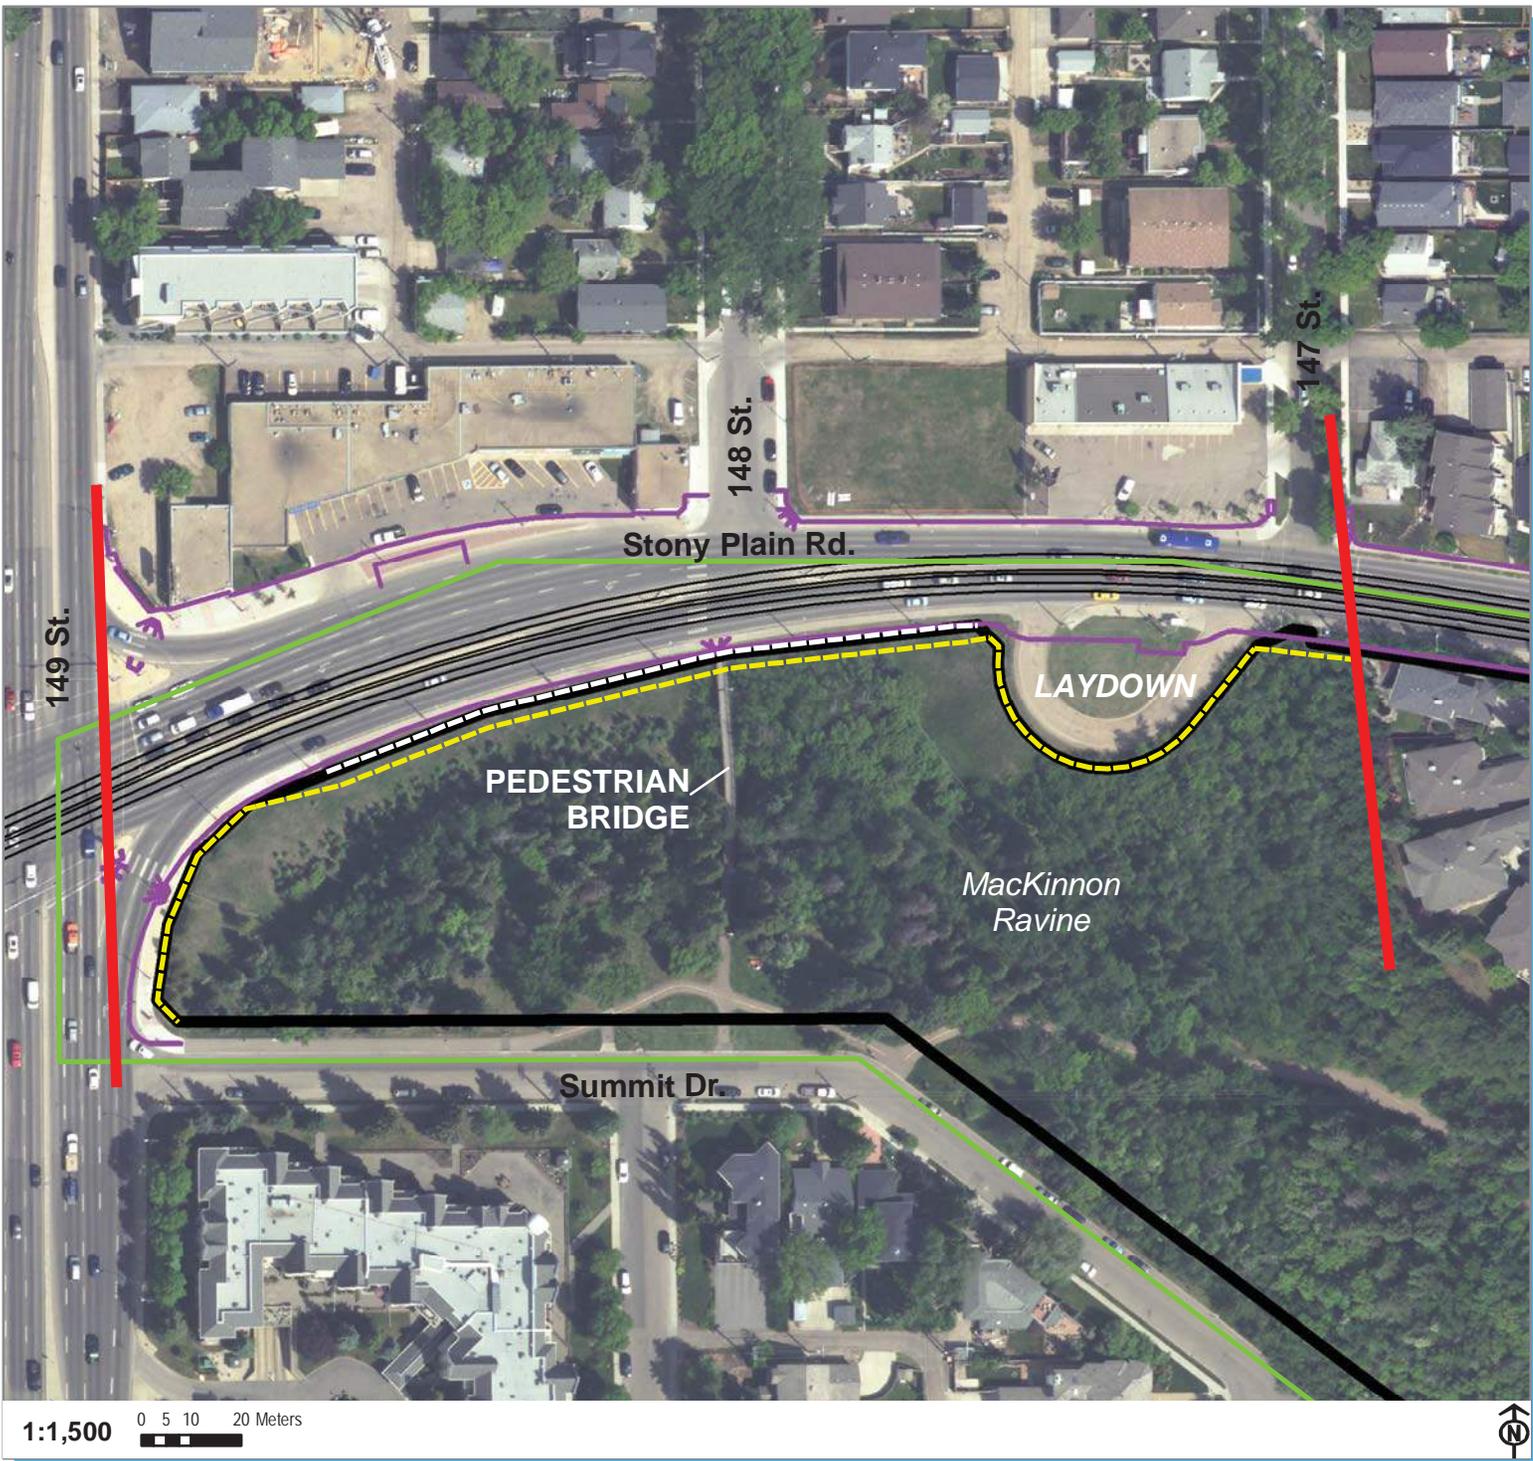
Figure 2.
MackInnon Ravine
Project Components
and Temporary Limits
MackInnon Ravine
Valley Line West EIA

- E-W EIA Study Limits
 - Bylaw 7188 Boundary
 - Road ROW
- Proposed:*
- Track Alignment
 - Back of Walk (BOW)/Edge of future sidewalk
 - Retaining Structure
 - Limits of Temporary Work

The existing bus turnaround, fully situated within the existing roadway ROW, will be replaced with a new bus bay and sidewalk along SPR (Figure 2 and 6). The turnaround area will be used as a laydown area, then decommissioned through removal of the existing asphalt and reclaimed to a natural area according to a detailed landscape plan to be developed by the Proponent. Landscape boundaries will respect the established temporary work limit (also the roadway ROW in this case). The laydown area will be centred on currently developed lands and will not extend into natural vegetation. Additional laydown areas inside bylaw lands will not be permitted. The PA will describe the boundaries of these designated areas. Nearby trees will be protected from disturbance according to PA specifications.

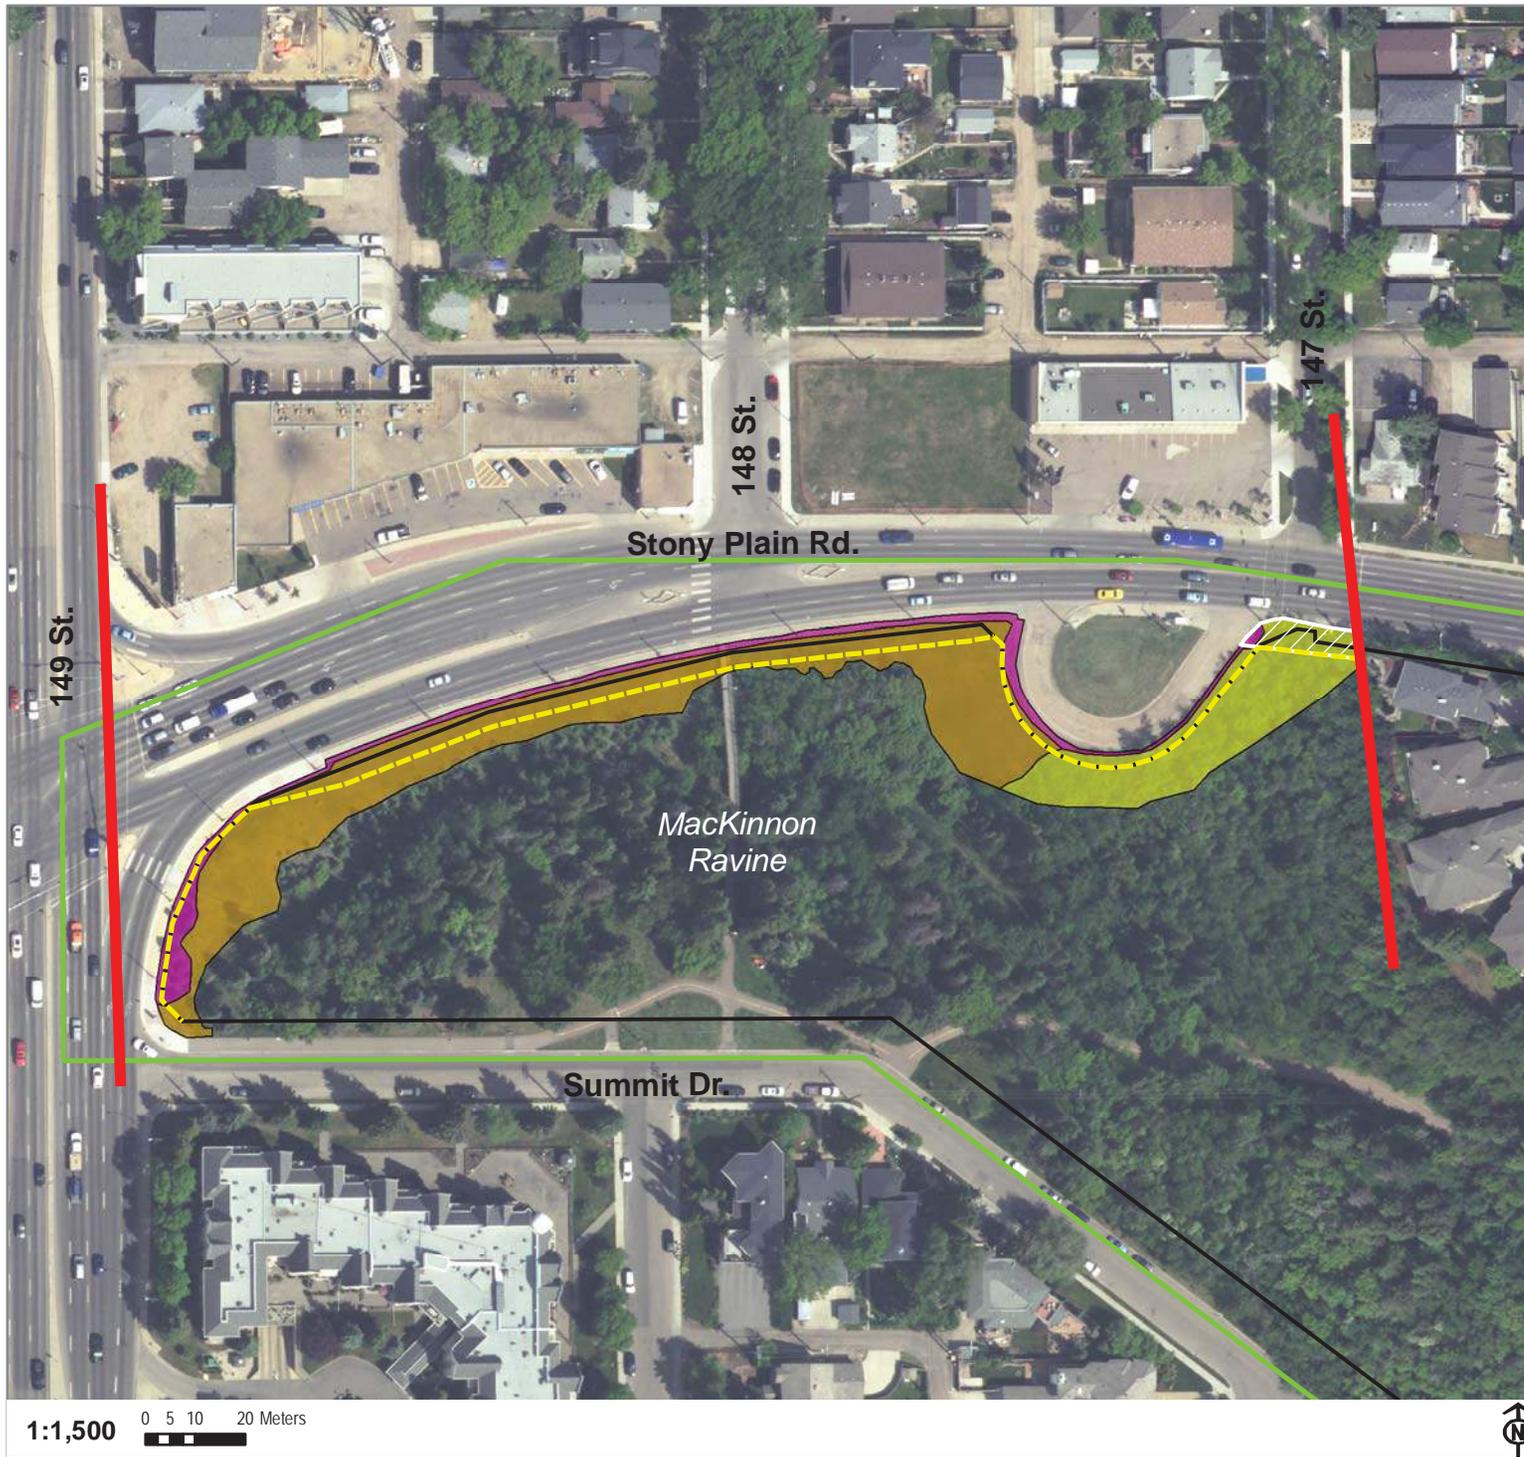
Figure 5.
Existing
Plant Communities
MacKinnon Ravine
Valley Line West EIA

- Non-Forested - Smooth Brome, Steep Slopes (NF.6)
- Non-Forested - Caragana, Steep Slopes (NF.1)
- Manicured (M)

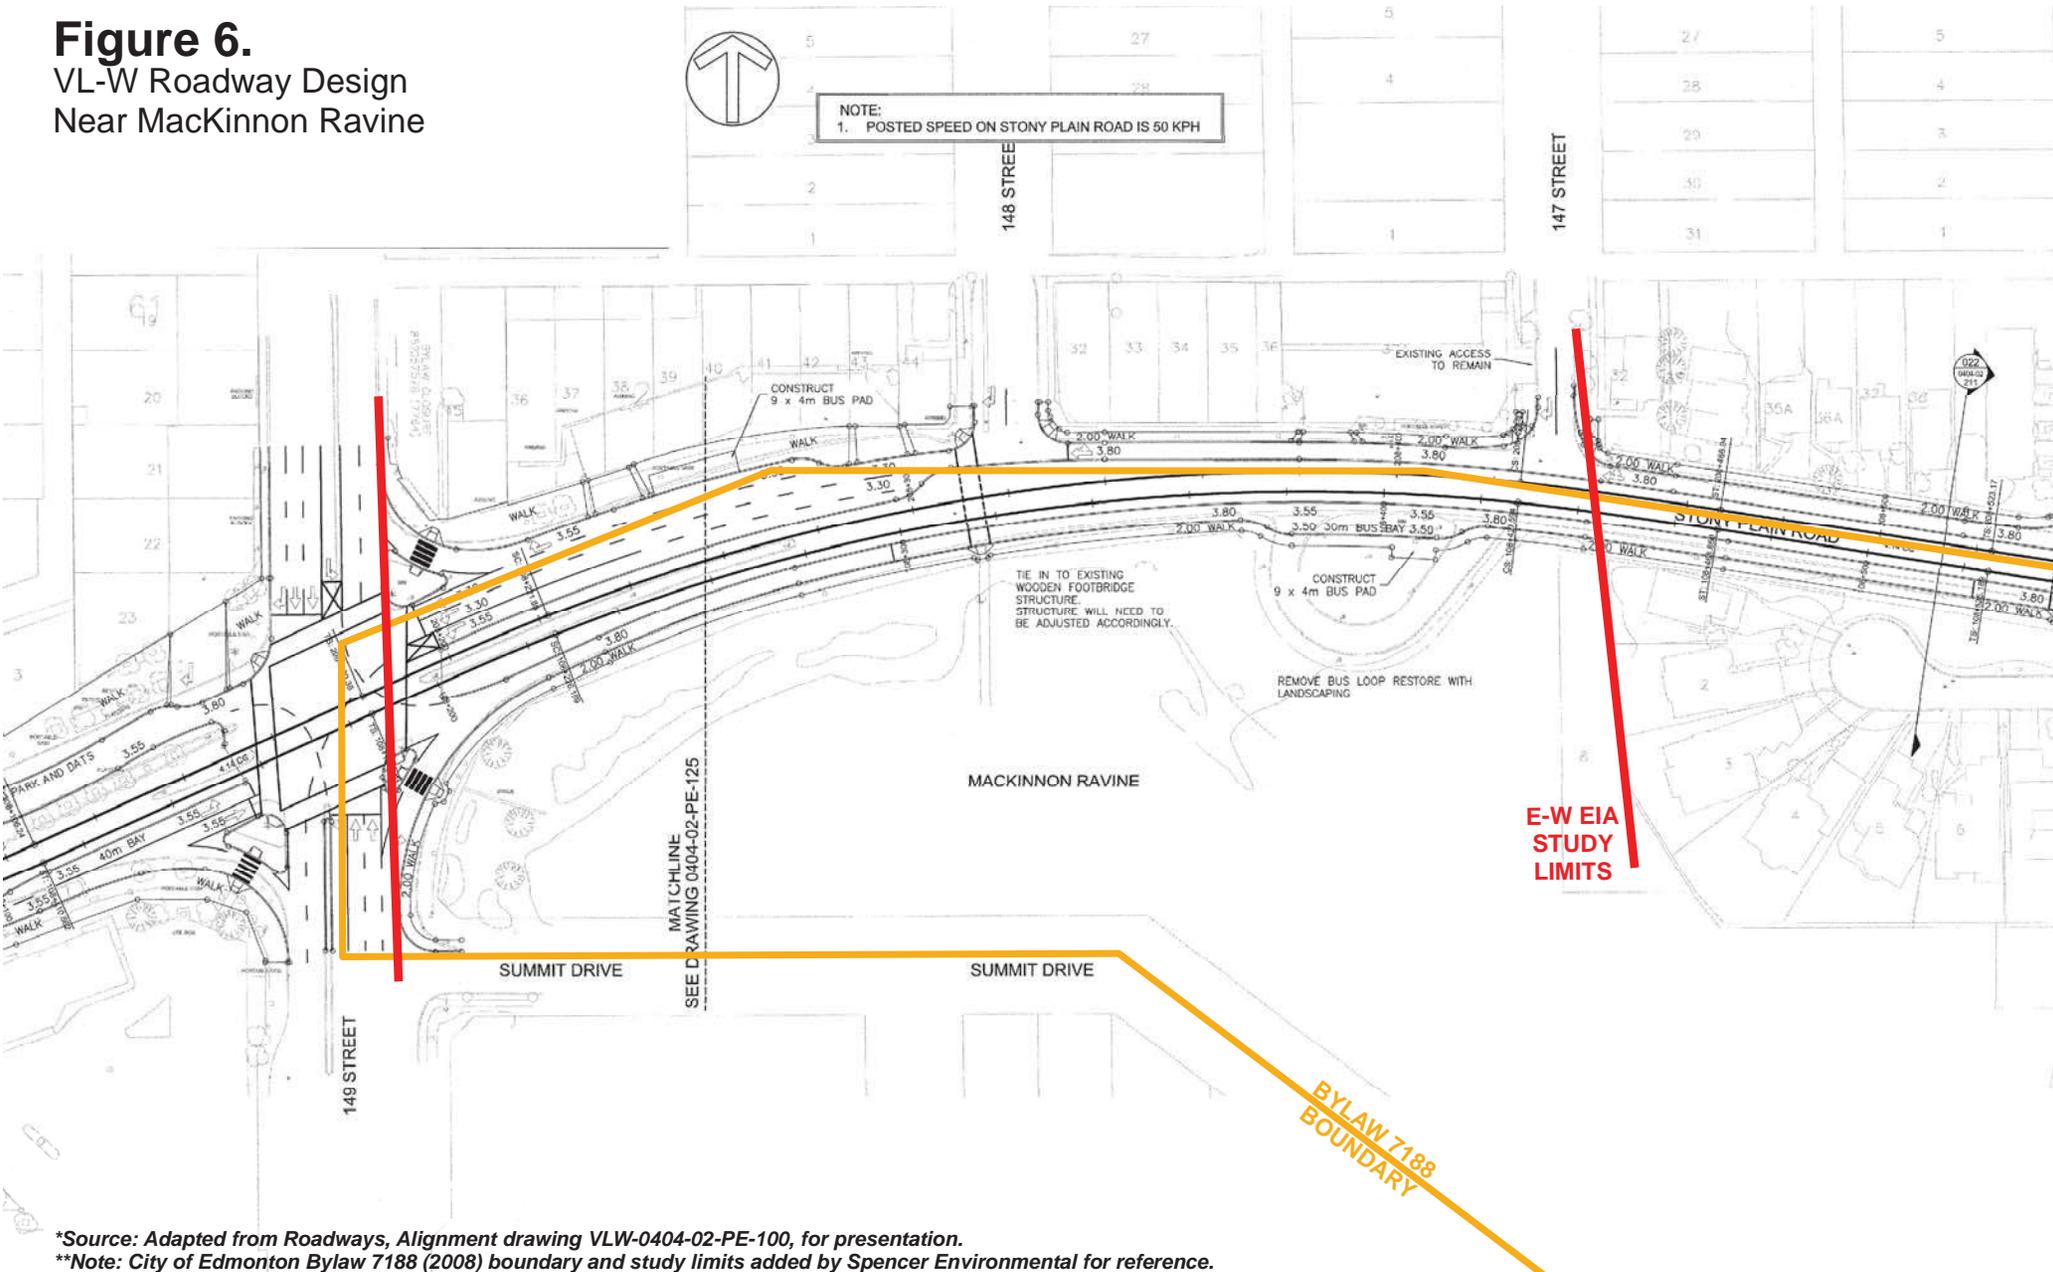
Figure 6.
VL-W Roadway Design
Near MacKinnon Ravine

*Source: Adapted from Roadways, Alignment drawing VLW-0404-02-PE-100, for presentation.

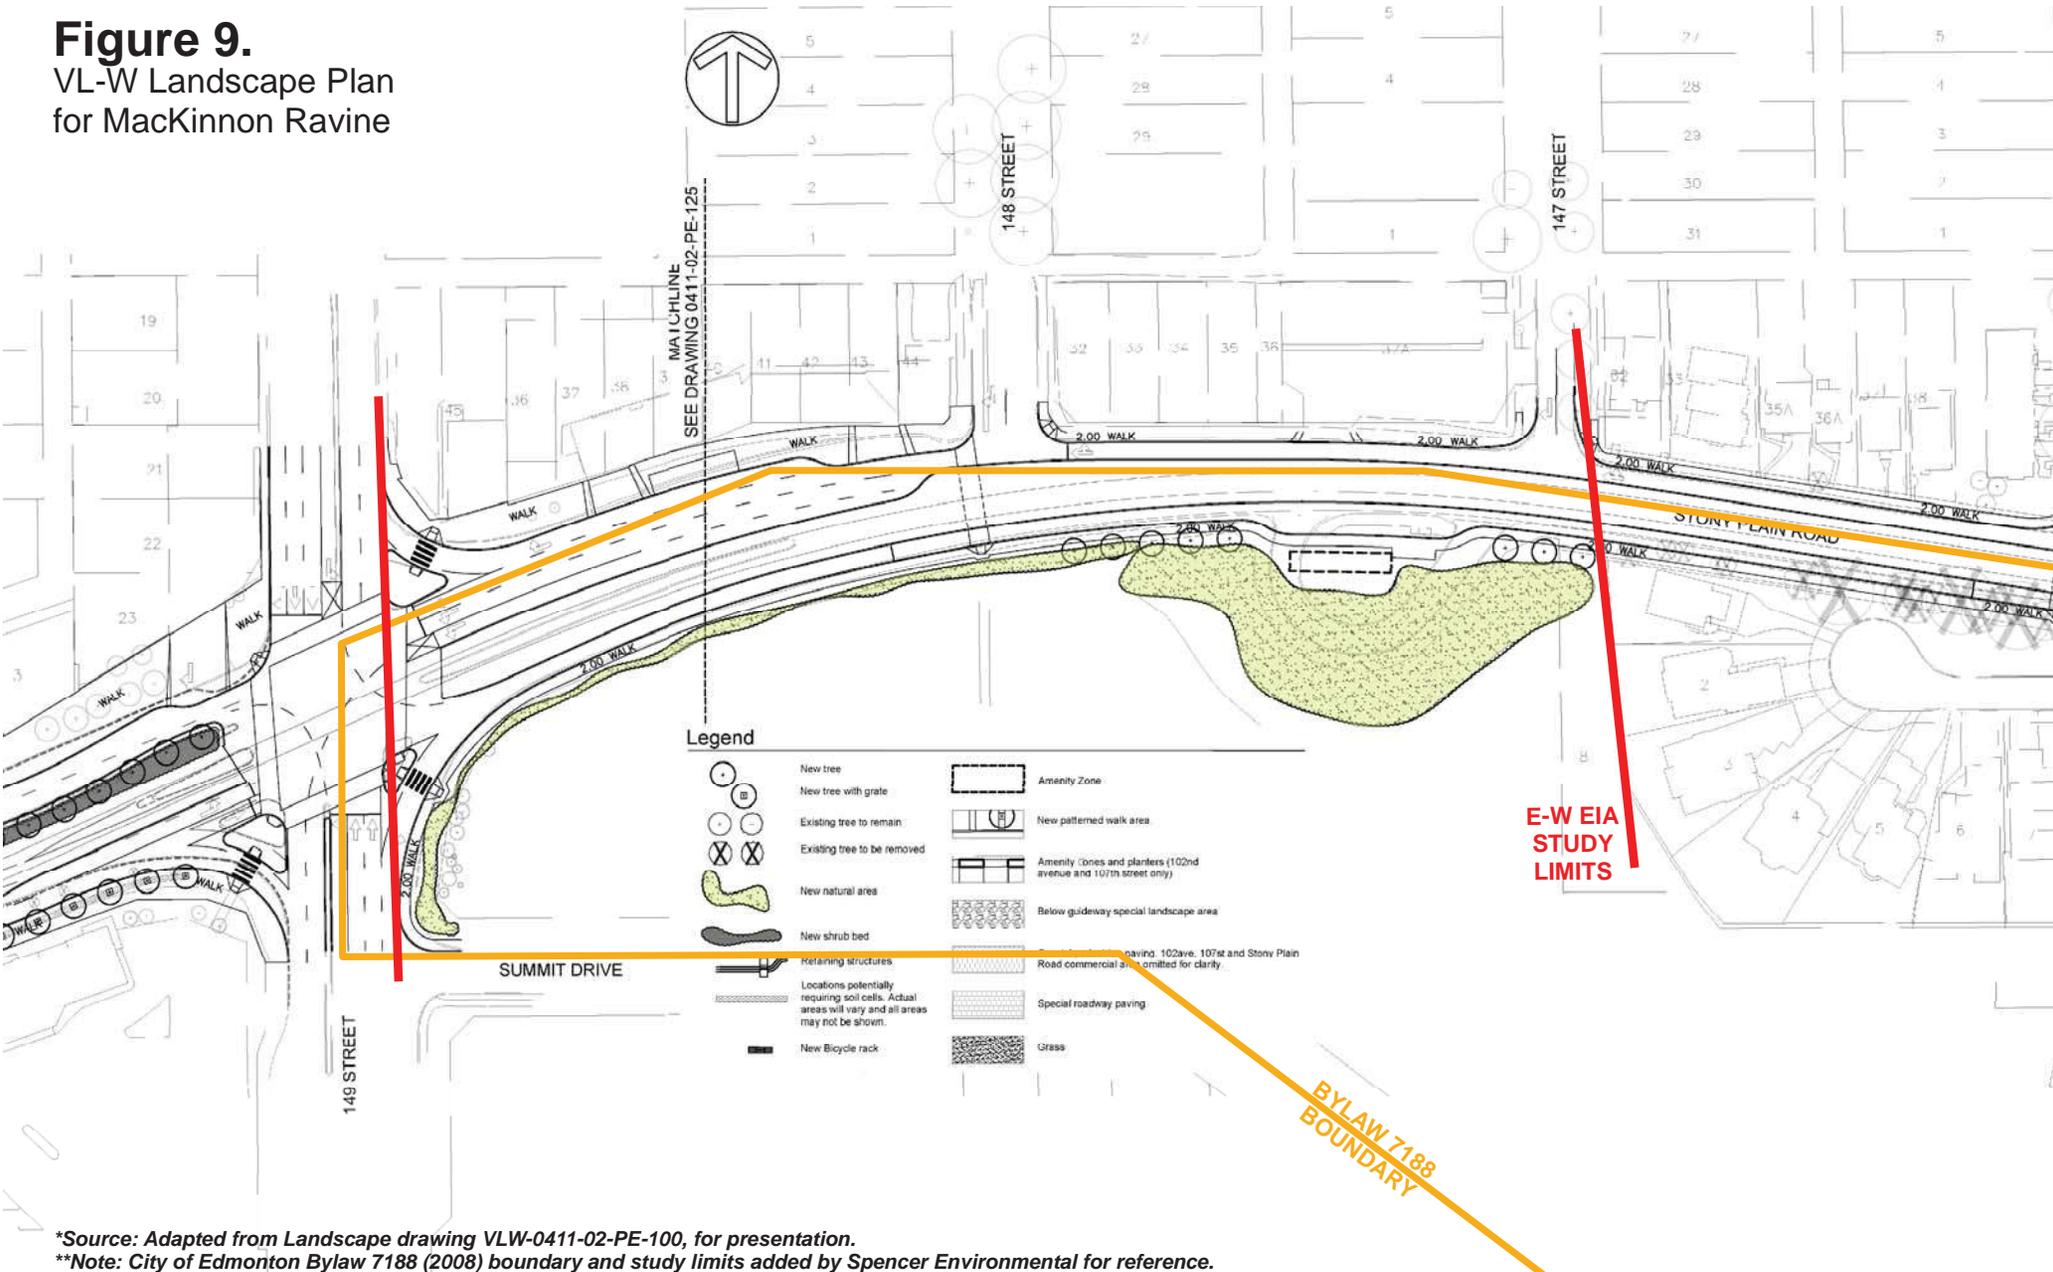
Figure 9.
VL-W Landscape Plan
for MacKinnon Ravine

*Source: Adapted from Landscape drawing VLW-0411-02-PE-100, for presentation.

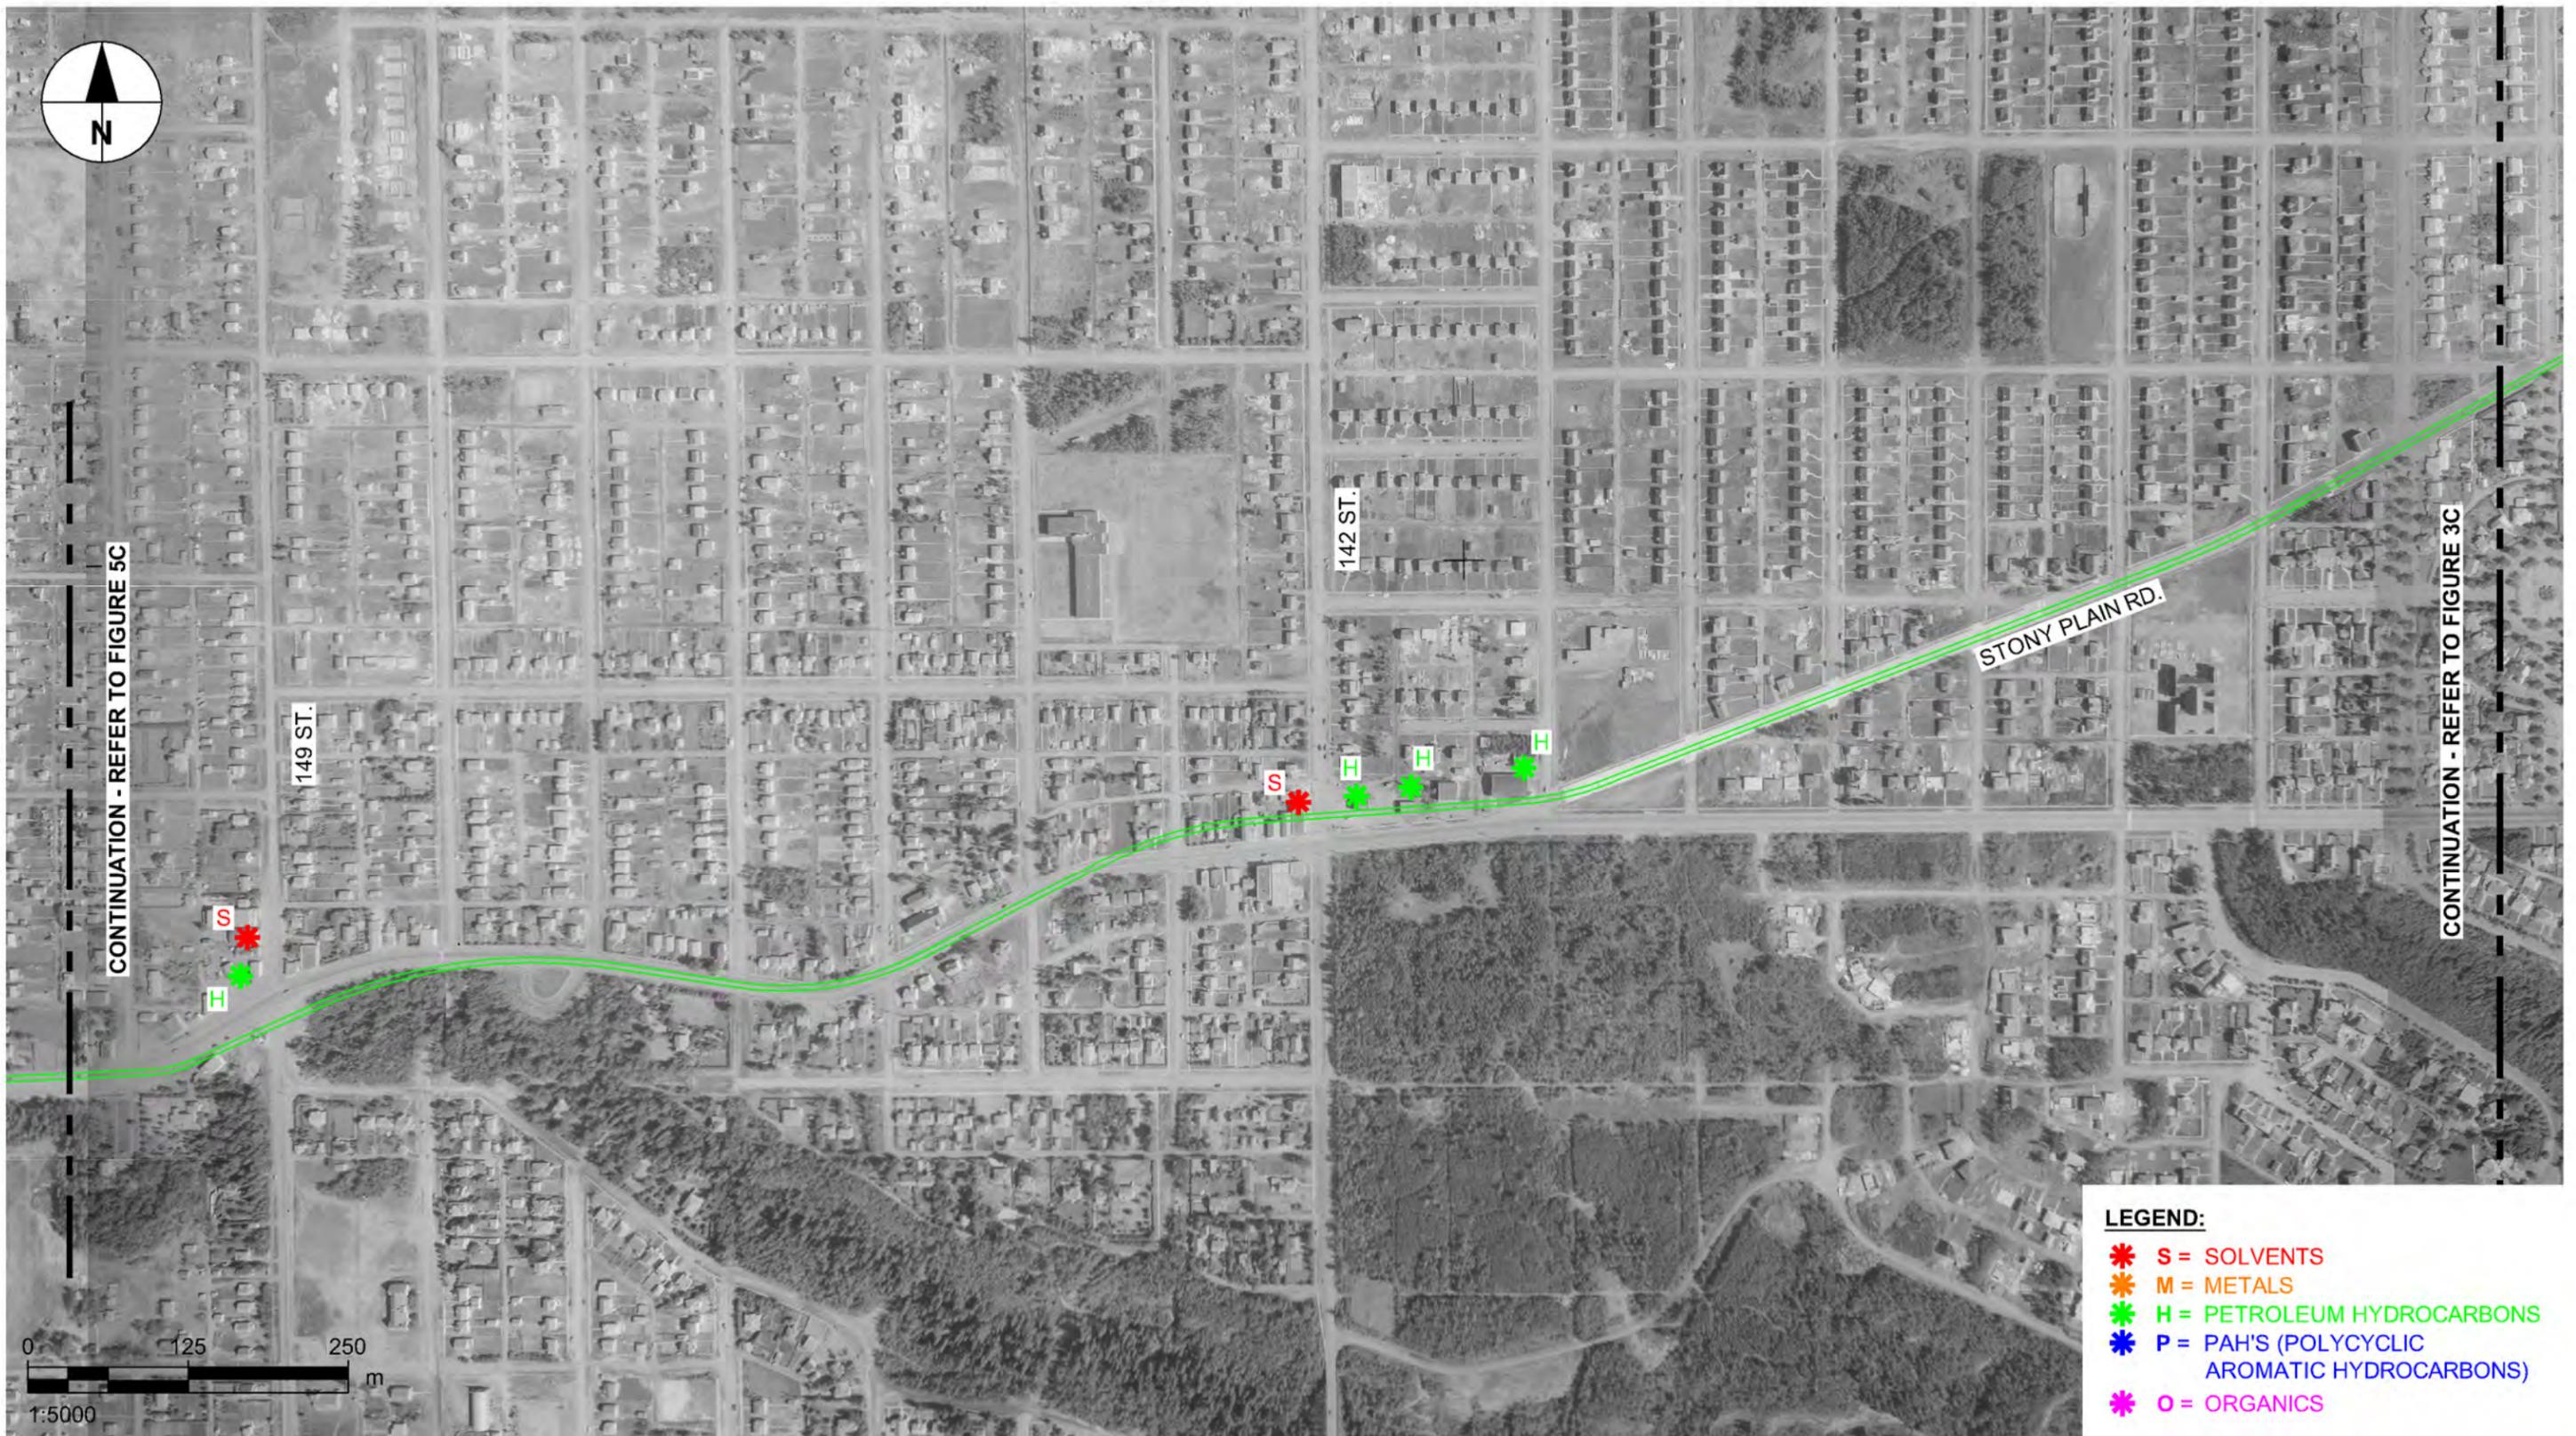
FIGURE 4B

- ★ S = SOLVENTS
- ★ M = METALS
- ★ H = PETROLEUM HYDROCARBONS
- ★ P = PAH'S (POLYCYCLIC AROMATIC HYDROCARBONS)
- ★ O = ORGANICS
