5.0 EXISTING CONDITIONS

5.1 Valued Ecosystem Components

5.1.1 Geology/Geomorphology

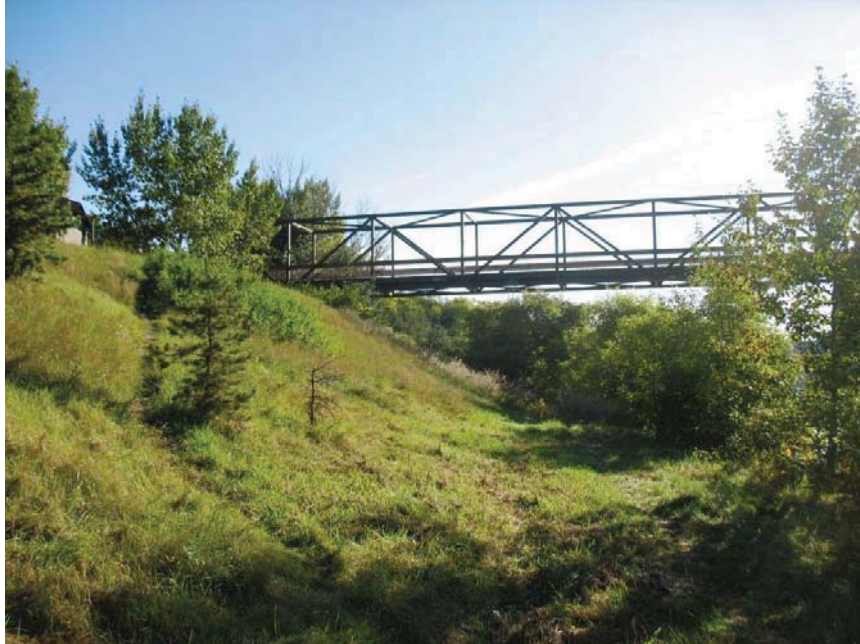
Plate 5.1. Steep slopes above the north river bank

The study area contains a mixture of steep slopes, rolling hills and a relatively flat floodplain. The north and south valley walls are both characterised by steep slopes; on the north side of the river, the slopes continue down to the river bank (Plate 5.1). The south river bank is characterised by a wide, low-lying, relatively flat terrace (Plate 5.2). The dominant geomorphological feature on the river terrace is the Mill Creek channel; however, a large portion of the channel has been backfilled, and only the northernmost portion of the channel remains on the landscape (Plate 5.3). Today, the channel winds from the 98 Avenue north backslope, through Henrietta Muir Edwards Park, to the NSR. Portions of that remnant ravine may have been filled during construction of the 98 Avenue pedestrian bridge and closer to the river, to accommodate construction of the Cloverdale pedestrian bridge. Rolling terrain is present at the base of Connors Hill; some of this might be the result of fill applied for landscaping purposes (Plate 5.4). Filling and grading have occurred on the slopes below Connors Road, at the site of the Edmonton Ski Club (Thurber Engineering 2012b).

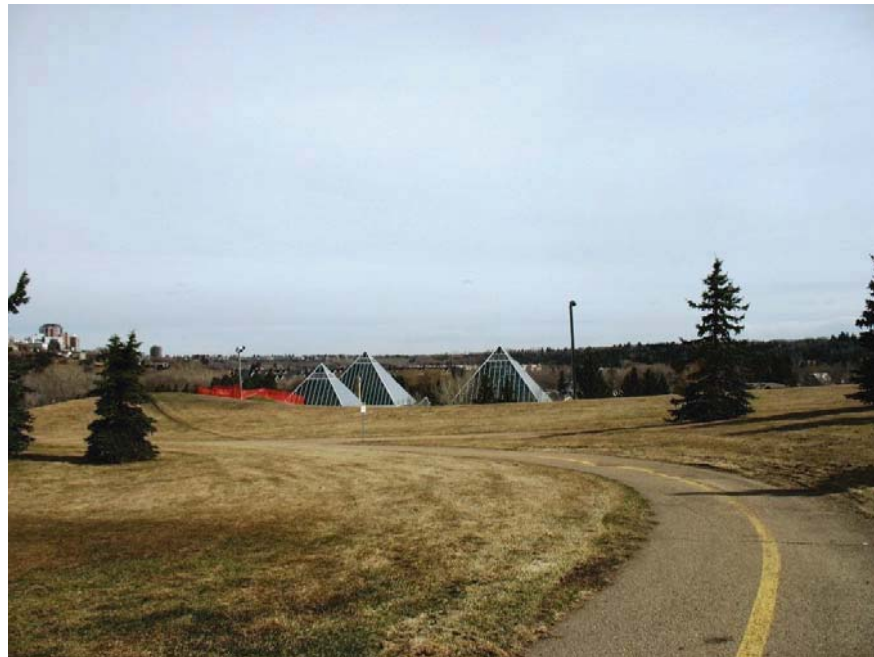
Plate 5.4. Graded slopes near the base of Connors Hill

The steep slopes of the Edmonton Ski Club, north of Connors Road, contain fills that are believed to vary with respect to thickness and consistency, and to be of relatively poor quality. Thurber Engineering (2012b) speculates that some of the fills may have been placed in an uncontrolled manner. Upper layers of boreholes drilled in this area were found to comprise clay.

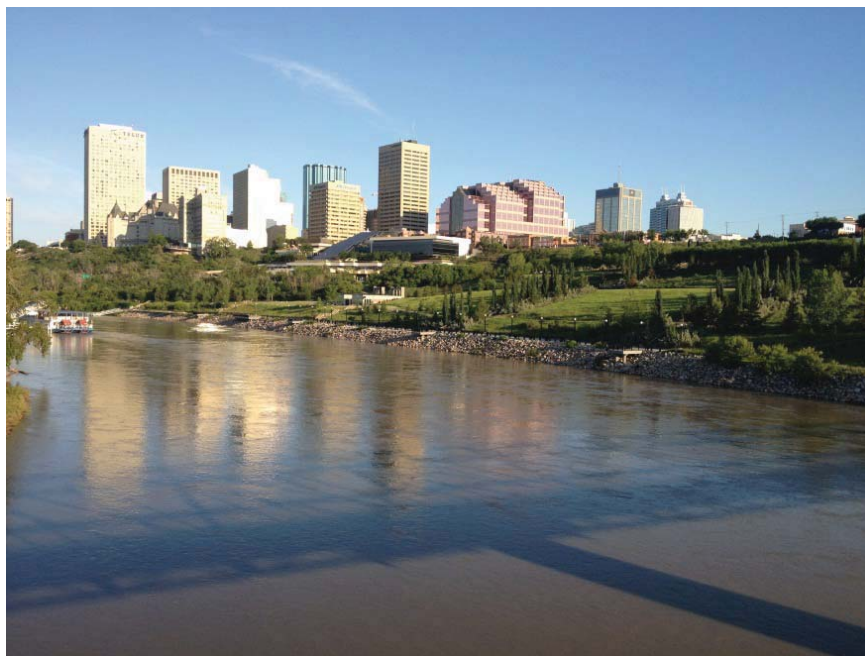
Plate 5.5. Upstream view of the NSR north bank from the Cloverdale pedestrian bridge

Two watercourses are present within the study area: the NSR and a short, abandoned reach of Mill Creek. The NSR (Plate 5.5) is obviously a focal and influential watercourse, influencing project construction and design. At the proposed crossing site the wetted river is approximately 130 m wide. Southward movement of the north bank due to historical landslides has resulted in a constriction of the channel in the vicinity of the study area. According to the NSR floodplain overlay shown on City zoning maps (City of Edmonton 2013e), in the study area, the north floodplain is limited to the vicinity of the near river bank. The north river bank is armoured through the study area (Plate 5.6). On the south bank, the floodplain is wider, with the farthest point extending south to the northeast corner of the site of the future LRT Muttart Stop. The river bank is naturally vegetated (Plate 5.7). There are two stormwater outfalls in the vicinity of the project area, one on each river bank.

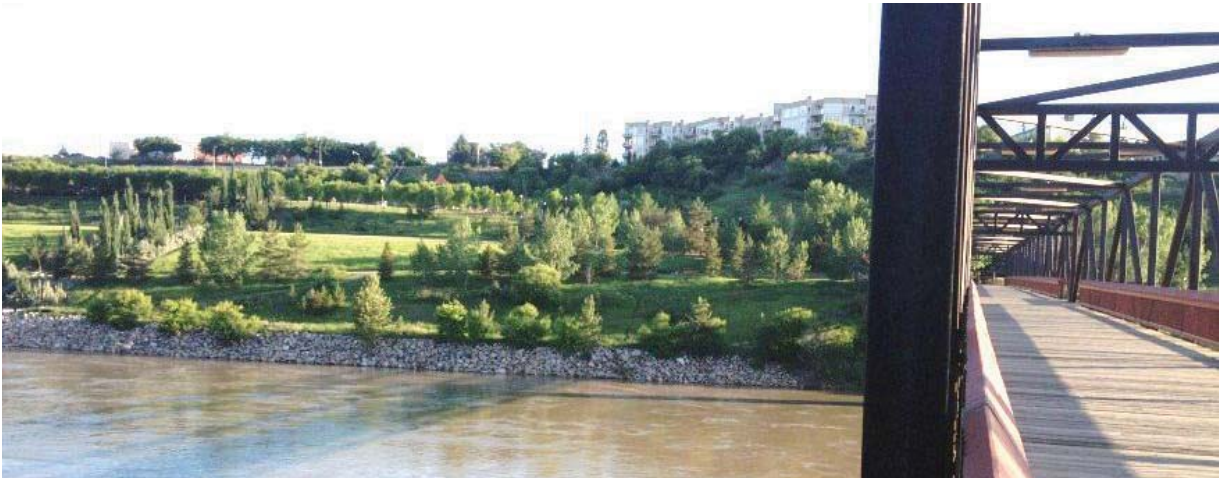
Plate 5.6. View of the armoured north bank from the Cloverdale pedestrian bridge

caused by overconsolidation of bedrock, and exposed bentonite layers. Four bentonite seams have been identified in the bedrock on the north slope. The intrinsic instability of the north bank was exacerbated by coal mining activities that occurred in the area from the late-19th century to the mid-20th century; during this period ten coal mines operated in the Louise McKinney-Grierson Hill area. Mine shafts formed areas of weakness that often collapsed and caused surface subsidence. Instability caused by mining, along with fluvial erosion of the riverbank and unusually high precipitation, are all believed to be factors underlying the 1901 Grierson Hill landslide. Translational movement along the deepest two bentonite seams led to slumping of surface material on the north bank, moving the bank of the river south by approximately 50 m, narrowing the river channel at this location. Since that time, additional slumping and filling have pushed the toe of the slope another 50 m further into the river. The landslide remains active, with movements of approximately 11-25 mm per year near the centre of the slide, located just east of the Shaw Conference Centre and approximately 500 m west of the LRT alignment. In 1986, summer flooding resulted in toe erosion significant enough to remove 8 m of material along the riverbank in Louise McKinney Park. Following this, a berm was constructed and riprap placed along the river's edge.

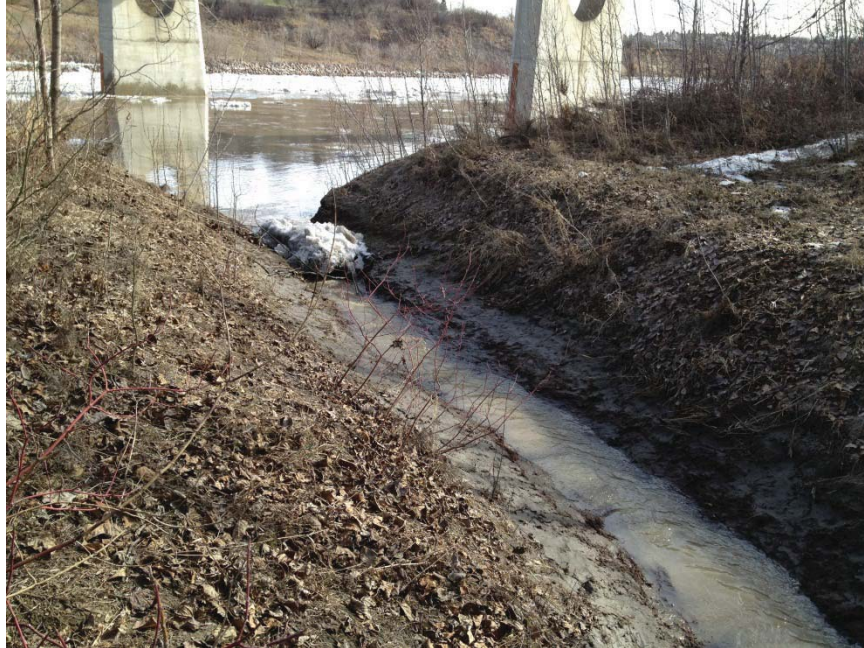
Plate 5.8. Abandoned reach of Mill Creek continues to convey water to the NSR, April 2013

Filling of Mill Creek for the 98 Avenue/bridges interchange, as described above, occurred on the lands situated in the southeastern corner of our study area; but the lowest reaches of Mill Creek, further east, were left intact. As a result, north of 98 Avenue, within HME Park, the abandoned creek reach and former creek/NSR confluence remain present. Under certain conditions this reach continues to convey water, as evidenced by flowing water present and discharging to the river during the spring freshet of April of 2013 (Plate 5.8). Ponding and local channel contours observed this spring suggest that localized rainwater ponding occurs regularly during the warmer seasons (Plate 5.9). The creek appears to continue to provide some stormwater storage/management function. The lowest reaches of the creek may also be occasionally backflooded from the NSR during flood conditions; but this has not been investigated. Drainage throughout HME Park appears to remain relatively natural and would be to the creek or directly to the river.

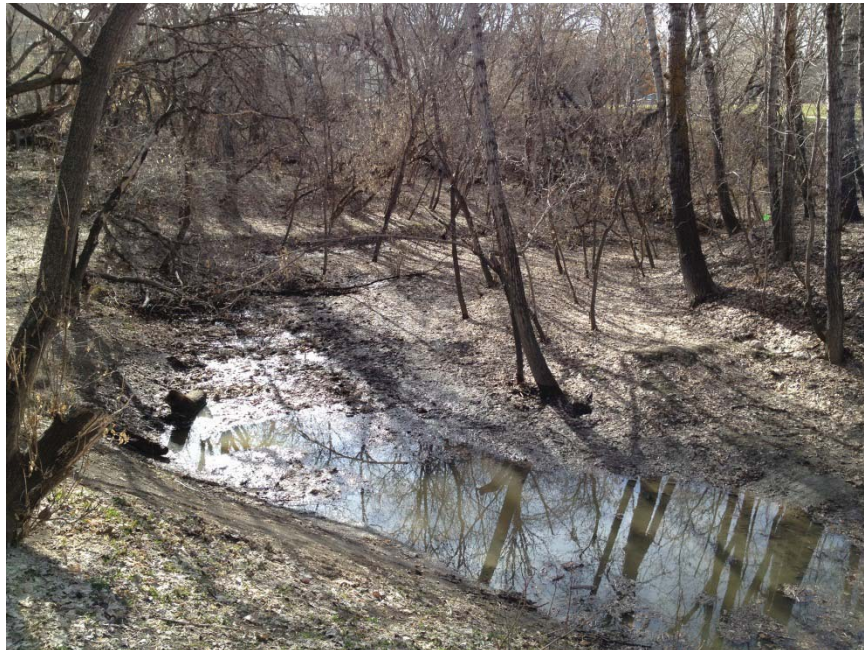
Plate 5.9. Water pooling in a former reach of Mill Creek ravine located in HME Park, April 2013

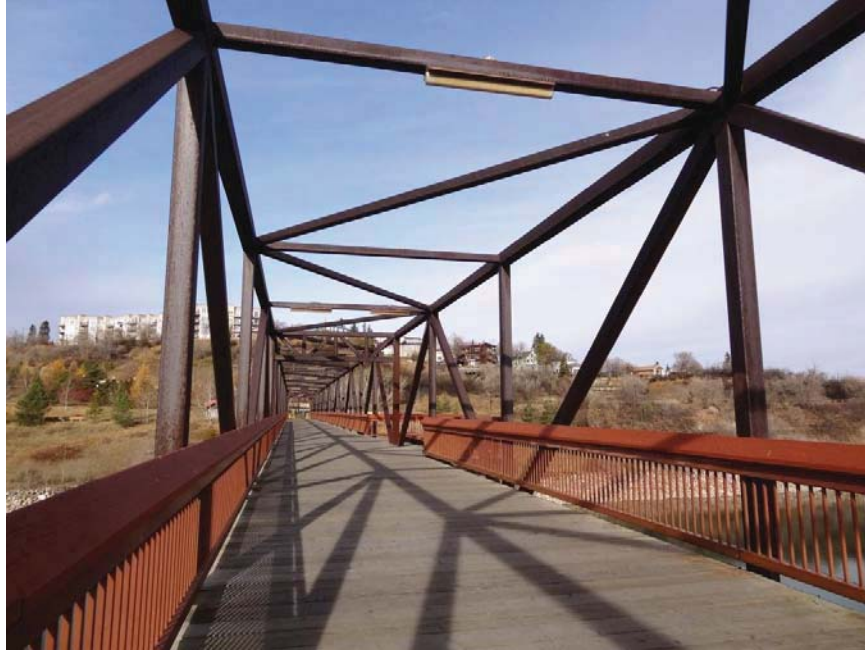
Plate 5.20. Cloverdale pedestrian bridge

The Cloverdale pedestrian bridge provides a pedestrian-friendly river crossing, and links to pathway networks on the north and south sides of the river (Plate 5.20, Figure 5.8). The bridge, built in the 1970s, is approximately 5 m wide. Seating and viewing areas are available at the two northernmost piers, where the bridge deck widens, as well as near the south abutment. The bridge is often used to view activities and events on the river, and provides a pathway connection across the river for casual and commuter pedestrians and cyclists. The bridge is one of four dedicated pedestrian bridges across the NSR in Edmonton.

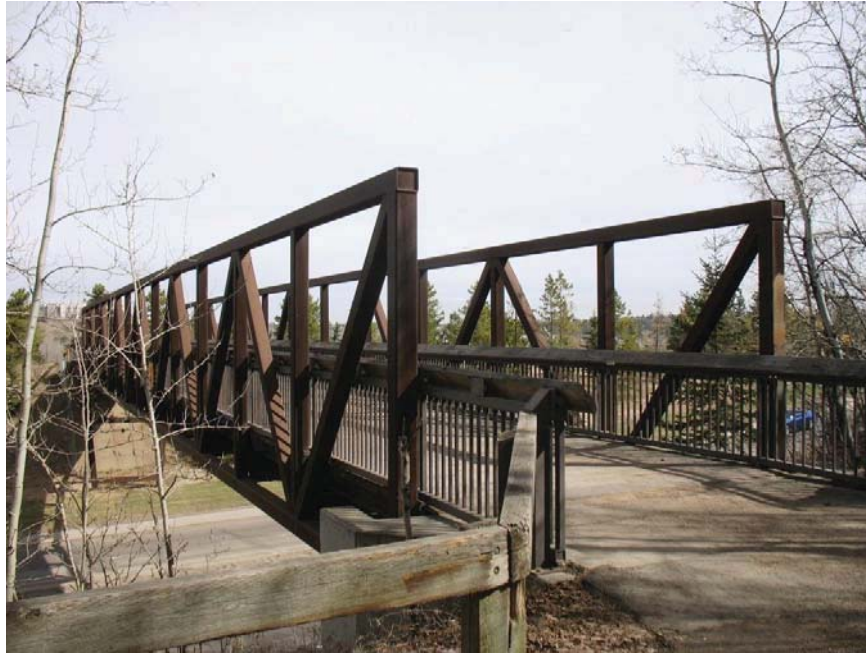
Plate 5.28. Connors Road pedestrian bridge

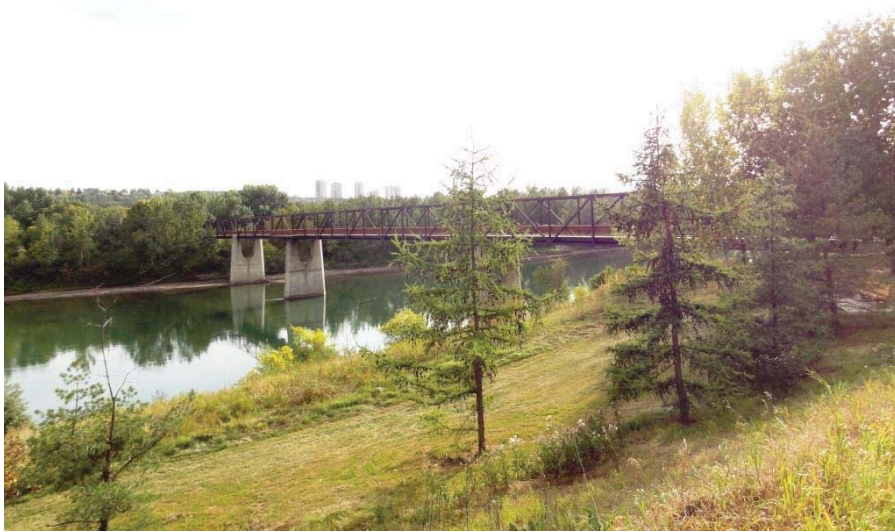
Plate 5.30. The Cloverdale Bridge from the north valley slope, looking west from Louise McKinney Park (upstream)

Views from Louise McKinney Park include the existing footbridge (Plate 5.30), World Walk (rose garden), the river, park landscaping, and shrubland/grassland surroundings near the east end of Louise McKinney Park. Currently, the steep slopes of the north valley wall at the east end of the park acts as a backdrop to the park, framing park views and providing a natural look and feel to the east areas of the park (Plates 5.31 and 5.32).
