## **4.0 NORTH VALLEY PRIMARY CONSTRUCTION ACCESS**

**PROPOSED NORTH BANK ACCESS ROAD  
PRELIMINARY GEOTECHNICAL  
INVESTIGATION AND ASSESSMENT**

City of Edmonton LRT Valley Line - Stage 1  
EISA Update

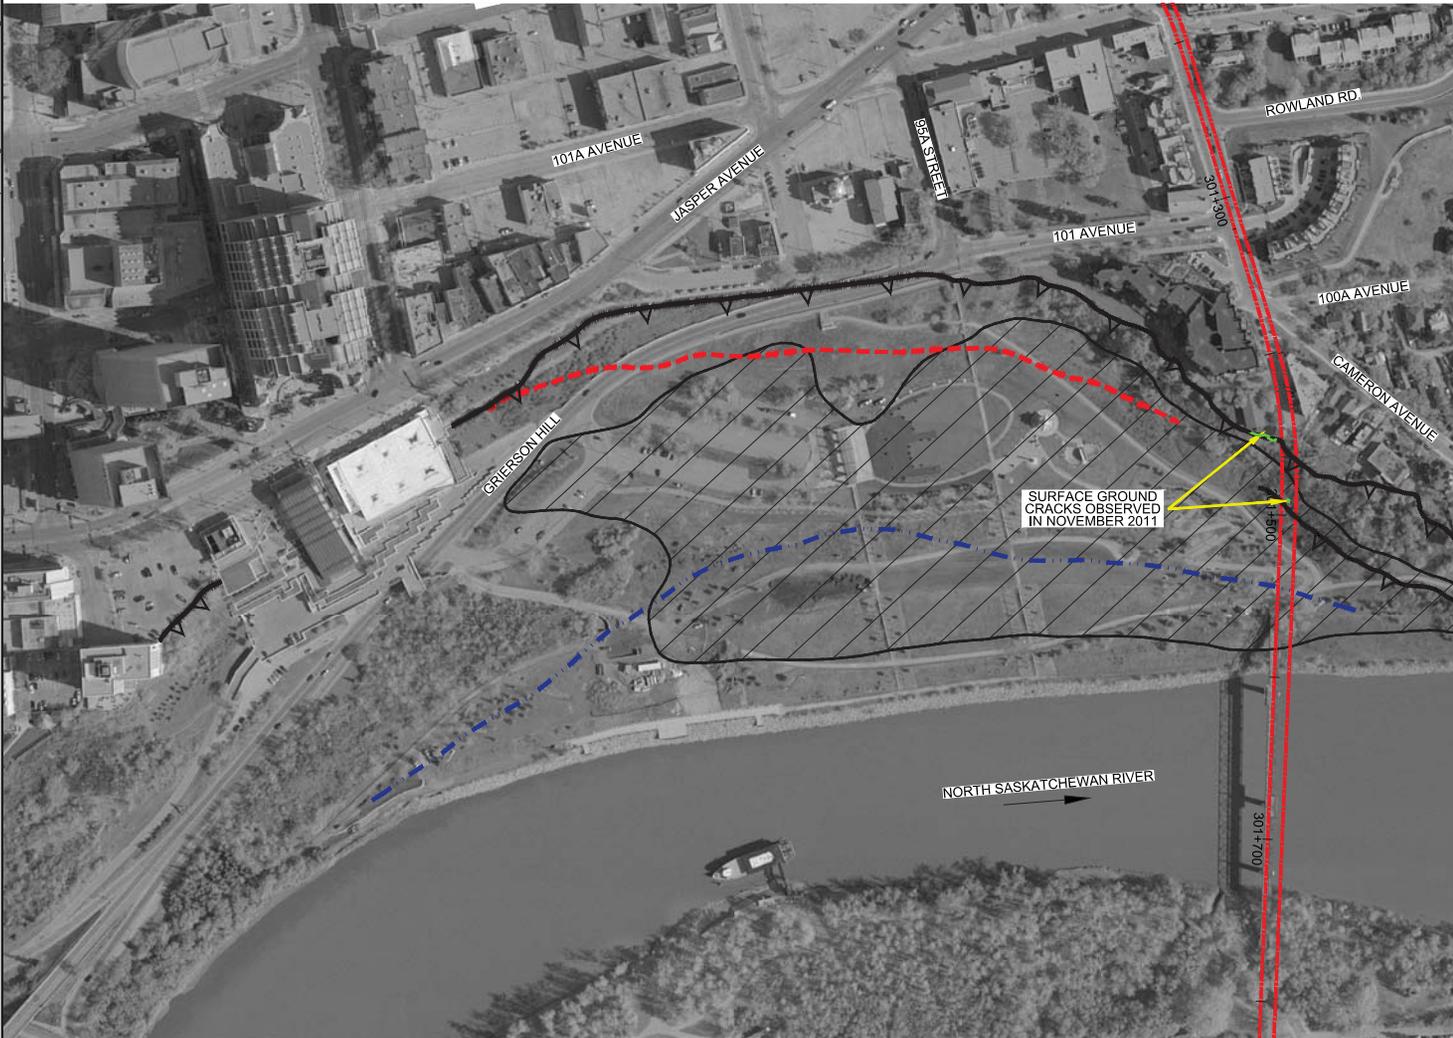
SLOPE CREST IN 1887 (BEFORE FAILURE)
-

TOE OF RIVERBANK IN 1887 (BEFORE FAILURE)
-

Hydrology investigations specific to this component focused on groundwater as there are no surface water features in the study area. The NSR, previously discussed in the 2013 EISA, is situated downslope from the proposed road, approximately 40 m at its closest point.

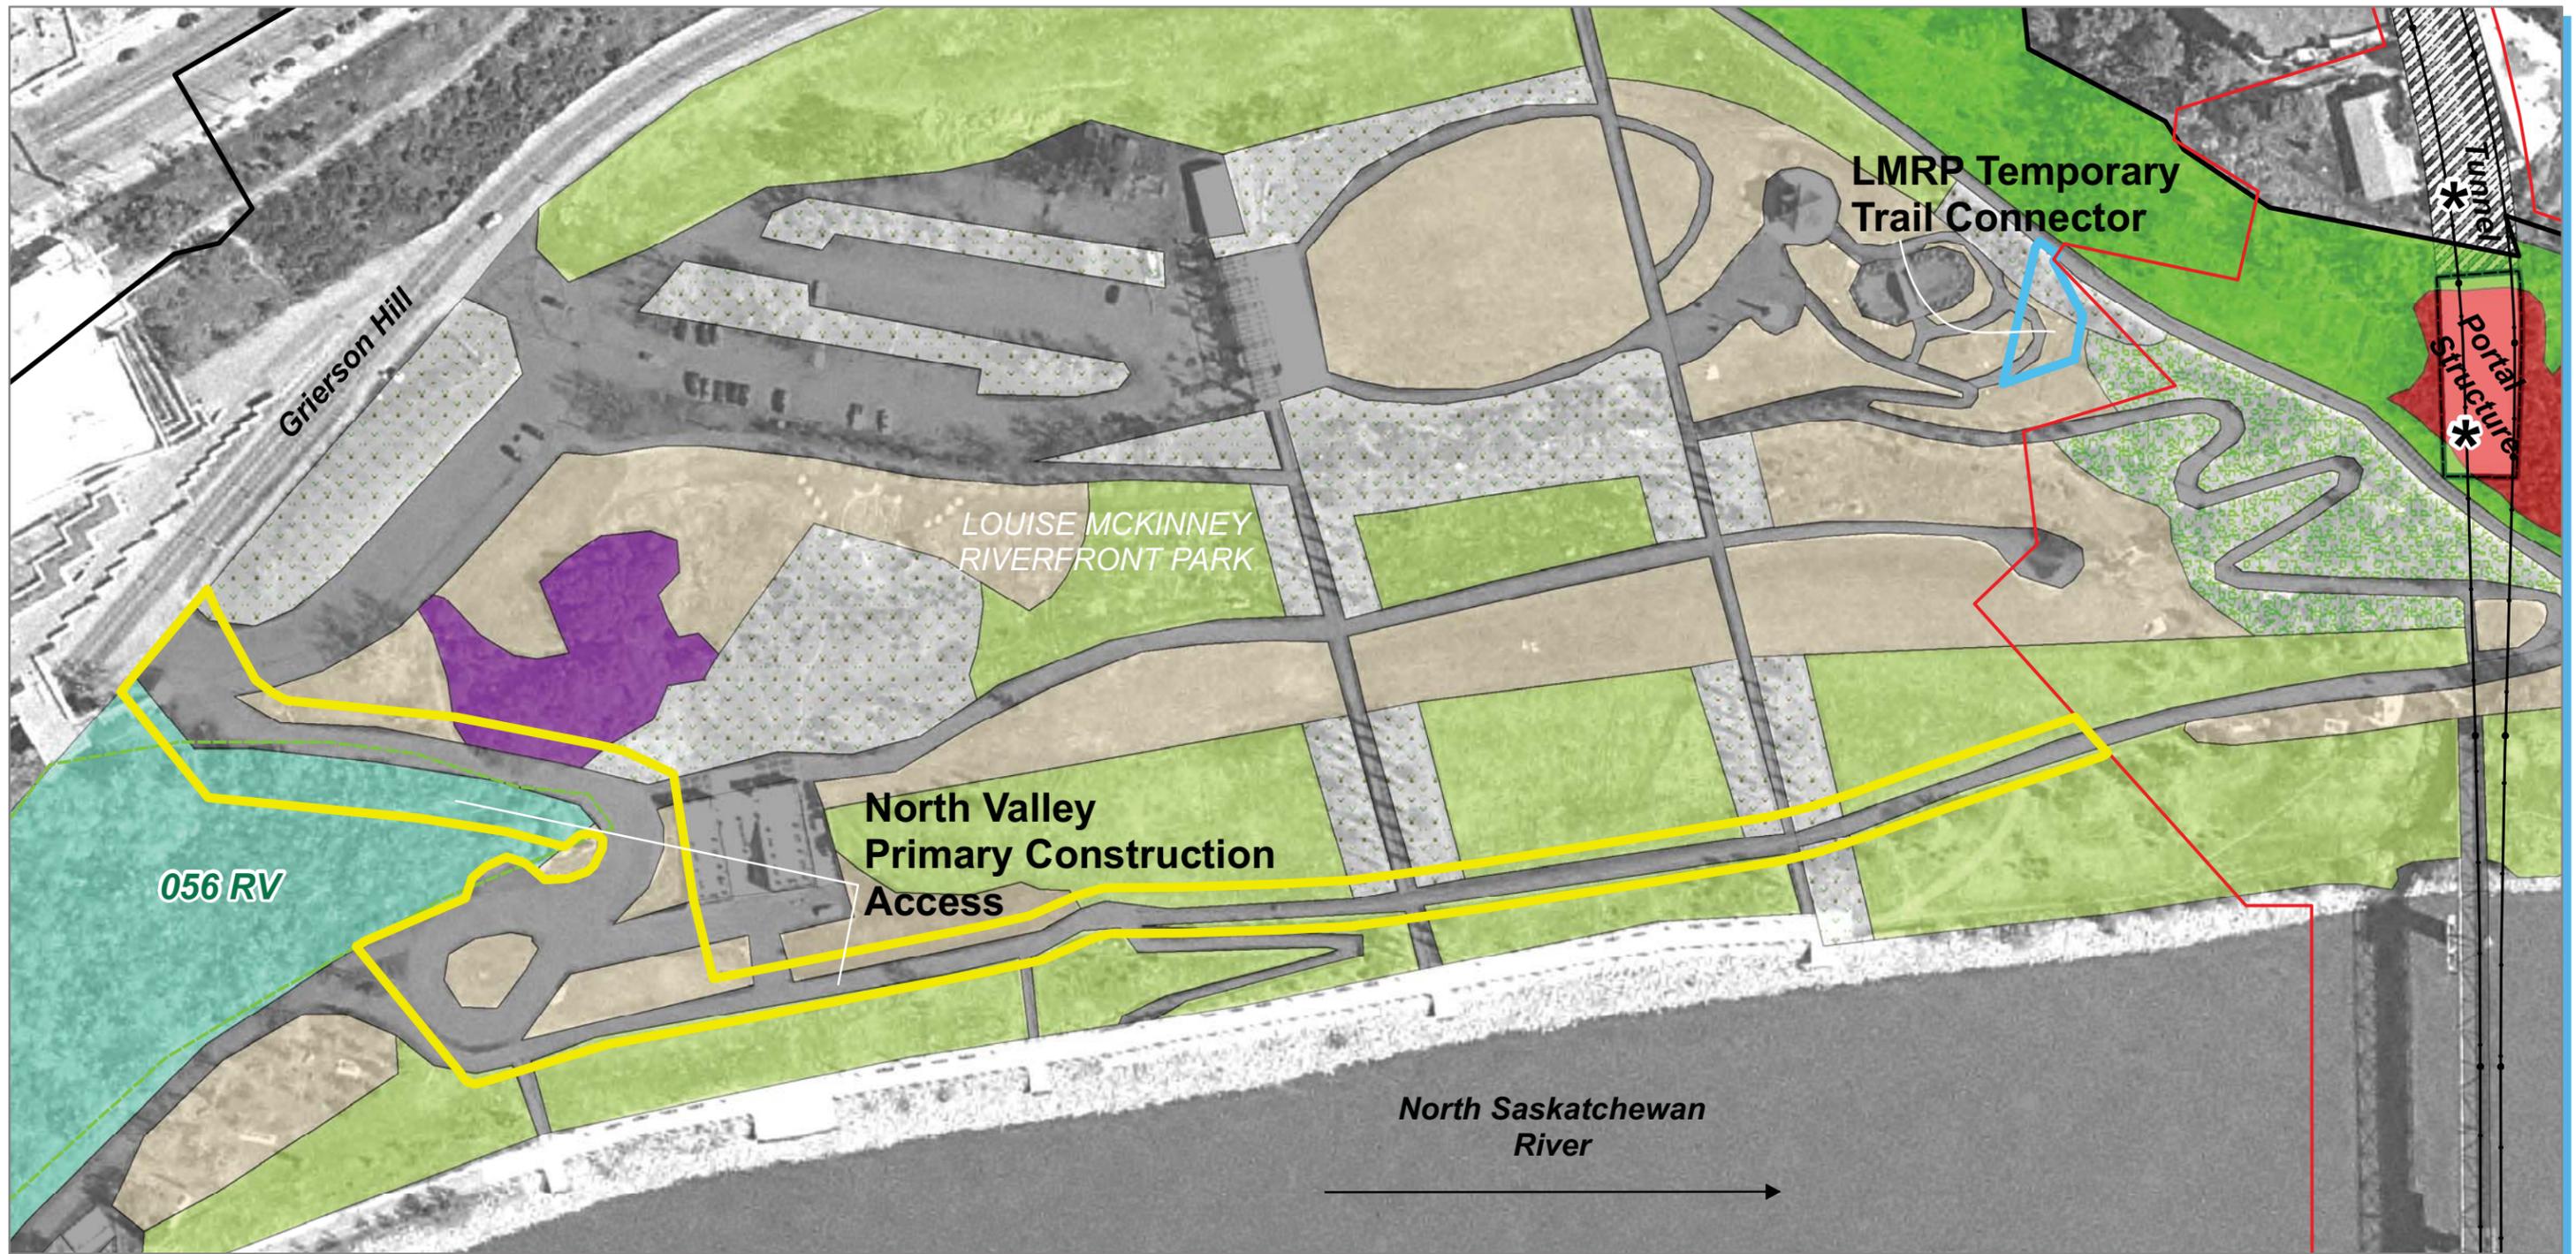
- Natural Communities**
- Balsam Poplar/Manitoba Maple (PMM) \*
  - Manitoba Maple (MM)
  - Caragana (C)
  - Grassland/Shrub (G/S)
  - Grassland (G)
- Manicured Communities**
- Lawn
  - Garden
  - Planted Bed
- \* Indicative Location Only

Vegetation in the west portion of LMRP is characterized by landscaped parkland, including manicured lawns and several types of formal gardens, and is traversed by several paved pathways (Plate 4.1). Non-manicured, natural communities in this area are relatively small and, at the time of our survey, consisted of grassland (G), Manitoba maple (MM) and a portion of one larger, poplar-Manitoba maple (PMM) forest community on the west edge of the study area (Figure 4.3). Detailed descriptions of each community are provided below. A full list of species observed in each community is provided in Appendix C.

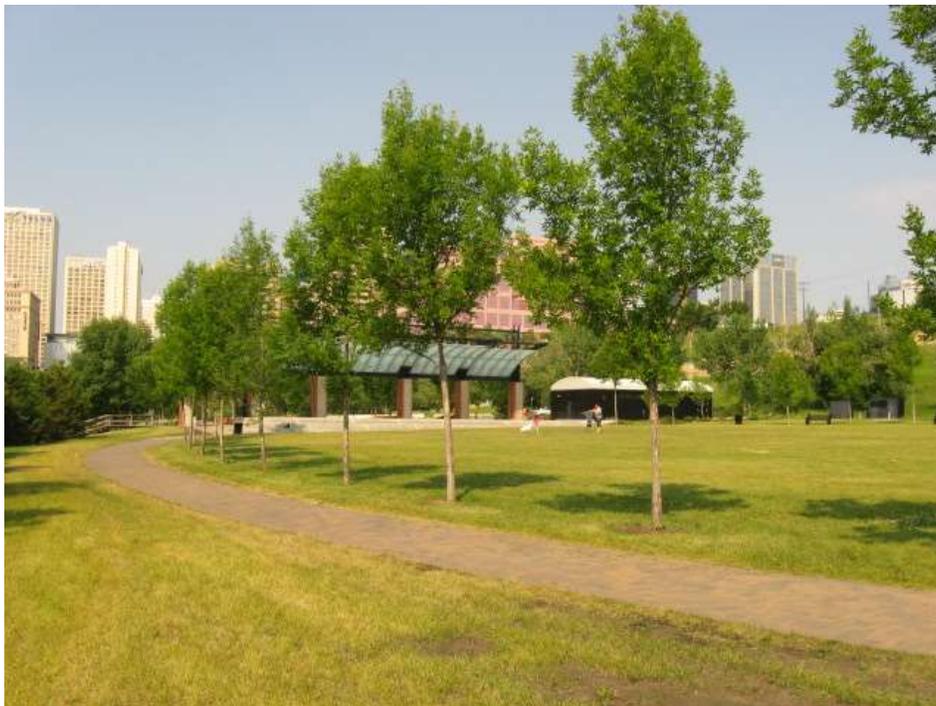
**Plate 4.1. The west portion of LMRP is characterized by landscaped parkland, including manicured lawn, gardens and paved pathways (July 2014)**

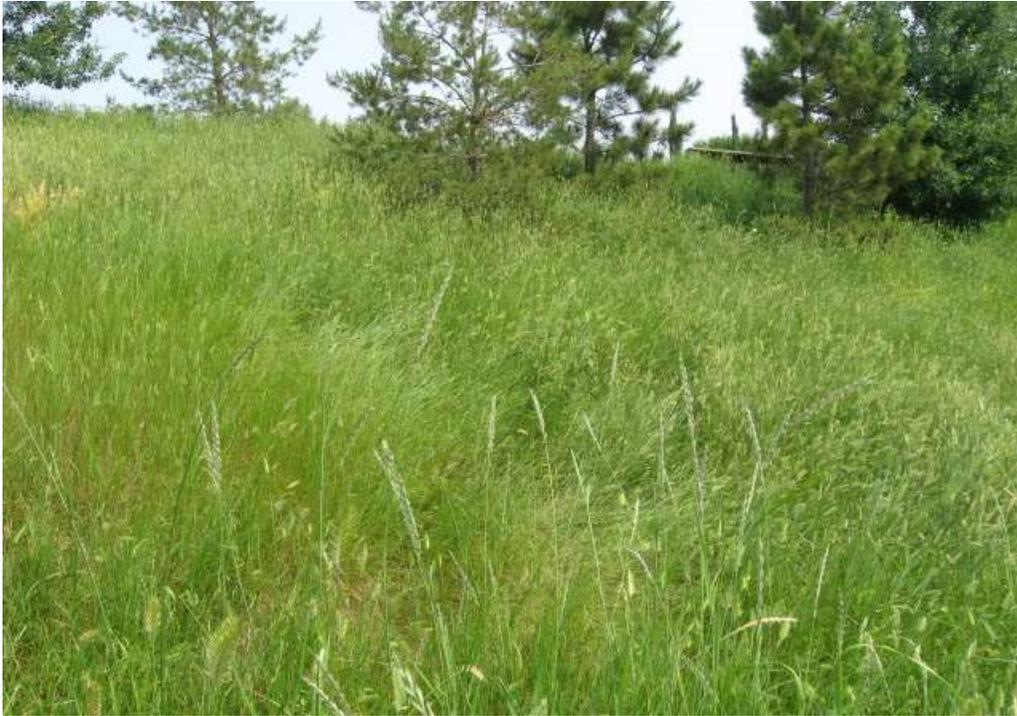
**Plate 4.2. Naturalized (unmanicured) grassland communities on the slopes of Louise McKinney Riverfront Park (July 2014)**

Small naturalized grasslands (G) communities were located throughout the park including parallel to the SUP that will form the proposed construction access road and were commonly dominated by exotic grass species, including smooth brome, quack grass, and crested wheatgrass (Plate 4.2). Reed canary grass (*Phalaris arundinacea*) and slender wheatgrass (*Elymus trachycaulus*), both native grasses, were also dominant or abundant in some areas; Kentucky bluegrass (*Poa pratensis*) and western wheatgrass (*Agropyron smithii*) were frequently observed. Other common species included wild vetch (*Vicia americana*), alsike clover (*Trifolium hybridum*), common goat's-beard (*Tragopogon dubius*), prickly rose (*Rosa acicularis*), and buckbrush (*Symphoricarpos occidentalis*). A total of 52 species was detected in grassland communities, 20 (38%) of which were native. The remaining 32 species (62%) were exotic, with five of those species listed as noxious under the Alberta *Weed Control Act*.

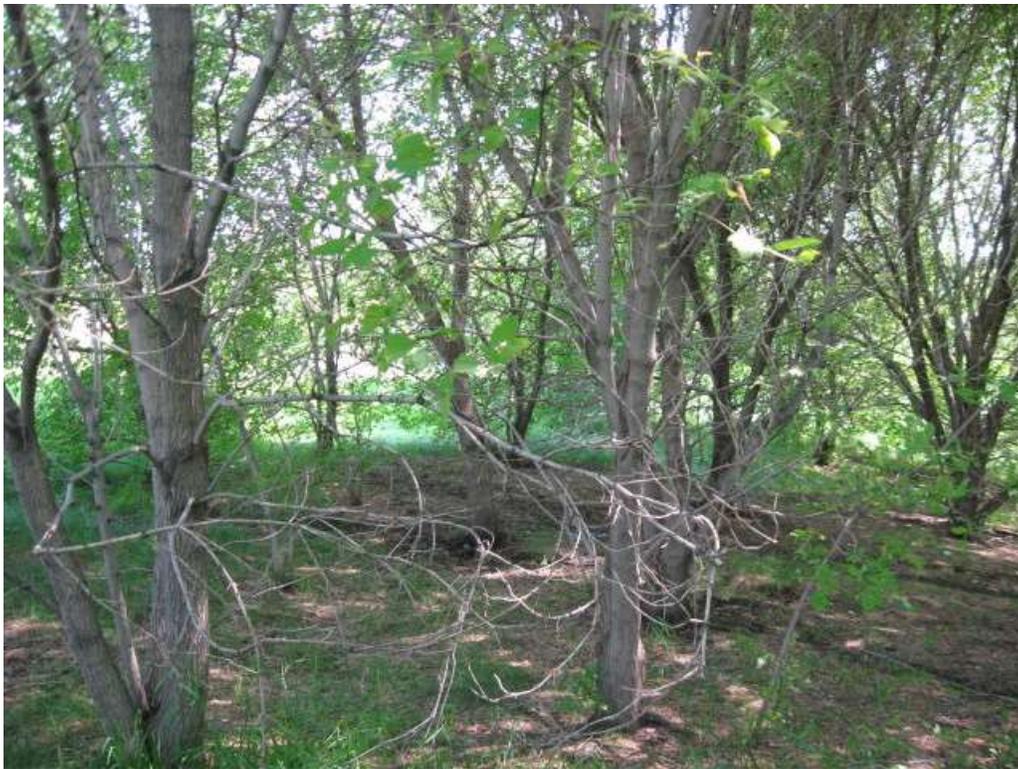
**Plate 4.3. Open understory in a Manitoba maple community in Louise McKinney Park (July 2014)**

One naturalized Manitoba maple (MM) community was located in the west end of the park bordering the maintenance vehicle access road (Figure 4.3). That community was dominated by Manitoba maple, with occasional balsam poplar (*Populus balsamifera*) and red-osier dogwood (*Cornus stolonifera*). The understory was typically open, comprising reed canary grass, smooth brome (*Bromus inermis*), and quack grass (*Elytrigia repens*) (Plate 4.3). A total of 11 species was detected in this community, 7 (64%) of which were native. The remaining four species (36%) were exotic, with one noxious weed species observed. Manitoba maple is not native to this region of Alberta but has naturalized and commonly occurs in the NSRV and is often found as a sub-dominant tall shrub or tree species.

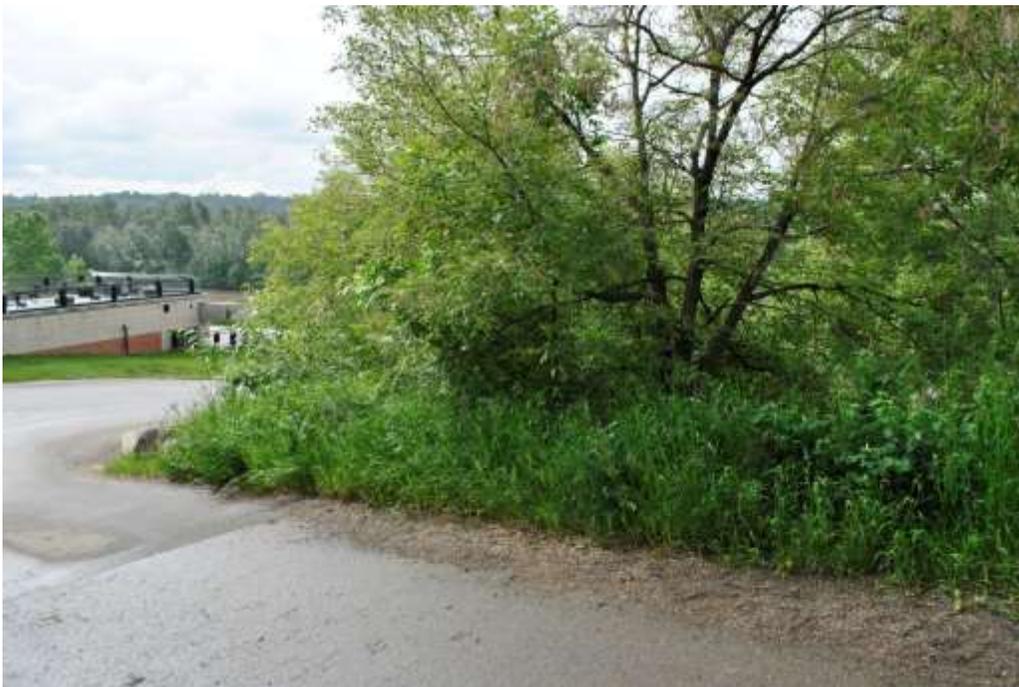
**Plate 4.4. The margins of the PMM community, adjacent to along the existing access road typified Edmonton river valley forest edge communities, view looking south (July 2014)**

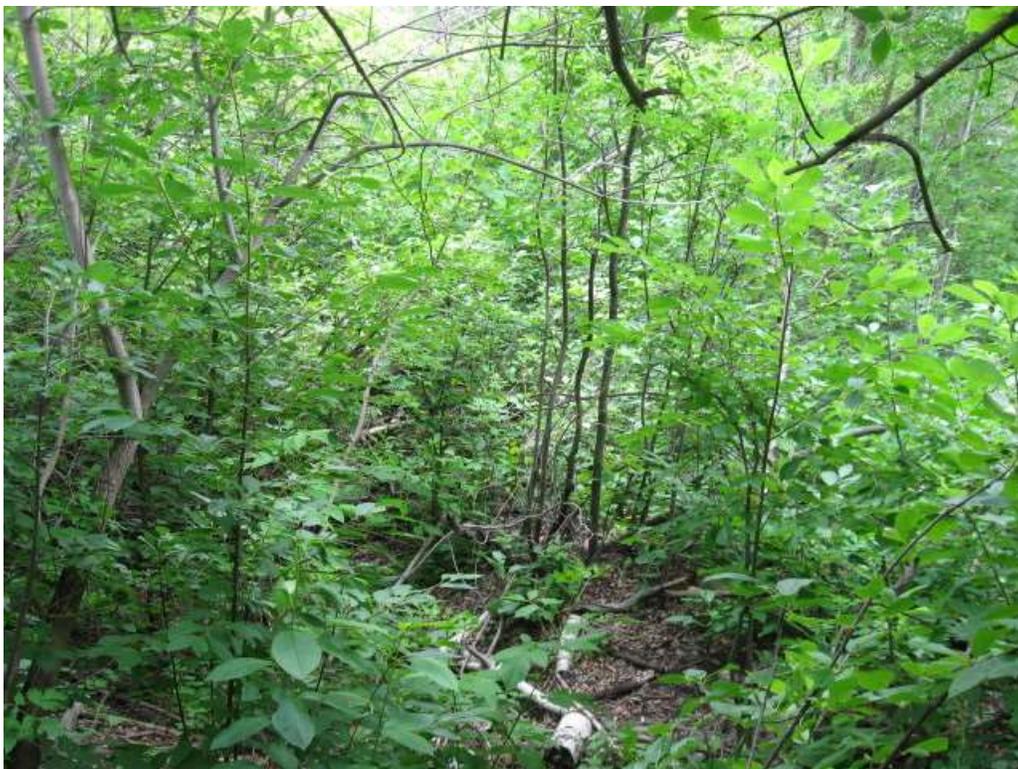
**Plate 4.5. Dense understorey in the interior of the PMM community along the west edge of LMRP (July 2014)**

with larger DBHs than closer to the edge (Plate 4.5). More space between trees promoted heterogeneity and facilitated the establishment of diverse shrub and herbaceous layers. Red-osier dogwood and prickly rose were common shrubs in the interior of the stand, as they were along the edges; however, snowberry and species of honeysuckle and currant were also frequently observed in the interior. Interior understorey was characterized by a variety of native forbs, such as wild sarsaparilla, northern bedstraw, star-flowered Solomon's-seal, and species of aster. Exotic and noxious weed species occurred throughout the stand, but they tended to be rare in the interior.

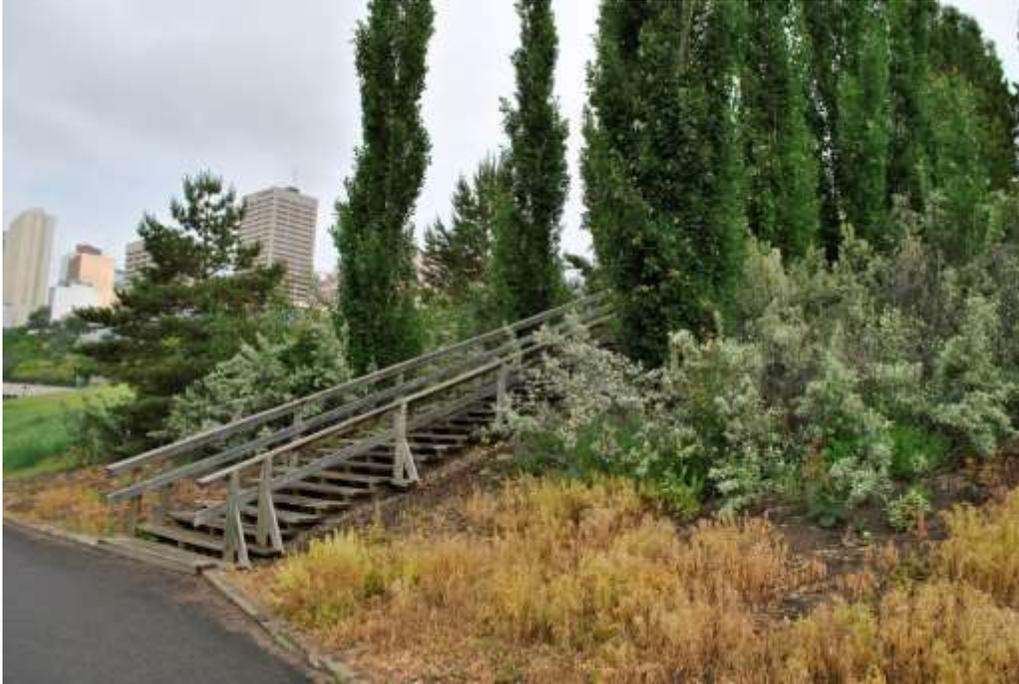
**Plate 4.6. Manicured areas and paths, including columnar poplar, adjacent to the proposed access road alignment (July 2014)**

Manicured lawns, gardens, and planted beds occupied most of the park including some occurrences in the vicinity of the SUP portion of the proposed access road. Planted beds in the park supported ornamental perennial forbs as well as trees and shrubs; common species included oleaster (*Elaeagnus sp.*), ornamental columnar poplar (*Populus sp.*), pine (*Pinus sp.*), and larch (*Larix sp.*). Planted beds comprising oleaster, pine, and columnar poplar were located along the staircases intersecting with the SUP to be upgraded (Plates 4.6 and 4.7).

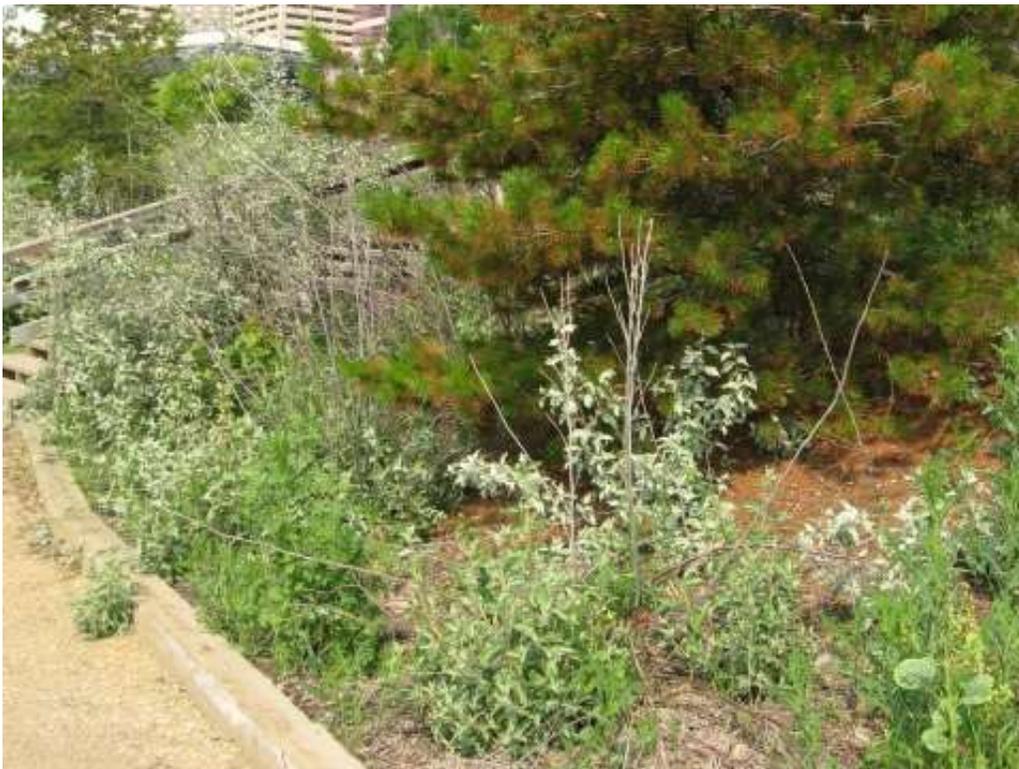
**Plate 4.7. A typical planted bed along a staircase intersecting with the to the proposed access road alignment (July 2014)**

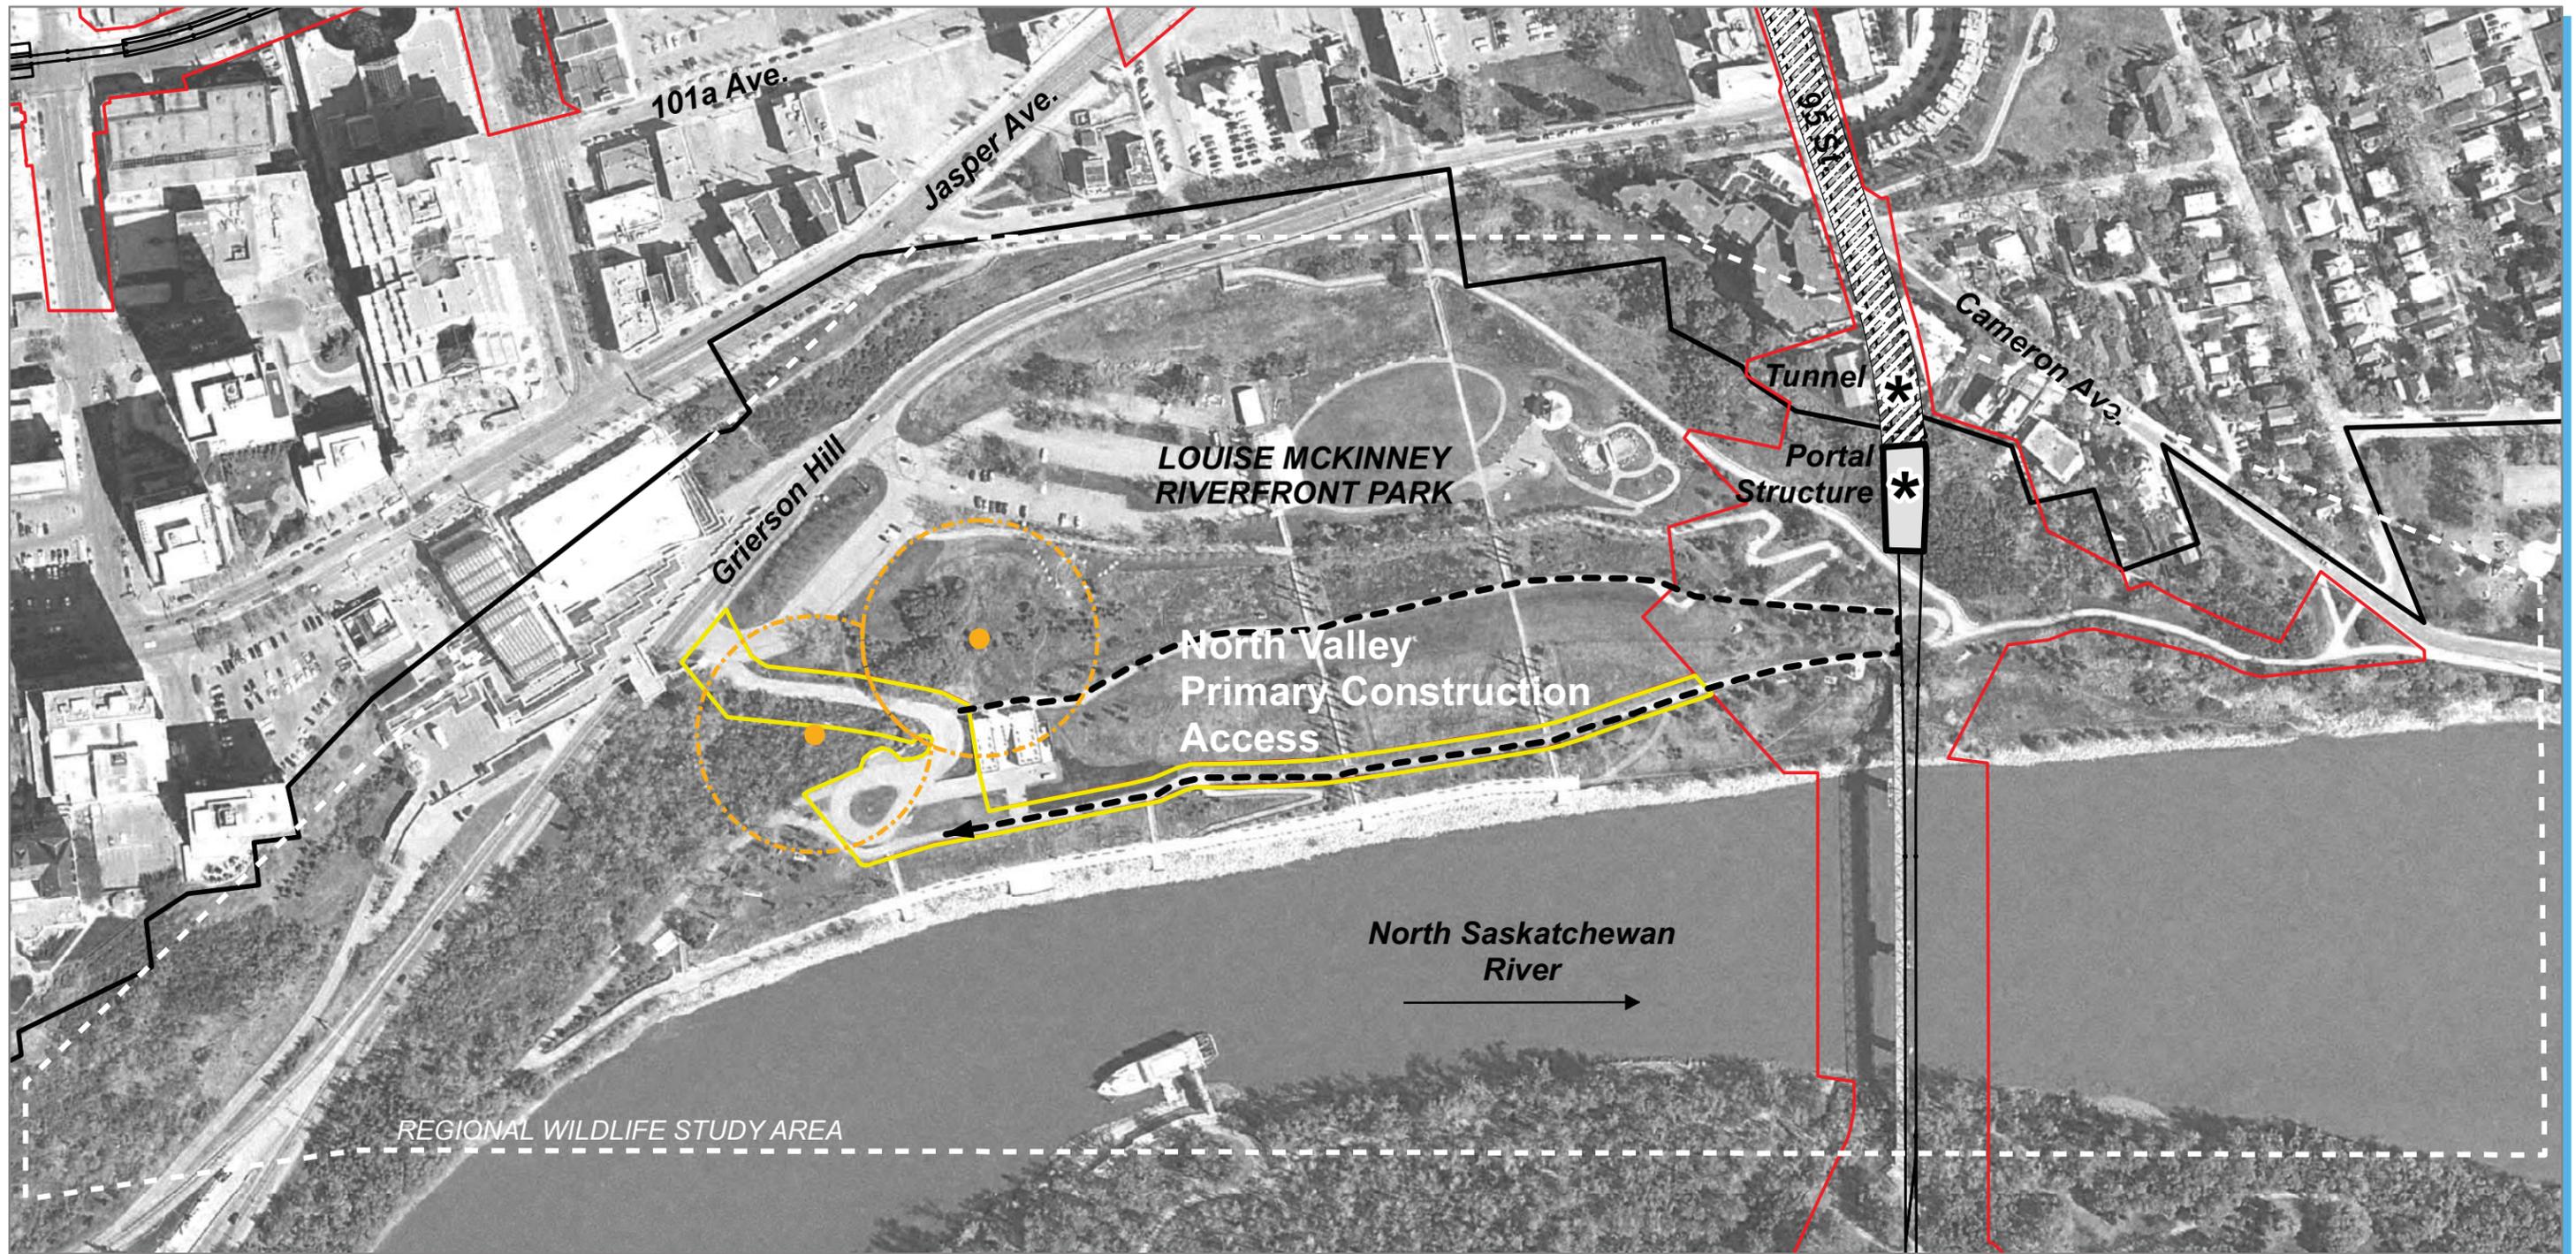
Bird Point Count Survey Location (with 50m radius plot)

Wildlife field investigations were limited to the spring and comprised breeding bird surveys. No suitable amphibian breeding habitat was identified in the park. For bird surveys, the study area was expanded to include natural habitat adjacent to the proposed road corridor. A breeding bird survey was conducted on 17 June 2014 and repeated on 27 June 2014, to characterize breeding bird richness and abundance. Each bird survey consisted of a point count at each of two stations located within areas of natural vegetation (i.e., the PMM and MM plant communities) and a meandering search of areas supporting manicured vegetation (Figure 4.4). Each point count was an eight-minute survey, wherein all birds detected (seen or heard) within a 50 m radius were recorded. The meandering survey consisted of walking SUPs in the vicinity of the proposed primary construction access road at a rate of approximately 40 m/s and recording all birds detected using habitat in that area. Data from the bird surveys were reported as the maximum number of individuals of each species detected on 17 or 27 June 2014, and the total number of surveys that each species was detected in (out of four point counts and two meandering surveys). All other animal observations or signs were documented and described in terms of presence and habitat use. All habitat types present were briefly described and qualitatively assessed with respect to habit potential.

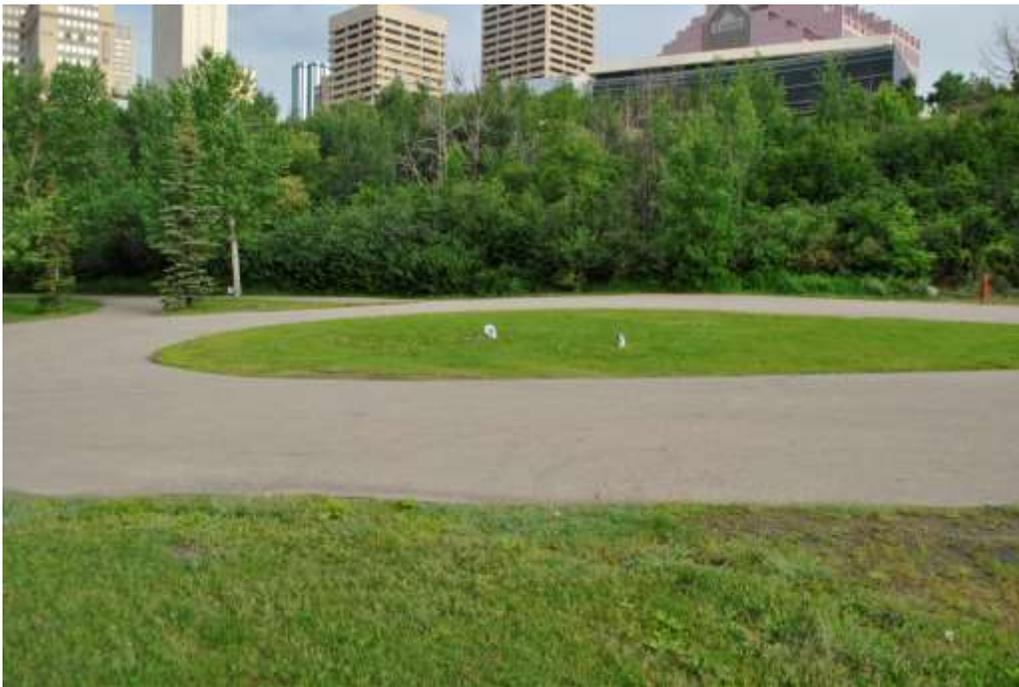
**Plate 4.9. Maintenance/service vehicle road turn-around, looking north (July 2014). This road does not provide vehicular park access or parking for the general public.**

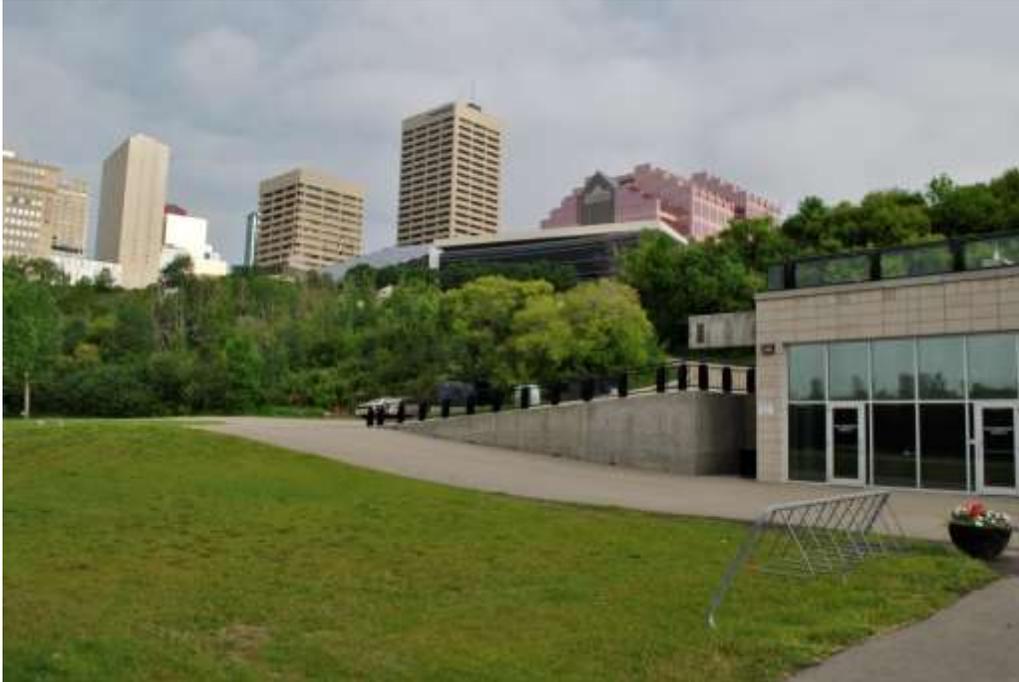
**Plate 4.10. Riverfront Plaza, looking northwest: River Valley Adventures operates a Segway rental service that relies on the connection to the paved Trans Canada Trail and the broader river valley SUP network (July 2014).**

- Situated along both the SUP and the vehicle access road is the Riverfront Plaza – which includes public washrooms and two businesses (River Valley Adventures/Urban Green Café). River Valley Adventures operates a Segway rental service that relies on their connection to the paved Trans Canada Trail and the broader river valley SUP network (Plate 4.10).

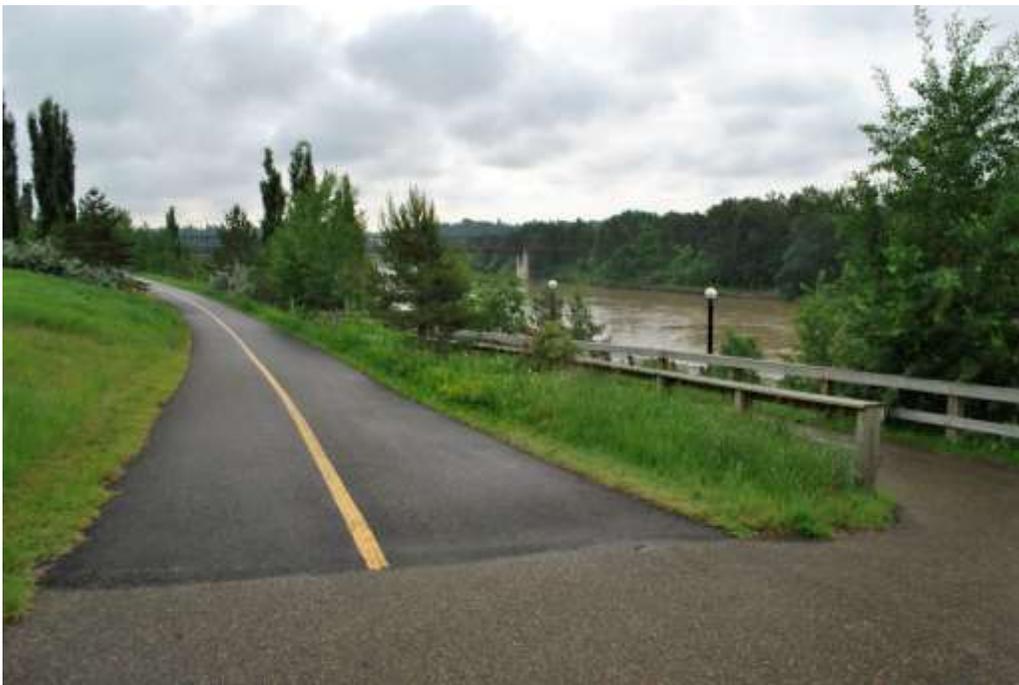
**Plate 4.11. Paved fully accessible trail leading south to the Riverfront Promenade, looking east (July 2014).**

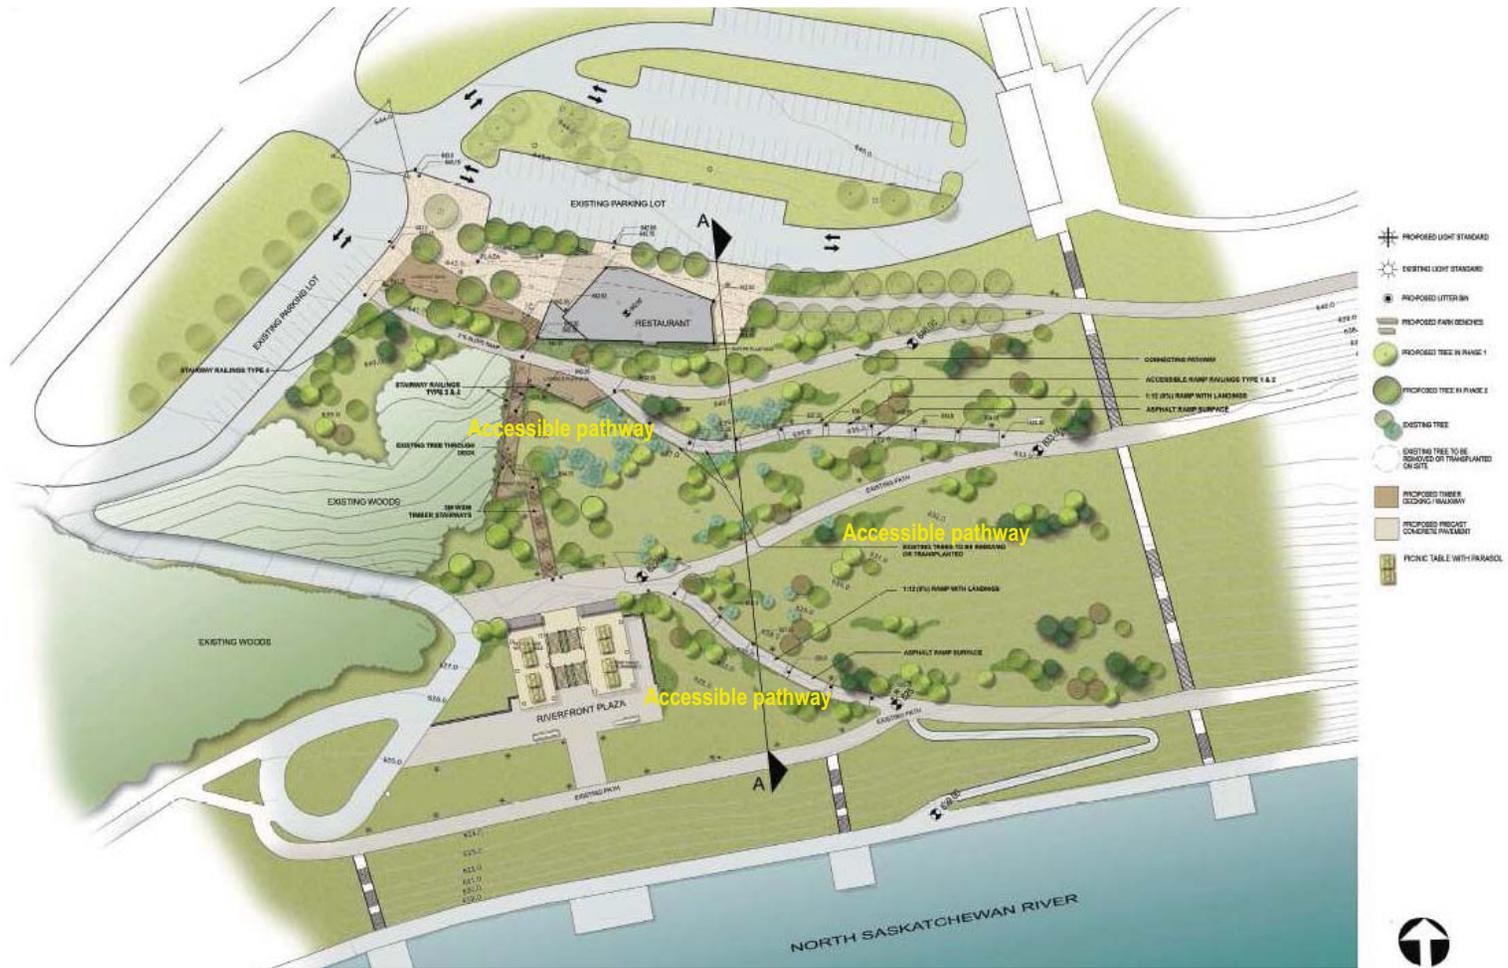
Figure 4.5

Site Plan - Louise McKinney Riverfront Park

- An additional, fully accessible north-south pathway is planned for construction in 2015 by City of Edmonton Community Services (Figure 4.5), to provide

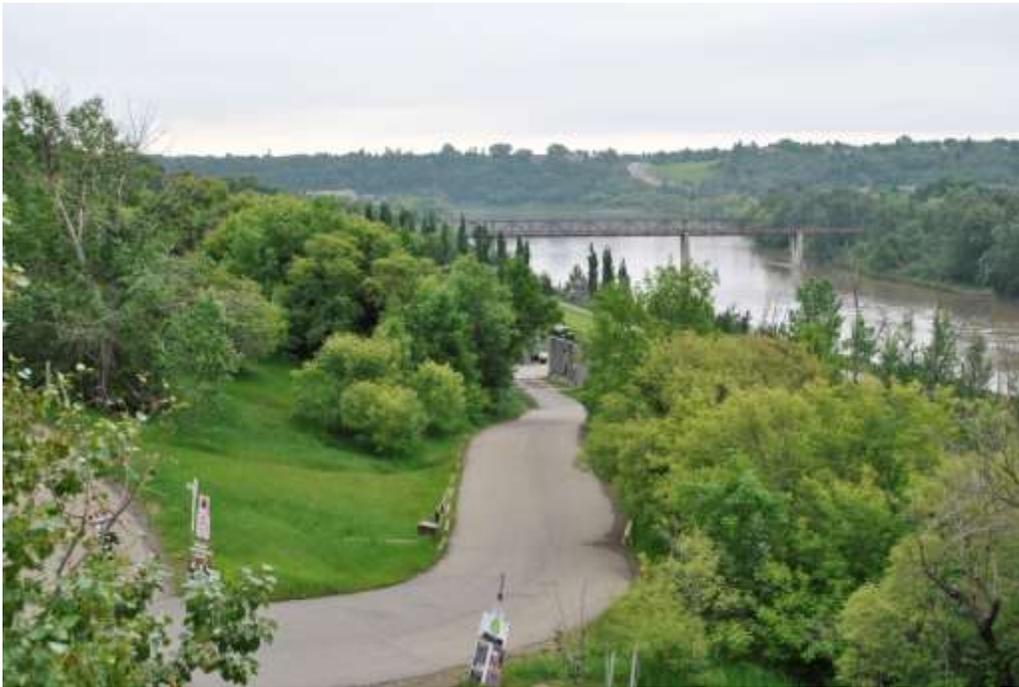
**Plate 4.12. West End of proposed primary construction access road, looking southeast along the maintenance vehicle access road, from the Shaw Conference Centre (June 2014).**

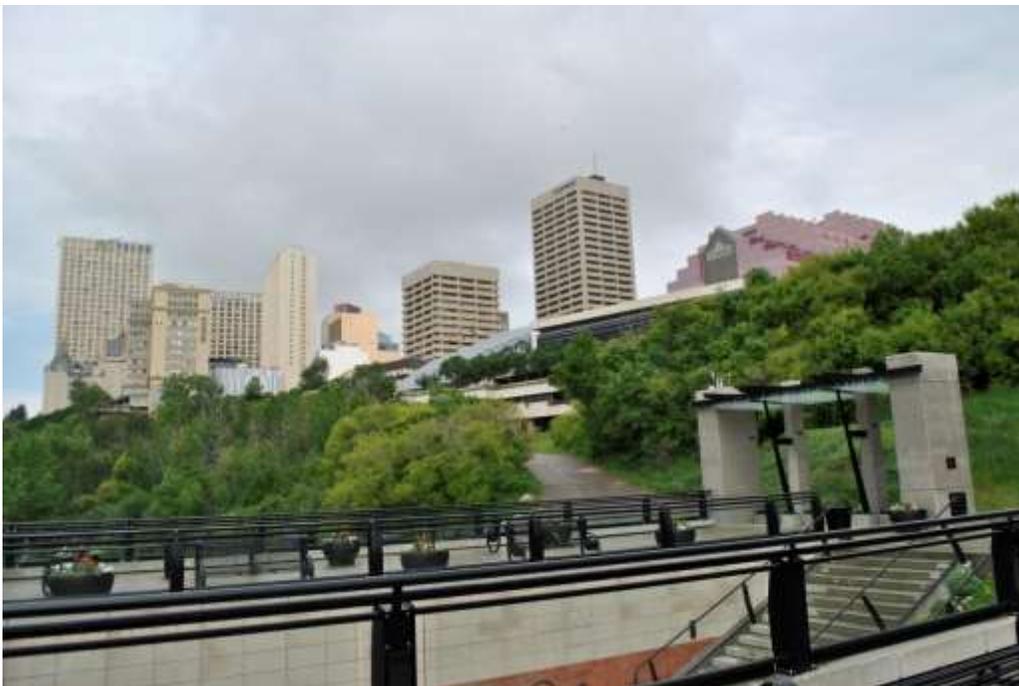
**Plate 4.13. West End of proposed primary construction access road, looking northeast towards the maintenance vehicle access road and the Shaw Conference Centre, from the Riverfront Plaza (June 2014).**

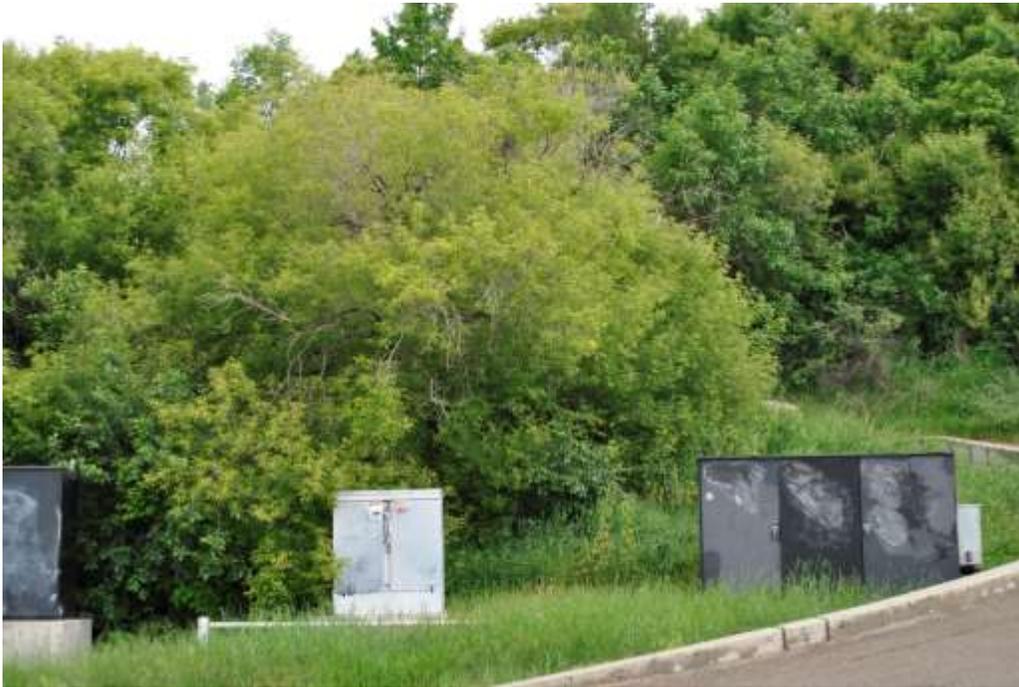
**Plate 4.15. Several utility panels/boxes are located along the vehicle access road turnaround, looking north.**

Multiple buried utility lines (and associated surface components) are present in the proposed construction access road project area (Appendix F). Several buried EPCOR electrical lines are within the project area including one running parallel with the Trans Canada SUP at the base of the slope, which terminates at an electrical panel near the east end of the Promenade. EPCOR lines also travel north, east and south and intersect with the project component area. Several utility panels/boxes are located along the vehicle access road turnaround (Plate 4.15). Two storm sewer lines are located across and adjacent to the entrance to the maintenance access road to the Riverfront Plaza building and two additional storm sewer lines are documented as running north/south across the valley slope east of the plaza building. A subsurface holding tank, an associated sanitary line and a monitoring cable are located west of the Riverfront Plaza building, with surface connections and the majority of the tank located in the grassed centre of the vehicle turn-around (Plate 4.16). This holding tank is anticipated to be replaced with a lift station and associated sanitary lines in 2015. One north-south water main and fire hydrant are situated immediately west of the Riverfront Plaza. An ATCO gas line is located under the west side of the vehicle access road to LMRP, within the project component lands. There are no identified overhead utilities. While some of the utility relocations required for the Valley Line are already underway, no relocation work has been undertaken in support of the proposed primary construction access road in LMRP.

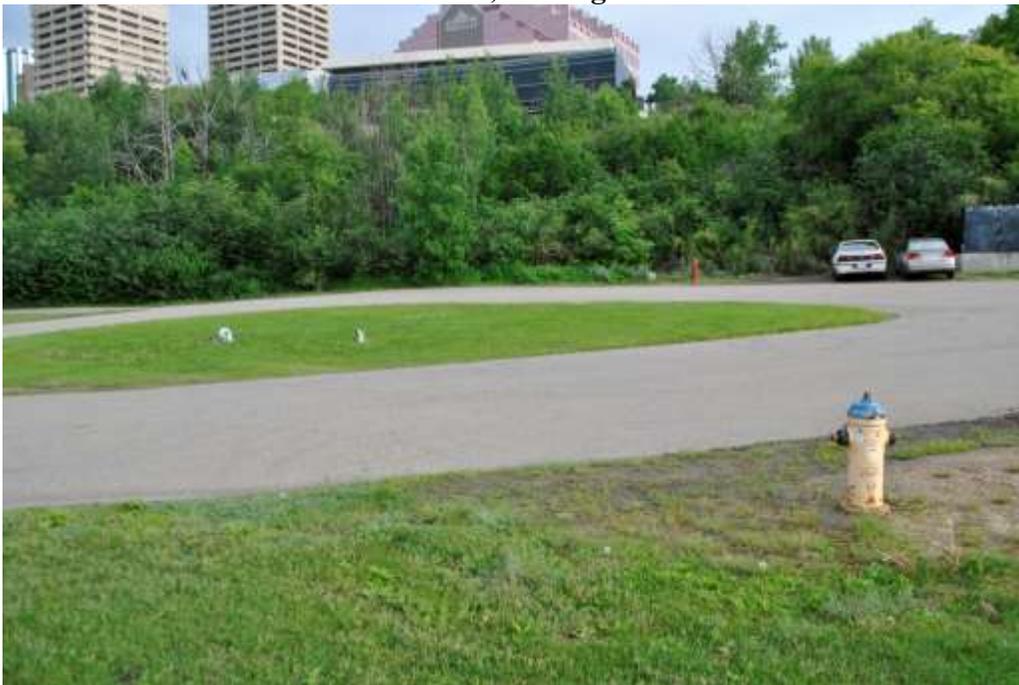
**Plate 4.16. A subsurface holding tank, an associated sanitary line and a monitoring cable are located west of the Riverfront Plaza building.**

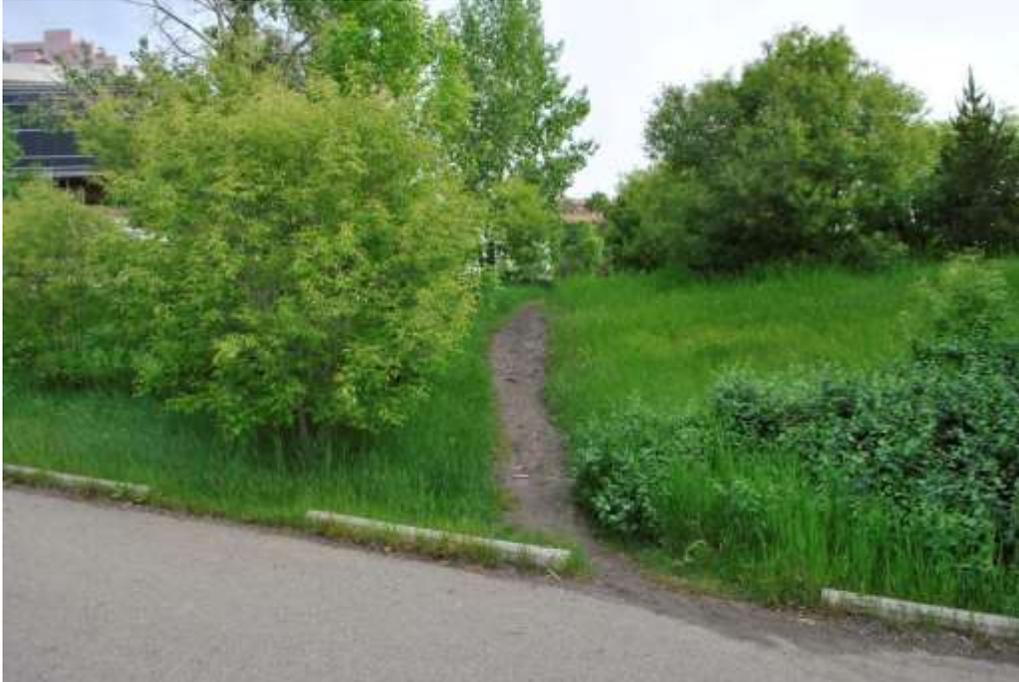
**Plate 4.17. An informal trail that connects to the maintenance access road from the LMRP parking lot, looking north (July 2014).**

- There is potential for construction traffic to pose a safety hazard to members of the public using available shared use routes and where pathways intersect with the vehicle access route (Plates 4.17 and 4.18).
