## **4.0 NORTH VALLEY PRIMARY CONSTRUCTION ACCESS**

**PROPOSED NORTH BANK ACCESS ROAD  
PRELIMINARY GEOTECHNICAL  
INVESTIGATION AND ASSESSMENT**

City of Edmonton LRT Valley Line - Stage 1  
EISA Update

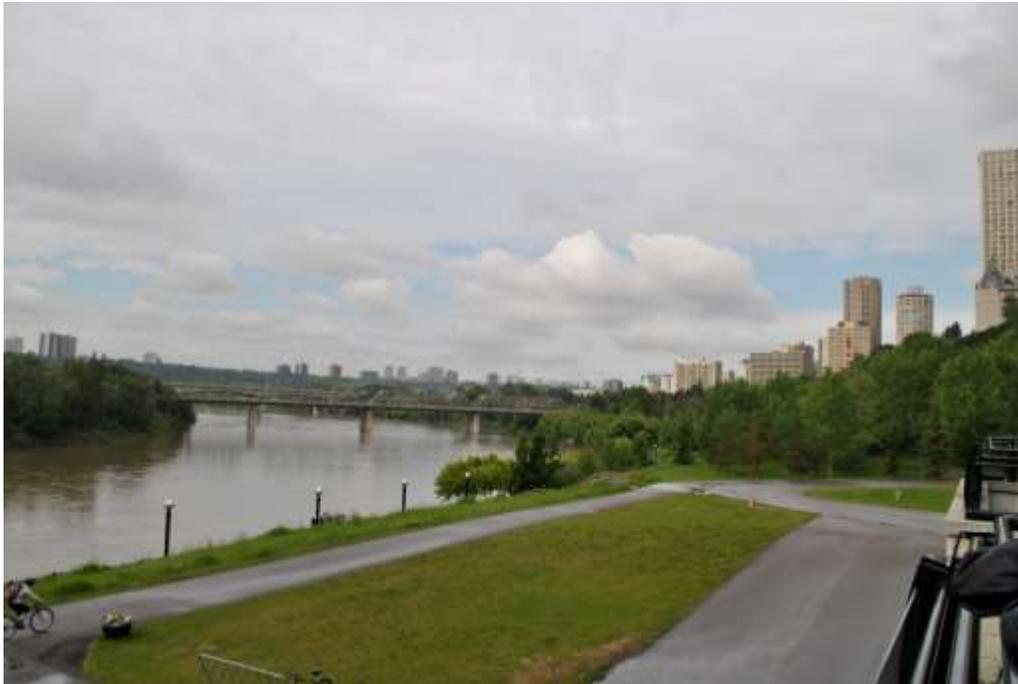
**Plate 4.18. Three pathways (from west, south and east) connect to vehicle maintenance access road (July 2014).**

- There is potential for construction traffic to pose a safety hazard to members of the public using available shared use routes and where pathways intersect with the vehicle access route (Plates 4.17 and 4.18).
