# **SUMMARY REPORT FOR BRINE CORROSION RESEARCH STUDY**

**City of Edmonton**

**Corrpro Canada, Inc.  
Edmonton, AB**

**SUMMARY REPORT**

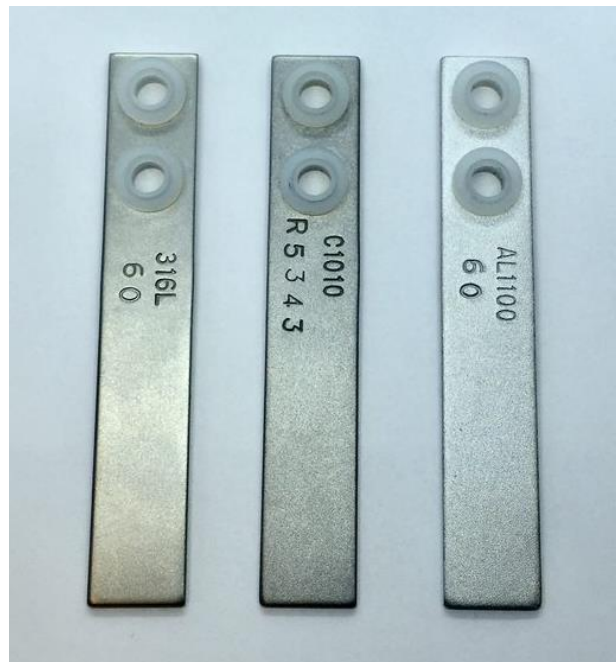
'Figure 2' shows the as-received condition of the field coupons for each metal type. The dimensions of the coupons are 0.5" wide, 3" long, and 0.063" thick.

**Figure 2 - As-Received Field Coupons**

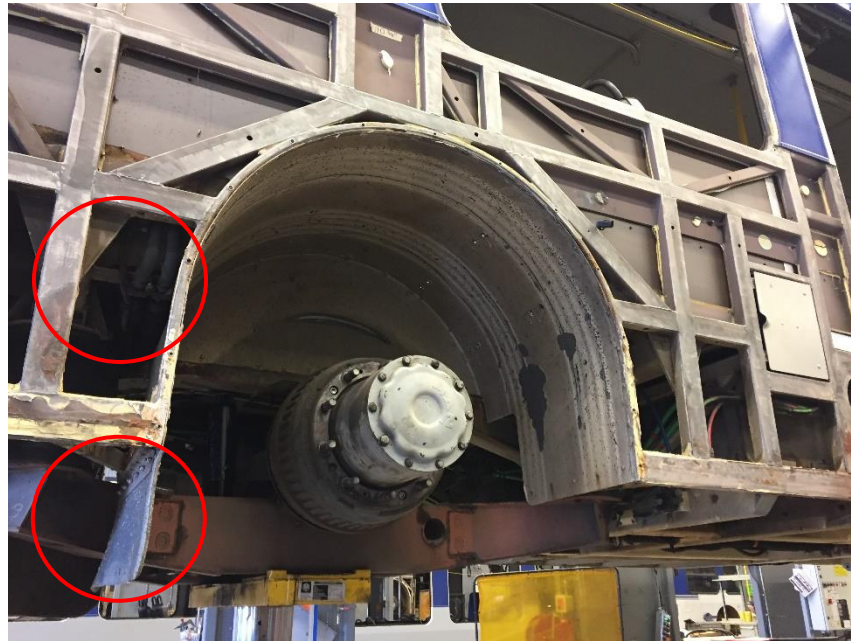
The coupons were installed on buses during the week of February 3 – 9, 2019. Two sets of each metal coupon (six coupons per bus) were mounted onto 12 buses; six City of Edmonton buses and six Spruce Grove buses were used. The Spruce Grove buses were expected to be exposed primarily to the existing program (NaCl salt). The City of Edmonton buses were exposed to the anti-icing pilot program (NaCl salt and inhibited  $\text{CaCl}_2$  brine). The coupons were attached near the rear, curb-side wheel of the buses in the locations indicated (circled) on 'Figure 3'.

**Figure 3 - Coupon Mounting Locations on Buses**

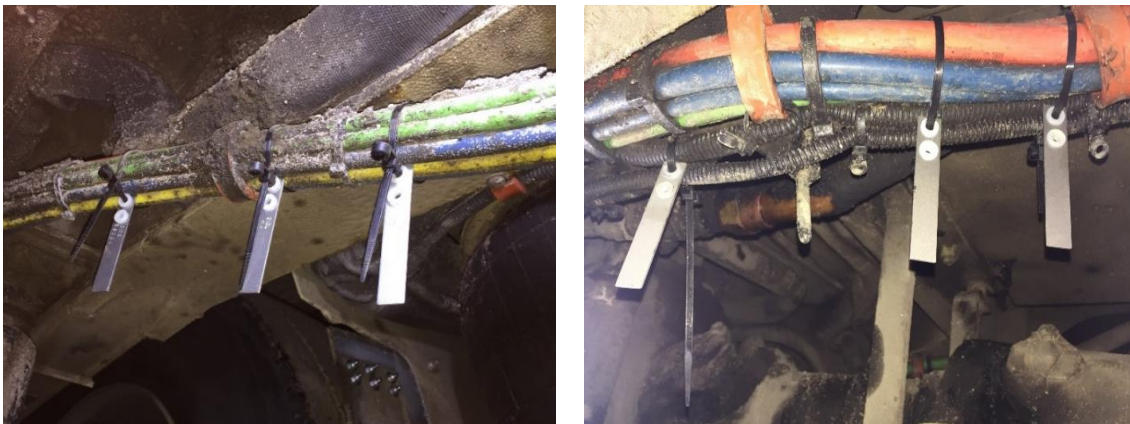
The coupons attached to wiring behind the back curb-side wheel well were secured with heavy duty plastic cable ties. 'Figure 4' shows images of the coupons after they were installed behind the back wheel well.

**Figure 4 - Coupons Mounted Behind the Wheel Well of Buses**

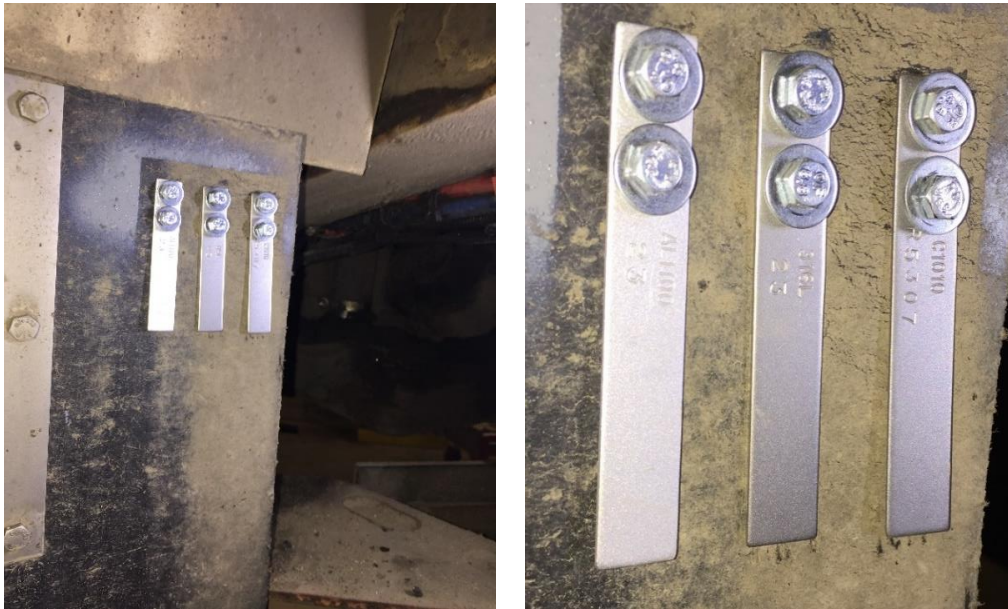
The coupons were also attached to the mud flaps and secured with stainless steel bolts, washers, and lock nuts. Nylon insulators were installed between the coupons and the mounting hardware to eliminate metal-to-metal contact. 'Figure 5' shows the coupons

after they were installed on the mud flaps. The coupons were placed in the upper corner of the mud flap to minimize the chances of damage or loss.

**Figure 5 - Coupons Mounted on Bus Mud Flaps**

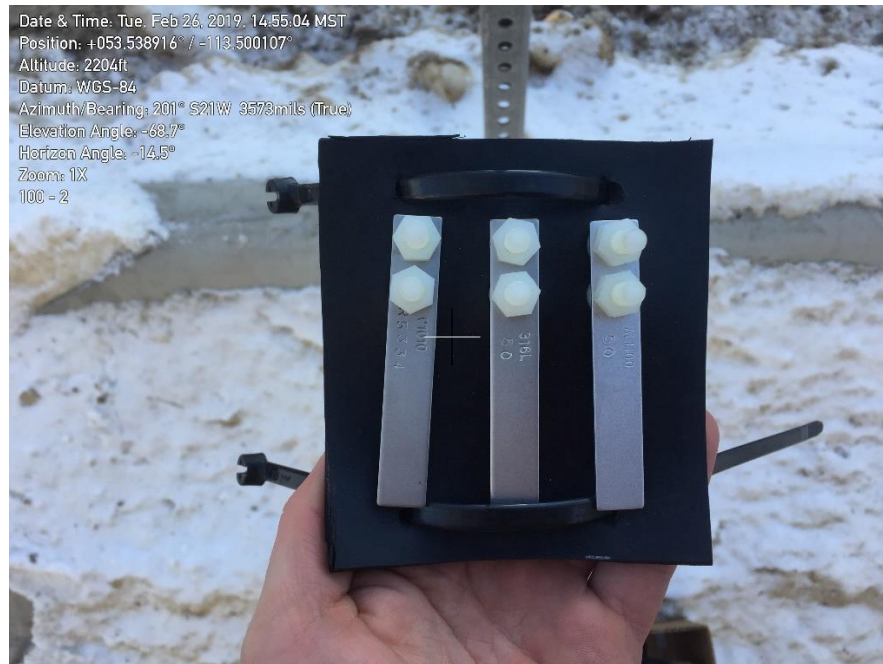
The coupons were mounted to a neoprene sheet with nylon bolts, washers and nuts. Holes were drilled into the neoprene to allow for heavy duty cable ties to secure the apparatus to metal infrastructure. 'Figure 6' and 'Figure 7' show the field coupon mounting apparatus and examples of how they were mounted to various metal infrastructure on the specified routes.

**Figure 6 - Field Coupon Mounting Apparatus**

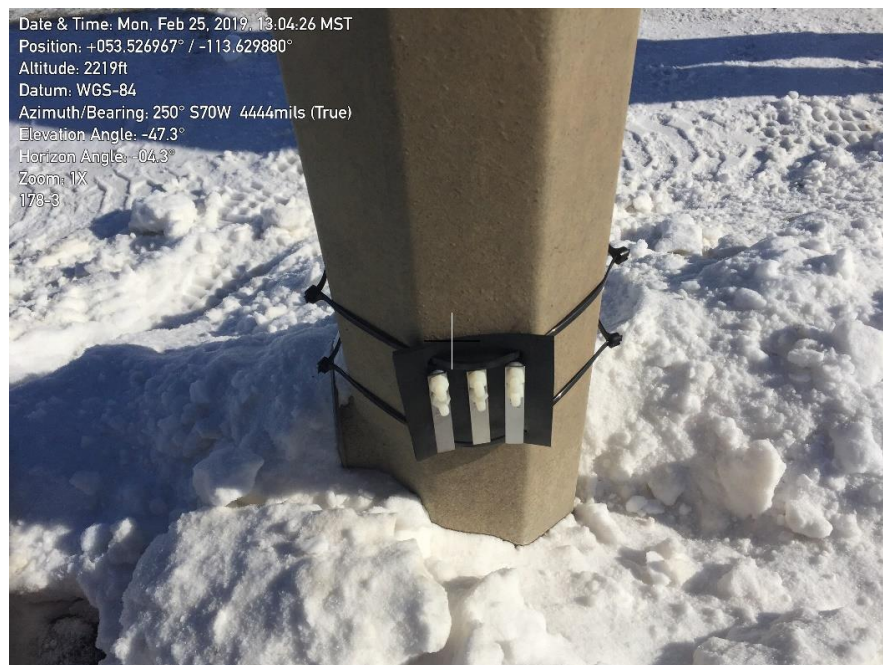
**Figure 7 - Coupon Installed on a Lamp post**

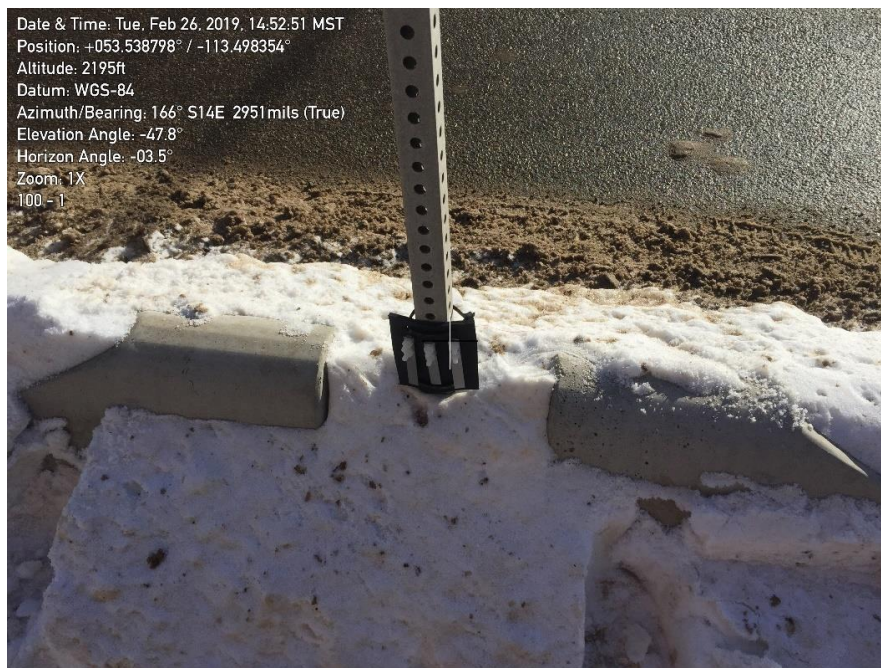
‘Figure 8’ shows an example of how the bicycle-related coupon were installed the bicycle lanes downtown.

**Figure 8 - Coupon Installed on Bicycle Lane Signpost**

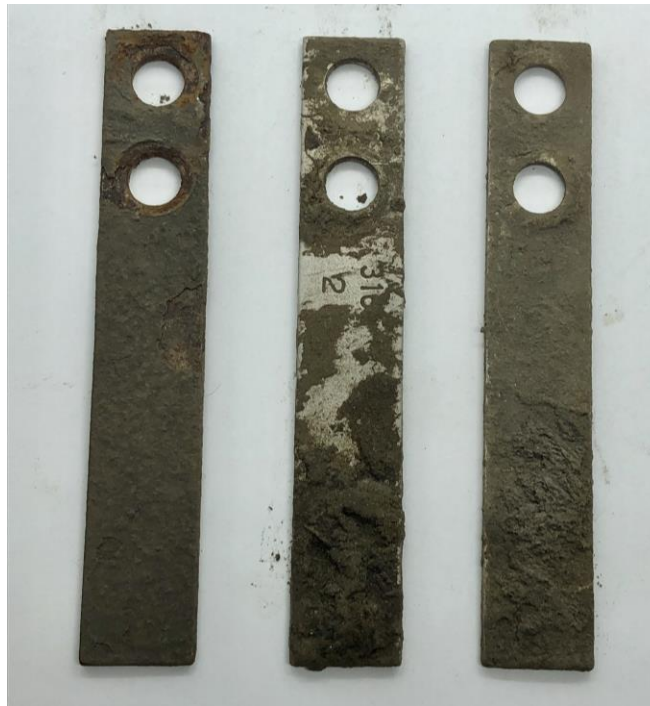
'Figure 10' shows the coupons retrieved from the buses. Visual inspection of corrosion could not be conducted initially because the coupons were completely covered in dirt.

Figure 10 - As-Retrieved Corroded Field Coupons Installed on Buses

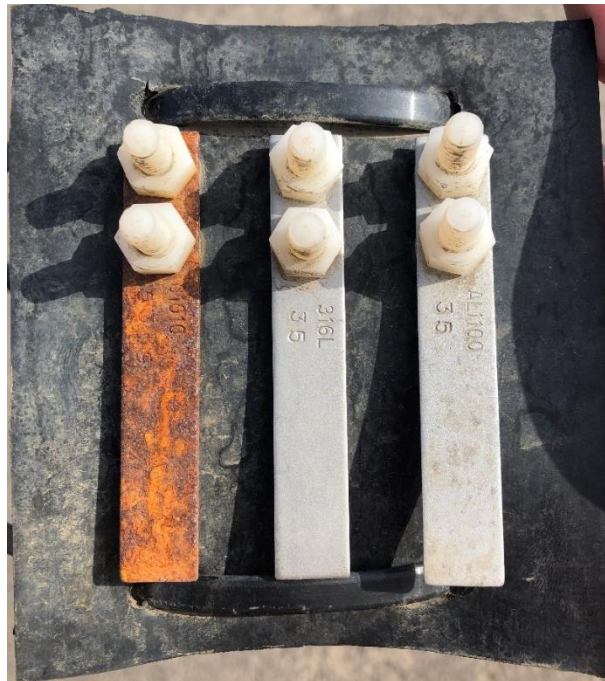
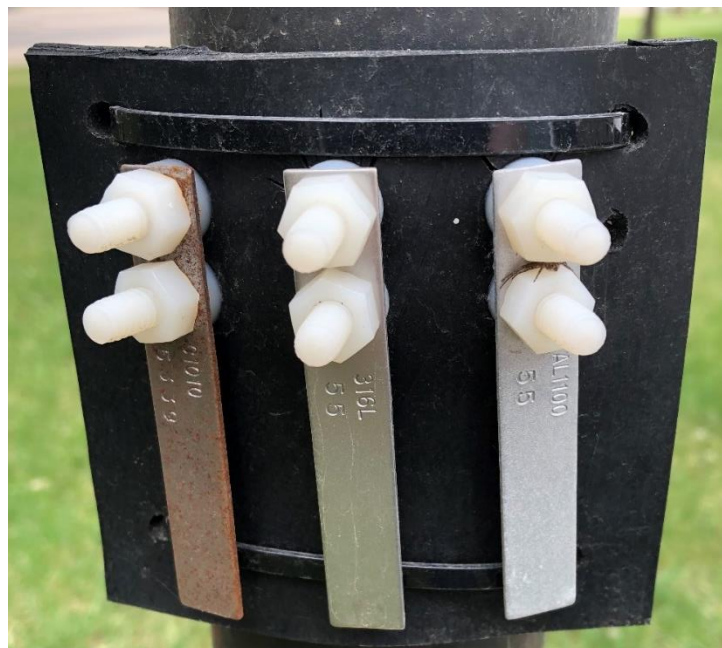
Photos of the as-received field coupons are shown in 'Figure 11', 'Figure 12', and 'Figure 13'. The coupons shown in these photos were installed in areas exposed the existing program, the anti-icing pilot program, and no anti-icing/de-icing chemicals (environmental control test), respectively.

**Figure 11 - Infrastructure-Related Field Coupons Retrieved from 122<sup>nd</sup> Street (Existing Program)**

**Figure 12 - Infrastructure-Related Field Coupons from 178<sup>th</sup> Street (Anti-Icing Pilot Program)**

**Figure 13 - Control Coupons Outside the Corrpro Office (Environmental Control)**

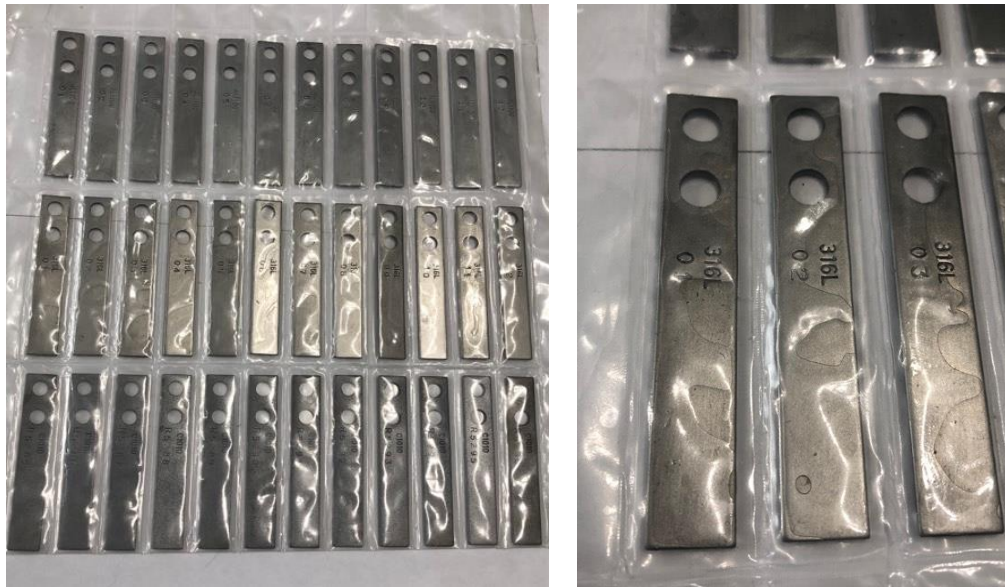
coupons, after cleaning and weighing, the coupons were placed in a paper towel soaked in mineral oil. Then the coupons were packaged in plastic to shield them from the environment. The coupons will have to be cleaned and reweighed before going back out into the field. 'Figure 14' shows the individually packaged coupons after cleaning.

**Figure 14 - Packaged Coupons After Cleaning & Weighing**

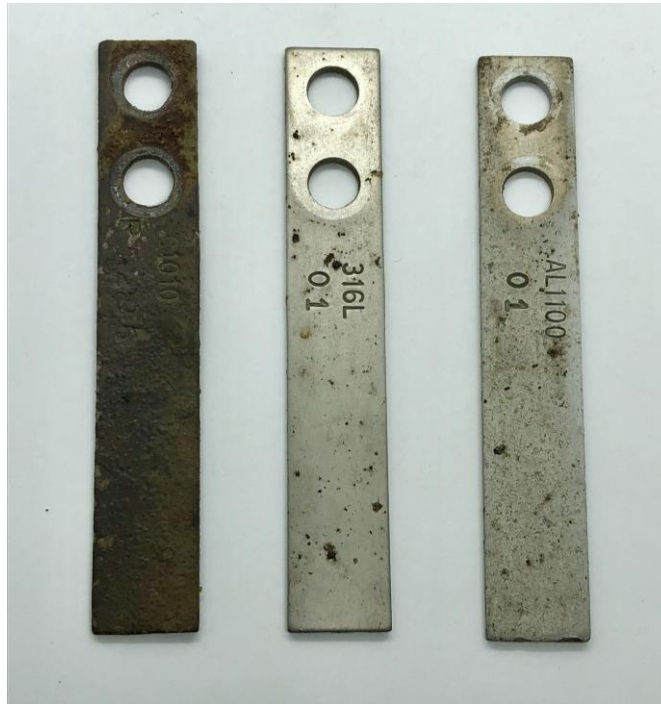
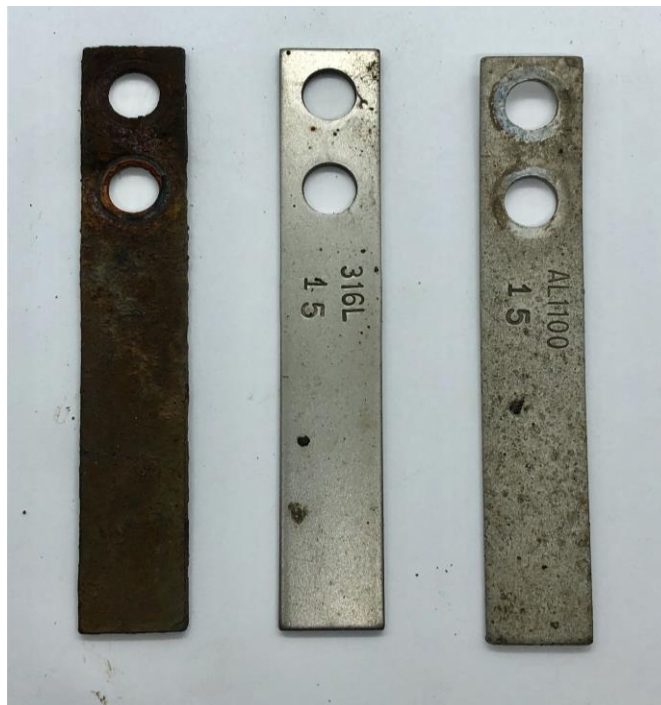
The coupons installed on buses were wiped with a damp cloth to remove some of the dirt before a full cleaning. 'Figure 15' and 'Figure 16' show the lightly cleaned coupons.

Figure 15 - Lightly Cleaned Field Coupons Recovered from Spruce Grove Buses (Existing Program)

Figure 16 - Lightly Cleaned Field Coupons Recovered from City of Edmonton Buses (Anti-Icing Pilot Program)

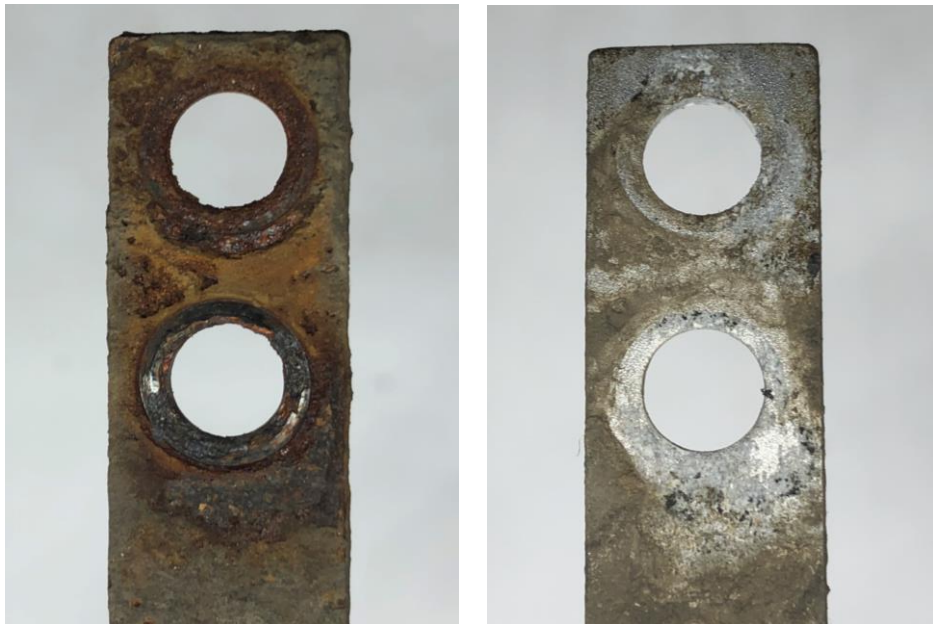
Significant corrosion typically occurred near the holes where the coupons were secured with the bolts. This localized corrosion is likely caused by the crevice between the nylon insulators and the coupon (crevice corrosion). 'Figure 17' shows a closer view of the corrosion near the mounting holes in the coupons.

**Figure 17 - Crevice Corrosion on Field Coupons Installed on Buses (Carbon Steel on Left, Aluminum on Right)**

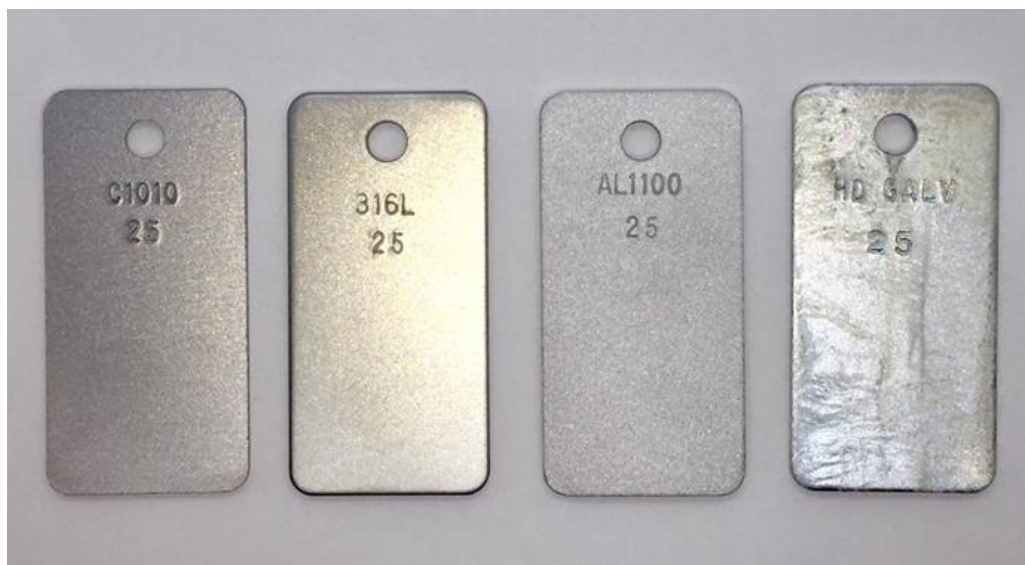
‘Figure 18’ shows the as-received condition of the laboratory coupons for each metal type. The order of the coupons from left to right in the image is carbon steel, stainless steel, aluminum, and galvanized steel.

**Figure 18 - As-Received Laboratory Coupons**

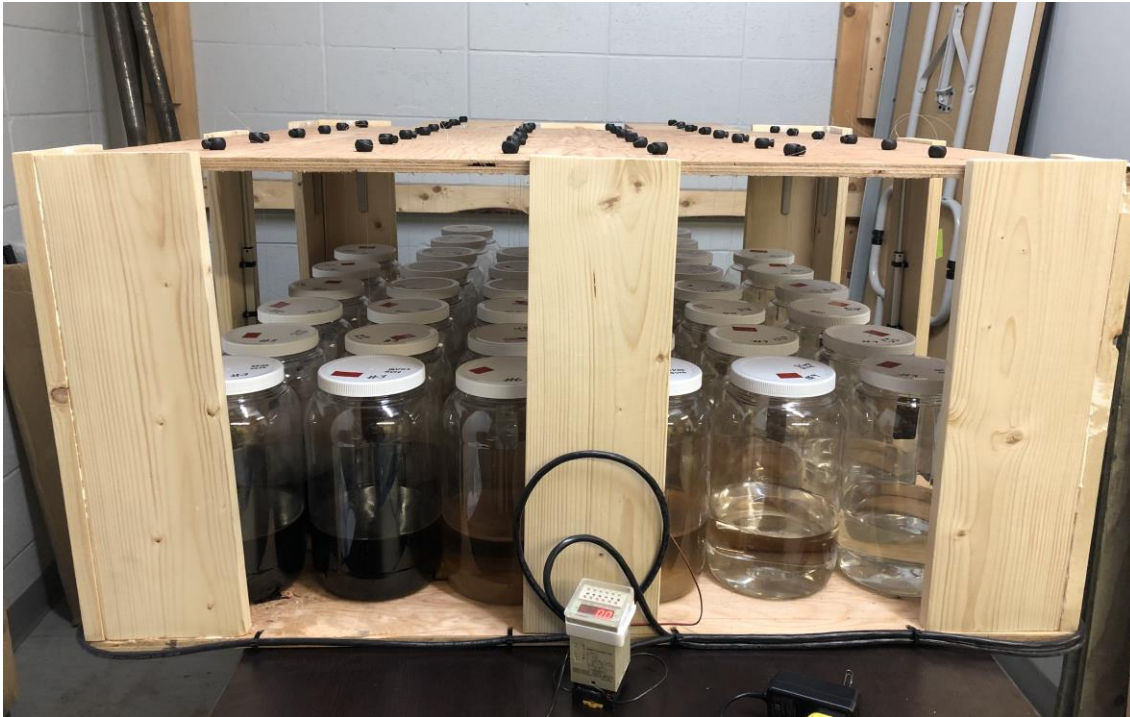
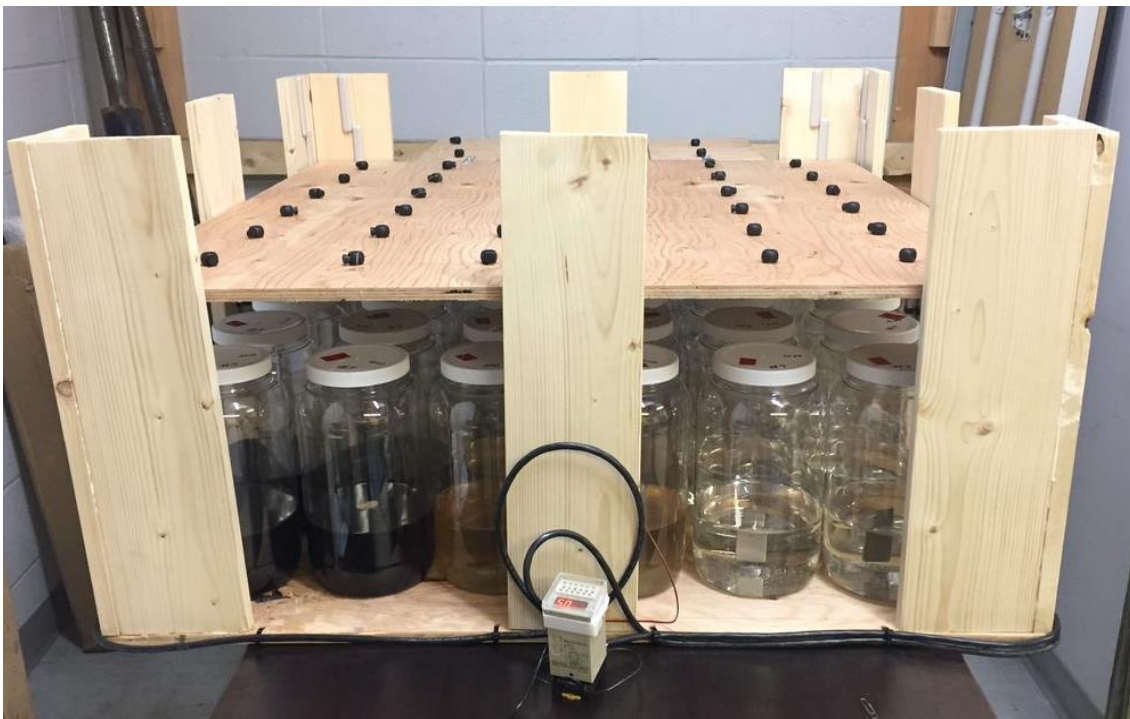
The experimental set up of this testing is based on NACE TM0169 and is shown in ‘Figure 19’ and ‘Figure 20’.

**Figure 19 – Side View of the Laboratory Setup (Coupons Out of Solution)**

**Figure 20 – Side View of the Laboratory Setup (Coupons Immersed in Solution)**

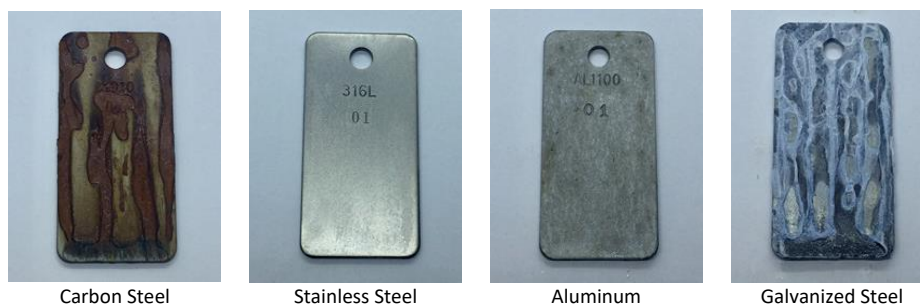
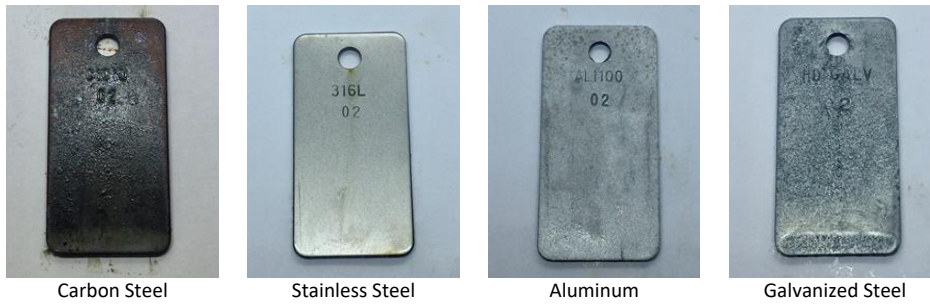
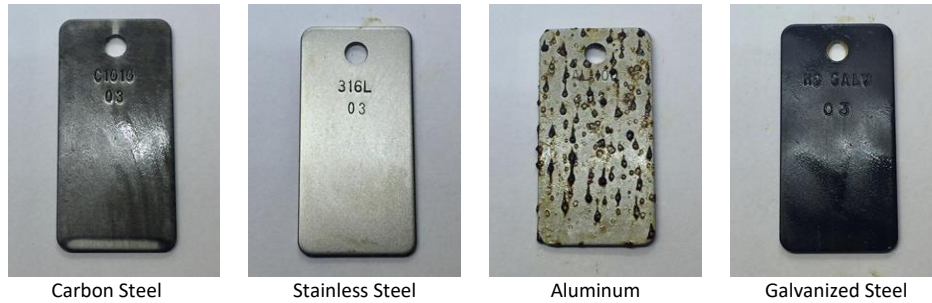
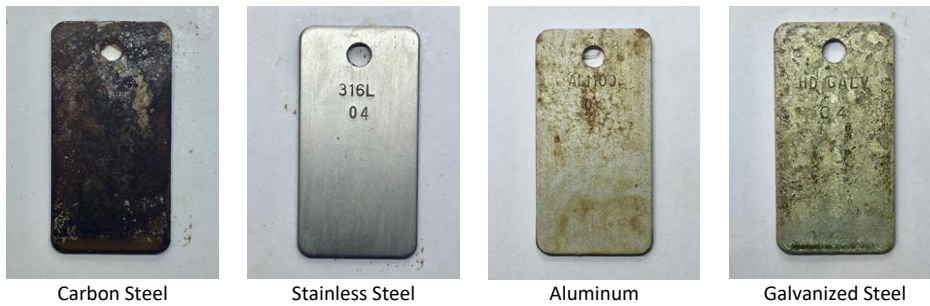
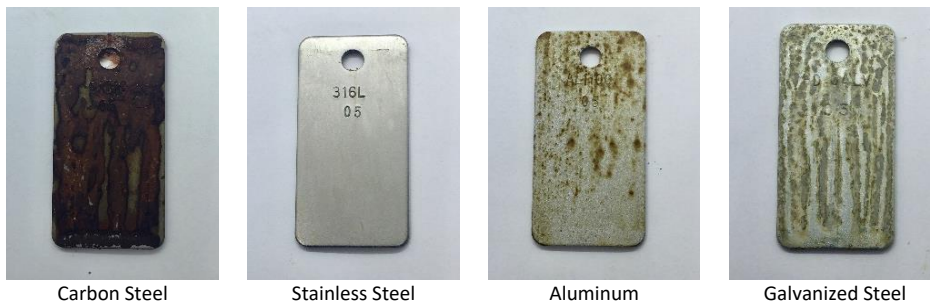
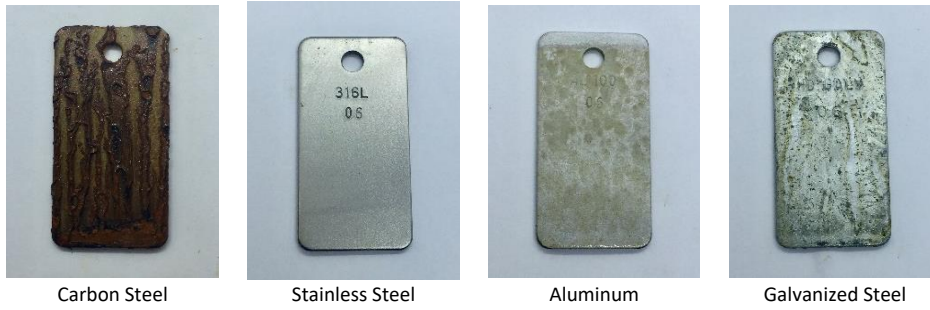
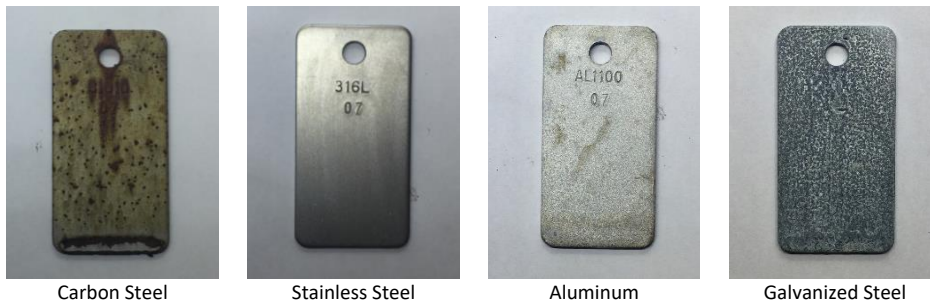
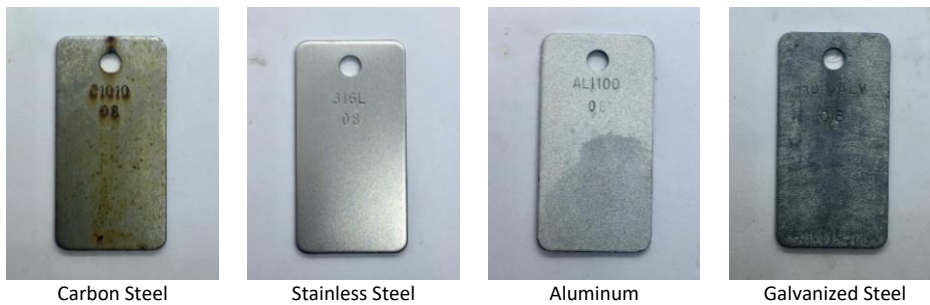
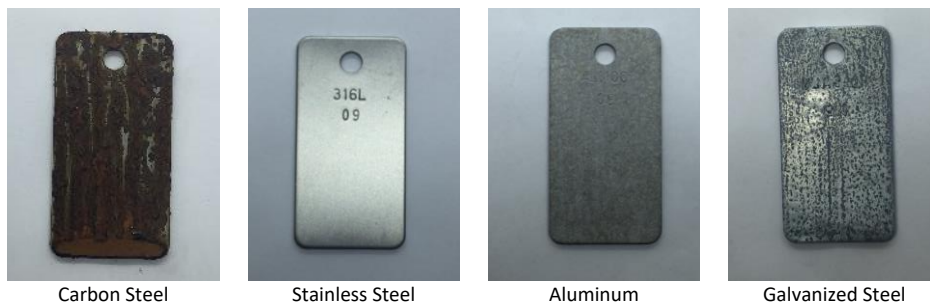
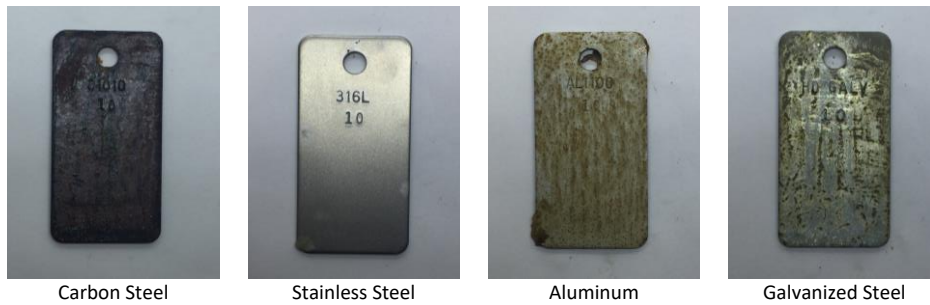
The standard version of the NACE test had a total test duration of 72 hours. 'Figure 21' to 'Figure 30' show pictures of the corroded coupons after the 72-hour test. The order of the coupons from left to right in each image is carbon steel, stainless steel, aluminum, and galvanized steel.

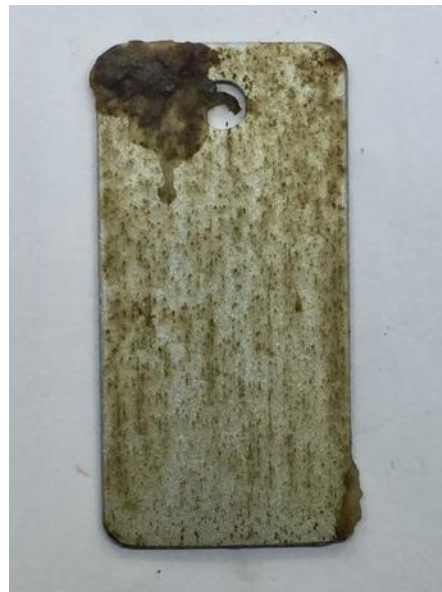
Biological product appeared in the solutions containing the inhibited  $\text{CaCl}_2$  brine, particularly in diluted and inhibited  $\text{CaCl}_2$  brine (solution 10), as shown in ‘Figure 31’. There was some biological product buildup observed on a number of coupons immersed in solution 10, as shown in ‘Figure 32’. The presence of the biological product could influence the corrosion rate of the coupons, though the exact impact on the test results is unknown.

**Figure 31 - Biological Products Appearing in Inhibited  $\text{CaCl}_2$  Solutions**

**Figure 32 - Biological Buildup on Coupons in Inhibited  $\text{CaCl}_2$  Brine Solutions**

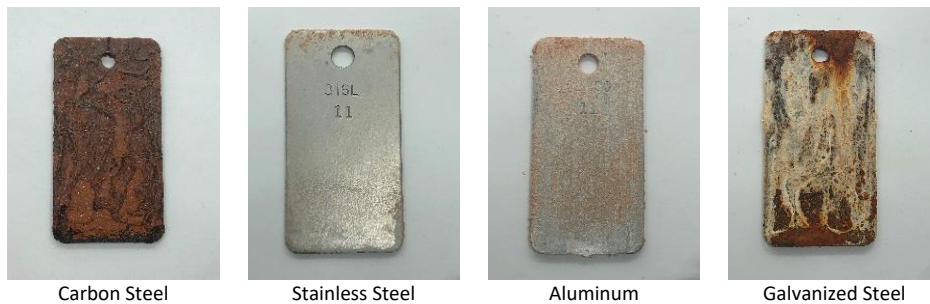
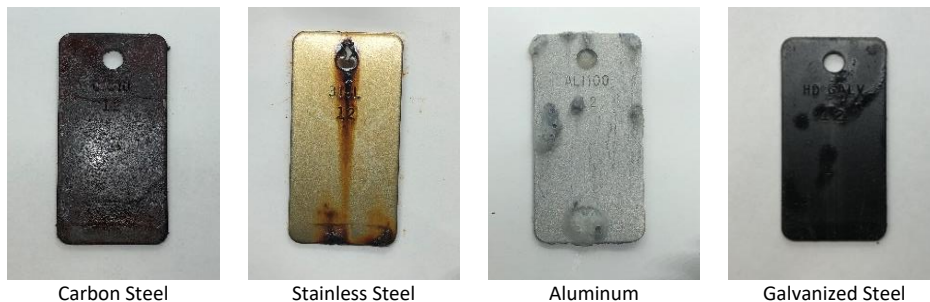
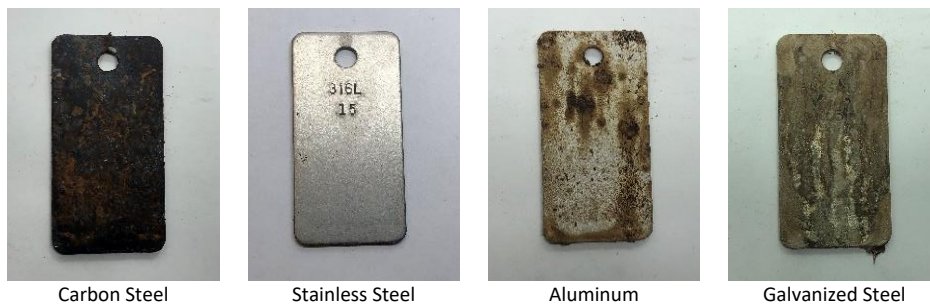
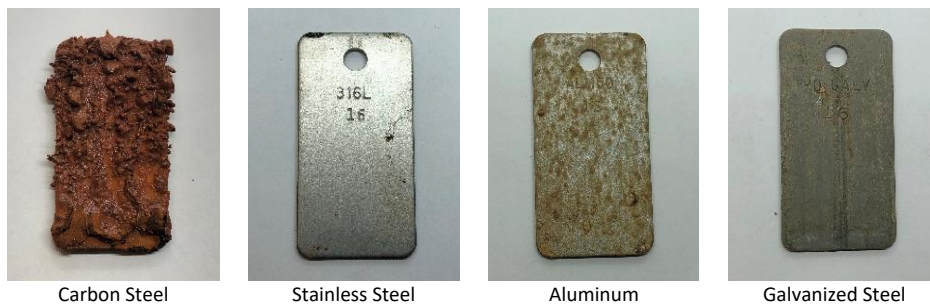
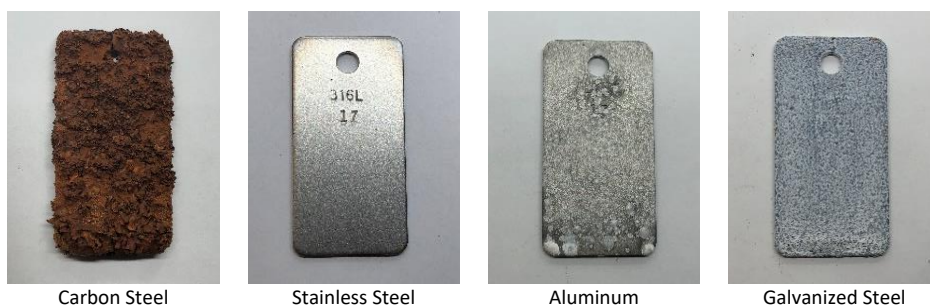
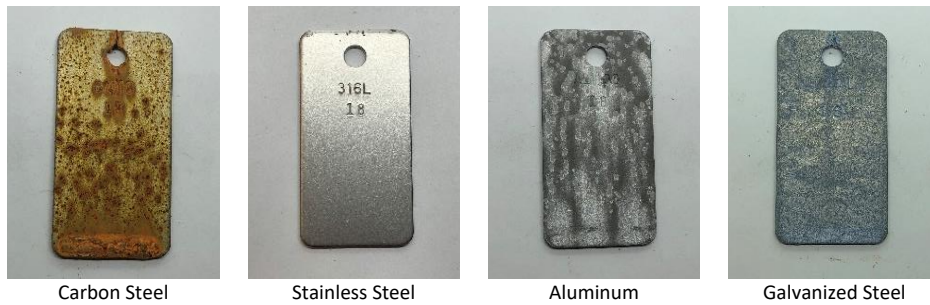
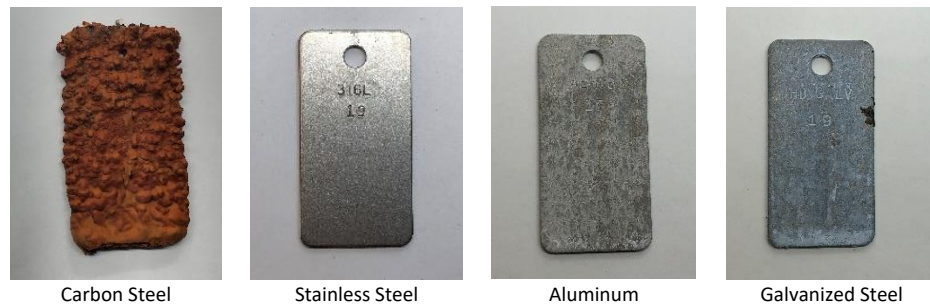
A modified test was completed based on the NACE TM0169 with an extended test duration. The modified laboratory test was concluded on June 13, 2019. The modified version of the NACE test had a total test duration of 69 days, or 1656 hours. 'Figure 33' to 'Figure 42' show pictures of the corroded coupons after the modified test. The order of the coupons from left to right in each image is carbon steel, stainless steel, aluminum, and galvanized steel.

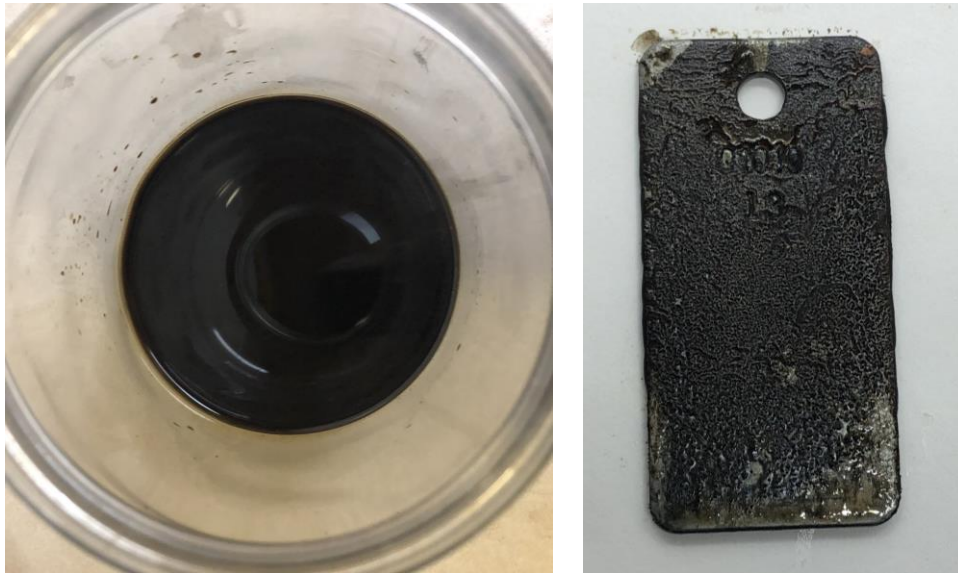
The as-received inhibited  $\text{CaCl}_2$  brine (solution 3) did not form a film of biological products on the surface of the solution; however, a black slime-like corrosion product or biological product formed on all coupons exposed to inhibited  $\text{CaCl}_2$  brine. The smell of degradation was also apparent on the as-received inhibited  $\text{CaCl}_2$  brine (solution 3).

**Figure 46 - Effect of As-Received Inhibited  $\text{CaCl}_2$  Brine (Solution 3) on Carbon Steel**

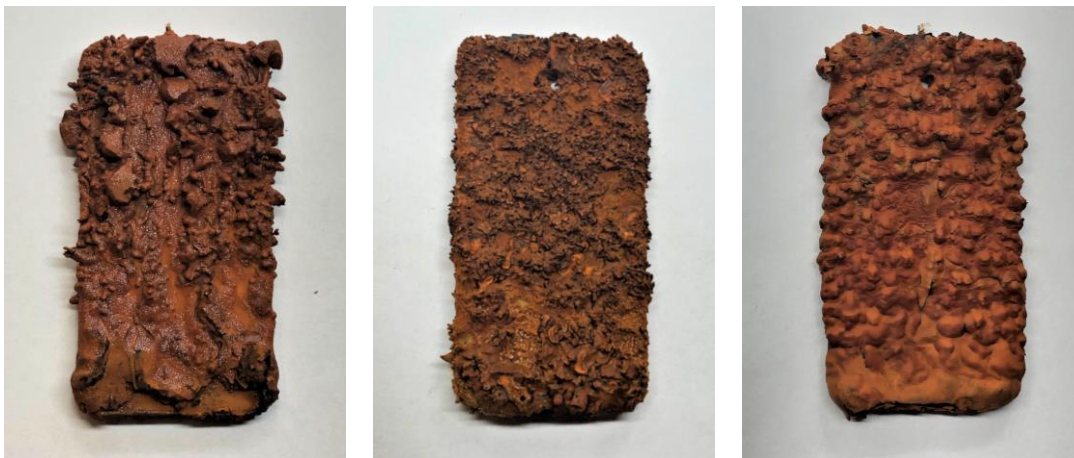
The most corrosive solutions to carbon steel were solution 6, 7, and 9. These solutions had significant mass loss, approximately 3.00 g of metal loss compared to the next highest of approximately 0.6 g. From initial visual inspection of these coupons, all the coupons from these coupons formed a thick orange-black layer of iron oxide over the coupons. The formation of the thick layer of corrosion product likely resulted in concentration cells all over the coupon creating anodic regions where metal loss would favourably occur. 'Figure 48' shows the formation of iron oxide on the carbon steel coupons.

**Figure 48 - Corroded Carbon Steel Coupons (From Left to Right: Solution 6, 7, and 9)**

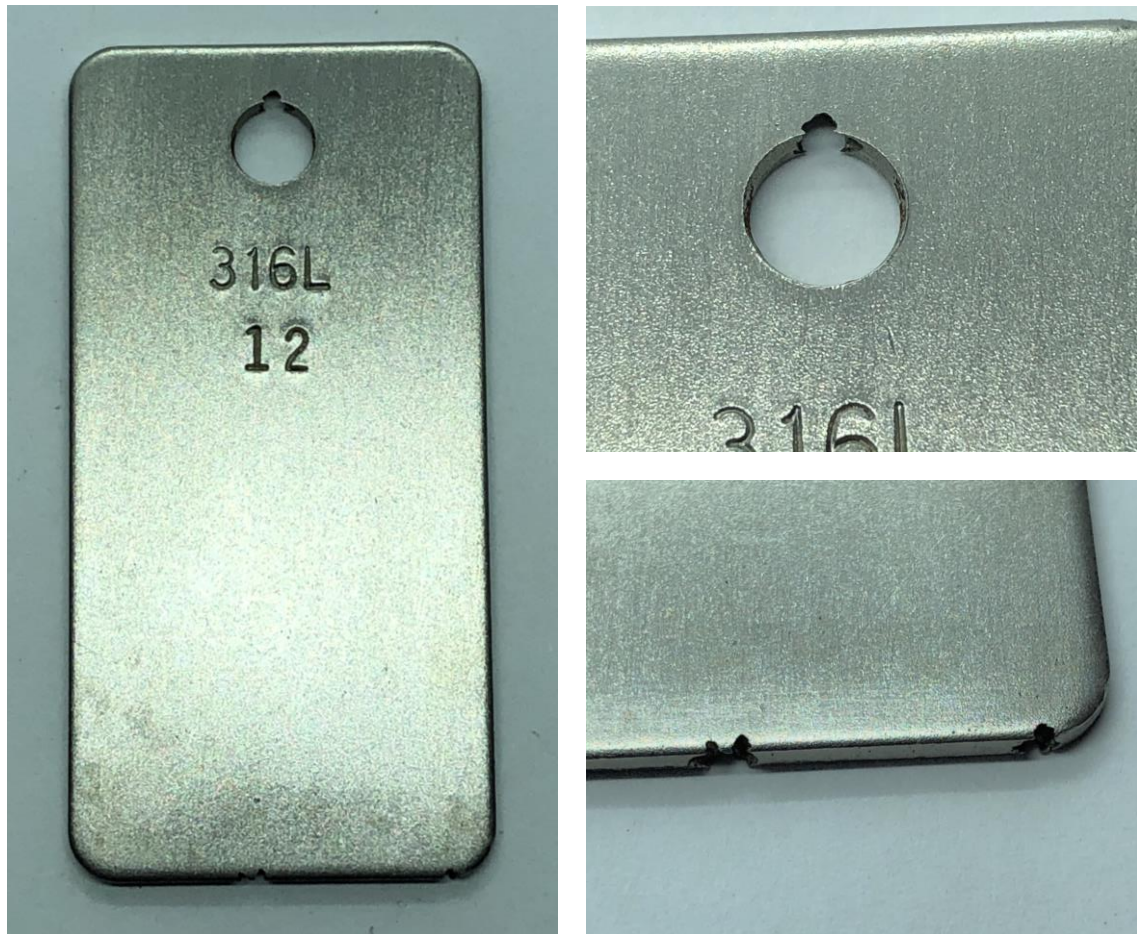
The stainless steel coupons did not seem to be affected by the anti-icing/de-icing chemicals at all, except for solution 2. The coupon exposed to the uninhibited as-received  $\text{CaCl}_2$  brine had three severe pits near the bottom of the coupon and where the fishing line was secured to the mounting hole. Observations during testing showed that the solutions would pool at the bottom of the coupons while they were out of the solution. Solution would also get trapped in the crevice between the fishing line and the mounting hole. This would increase the exposure time of the coupons to their respective solutions. ‘Figure 51’ shows the pits observed on the stainless steel coupon exposed to uninhibited  $\text{CaCl}_2$  brine.

**Figure 51 - Stainless Steel Coupon Exposed to  $\text{CaCl}_2$  Brine**

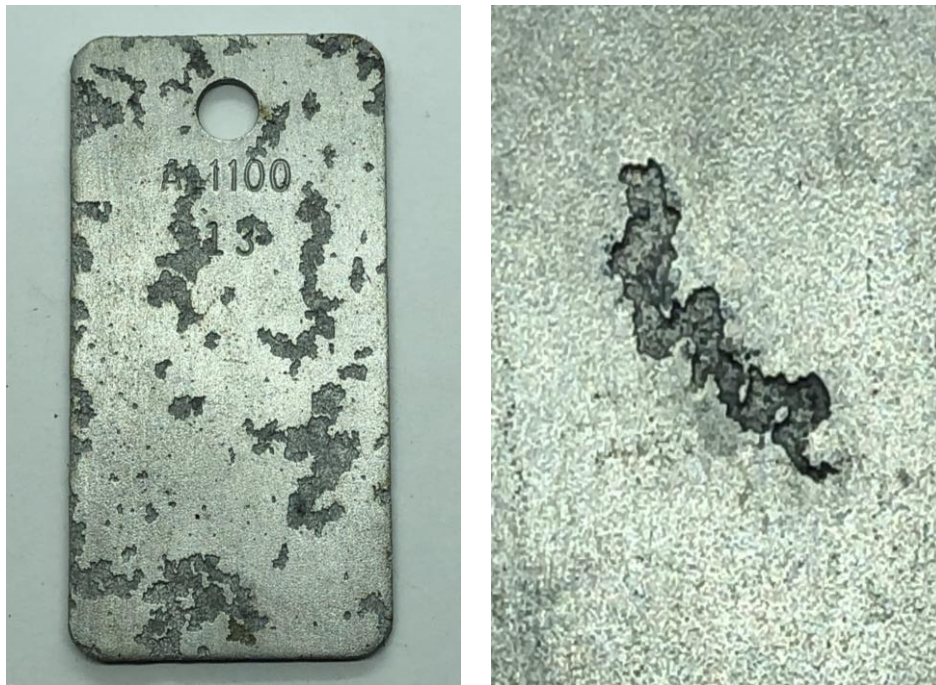
Corrosion was observed on all of the aluminum coupons; however, the amount of corrosion was relatively small when compared to the corrosion observed on the carbon steel and galvanized steel coupons. The only corrosion observed on the coupons was due to the expected pitting corrosion mechanism (shown in 'Figure 53').

**Figure 53 - Pitting Corrosion on Aluminum Coupons**

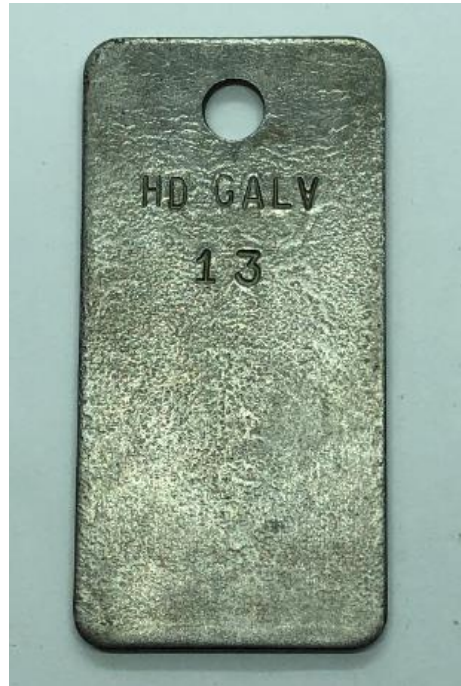
Additionally, after the corrosion products were cleaned off degradation of the carbon steel base metal was seen, shown in 'Figure 55'.

**Figure 55 - Zinc Coating Entirely Consumed from Inhibited  $\text{CaCl}_2$  Brine (Solution 3)**

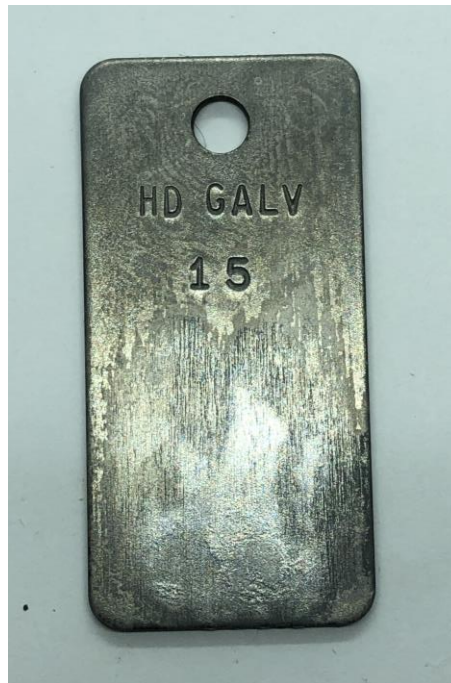
On all other coupons, the zinc protective coating was still partially intact. In some of the coupons, the break-down of the zinc coating can visibly be seen (shown in 'Figure 56'). The zinc coating is still intact at the top of the coupon but the bottom the coating has broken down. This shows that applying a zinc coating on carbon steel can be an effective way a preventing corrosion of the base metal. However, the coating may need to be reapplied after a period of time.

**Figure 56 - Zinc Coating Break-down on Galvanized Steel Coupons**
