## EXISTING SITE REVIEW

Based on several site visits and interviews with site stakeholders in the fall of 2006 and in the spring and summer of 2007, this section summarizes information about the current conditions at the site.

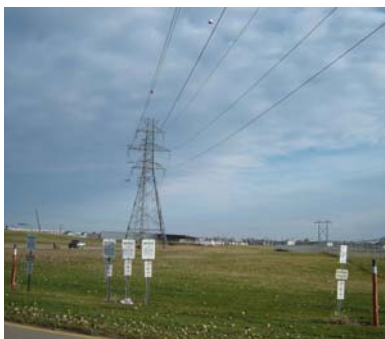
A major underground pipeline utility corridor traverses the site from the southwest to the northeast and a major Altalink power line corridor runs from west to east across the centre of the site. All utility companies restrict development on their right of ways. Plan approval and crossing permits are required from each before any development can occur on or adjacent to their right of ways. Crossing agreements are required within one year of construction of any improvements on or within 30m of a right of way. All utility companies have been provided with copies of the master plan.

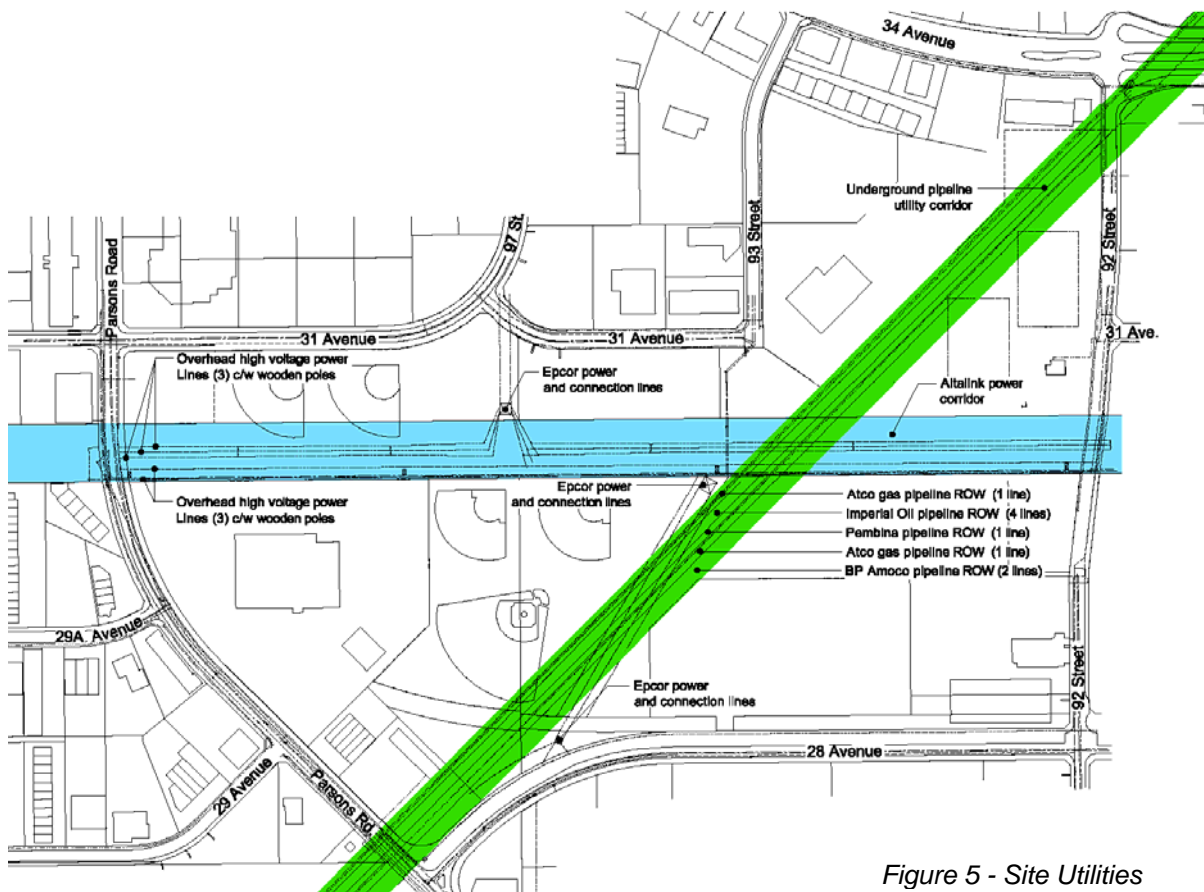
Figure 5 - Site Utilities

**AltaLink** has several overhead high voltage power lines crossing the site. A series of wooden power poles carry lines along the north edge of their R.O.W. and large metal towers carry lines along the south edge.

**Epcor** also has two power towers which connect to the AltaLink power lines

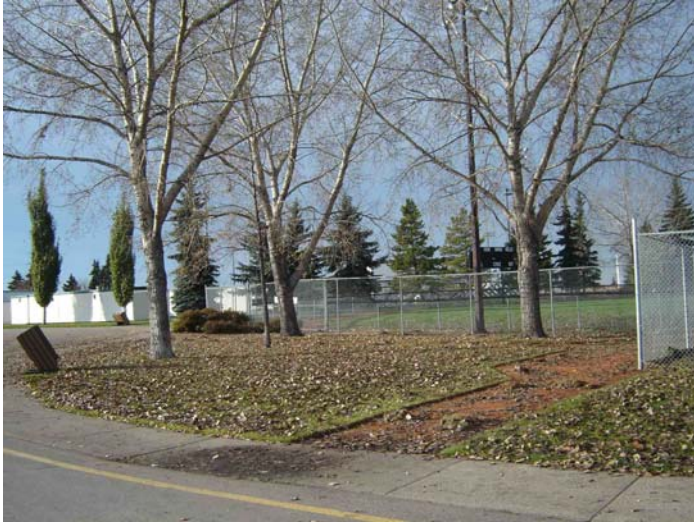
Landscaping of the site was completed with the original ball diamond development and there are many mature trees in the west half of the site and surrounding the ball diamonds. More recent development of the site, however, has not included a landscape component and overall, the site is deficient in landscaping. Currently there are approximately 155 trees on site. The City of Edmonton parks standard planting rate for park development is 70 trees per plantable hectare. With this standard, the total tree requirement

would be 877 trees, implying a shortage of 722 trees. Landscape enhancements are a key component of the upgrading proposals for the park.

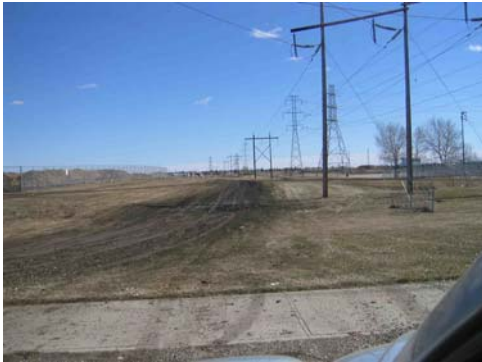
In the past, movable concrete curbs restricted vehicles to the parking areas and designated roads; these have been recently removed and unauthorized traffic throughout the park has become an issue. People often drive between the north and south parking lots across the grass, and drive onto the Altalink ROW, accessing it from both the north parking lot and from the rugby parking lot. The Master Plan provides recommendations to improve efficiency and to provide control for unauthorized vehicular traffic on site.
