**City of Edmonton**  
**Valley Line Stage 1 – Light Rail Transit (LRT) Project**  
**Environmental Impact Screening Assessment Update**  
**Final Report**

Project Number EP - 576

February 2015

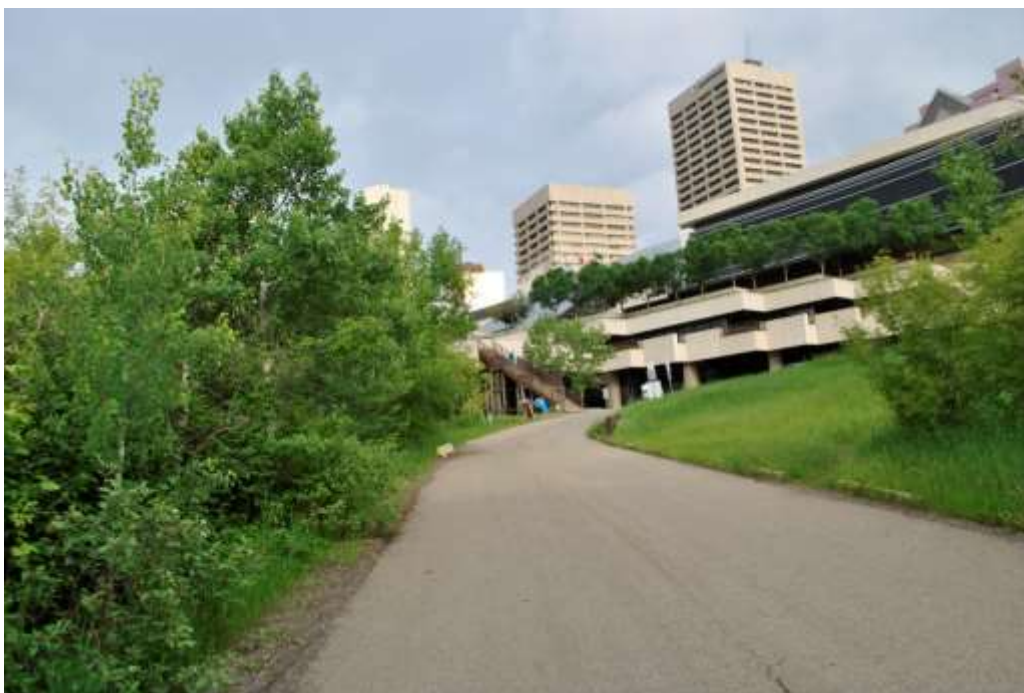
**Plate 2.1. Segment of proposed Louise McKinney Riverfront Park Construction Access Road using existing maintenance road, looking northeast.**

The proposed primary north valley construction access route enters LMRP from Grierson Hill Road near the Shaw Conference Centre, at the park main vehicle access point (Plate 2.1). From there, the access road travels southeast along the existing paved maintenance vehicle access, to the Riverfront Plaza, and then ties into an existing paved SUP (Figure 2.1b; Plate 2.2). The entire route follows existing asphalt, of variable width. Project Co will be required to design and construct the access road to the standard needed to carry out the work safely and without adversely affecting slope stability in the park. Based on the anticipated types of required construction equipment and the anticipated volume of traffic, Project Co is expected to upgrade the existing route. At a minimum, this is expected to involve some re-grading along the SUP to create a road base, and some preparatory work to assure a stable base. The road will have to accommodate two-way construction traffic and must fit within the corridor shown on Figure 2.1b. Temporary fencing may be installed to ensure safe separation of the route from public areas. The tight curves and narrow width of the existing access road from Grierson Hill to the Riverfront Plaza may be unable to accommodate large construction equipment. Thus, at this stage the City has not ruled out the need for Project Co to widen that route, which may require some clearing into adjacent natural vegetation.

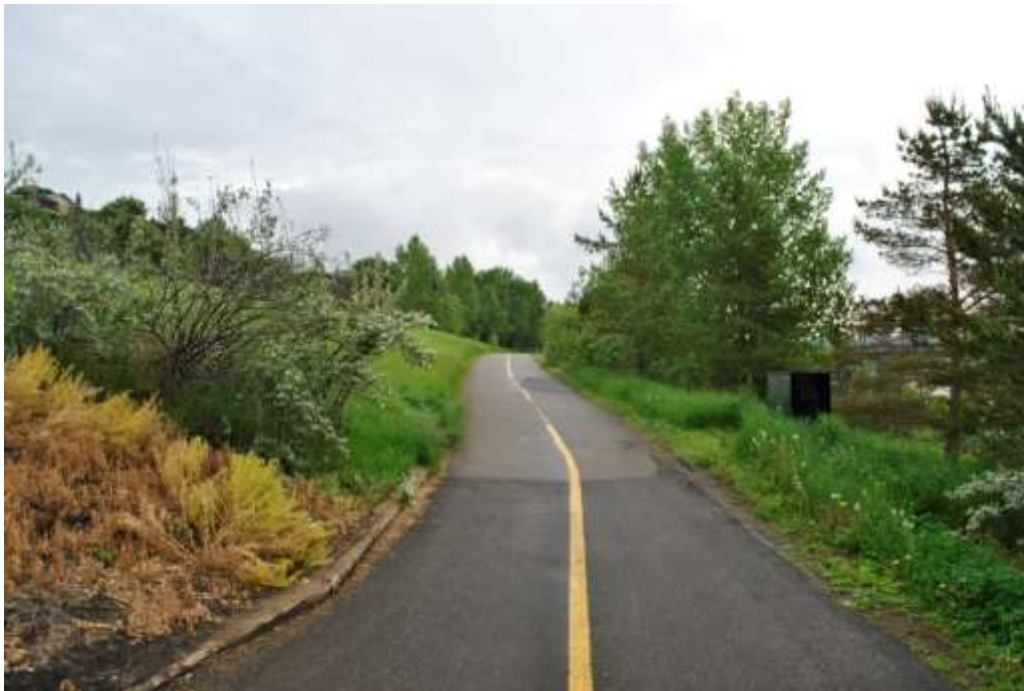
**Plate 2.2: Trans Canada SUP to be used as Primary construction Access Route in LMRP.**

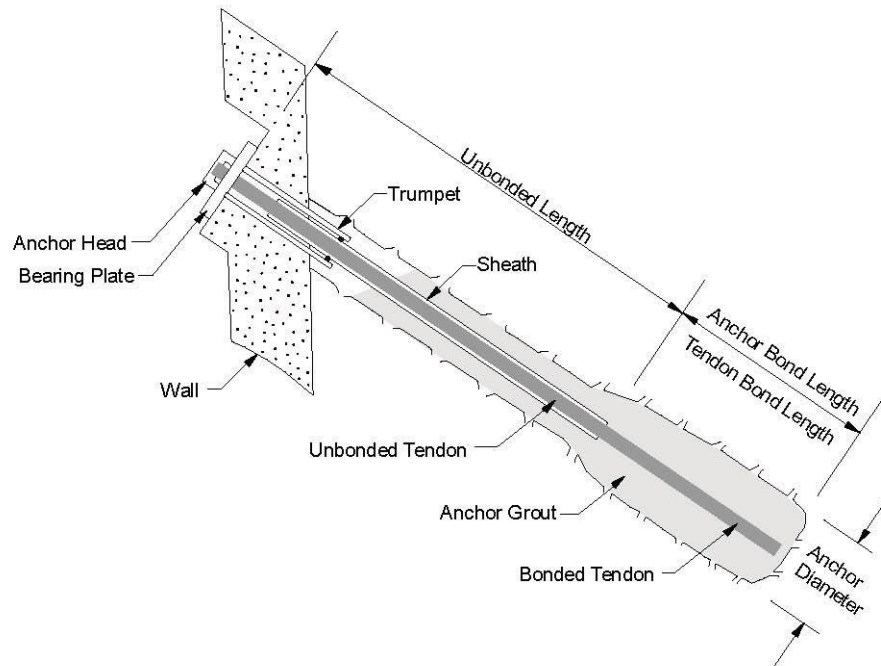
Figure 1 – Main Components of a ground anchor (FHWA, 1999)

Construction of a ground anchor involves the insertion of high strength steel element (bar or stand) into a predrilled hole that extends a certain design distance behind the excavation face. The hole is subsequently filled with cement grout (usually under pressure) and the steel member pre-tensioned. The pre-stressing force is transmitted to the retaining structure at the cut face via an anchorage system. Figure 2.3a shows a schematic diagram of the main components of a typical ground anchor. Figure 2.3b illustrates the construction sequence of one type of anchored retaining wall systems, namely, soldier piles and lagging.

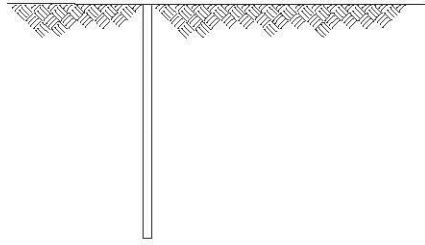
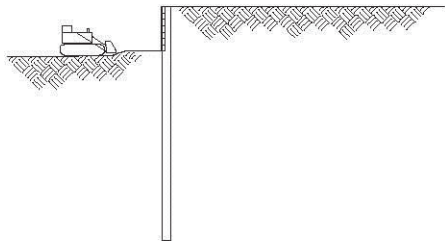
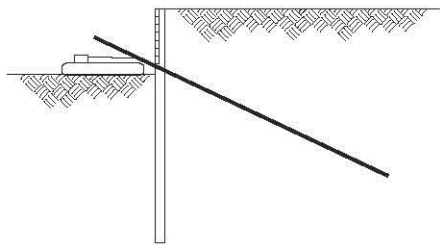
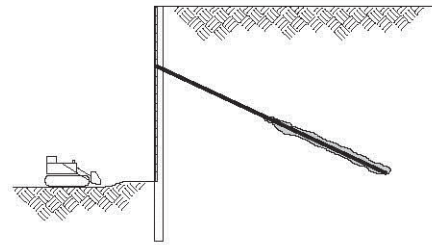
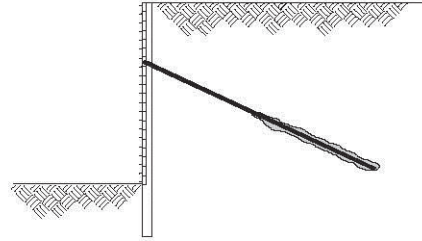
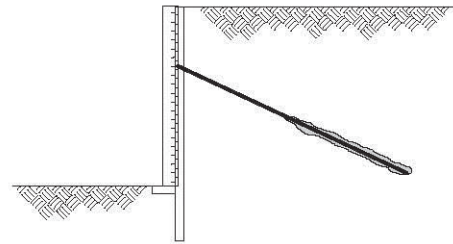
Figure 2.3b

**STEP 1: Install soldier beam**

**STEP 4: Complete excavation**

**STEP 2: Excavate and install lagging**

**STEP 5: Install headed studs and prefabricated drainage**

**STEP 3: Install and test ground anchor**

**STEP 6: Pour cast-in-place facing**

Figure 2 – Construction sequence for permanent soldier beam and lagging wall (FHWA, 1999)

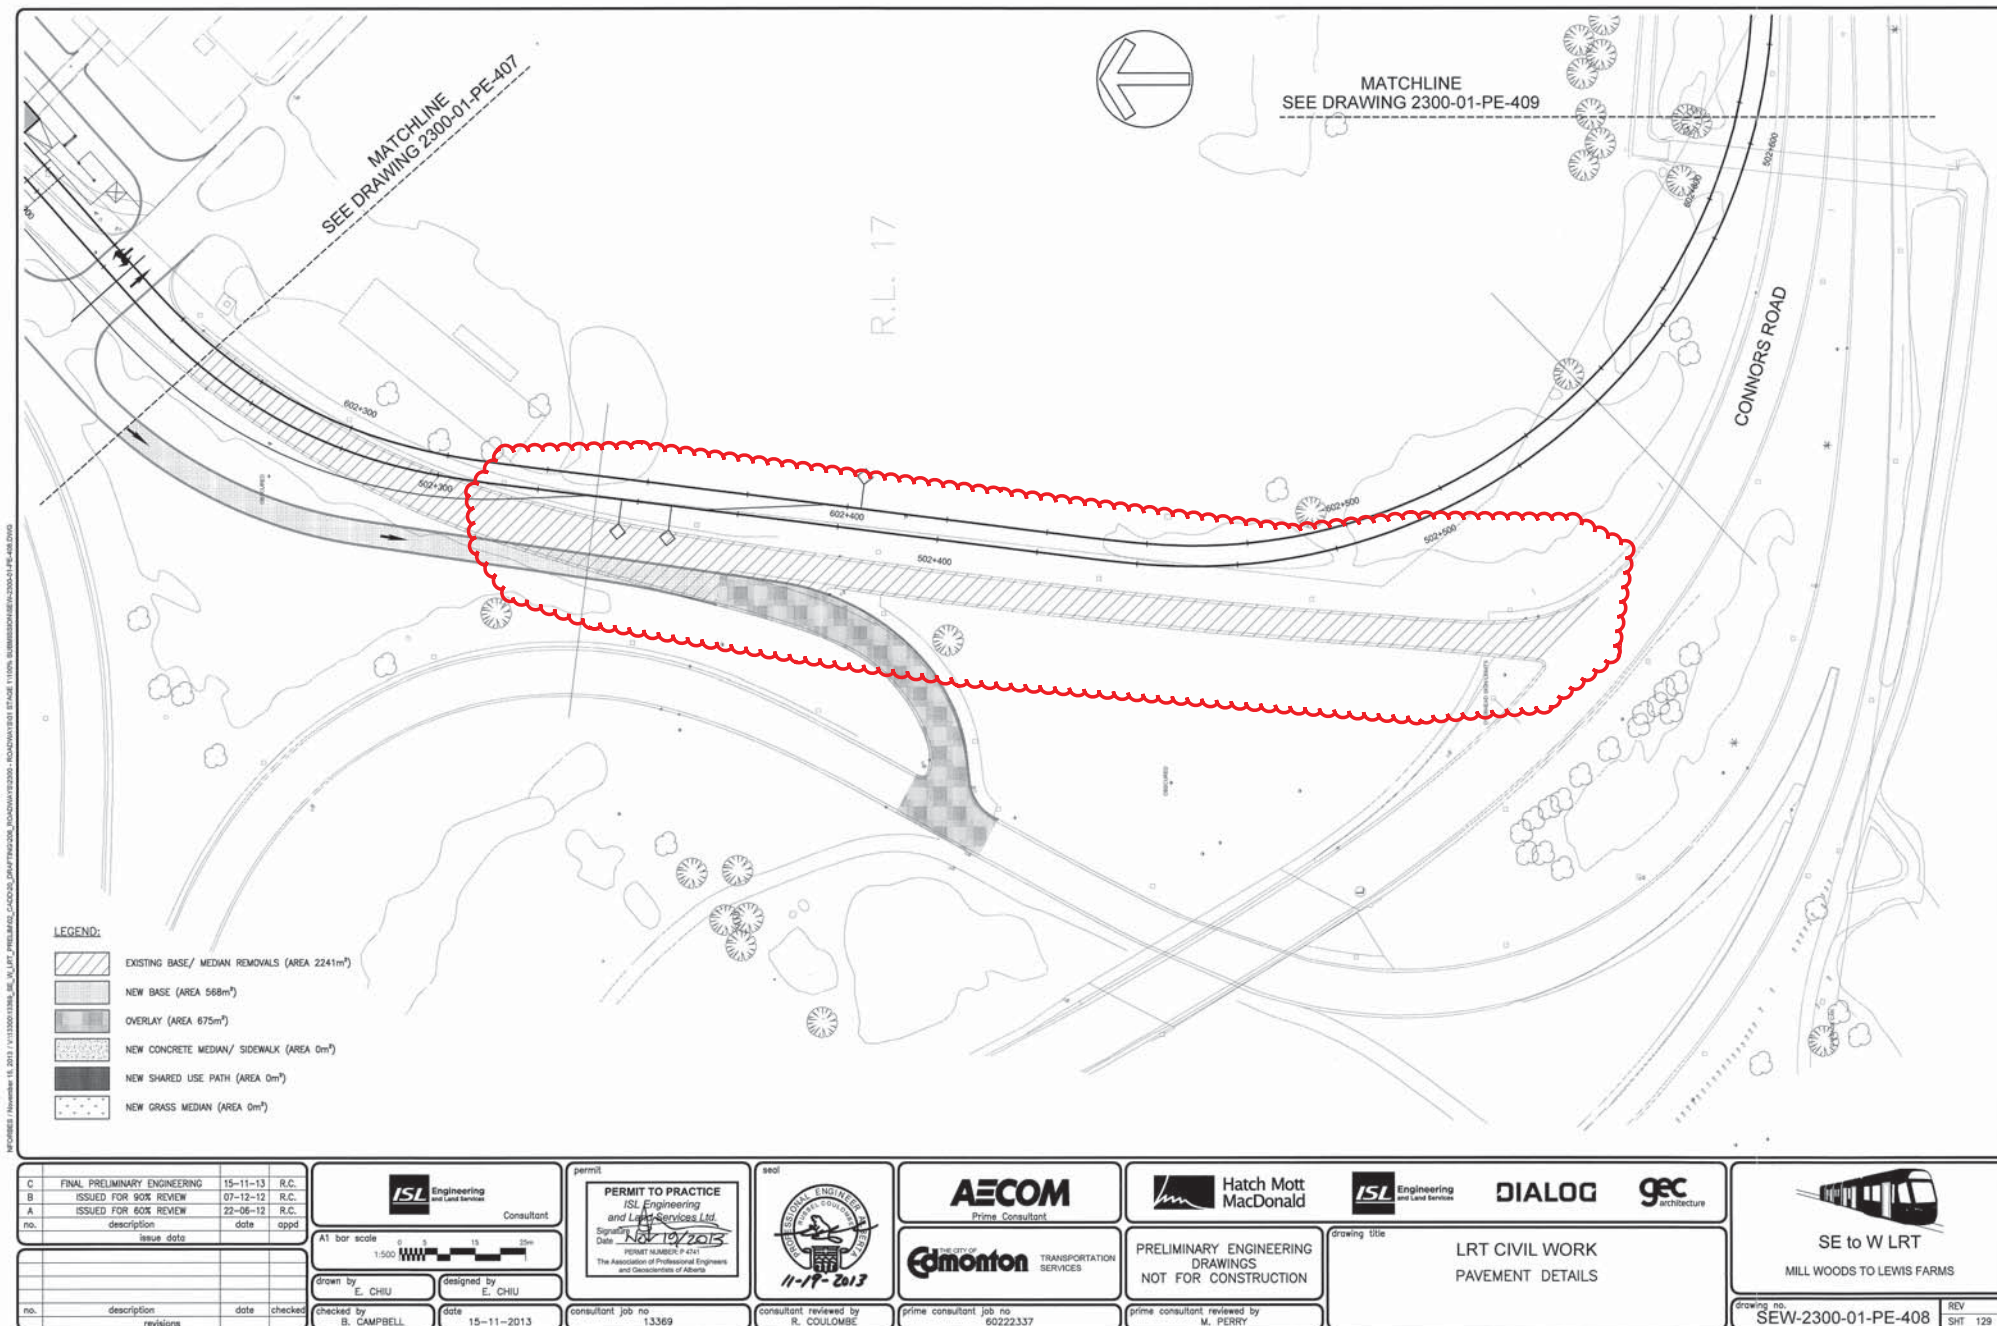
Figure 2.4 Muttart Access Road Partial Removal

As part of Valley Line LRT construction, the Muttart Access Road, connecting Connors Road northbound and 98 Avenue, and providing access to the conservatory grounds, will be permanently realigned to accommodate the LRT trackway and Muttart Stop. The need for realignment was covered in the 2013 EISA. As part of that realignment, closure/demolition of a 200 m long, one-way road connecting northbound Connors Road to the Muttart Access Road will be required (Figure 2.4). That connector road will be permanently removed as part of the Valley Line project. As 2013 EISA stated that the existing connector from Connors Road north would remain intact, this minor, permanent change in the road network was not fully assessed. The road removal involves approximately 2,070 m<sup>2</sup> of land. This project component differs from the others assessed in this update in that it requires no adjustments to the Project Area *and* most of the activities associated with removal would be the same as which these undertaken as part of the realignment of the access road, was covered in the 2013 EISA.

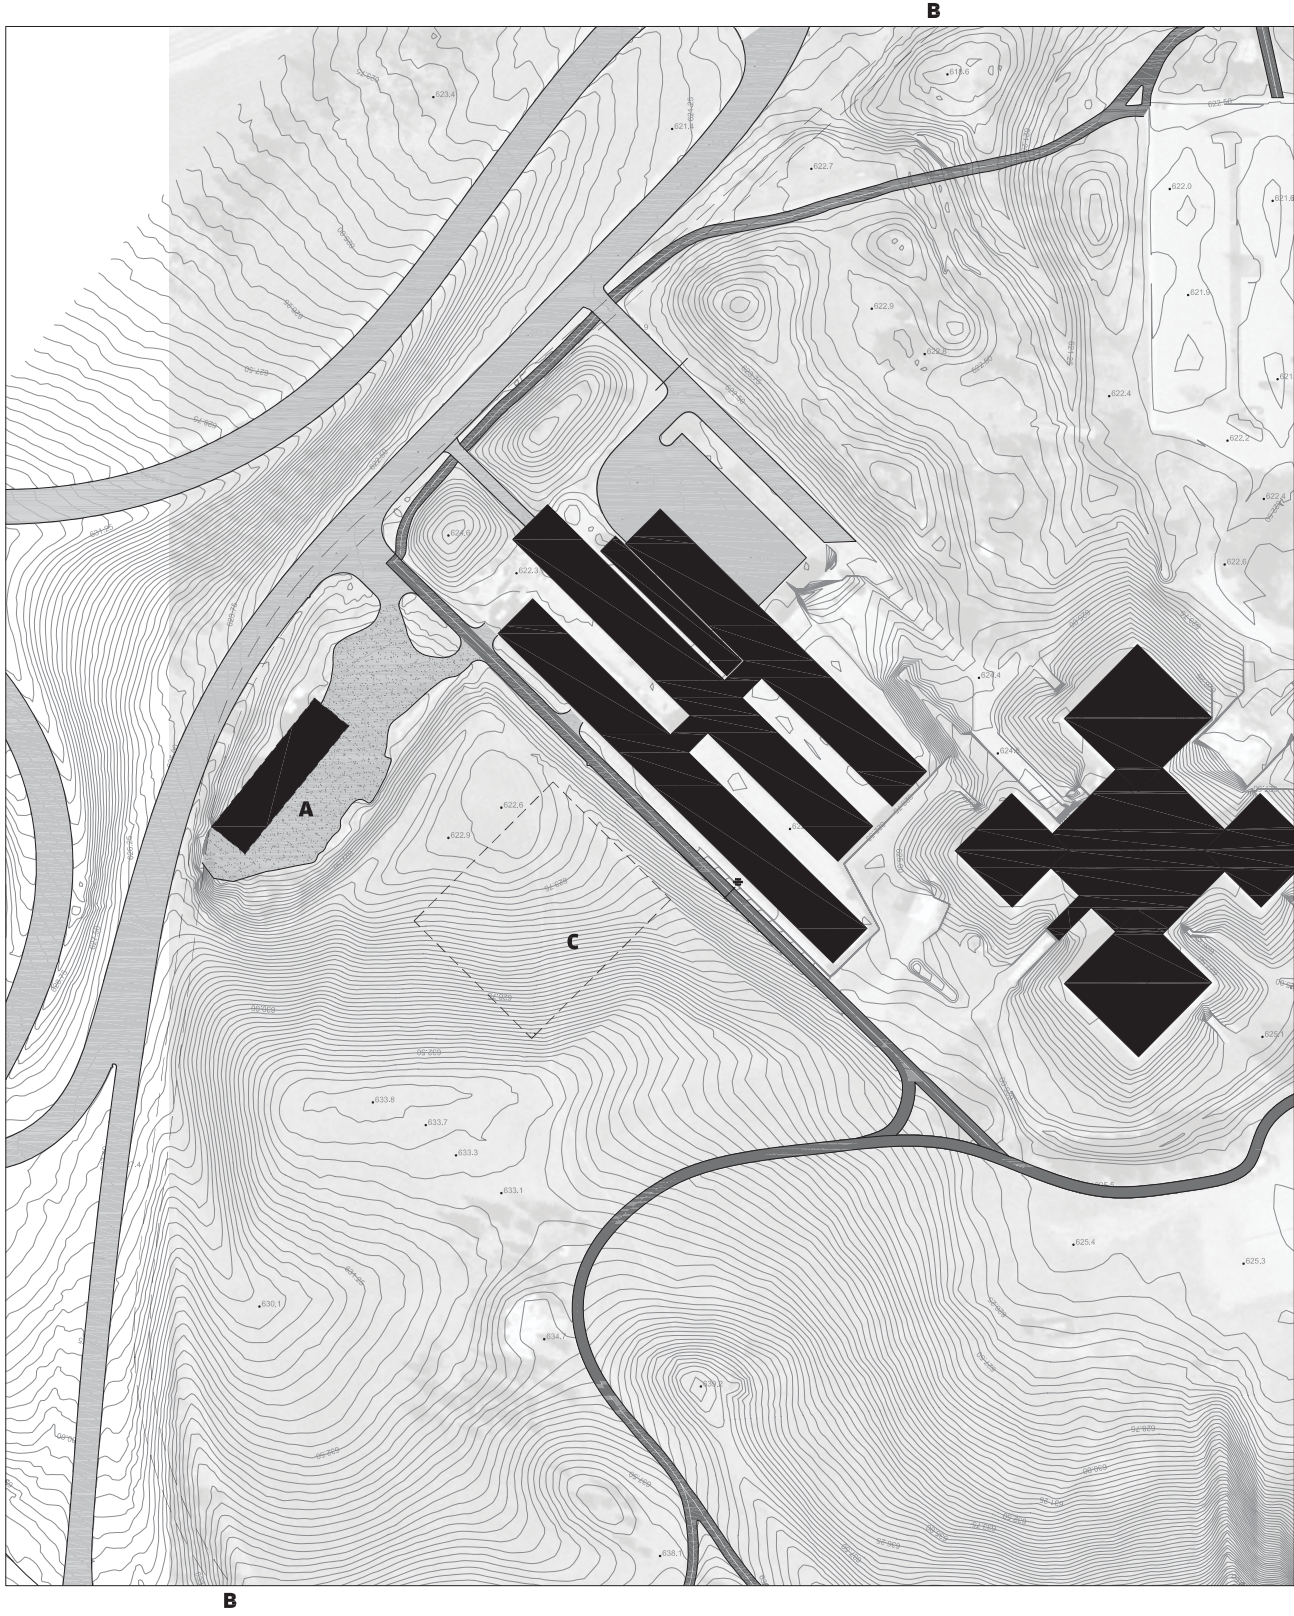
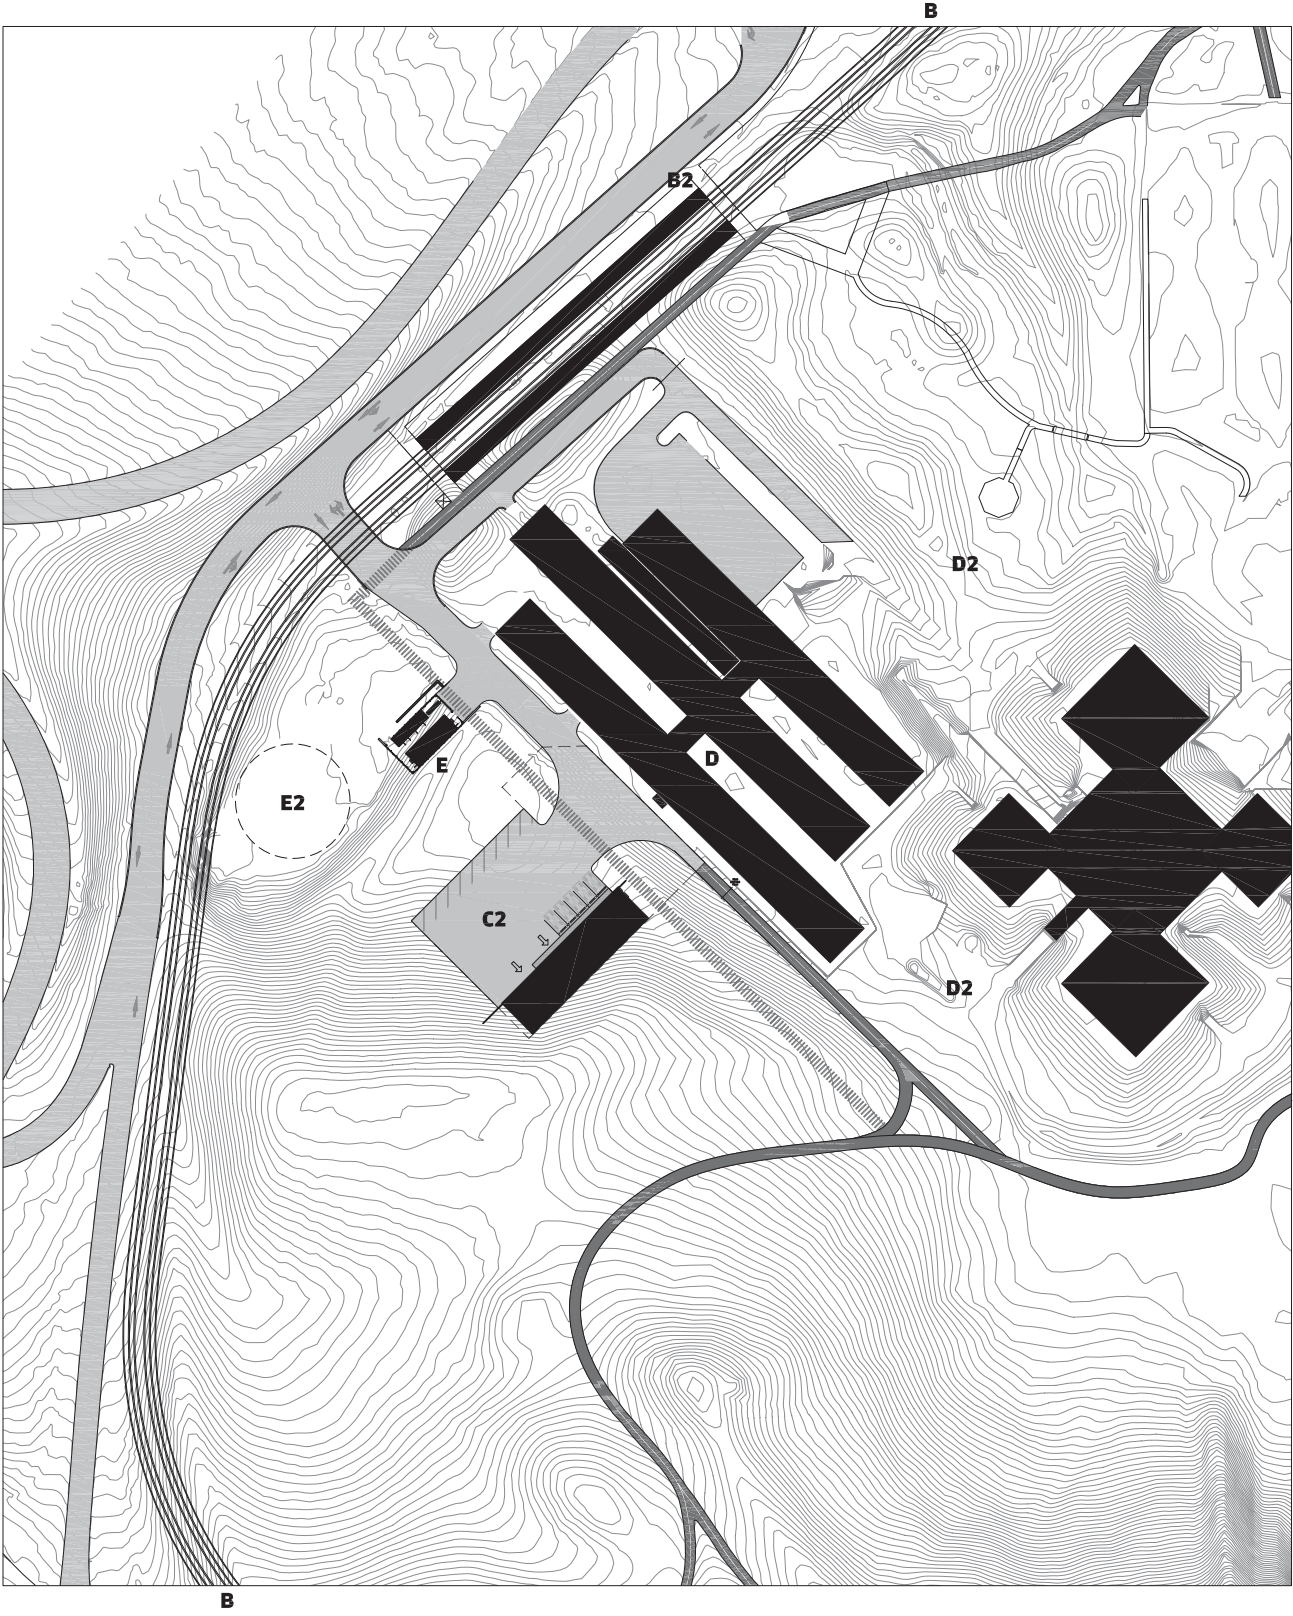
Figure 2.5a

PROJECT CONTEXT - EXISTING  
SCALE 1:2000

PROJECT CONTEXT - FUTURE  
SCALE 1:2000

- B** Anticipated Valley-Line LRT alignment.
- B2** Valley Line LRT Stop.
- C** New Storage Building, re-located next to existing greenhouses ( D ).
- E** Traction power substation (T.P.S.S.) site, part of LRT.
- E2** Potential storm water management pond, part of LRT.
- Shared-Use-Path (SUP)
- Potential Future Shared-Use-Path
- Buildings
- Hard Surface (asphalt / pavement)
- Gravel Surface
- Topography (0.25m intervals)
- L.R.T. TRACK ALIGNMENT (at grade)

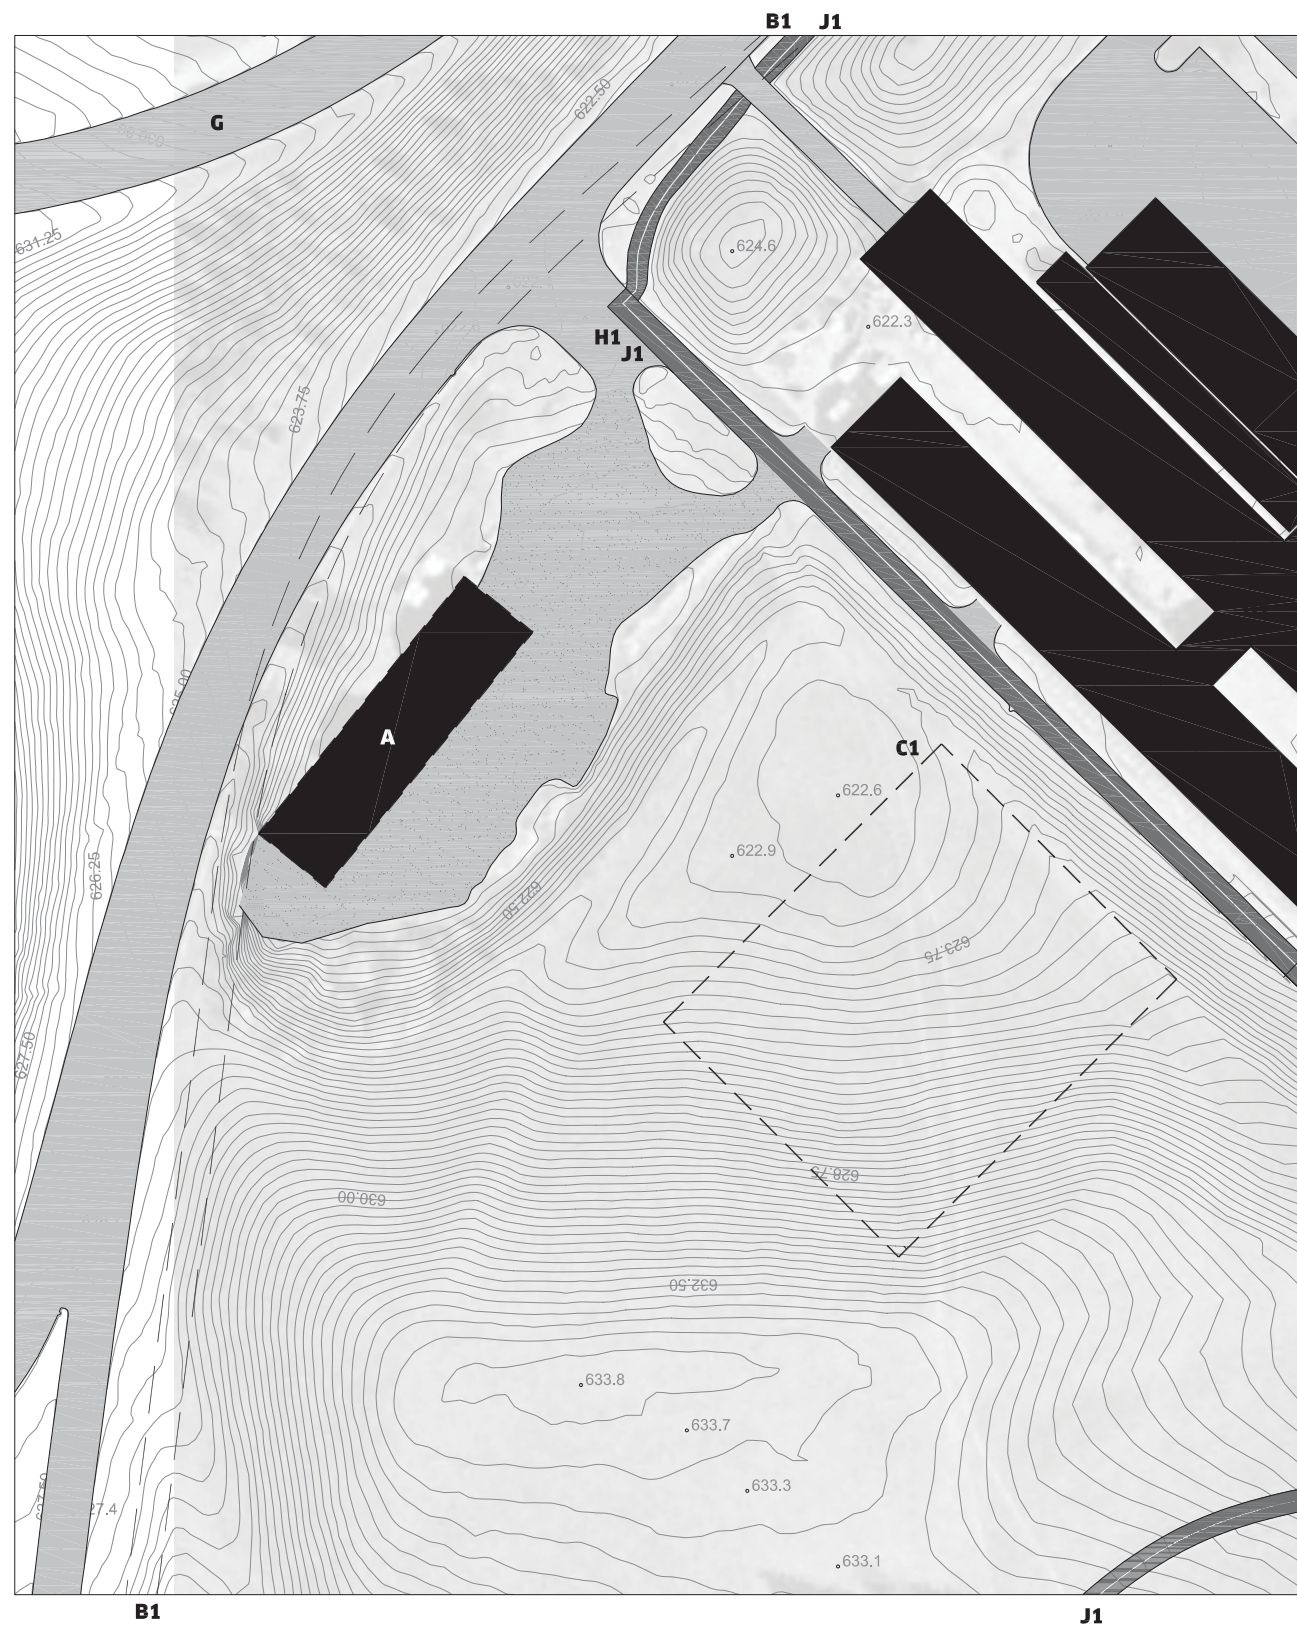
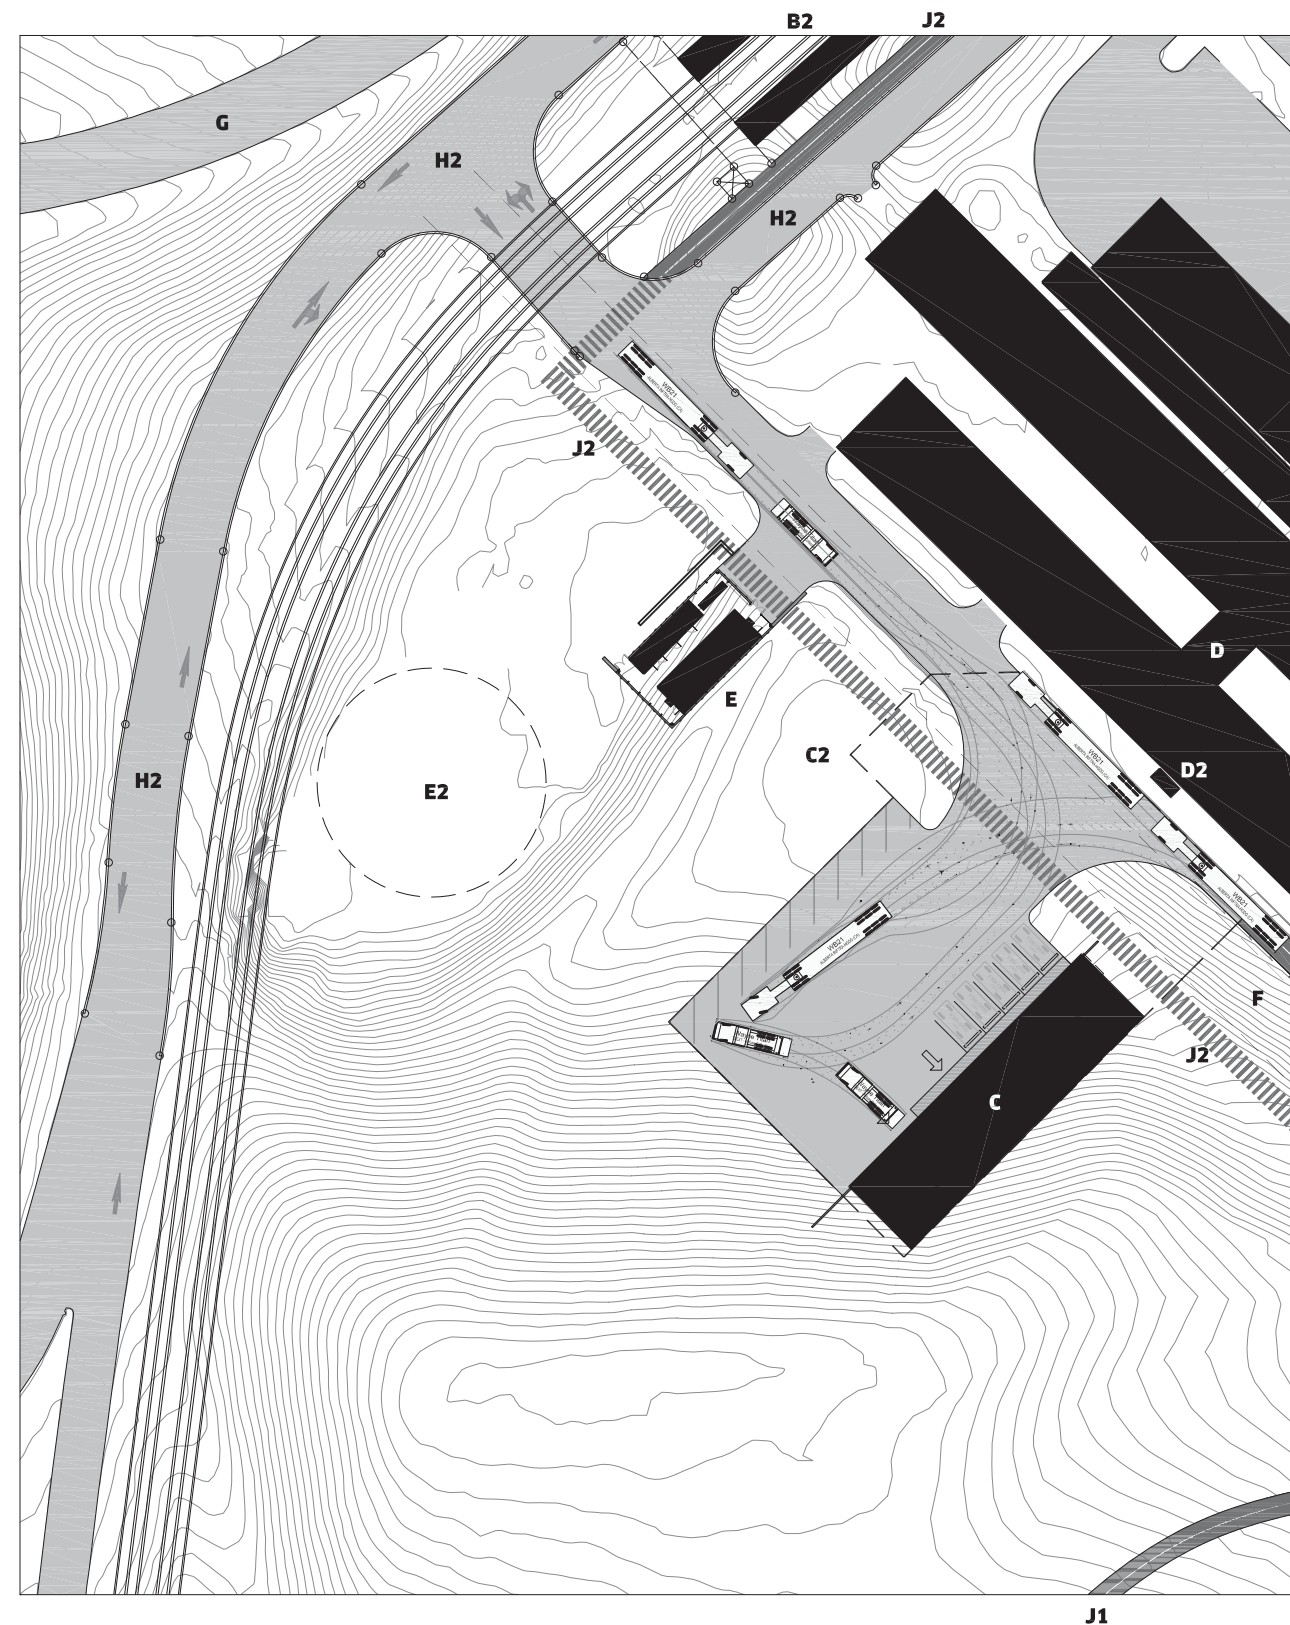
### Figure 2.5b

SITE CONTEXT PLAN - EXISTING

**1 SITE CONTEXT PLAN - FUTURE**  
SCALE 1:1000

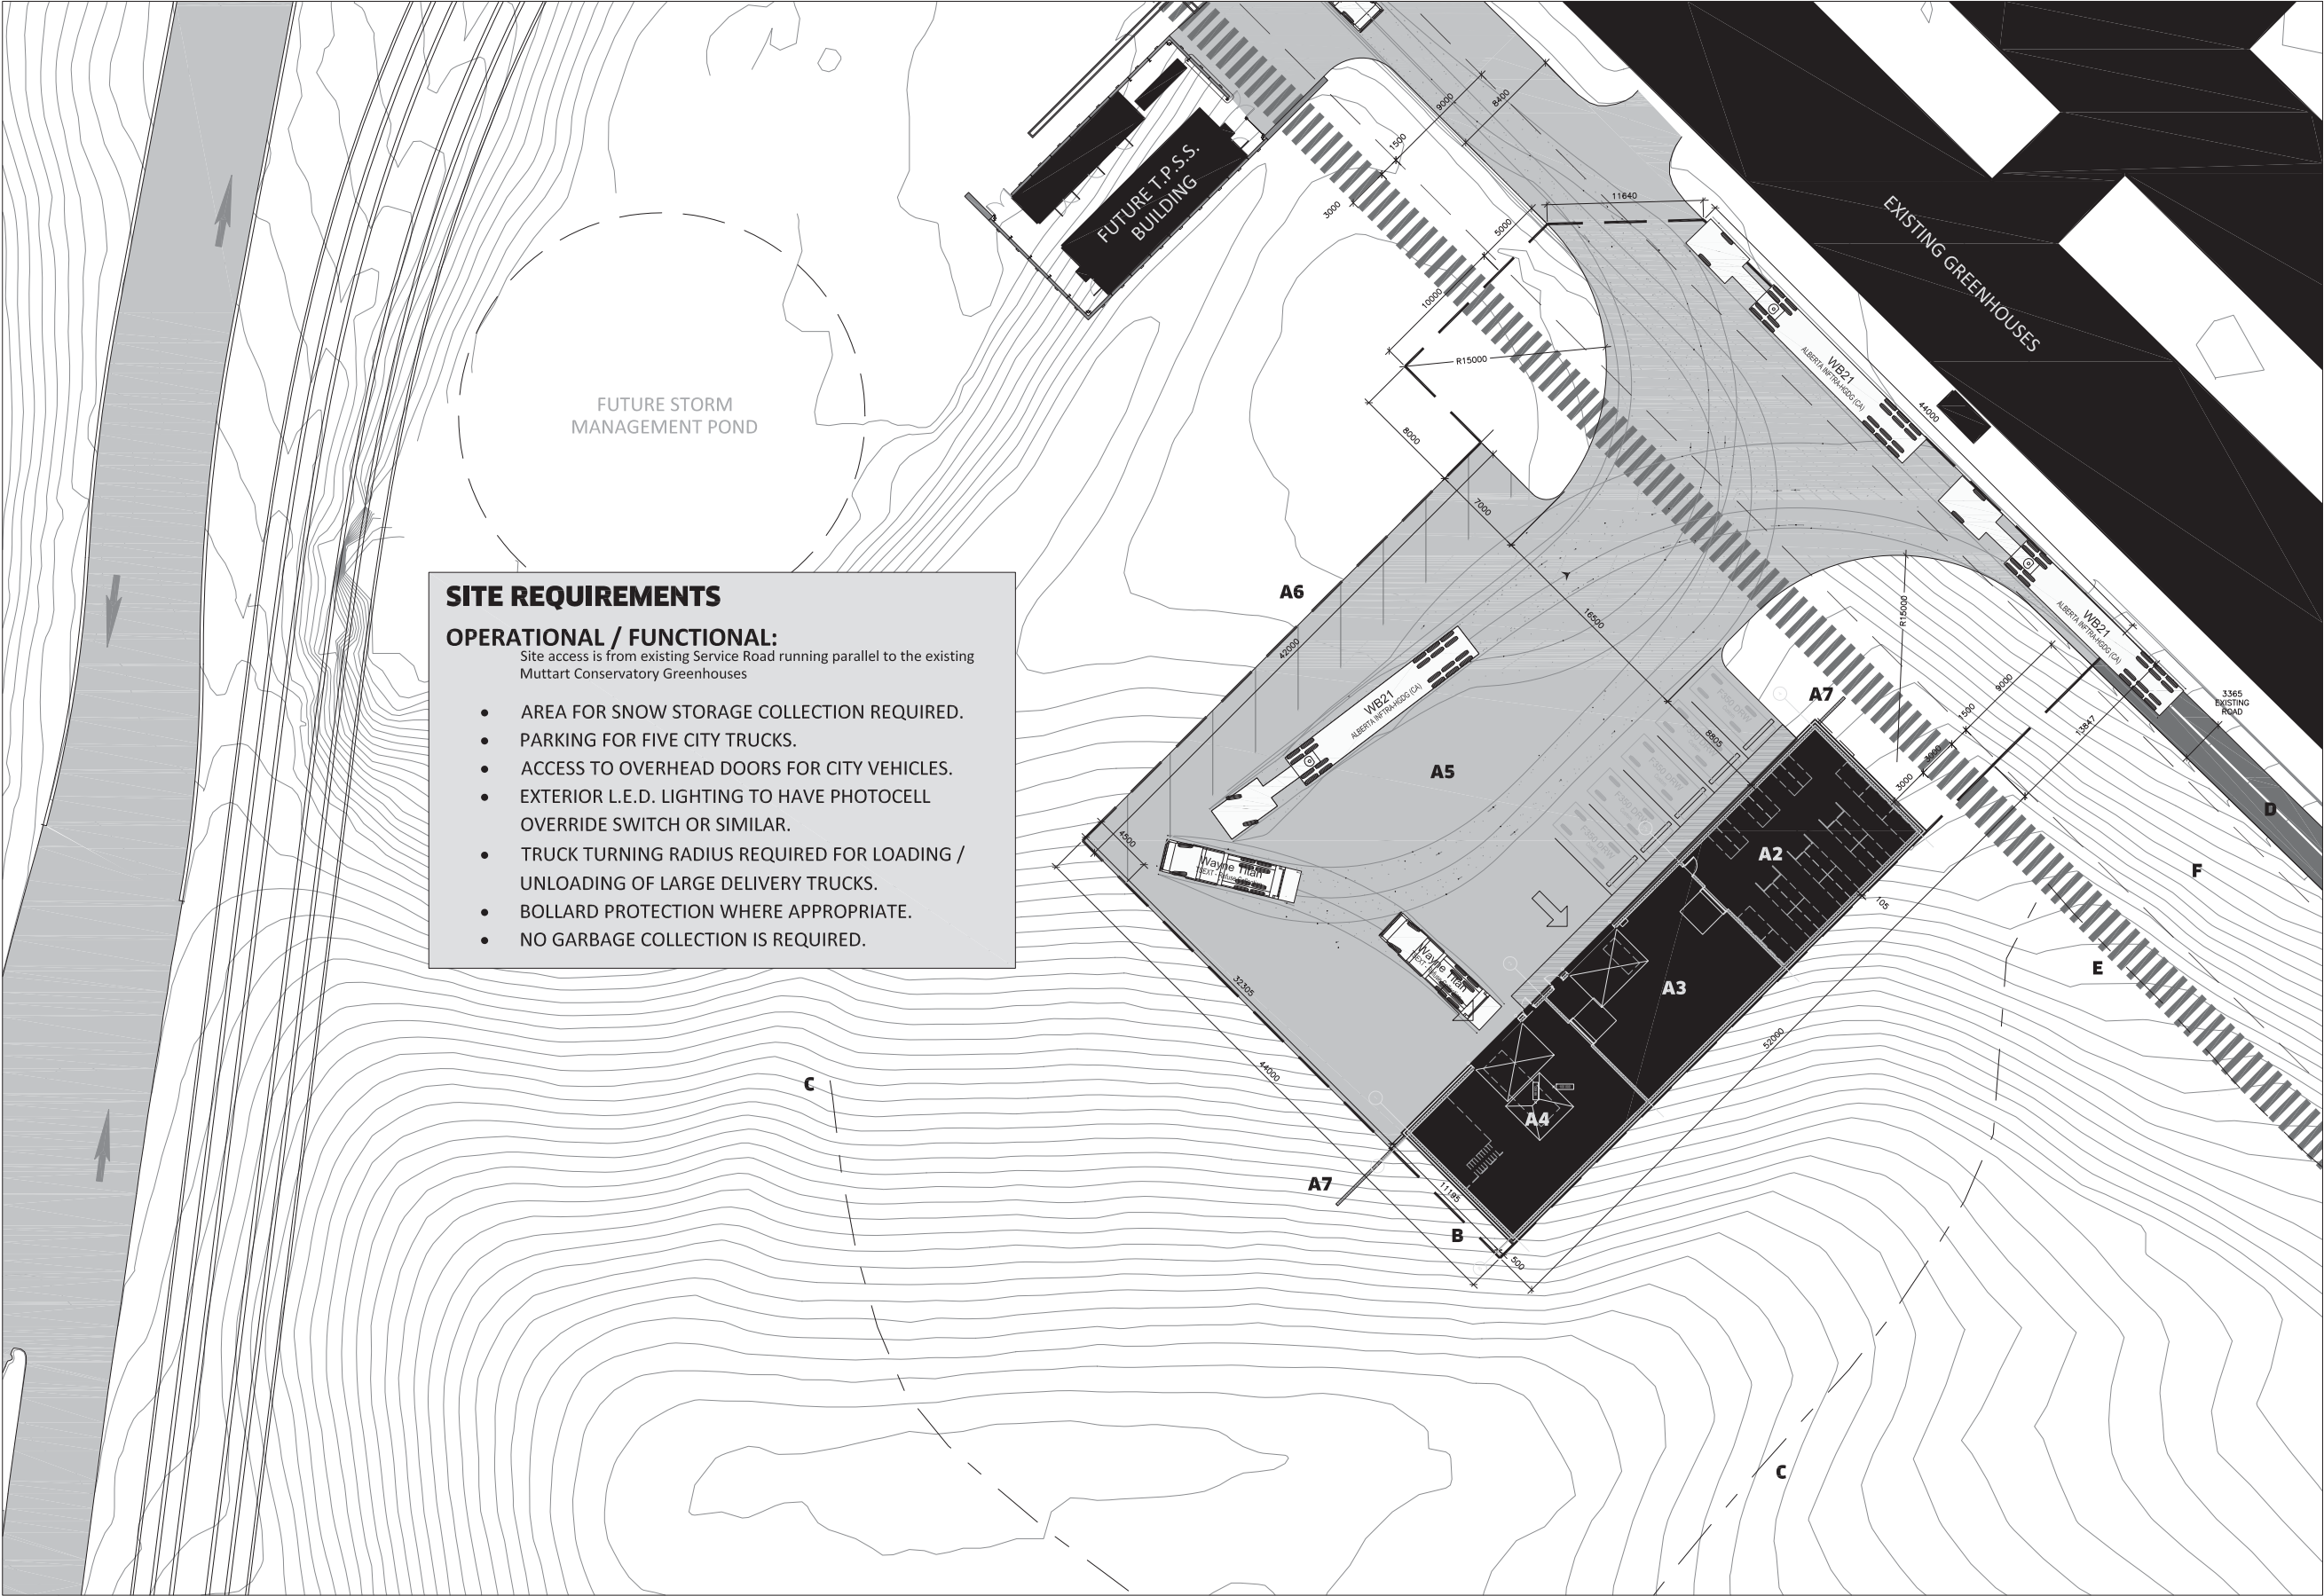
Figure 2.5c

New Storage Building .  
= 502.8 m<sup>2</sup> or 5412.6 s.f.

- AREA FOR SNOW STORAGE COLLECTION REQUIRED.
- PARKING FOR FIVE CITY TRUCKS.
- ACCESS TO OVERHEAD DOORS FOR CITY VEHICLES.
- EXTERIOR L.E.D. LIGHTING TO HAVE PHOTOCCELL OVERRIDE SWITCH OR SIMILAR.
- TRUCK TURNING RADIUS REQUIRED FOR LOADING / UNLOADING OF LARGE DELIVERY TRUCKS.
- BOLLARD PROTECTION WHERE APPROPRIATE.
- NO GARBAGE COLLECTION IS REQUIRED.

**SITE PLAN**  
SCALE 1:500

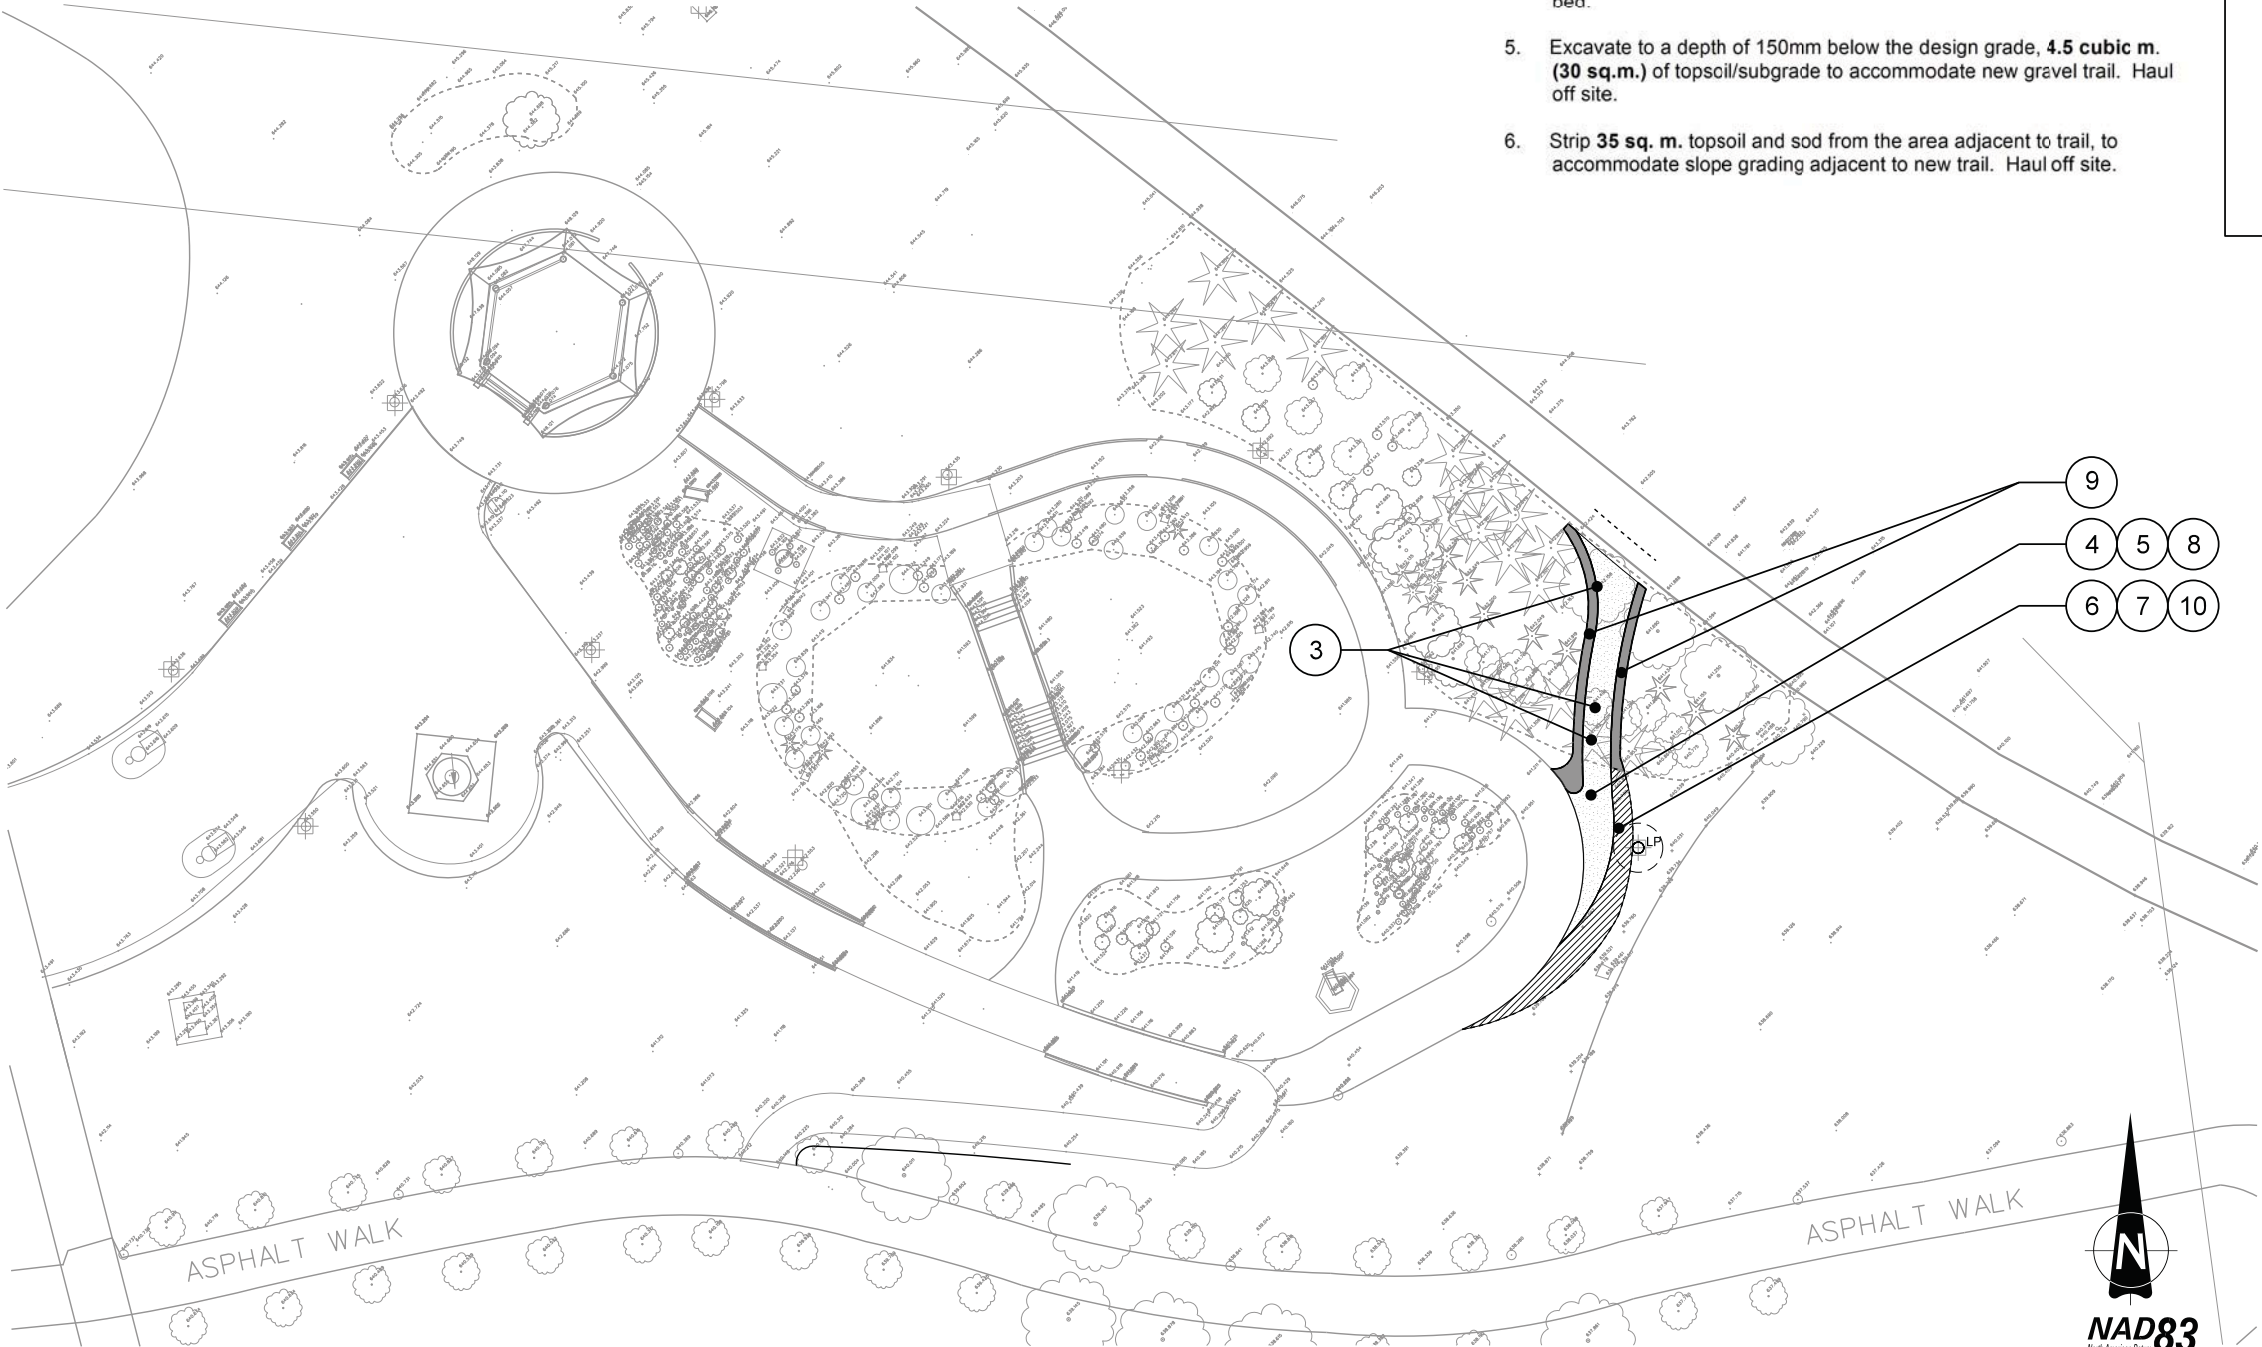
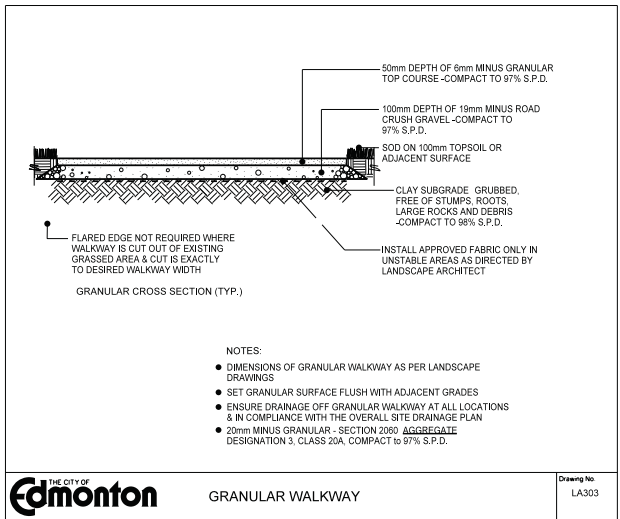
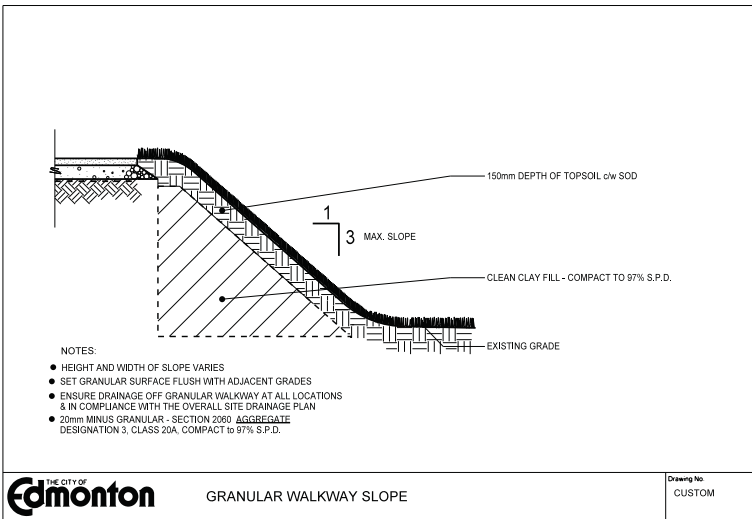
Figure 2.6

- Build up the grade adjacent to existing trail to accommodate new trail construction. Construct **25.0 cubic m.** base with clay fill adjacent to trail tapering down to existing grade. Maximum slope is 1:3. Refer to custom detail on this drawing.
- Construct **30 sq. m.** of 50mm depth granular paving c/w 150mm granular base on compacted clay sub-grade. Trail is 1.5m wide. Refer to detail LA302 on this drawing. Contact Community Project to arrange for compaction testing.
- Install **10 sq. m.** 100mm depth mulch adjacent to new trail through existing shrub bed. Ensure positive drainage
- Install **20 sq. m.** 150mm depth topsoil and sod adjacent to new trail. Ensure positive drainage.

Prior to commencement of Valley Line construction, to reduce the impact of the up to five years of construction on LMRP trails and facility use, the City will construct a short, temporary connector trail just west of the Project Area in the Chinese Gardens (Figure 2.1b; Plate 2.8). The temporary trail will connect the western portion of the primary north-south SUP to an established trail in the Chinese Garden, allowing pedestrians and cyclists to circulate through the broader network of park trails situated west of the main LRT project corridor and avoiding trail dead ends. The proposed temporary gravel trail will be approximately 1.5 m wide and 15 m in length. Design details and location are shown on Figure 2.6.

Construction drawings indicate that the trail will be sub-excavated to 150 mm depth, filled with compact clay and topped with gravel. Trail construction in this sloped area will involve grade changes. The grade adjacent to the existing trail will be raised using clay fill and will taper down to the existing grade with a maximum slope of 1:3 (Figure 2.6). Fill will be stabilized using 300-600 mm boulders installed at the bottom of the new embankment with one third of the boulders buried into the subgrade/topsoil. Topsoil and sod will be placed on disturbed soil adjacent to the new trail and positive drainage will be provided. The width of disturbed area will be approximately 2-3 m; total area of disturbance will be approximately 65 m<sup>2</sup>.
