**City of Edmonton**  
**Valley Line Stage 1 – Light Rail Transit (LRT) Project**  
**Environmental Impact Screening Assessment Update**  
**Final Report**

Project Number EP - 576

February 2015

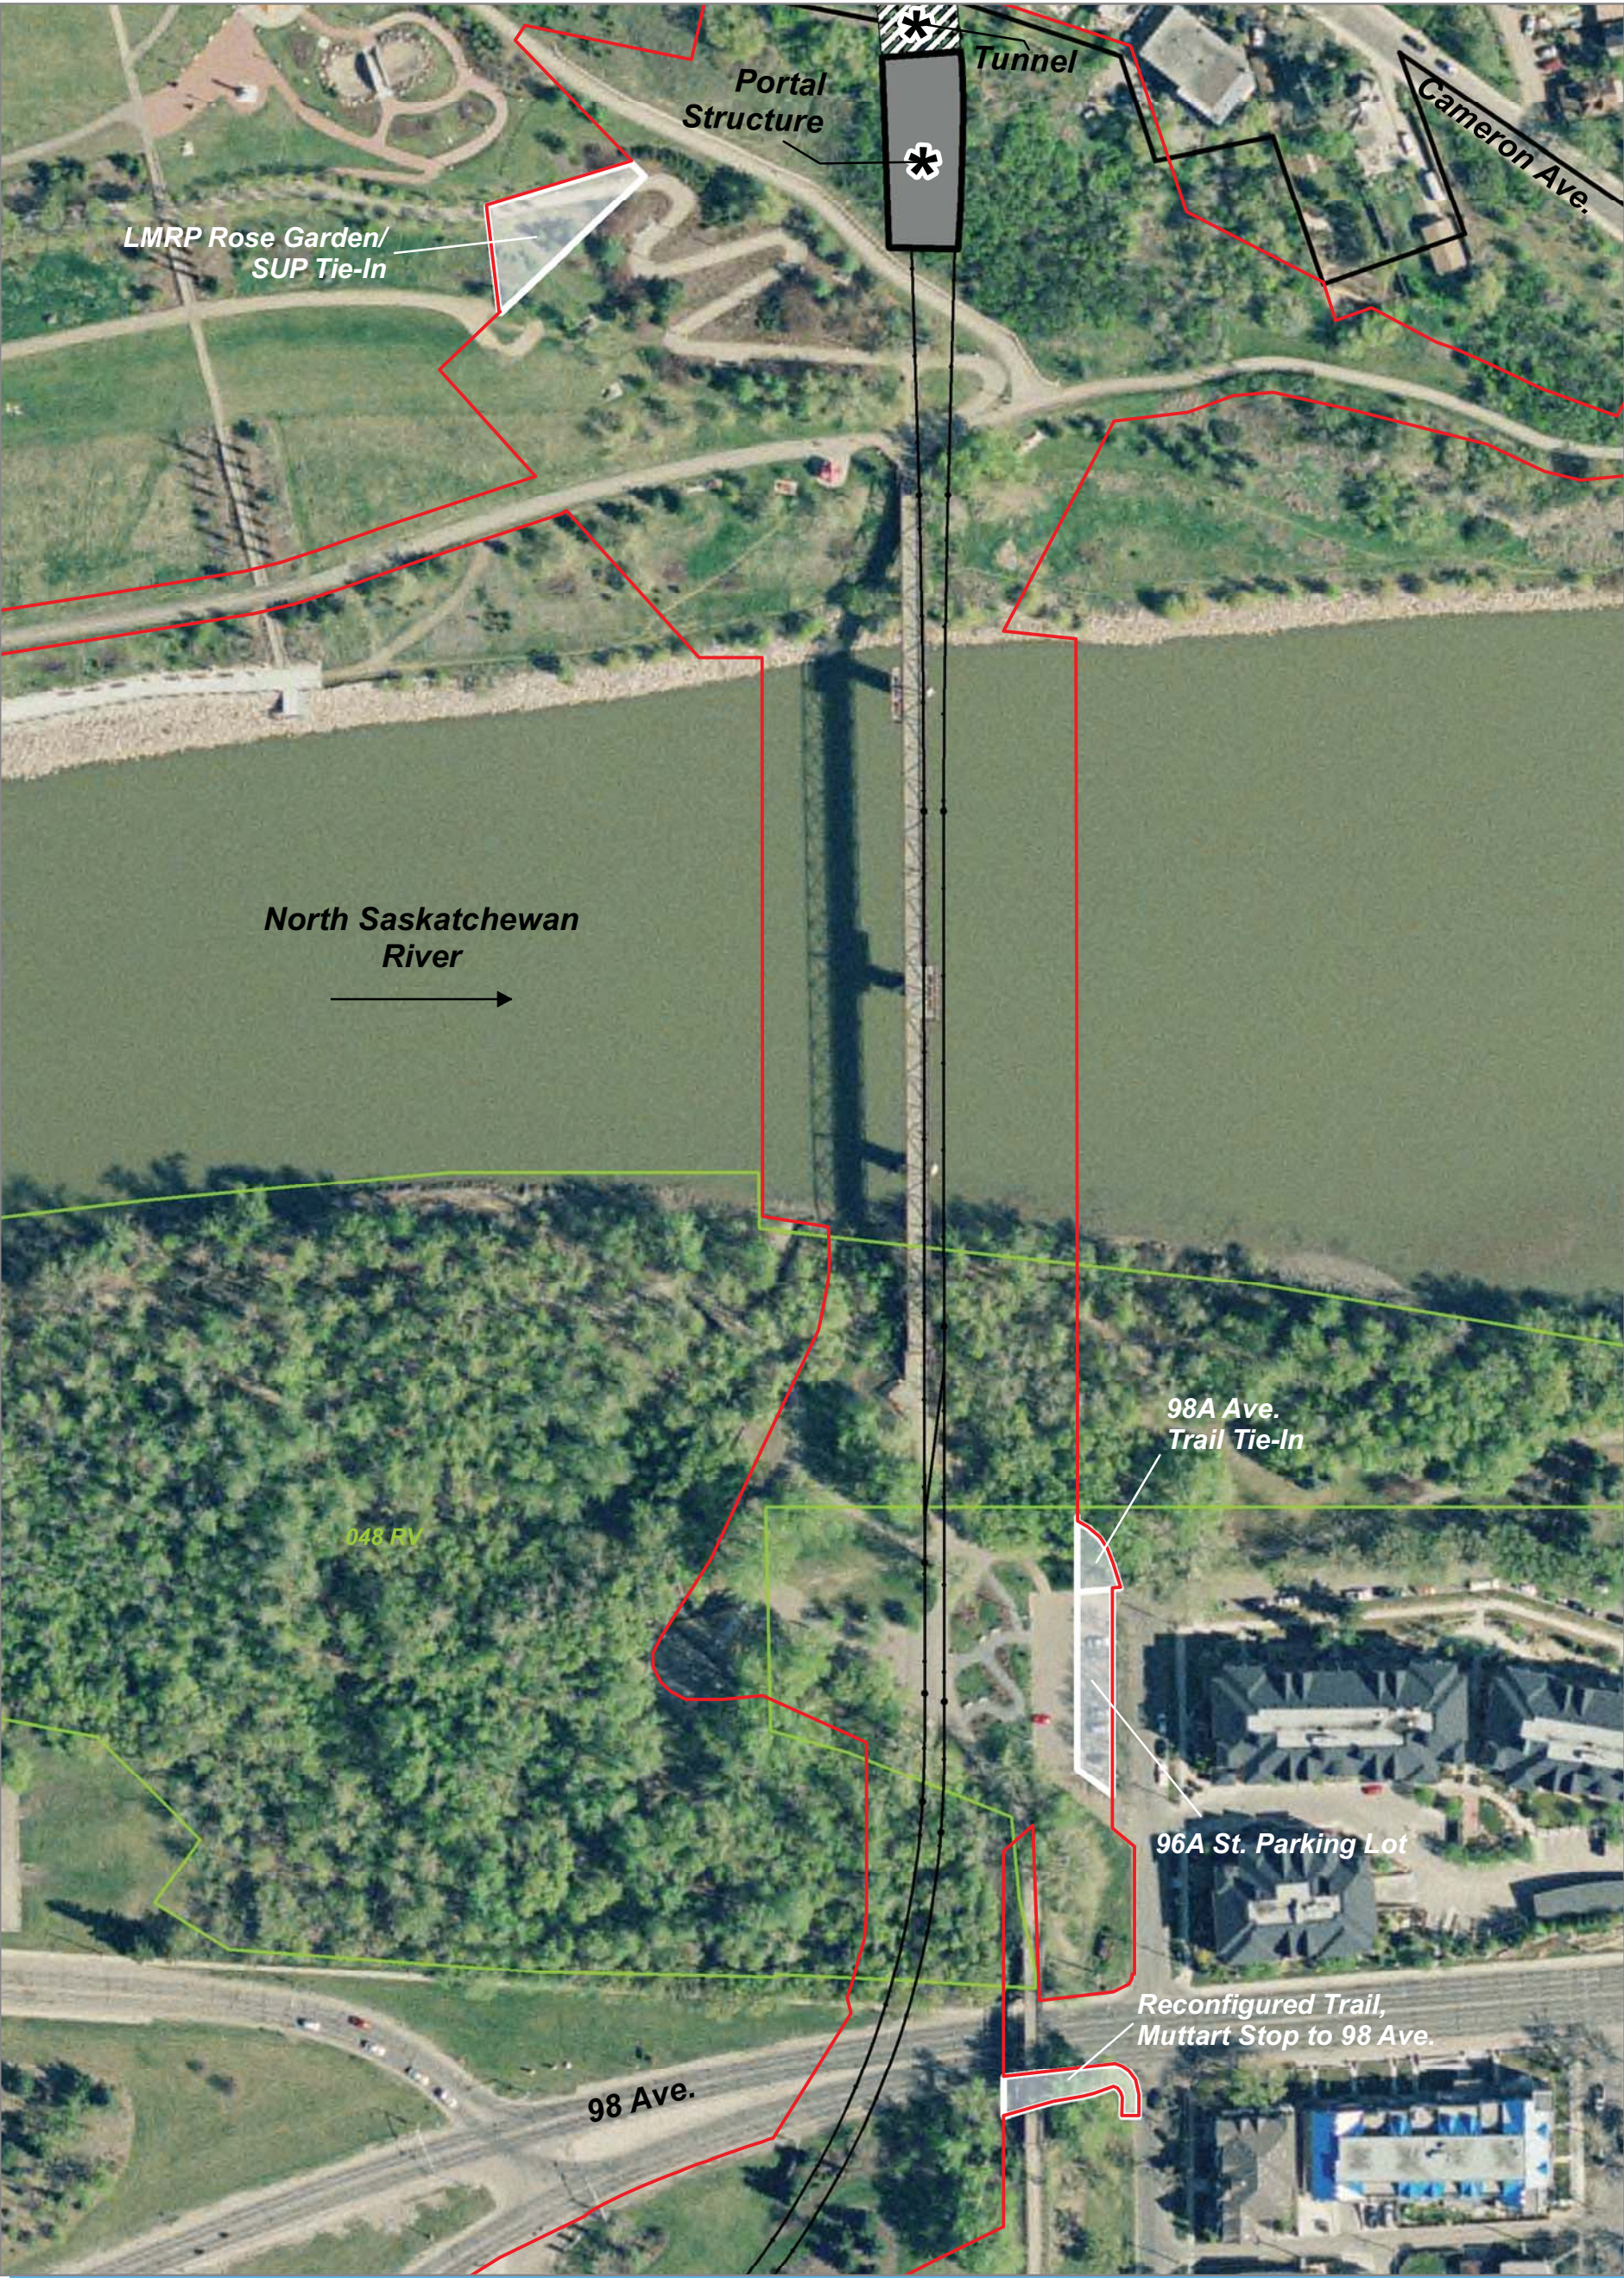
**Figure 2.7 Spatial Clarifications**  
City of Edmonton LRT Valley Line - Stage 1  
EISA Update

Figure 2.7 shows the location and relative extent of the four project components requiring spatial clarification. All of the activities associated with each of the four project components will be undertaken by Project Co.

following construction, or relocated to a new, permanent site. The 70% River Valley Landscape Drawings and the Project Agreement now in place for the project require Project Co to install a revisioned Rose Garden within the original Project Area. The drawings also require that the new garden area properly tie-in to the remnant portions of the Rose Garden and SUP situated west of the Project Area (Figure 2.8a). These activities represent a refinement of a mitigation measure committed to in the 2013 EISA; however, the tie-in work requires a slight extension of the Project Area. The project contract documents restrict Project Co activities in this area to landscaping activities only (Figure 2.8b). The total area associated with the tie-in work for the SUP and Rose Garden is approximately 527 m<sup>2</sup> (Figure 2.7).

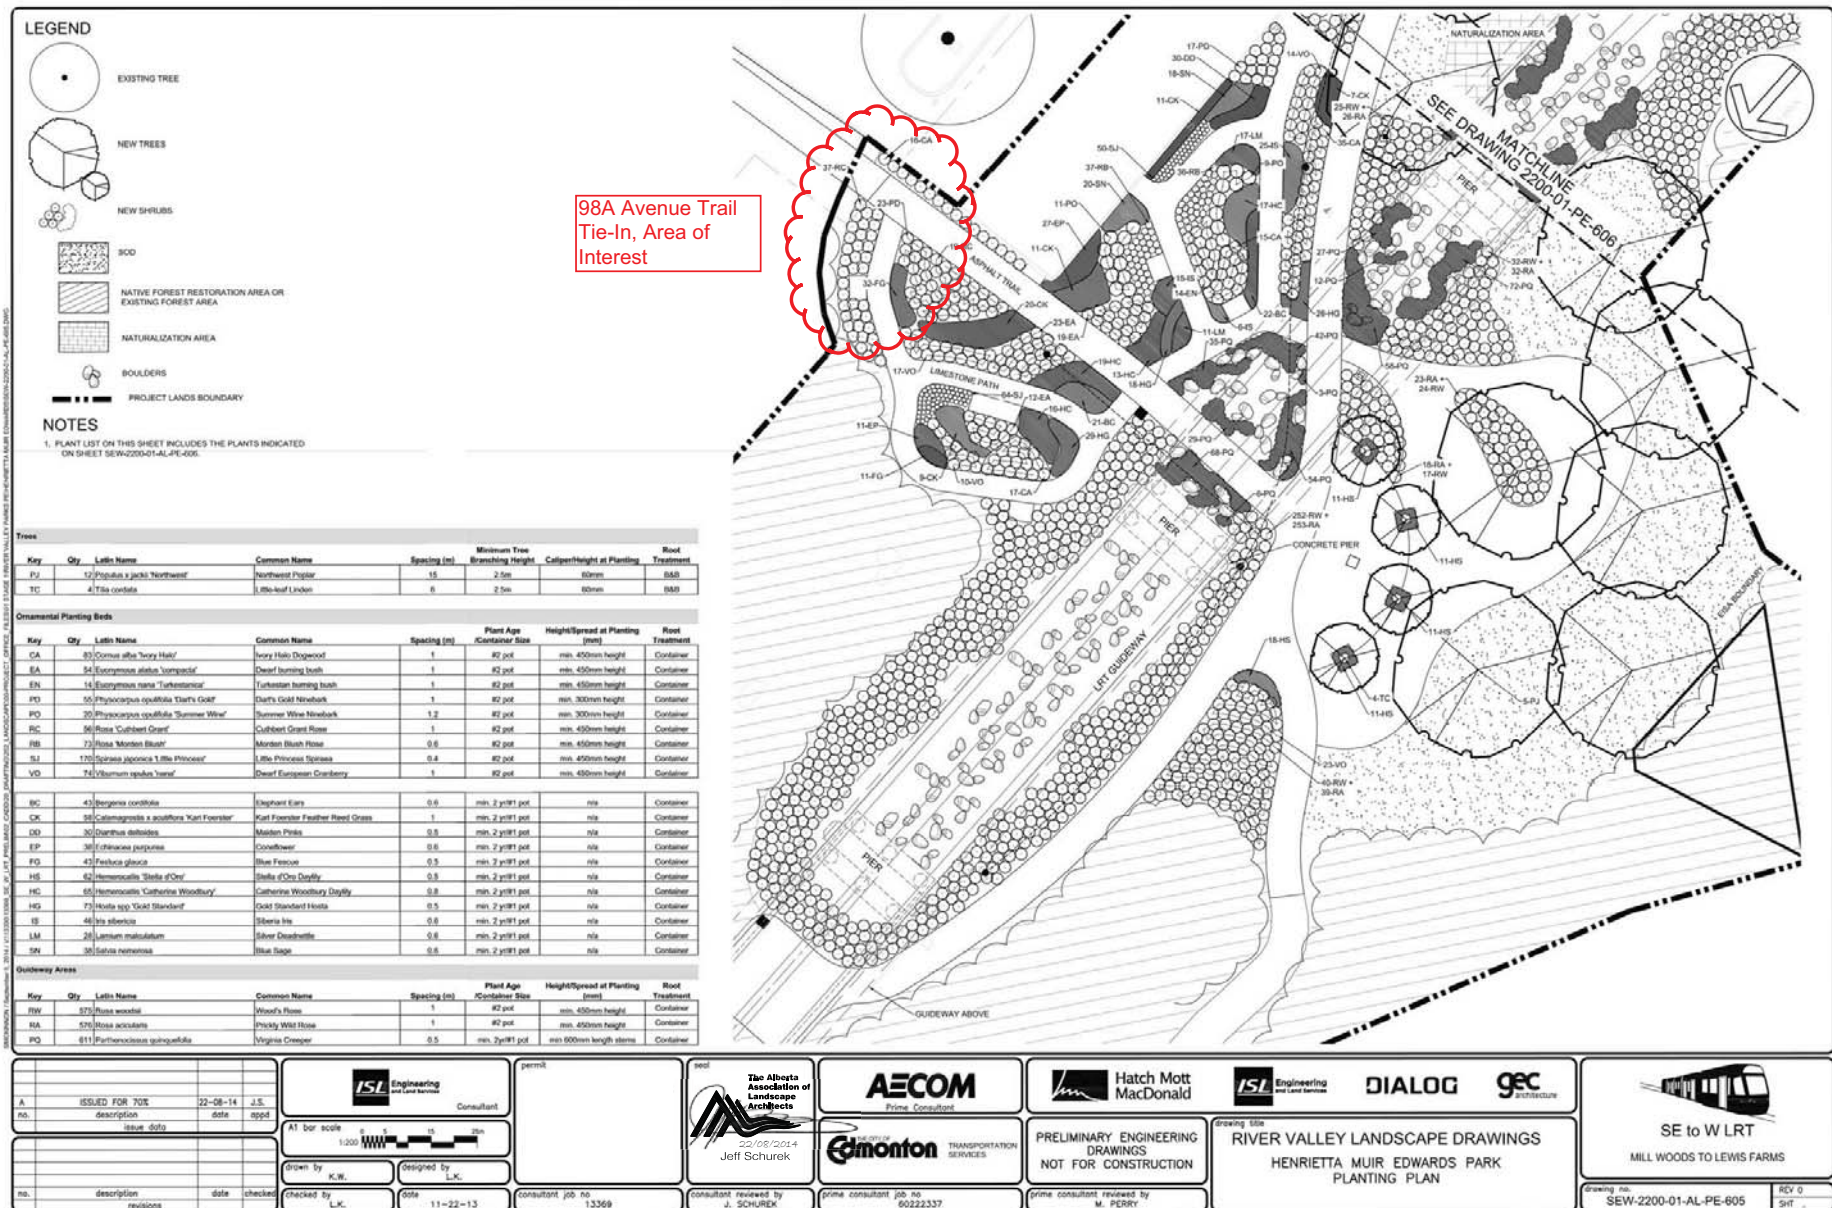
**Plate 2.10. Site of trail tie-in work required at HMEP and 98A Avenue, behind the no-stopping sign, see in the foreground (Jan. 2015).**

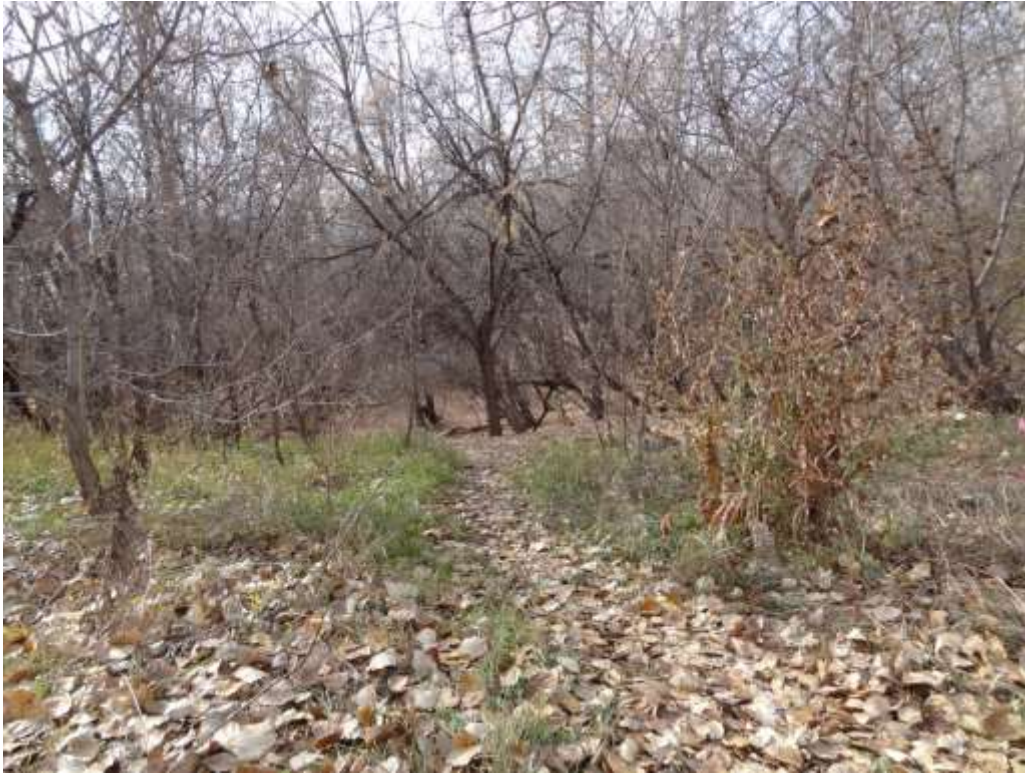
**Plate 2.11. Site of trail tie-in work required at HMEP and 98A Avenue, looking north from within HMEP (April 2013).**

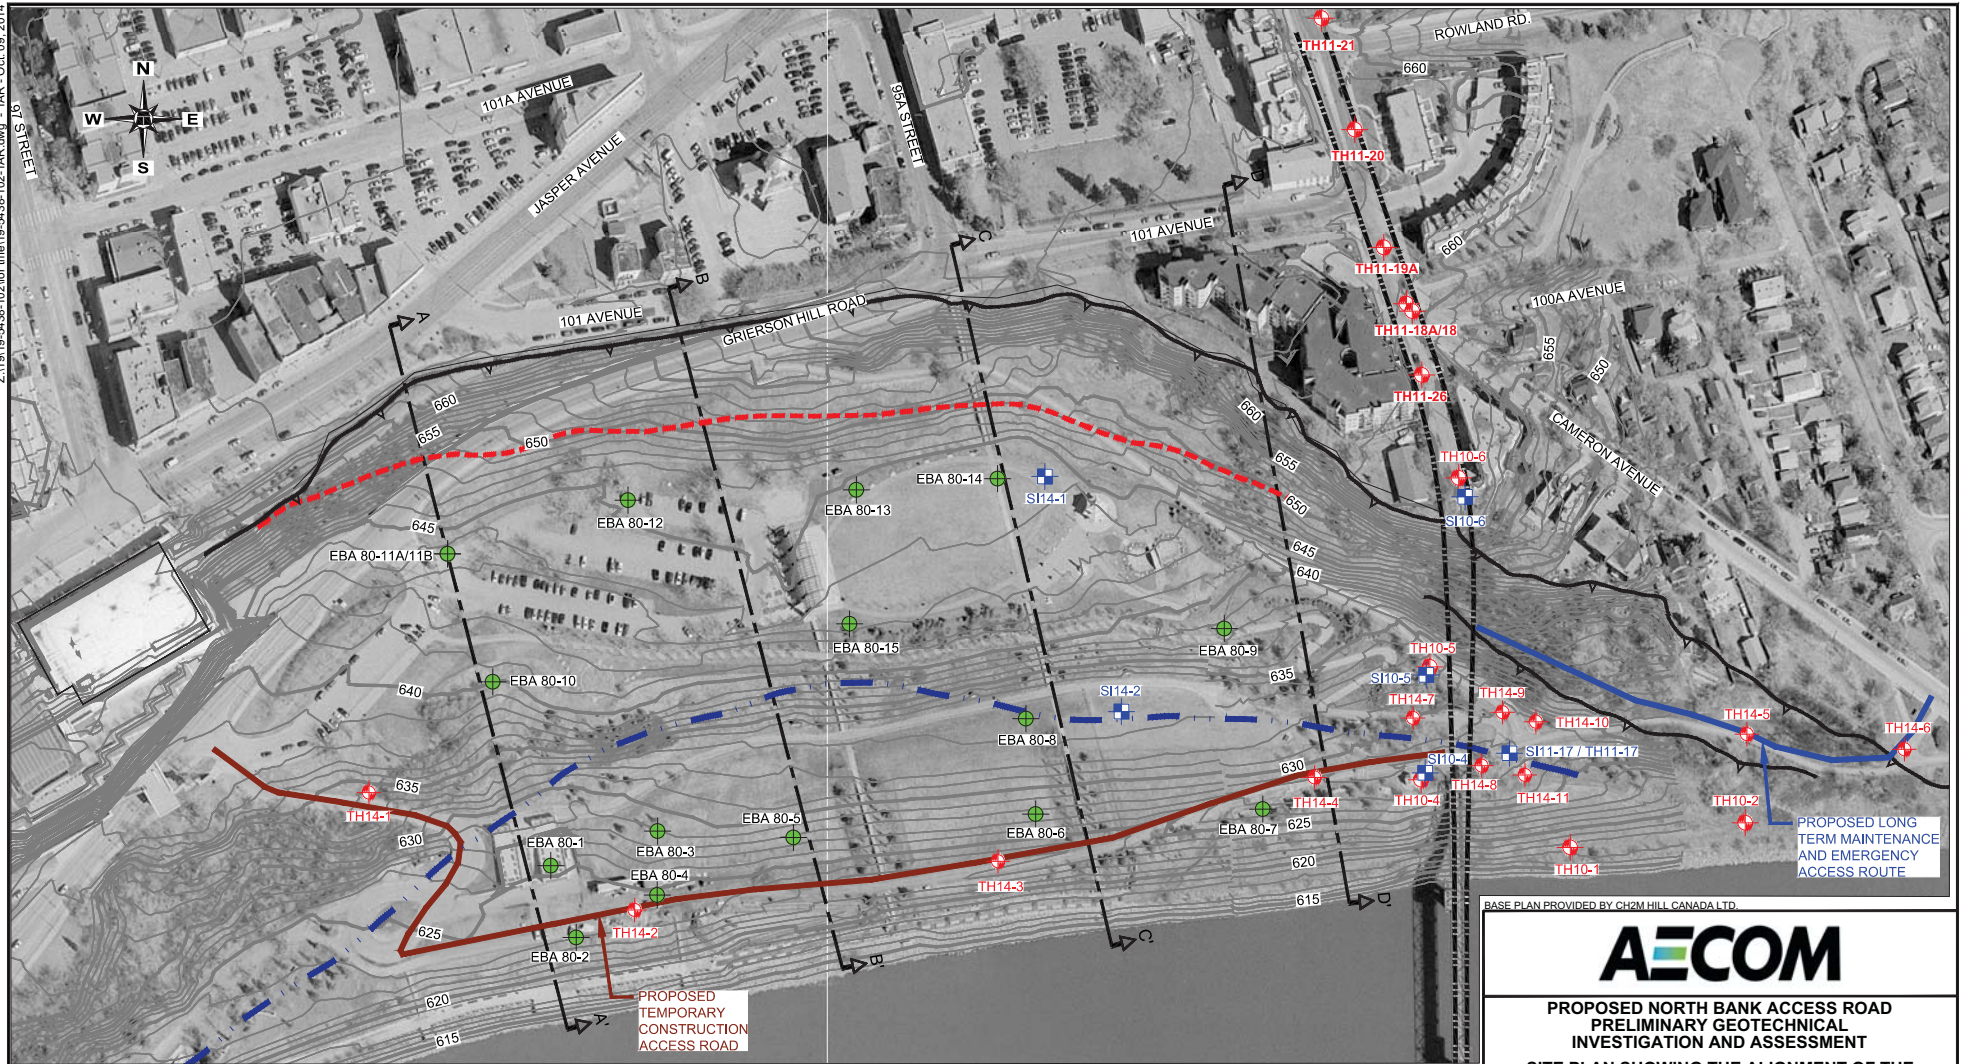
Figure 4.1

- ◆ TEST HOLE LOCATION BY THURBER
- PREVIOUS TEST HOLE LOCATION BY OTHERS
- ◆ TEST HOLE LOCATION WITH EXISTING SLOPE INCLINOMETER BY THURBER
- CURRENT SLOPE CREST / SCARP (APPROXIMATE)
- APPROXIMATE SLOPE CREST IN 1887 (BEFORE FAILURE)
- APPROXIMATE TOE OF RIVERBANK IN 1887 (BEFORE FAILURE)
- PROPOSED LRT ALIGNMENT

The cross-slope, proposed primary construction access road would be located near the toe of the Grierson Hill Slide, a major deep-seated landslide that occurred on the north slope of the North Saskatchewan Valley in 1901 (Thurber Engineering 2014). The landslide measures approximately 600 m east-west along the riverbank in LMRP extending from the Shaw Conference Centre in the west to the Cloverdale Pedestrian Bridge to the east. The northern limits of the slide are bounded by Grierson Hill Road and the south limits by the north bank of the NSR (Figure 4.1) (Thurber Engineering 2014). Since the initial slope failure in 1901, the Grierson Hill slope has been modified by extensive dumping and backfilling, mainly on the upper portions of the slope, including using the area as a City landfill (Grierson Nuisance Grounds – see below). Movement of the valley slope has been monitored since the 1950’s and movement rates have been noted as very sensitive to changes in slope condition (e.g., grading works, toe erosion, precipitation, etc.). Various slope stabilization measures have been implemented over the years, which have considerably improved overall slope stability. Slope inclinometers, installed in 2000, 2010 and 2011, and monitored regularly since November 2010, have detected no noticeable slope movements since their installation (Thurber Engineering 2014; Appendix B).

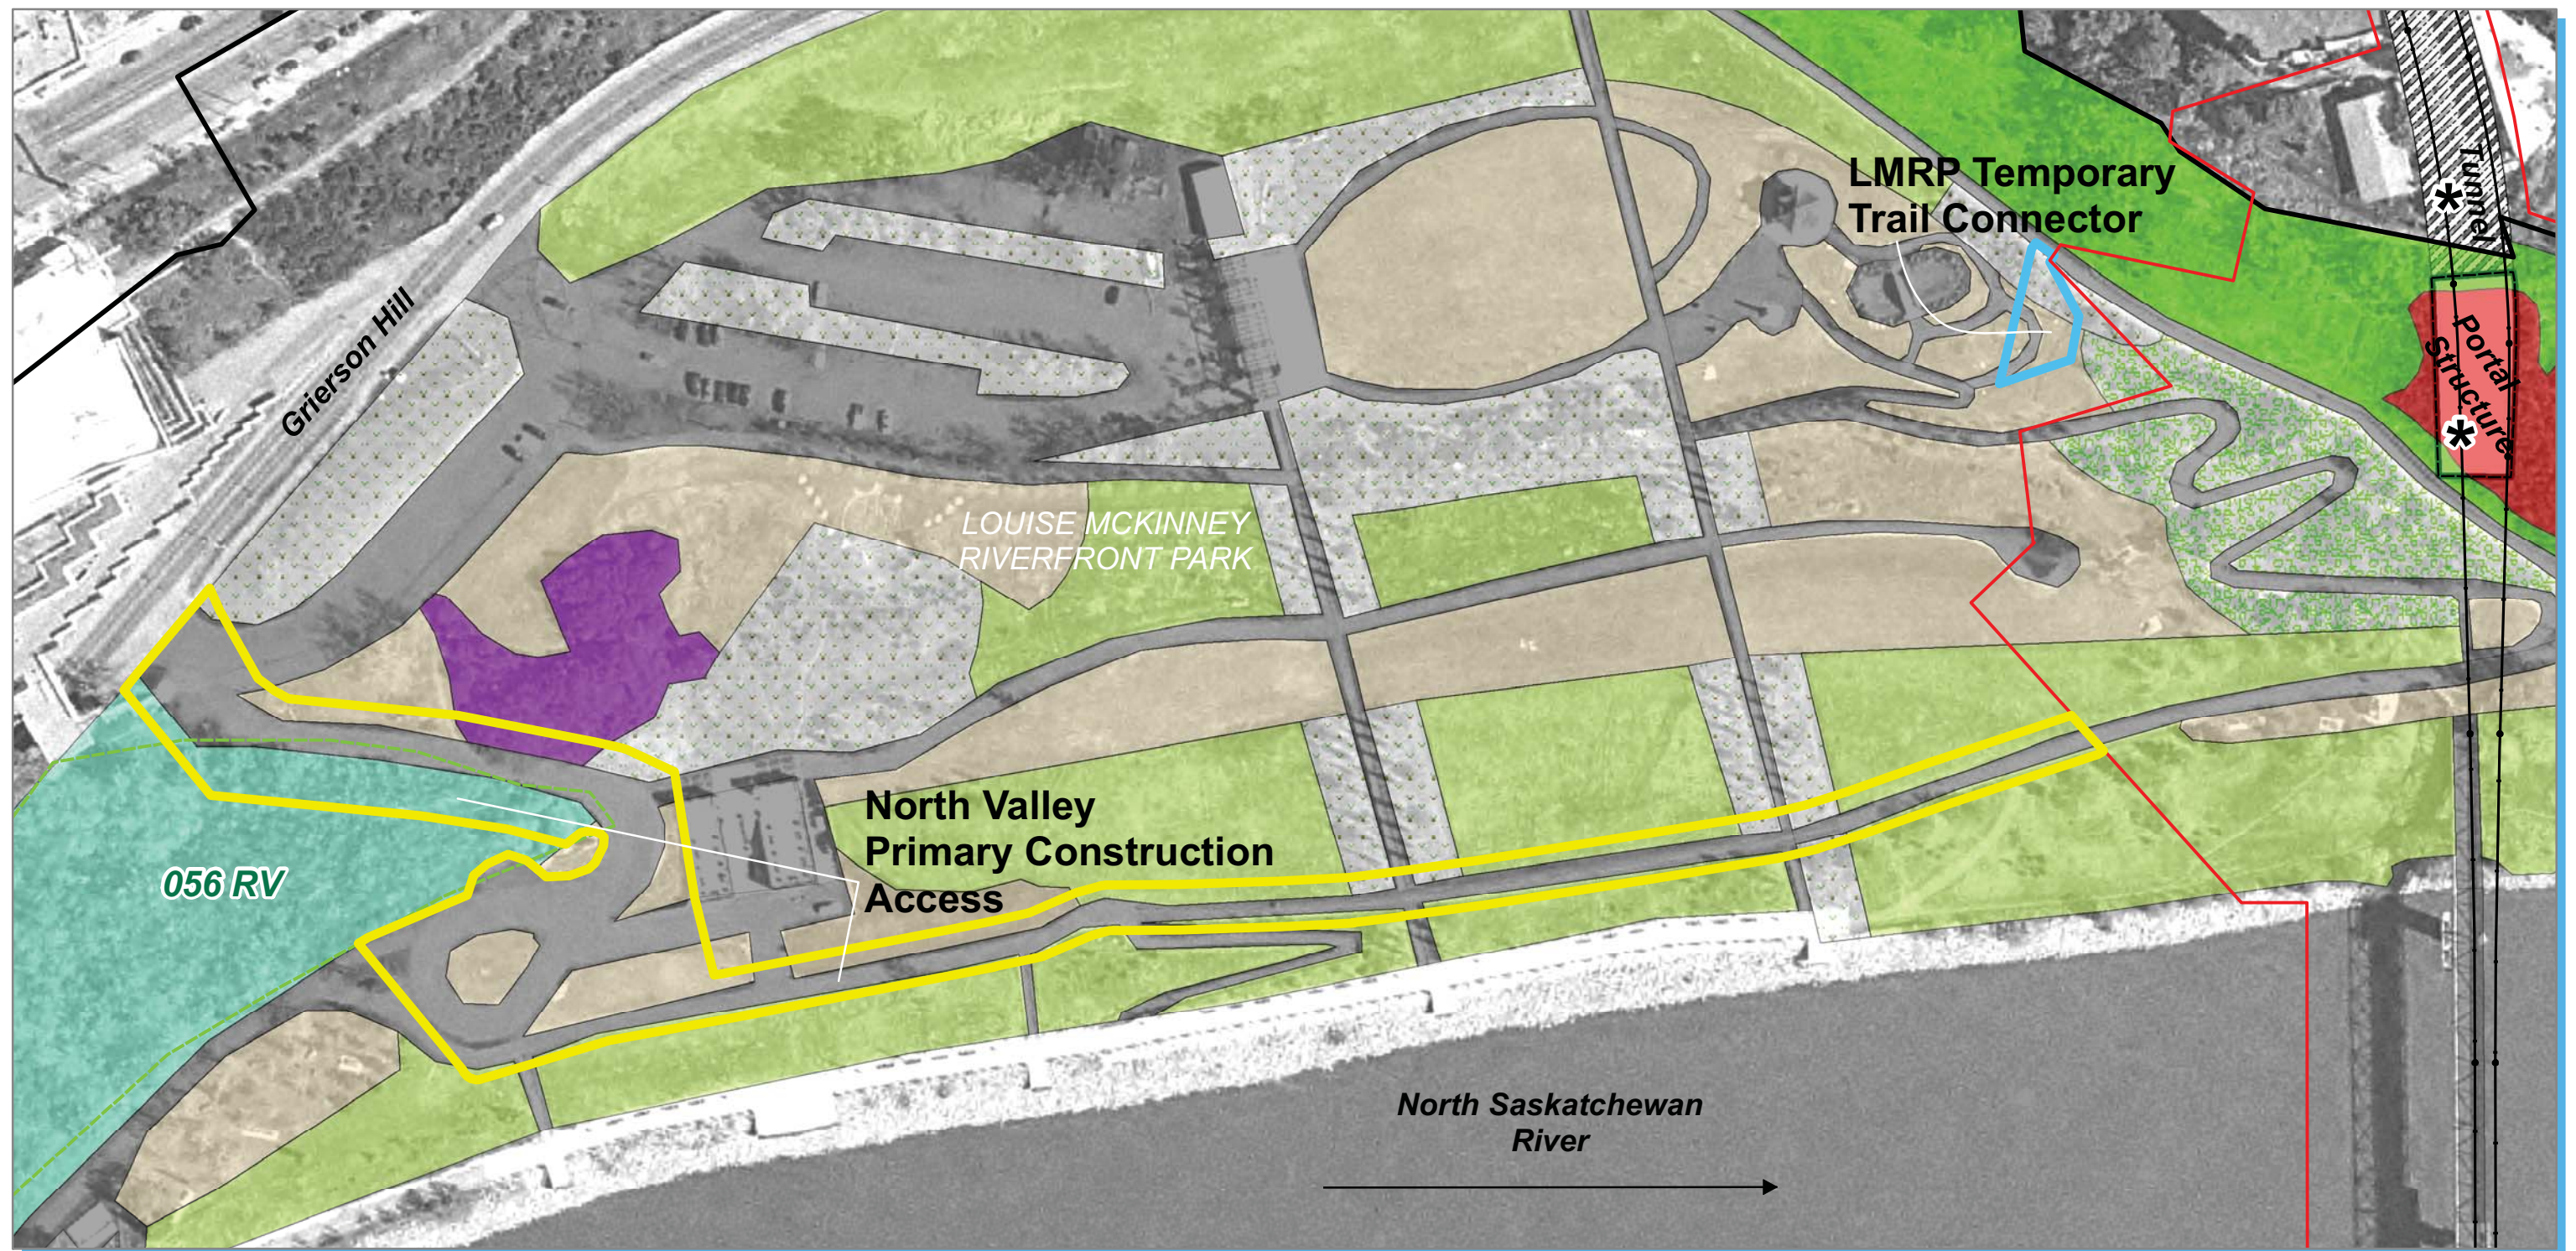
**Figure 4.3 North Valley Primary Construction Access & LMRP Temporary Trail Connector, Existing Plant Communities**

One naturalized Manitoba maple (MM) community was located in the west end of the park bordering the maintenance vehicle access road (Figure 4.3). That community was dominated by Manitoba maple, with occasional balsam poplar (*Populus balsamifera*) and red-osier dogwood (*Cornus stolonifera*). The understory was typically open, comprising reed canary grass, smooth brome (*Bromus inermis*), and quack grass (*Elytrigia repens*) (Plate 4.3). A total of 11 species was detected in this community, 7 (64%) of which were native. The remaining four species (36%) were exotic, with one noxious weed species observed. Manitoba maple is not native to this region of Alberta but has naturalized and commonly occurs in the NSRV and is often found as a sub-dominant tall shrub or tree species.

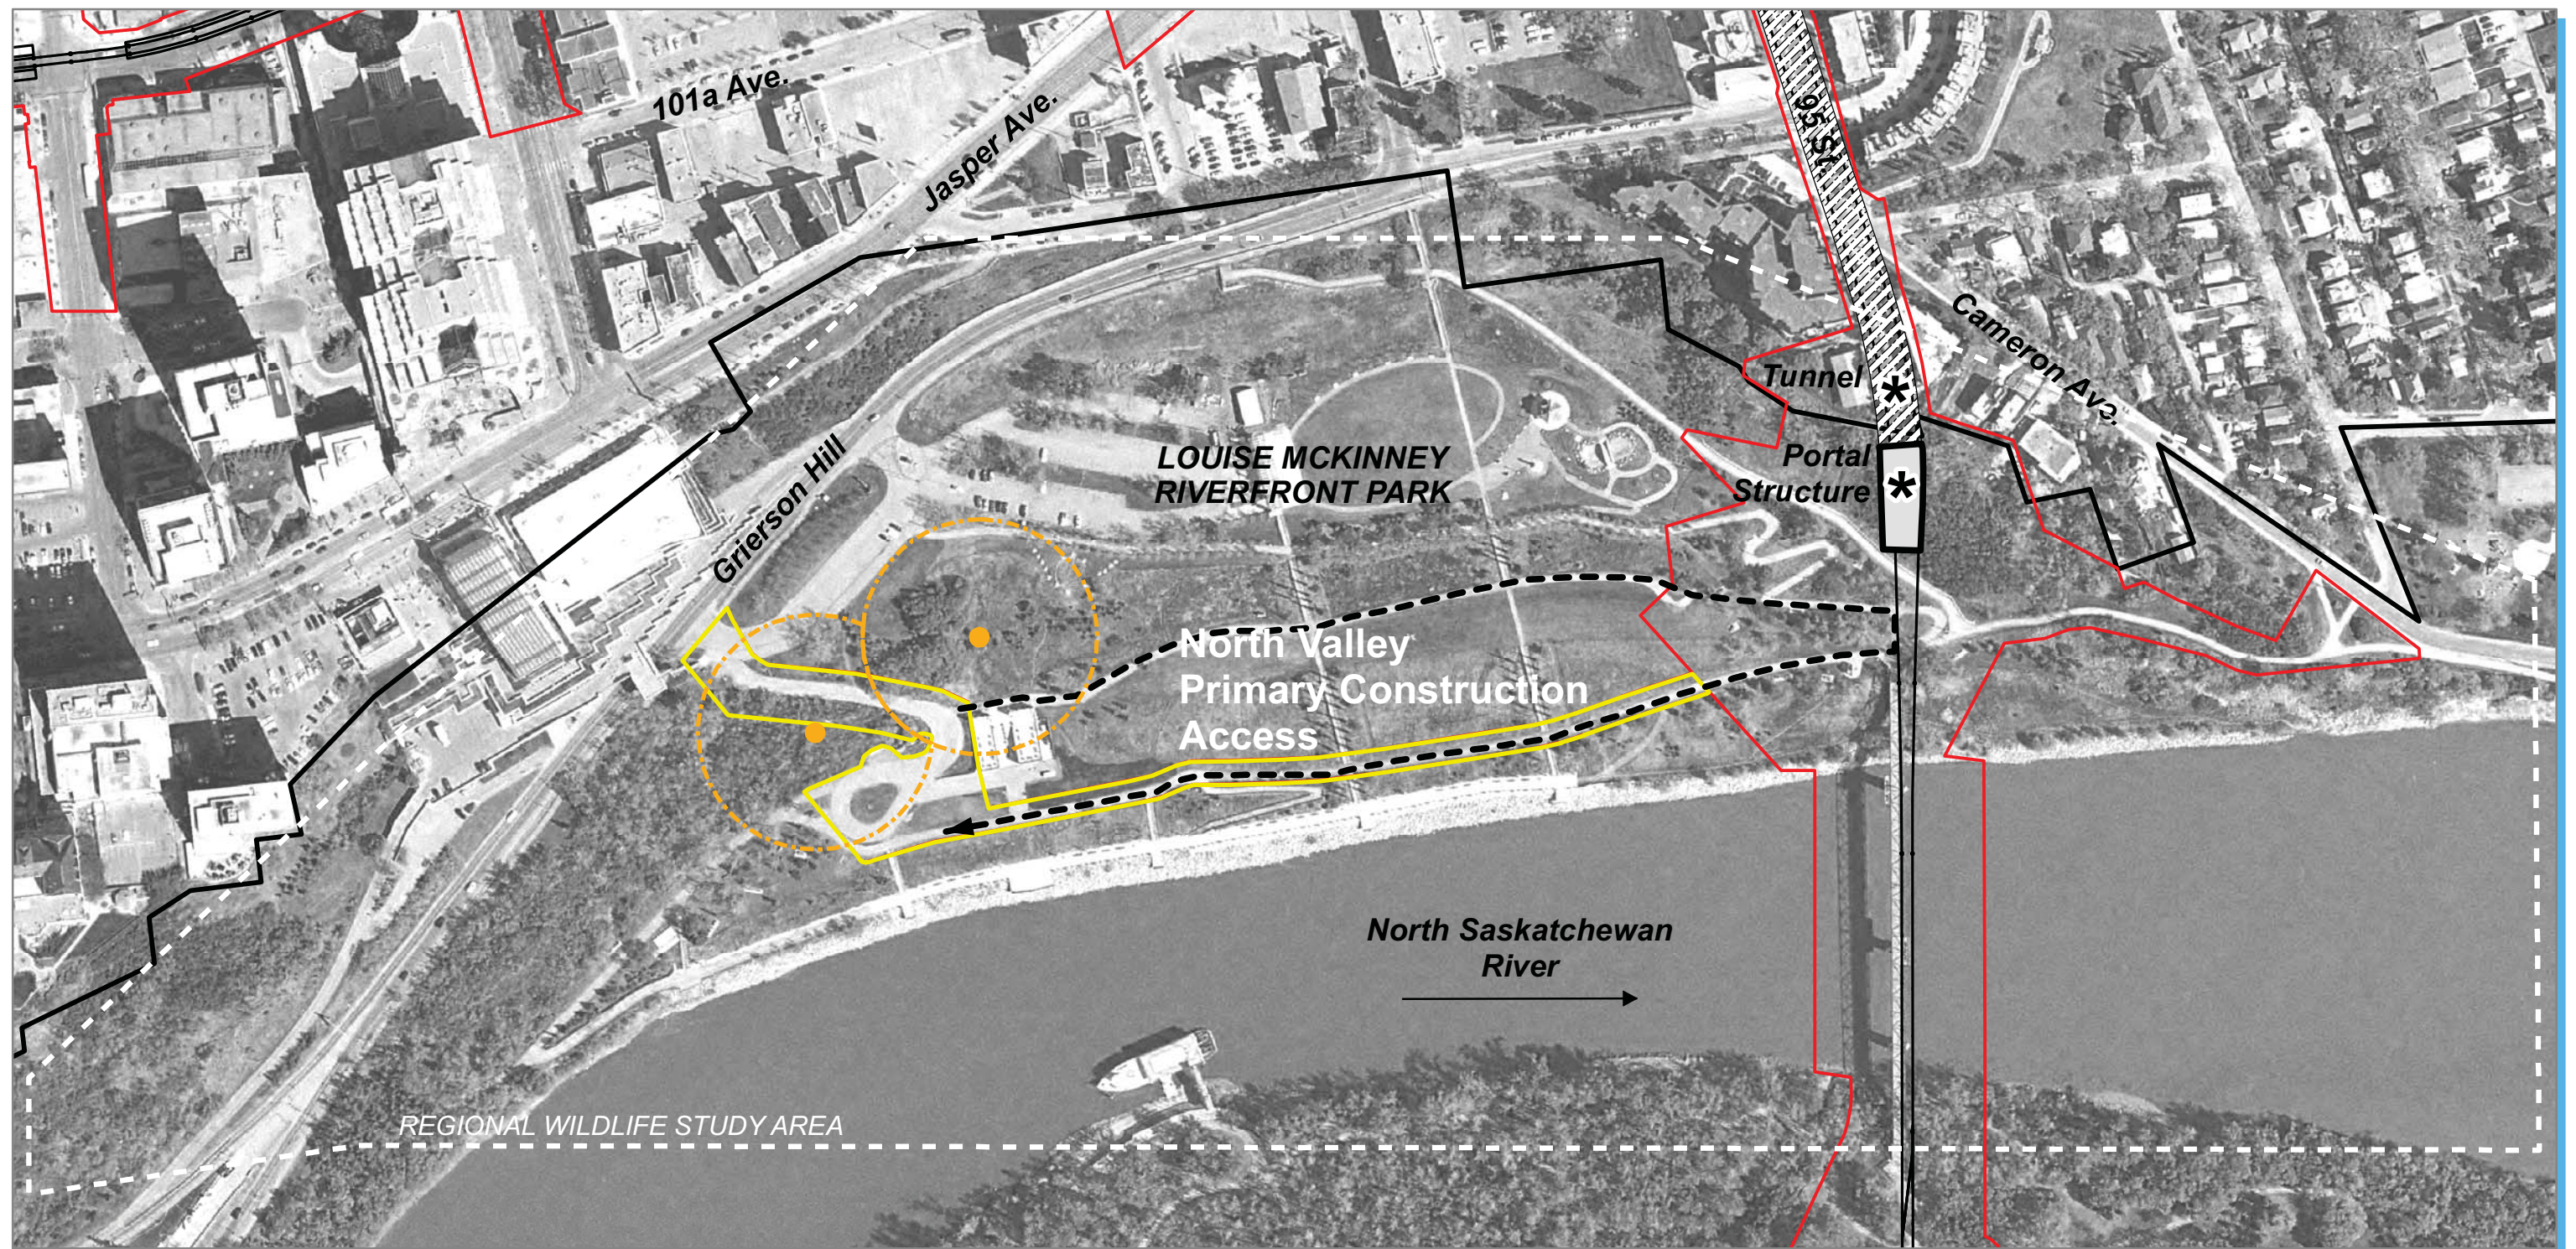
Bird Point Count Survey Location (with 50m radius plot)

**Figure 4.4 North Valley Primary Construction Access,  
Wildlife Survey Locations**

Wildlife field investigations were limited to the spring and comprised breeding bird surveys. No suitable amphibian breeding habitat was identified in the park. For bird surveys, the study area was expanded to include natural habitat adjacent to the proposed road corridor. A breeding bird survey was conducted on 17 June 2014 and repeated on 27 June 2014, to characterize breeding bird richness and abundance. Each bird survey consisted of a point count at each of two stations located within areas of natural vegetation (i.e., the PMM and MM plant communities) and a meandering search of areas supporting manicured vegetation (Figure 4.4). Each point count was an eight-minute survey, wherein all birds detected (seen or heard) within a 50 m radius were recorded. The meandering survey consisted of walking SUPs in the vicinity of the proposed primary construction access road at a rate of approximately 40 m/s and recording all birds detected using habitat in that area. Data from the bird surveys were reported as the maximum number of individuals of each species detected on 17 or 27 June 2014, and the total number of surveys that each species was detected in (out of four point counts and two meandering surveys). All other animal observations or signs were documented and described in terms of presence and habitat use. All habitat types present were briefly described and qualitatively assessed with respect to habitat potential.

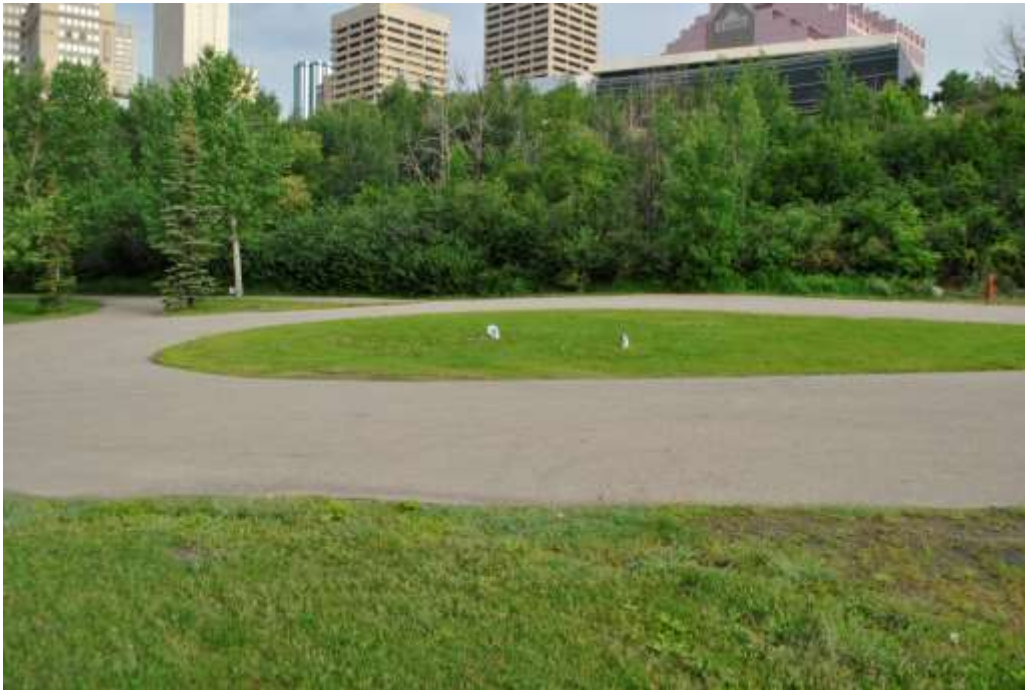
**Plate 4.9. Maintenance/service vehicle road turn-around, looking north (July 2014). This road does not provide vehicular park access or parking for the general public.**

- A paved maintenance/service vehicle road and turn-around that connects to the gravel east-west park maintenance road and recreational businesses and public washrooms. It also facilitates regular holding tank service. This road does not provide vehicular park access or parking for the general public (Plate 4.9)

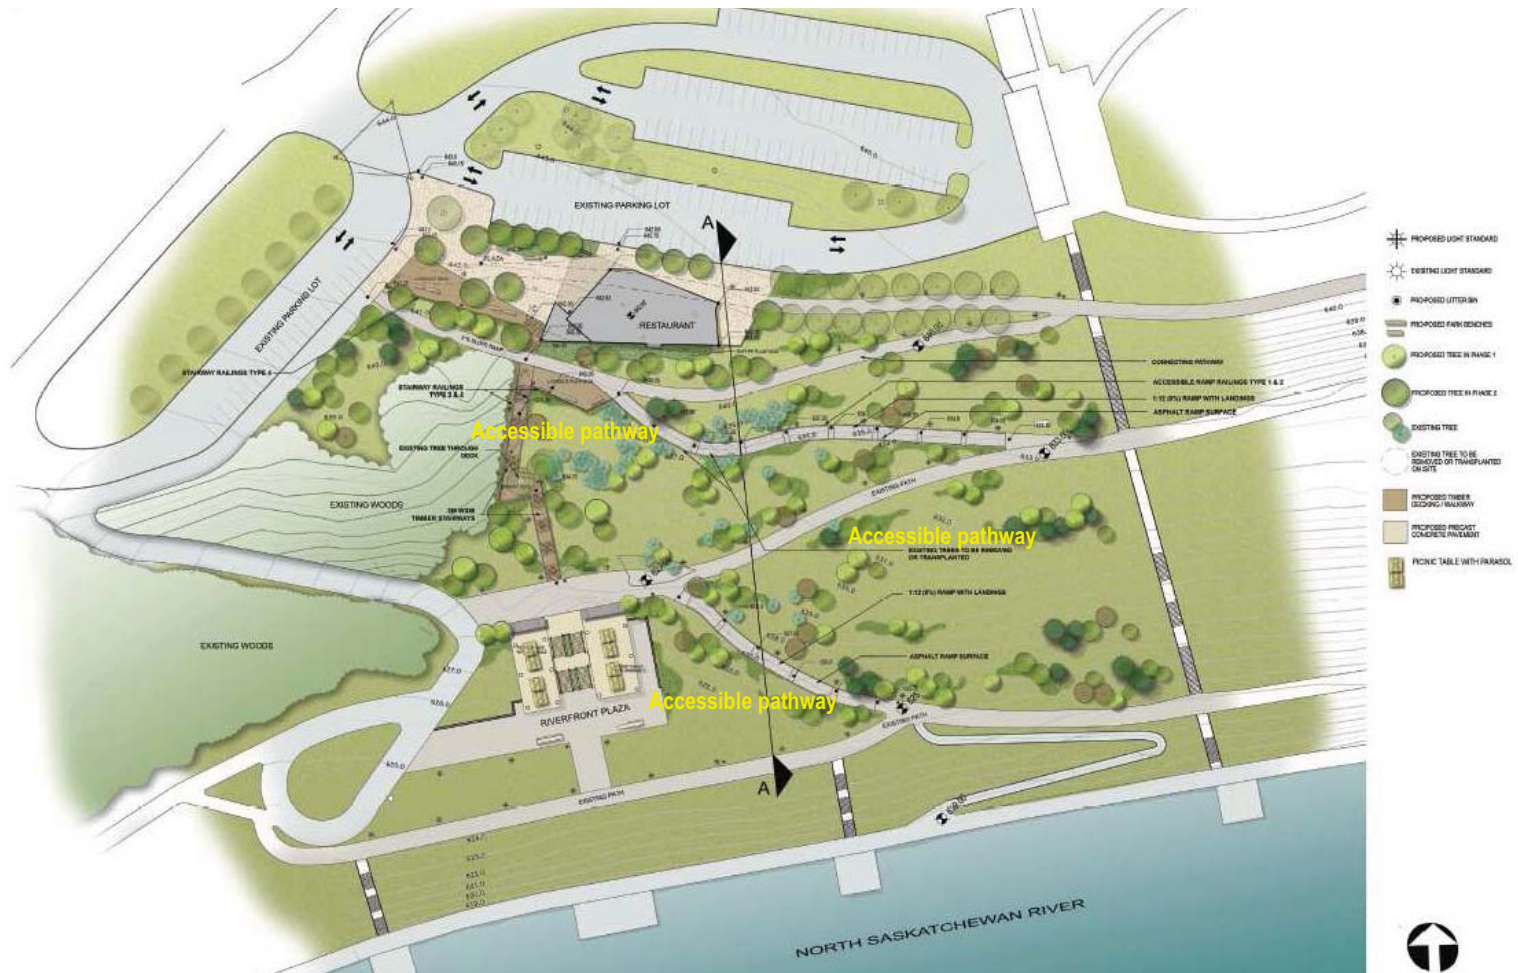
Figure 4.5

## Site Plan - Louise McKinney Riverfront Park

- An additional, fully accessible north-south pathway is planned for construction in 2015 by City of Edmonton Community Services (Figure 4.5), to provide

- increased accessibility to the Riverfront Plaza, the SUP and the Riverfront Promenade and to replace the accessible trail in the east park that will be temporarily closed by LRT construction. Since trail construction is scheduled to be undertaken prior to Valley Line LRT construction, this assessment assumes this trail to be an operating park facility that must be accounted for by the proposed primary construction access road.
- An additional staircase connecting the above-mentioned accessible path to the Riverfront Plaza is also anticipated to be constructed by Community Services in 2015 (Figure 4.5).

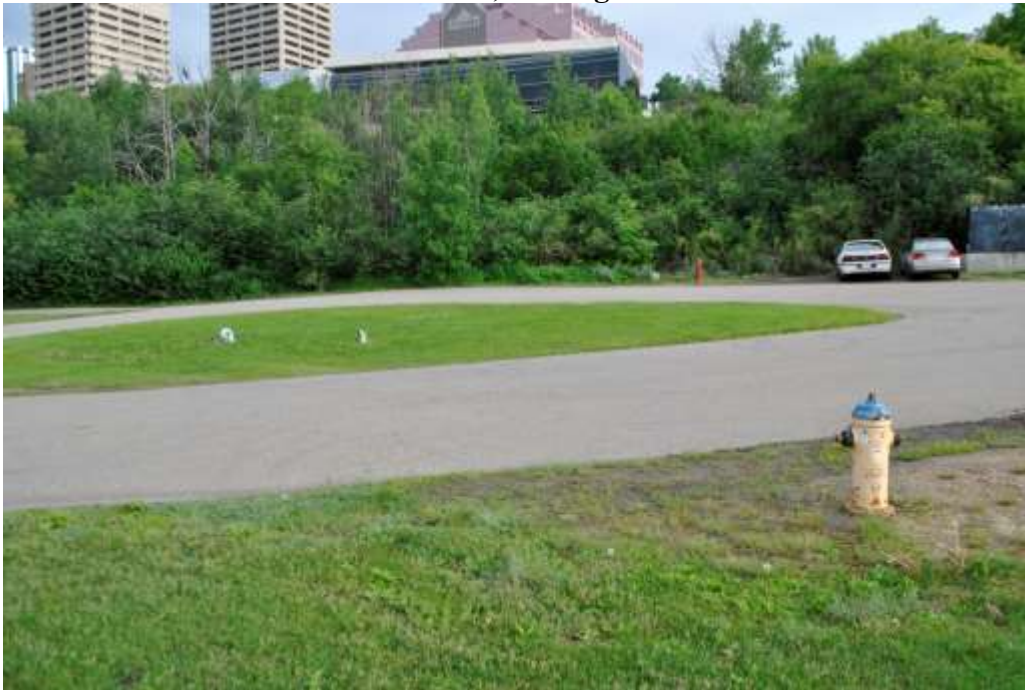
**Plate 4.16. A subsurface holding tank, an associated sanitary line and a monitoring cable are located west of the Riverfront Plaza building.**

Multiple buried utility lines (and associated surface components) are present in the proposed construction access road project area (Appendix F). Several buried EPCOR electrical lines are within the project area including one running parallel with the Trans Canada SUP at the base of the slope, which terminates at an electrical panel near the east end of the Promenade. EPCOR lines also travel north, east and south and intersect with the project component area. Several utility panels/boxes are located along the vehicle access road turnaround (Plate 4.15). Two storm sewer lines are located across and adjacent to the entrance to the maintenance access road to the Riverfront Plaza building and two additional storm sewer lines are documented as running north/south across the valley slope east of the plaza building. A subsurface holding tank, an associated sanitary line and a monitoring cable are located west of the Riverfront Plaza building, with surface connections and the majority of the tank located in the grassed centre of the vehicle turn-around (Plate 4.16). This holding tank is anticipated to be replaced with a lift station and associated sanitary lines in 2015. One north-south water main and fire hydrant are situated immediately west of the Riverfront Plaza. An ATCO gas line is located under the west side of the vehicle access road to LMRP, within the project component lands. There are no identified overhead utilities. While some of the utility relocations required for the Valley Line are already underway, no relocation work has been undertaken in support of the proposed primary construction access road in LMRP.
