**City of Edmonton**  
**Valley Line Stage 1 – Light Rail Transit (LRT) Project**  
**Environmental Impact Screening Assessment Update**  
**Final Report**

Project Number EP - 576

February 2015

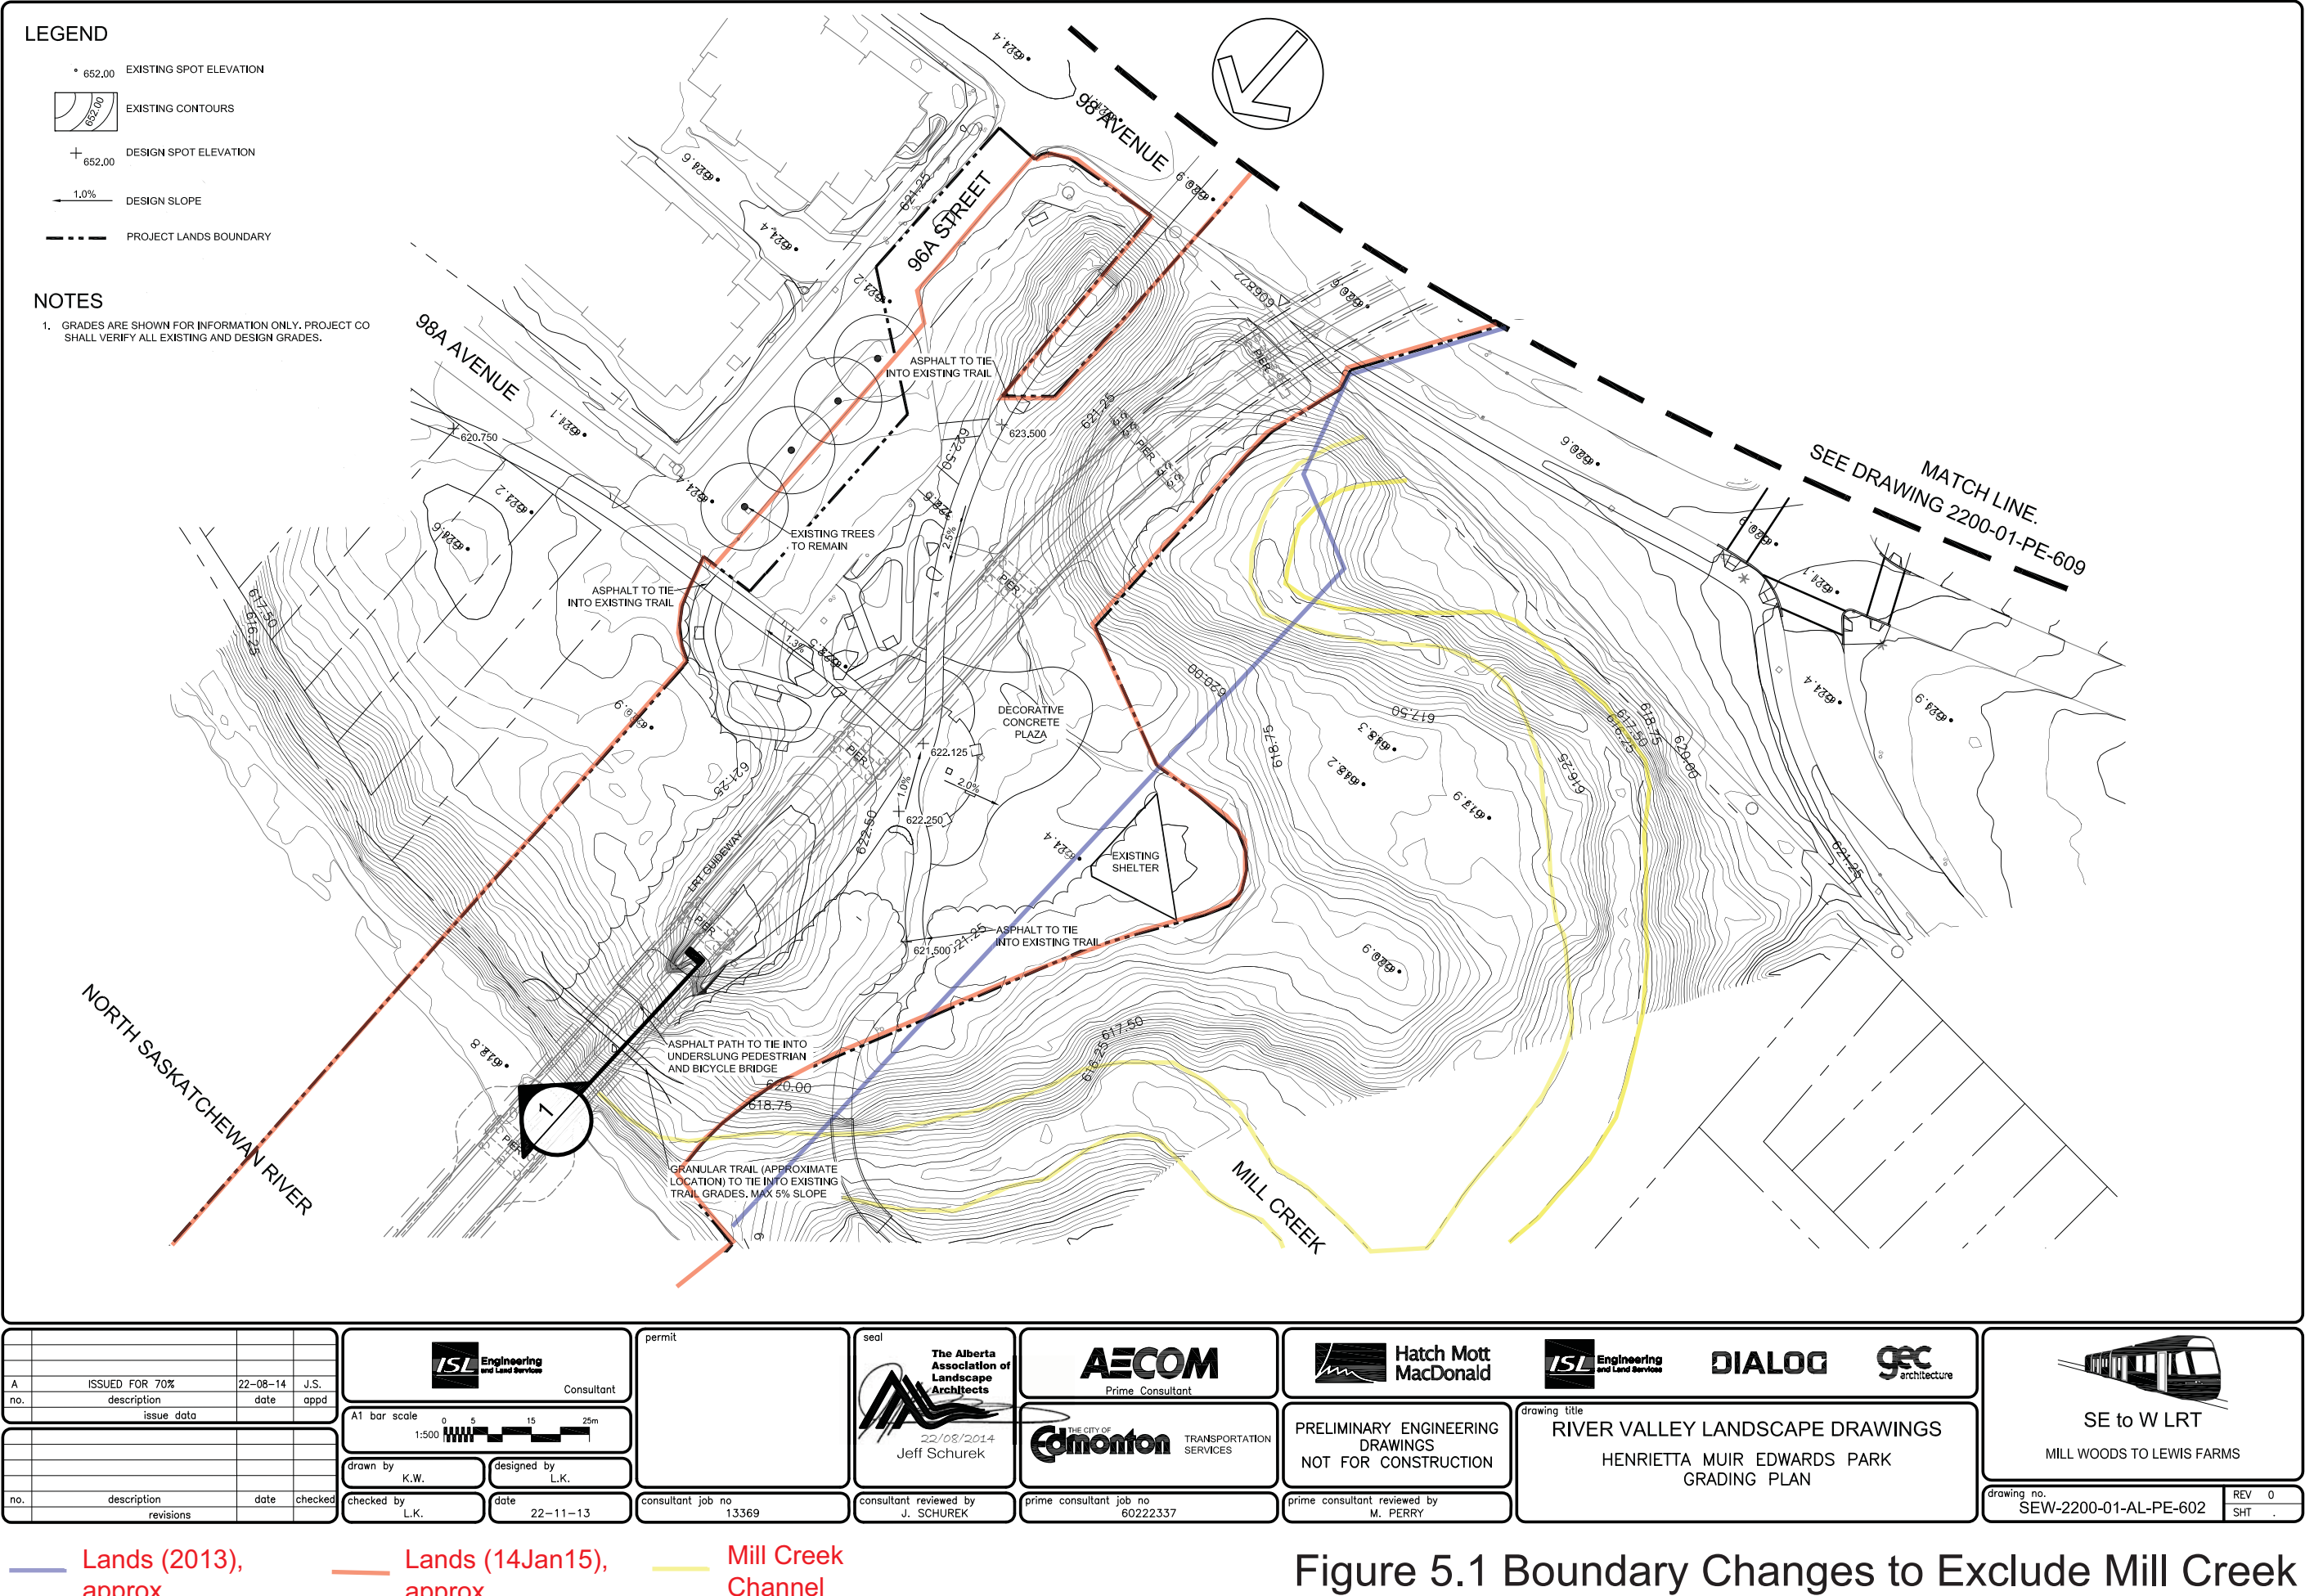
\*Adapted by Spencer Environmental from base information provided by CTP.

Lands to be removed from the Project Area support mature native forest, suggesting native soils with no recent history of disturbance. These lands slope to the west toward an abandoned reach of Mill Creek (Figure 5.1), and show some slight terracing. This reach of Mill Creek, north of 98 Avenue, was isolated from upstream reaches as a result of a full creek diversion in the 1960s and significant road development. Nevertheless, the abandoned channel remains evident and short sections intersect with these small parcels.

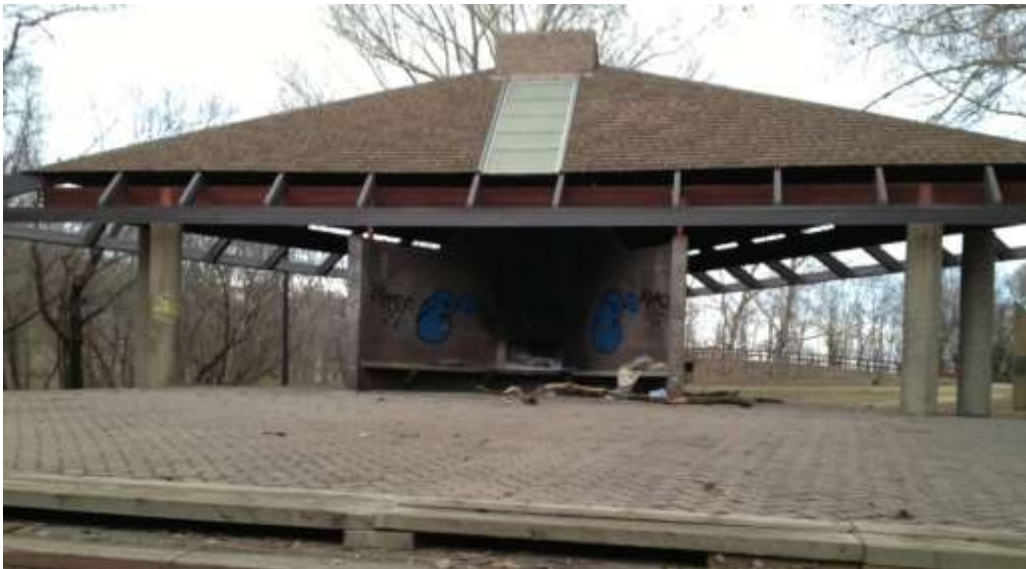
**Plate 5.8. The picnic shelter and hard surface appear to be in disrepair and public fireplaces installed as part of the picnic shelter structure have been boarded over (April 2013).**

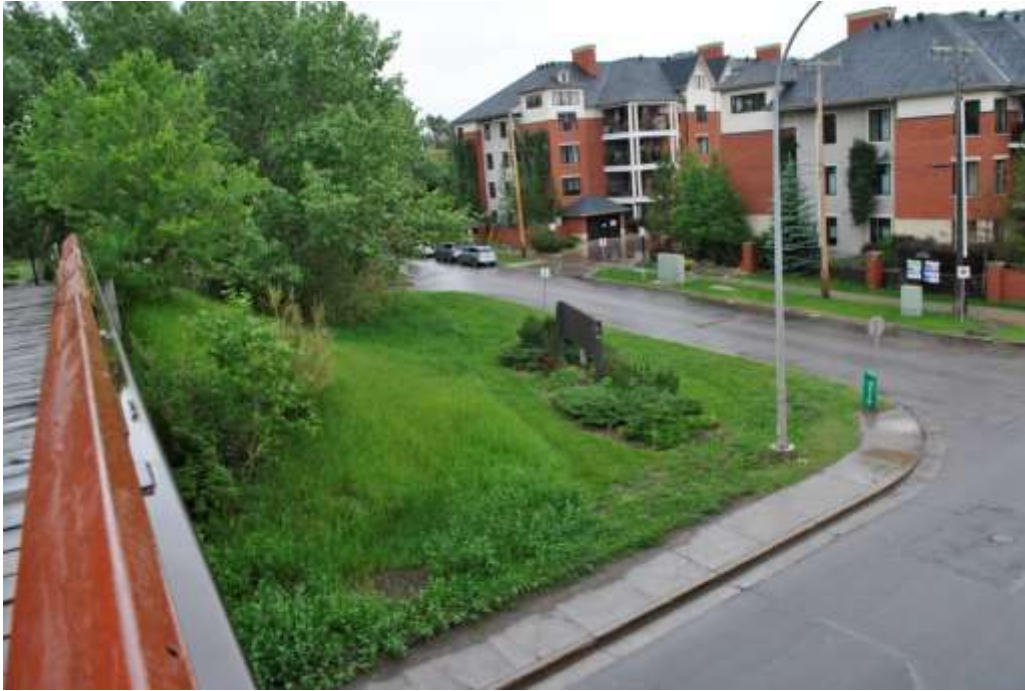
**Plate 6.1: Bridge abutment fill in the parcel to be added to the Project Area, looking northeast (June 2014).**

Soils in this parcel have likely been subject to past disturbance associated with the construction of the existing 98 Avenue Pedestrian Bridge and associated landscaping. The soils present appear to be fill material. A constructed embankment associated with the bridge abutment occupies much of the area (Plate 6.1). The Phase 1 ESA undertaken for the Valley Line LRT did not identify issues pertaining to soil contamination or slope stability for these lands (ConnectEd Transit Partnership 2013a). Geotechnical studies have not been undertaken as there is no intended infrastructure in this area.

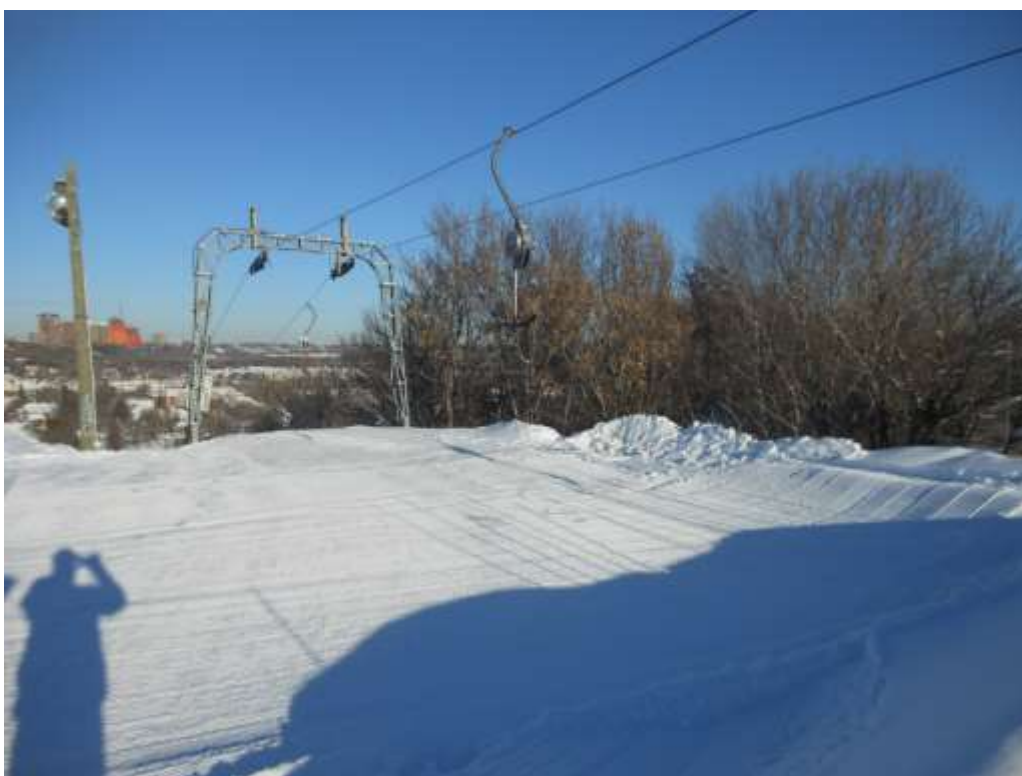
**Plate 8.1. Sloping terrain of existing T-bar run to be re-graded. (Jan. 2015).**

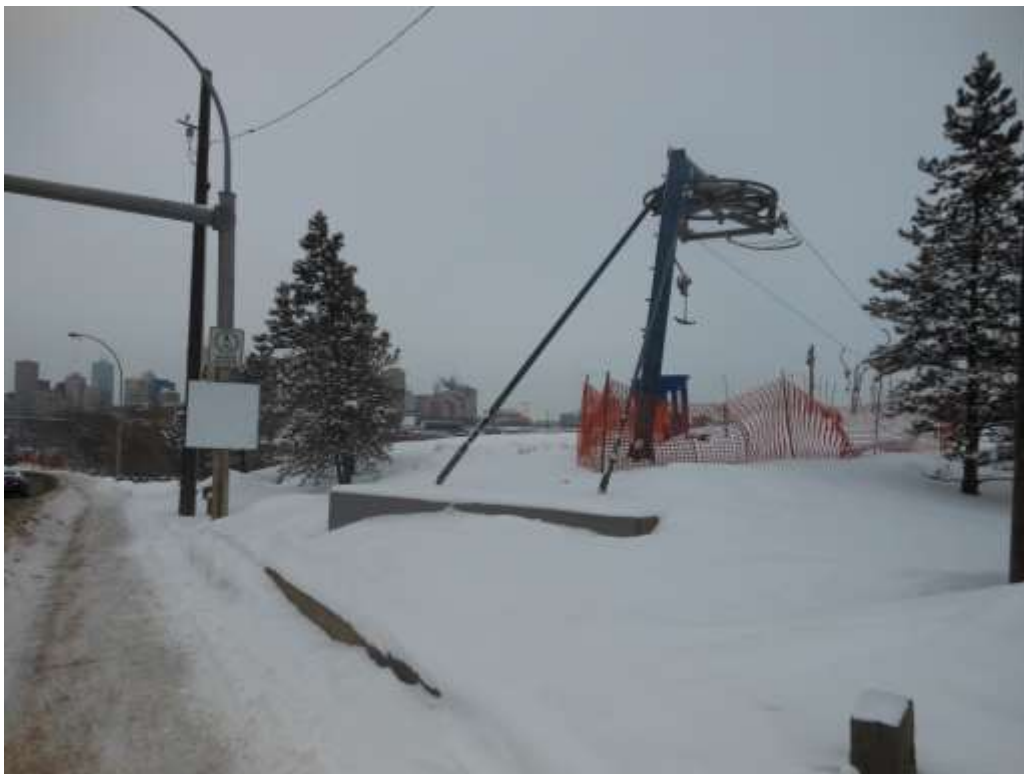
**Plate 8.4. The existing T-bar terminus is clearly visible from Connors Road, dominating views at the crest of the hill, looking northwest (Jan. 2015).**

This project component area is dominated by manicured lawn; the small parcel is screened by planted spruce at the corner of Connors and Cloverdale Road and a linear natural tree stand descending the hill. Nearby residents along Strathern Drive, to the immediate east and residences along 95 Avenue, to the south have views of this area. Motorists along Connors Road and Cloverdale Hill Road also have views of this area. The existing T-bar terminus is clearly visible from Connors Road, dominating views at the crest of the hill (Plate 8.4)

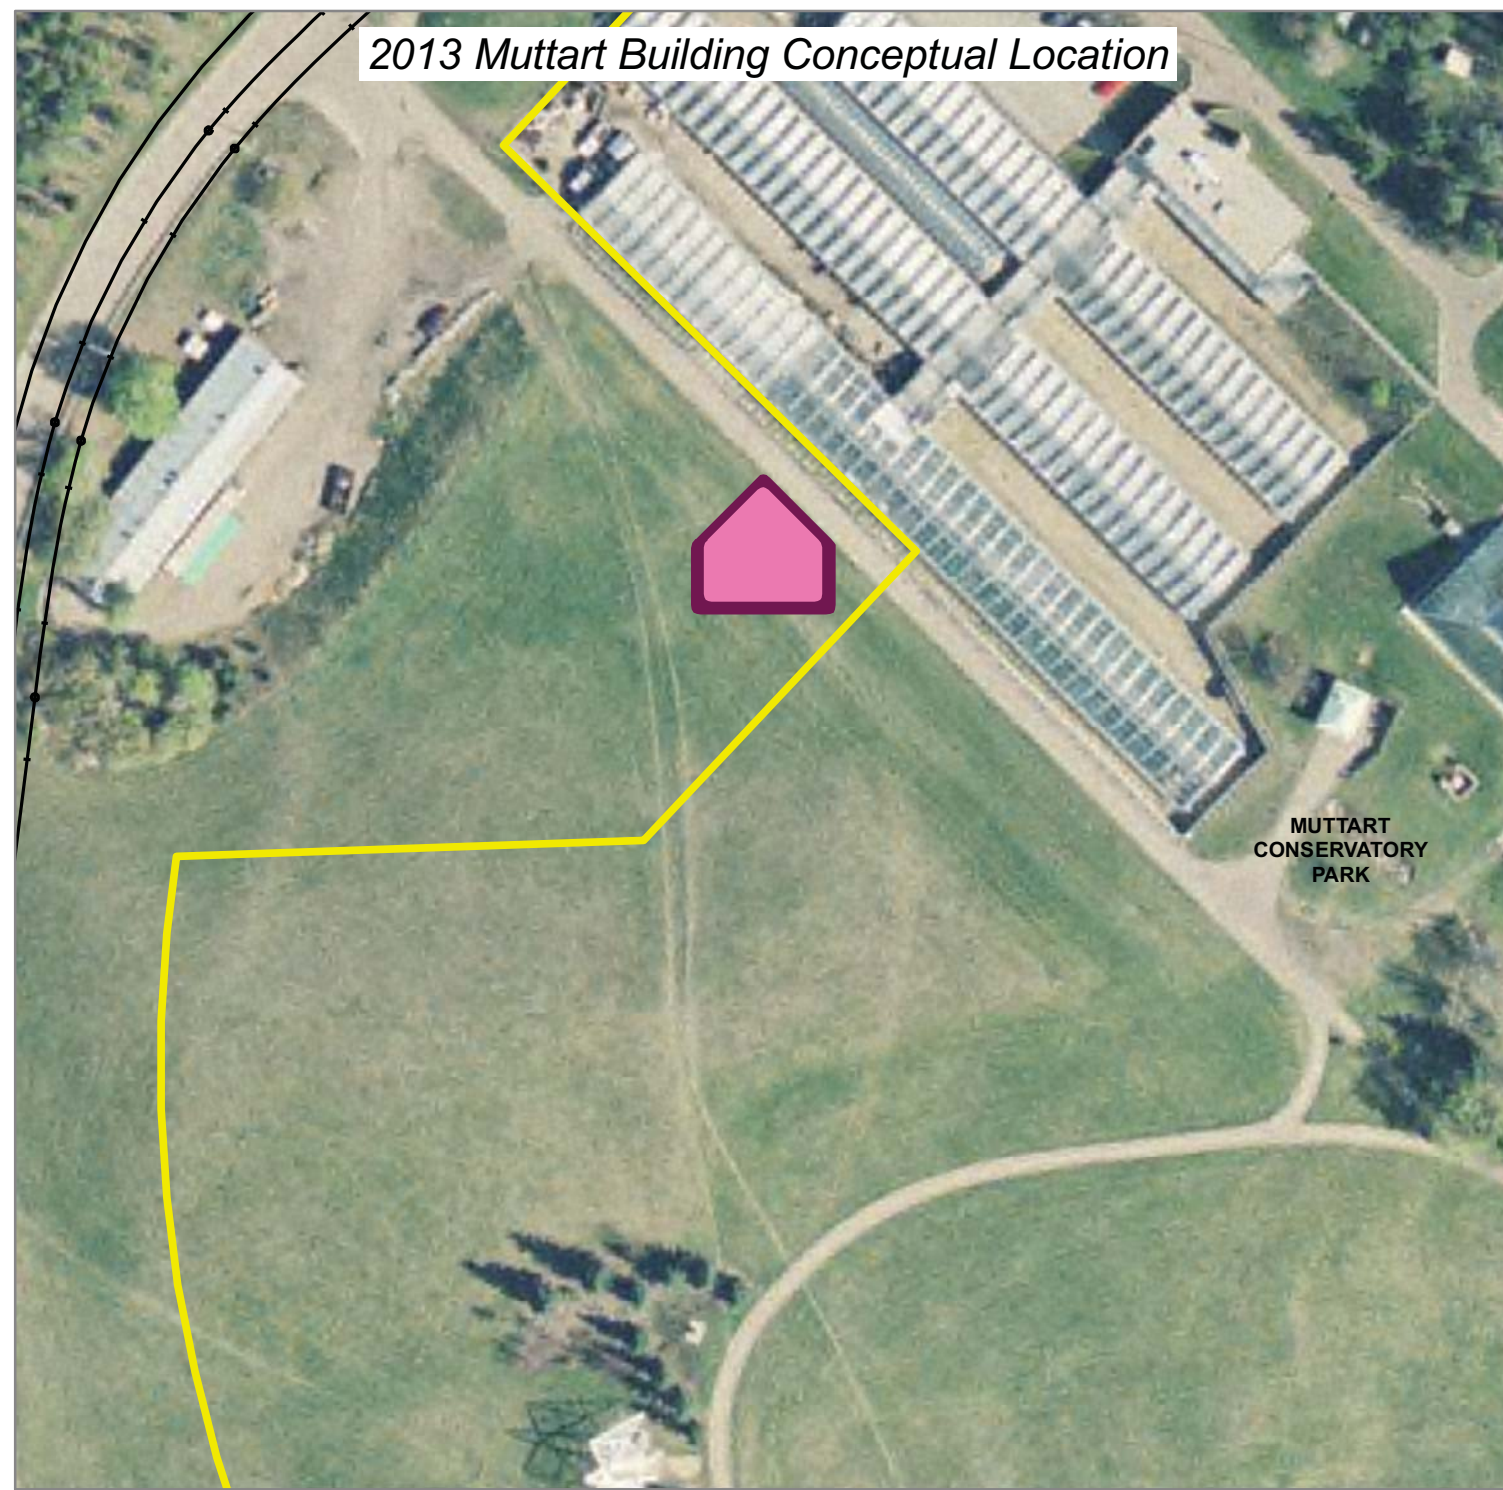
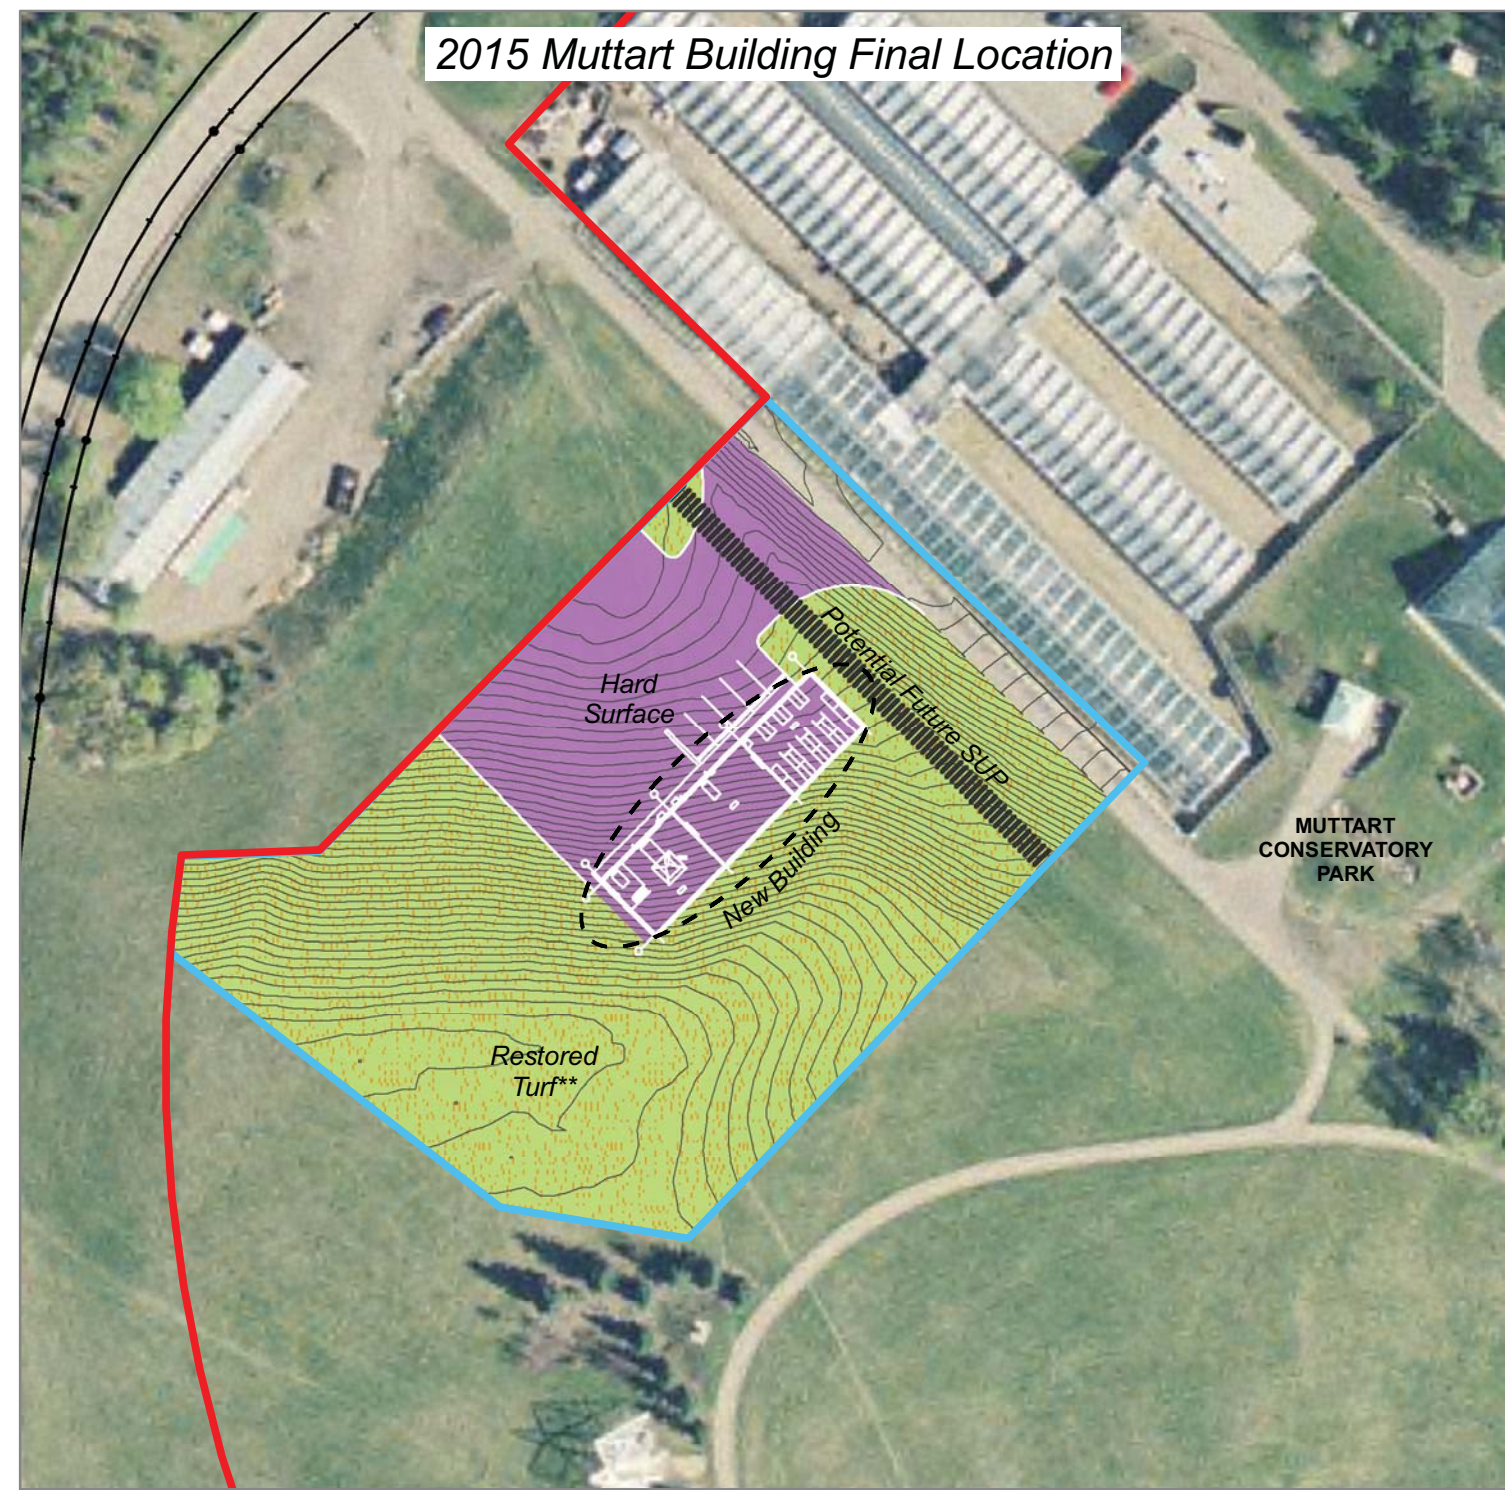
**Figure 10.1 Muttart Storage Building Replacement Site Plan**

- 2013 Project Area
- Replacement Muttart Storage Building (as shown in 2013 EISA)
- Valley Line LRT Alignment (Reference Design)

- Project Area
- Construction Footprint
- Existing Contours
- Valley Line LRT Alignment (Reference Design)

\*\*Potential for some additional landscaping features near new building

The location of the replacement Muttart Conservatory Storage Building (MCSB) has shifted approximately 40 m to the southeast of its previously approved location (Figure 10.1). The new building, ancillary facilities (parking and access) plus the necessary site re-grading will disturb an additional area totaling 6,353 m<sup>2</sup> (0.64 ha). Lands to be disturbed consist entirely of manicured lawn and one SUP situated along the existing west margin of the Muttart working greenhouses. Minor realignment of the SUP will be required. Construction activities associated with this project component are planned to be undertaken by the City in summer and autumn of 2015.

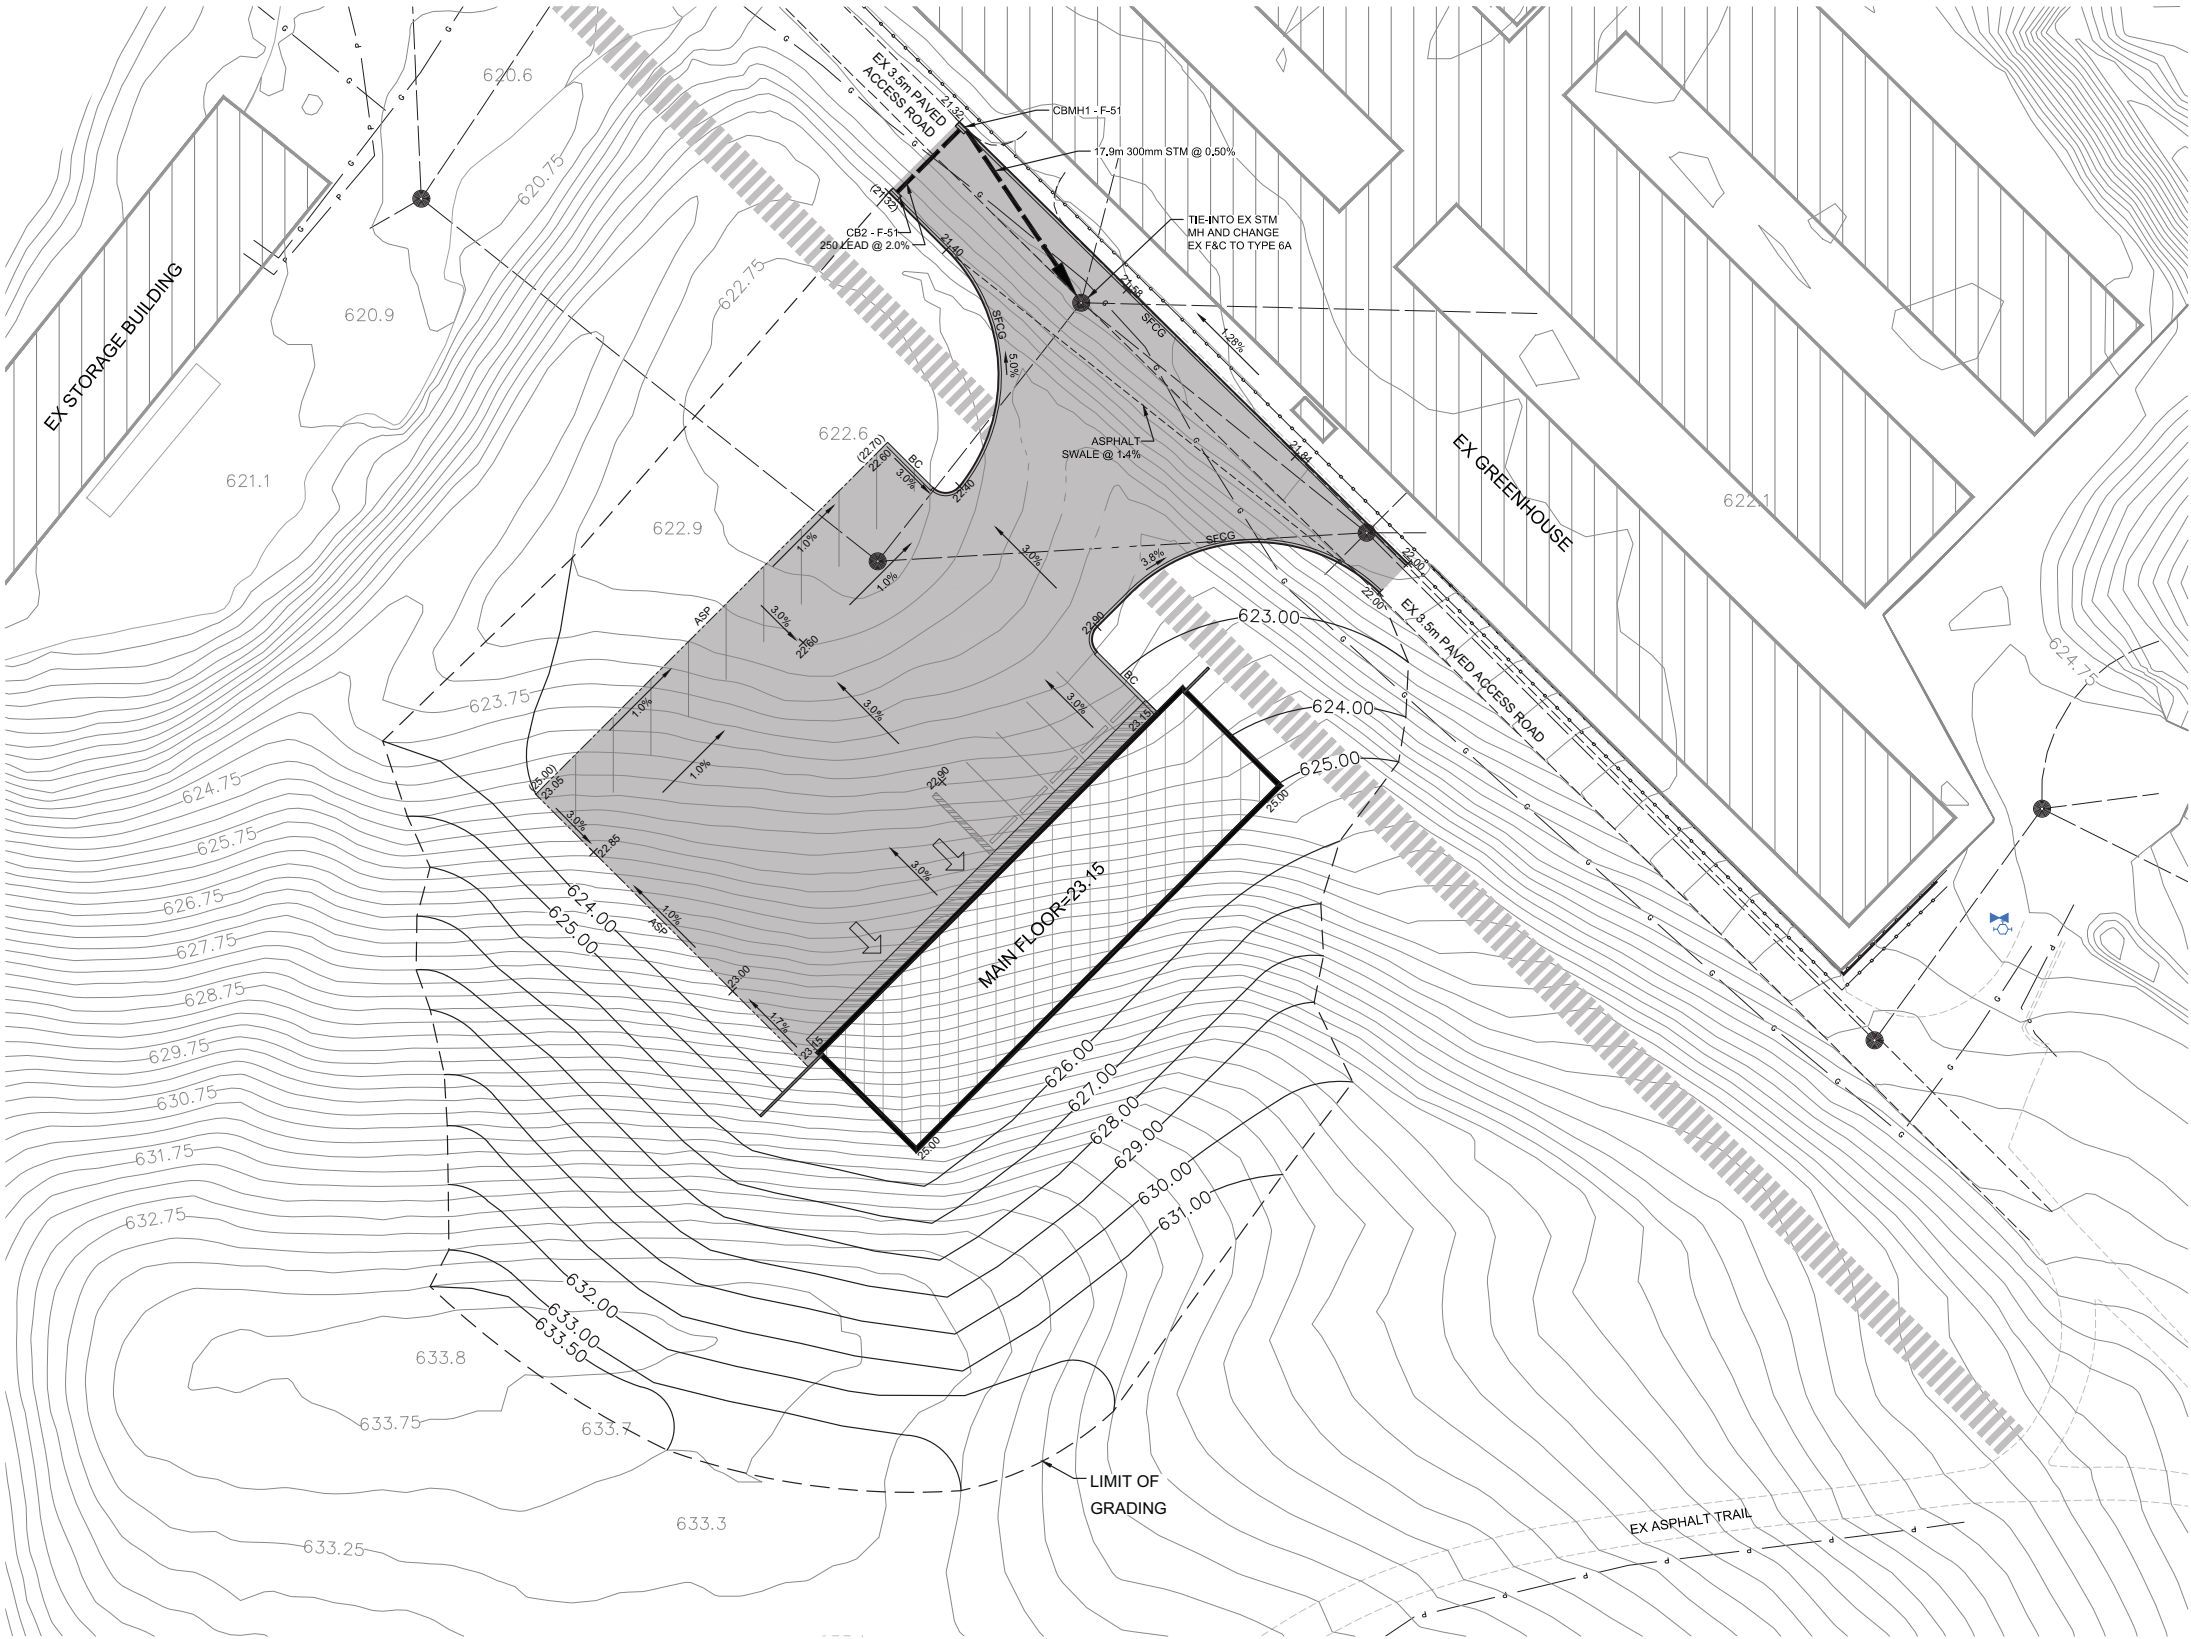
Figure 10.2

SUBSTRUCTURE TABLE			
AREA	MATERIAL	DEPTH	COMPACTION
HEAVY DUTY PAVEMENT	Asphalt Concrete Pavement (ACF-HT)	100mm	97% M.D
	Crushed Gravel Base Course (20 mm)	300mm	100% S.P.D
	Subgrade with 10kg/m <sup>2</sup> cement	150mm	100% S.P.D

This project component will involve soil stripping and grading, including cutting into a hill and the project therefore has potential to adversely affect soils (Figure 10.2).

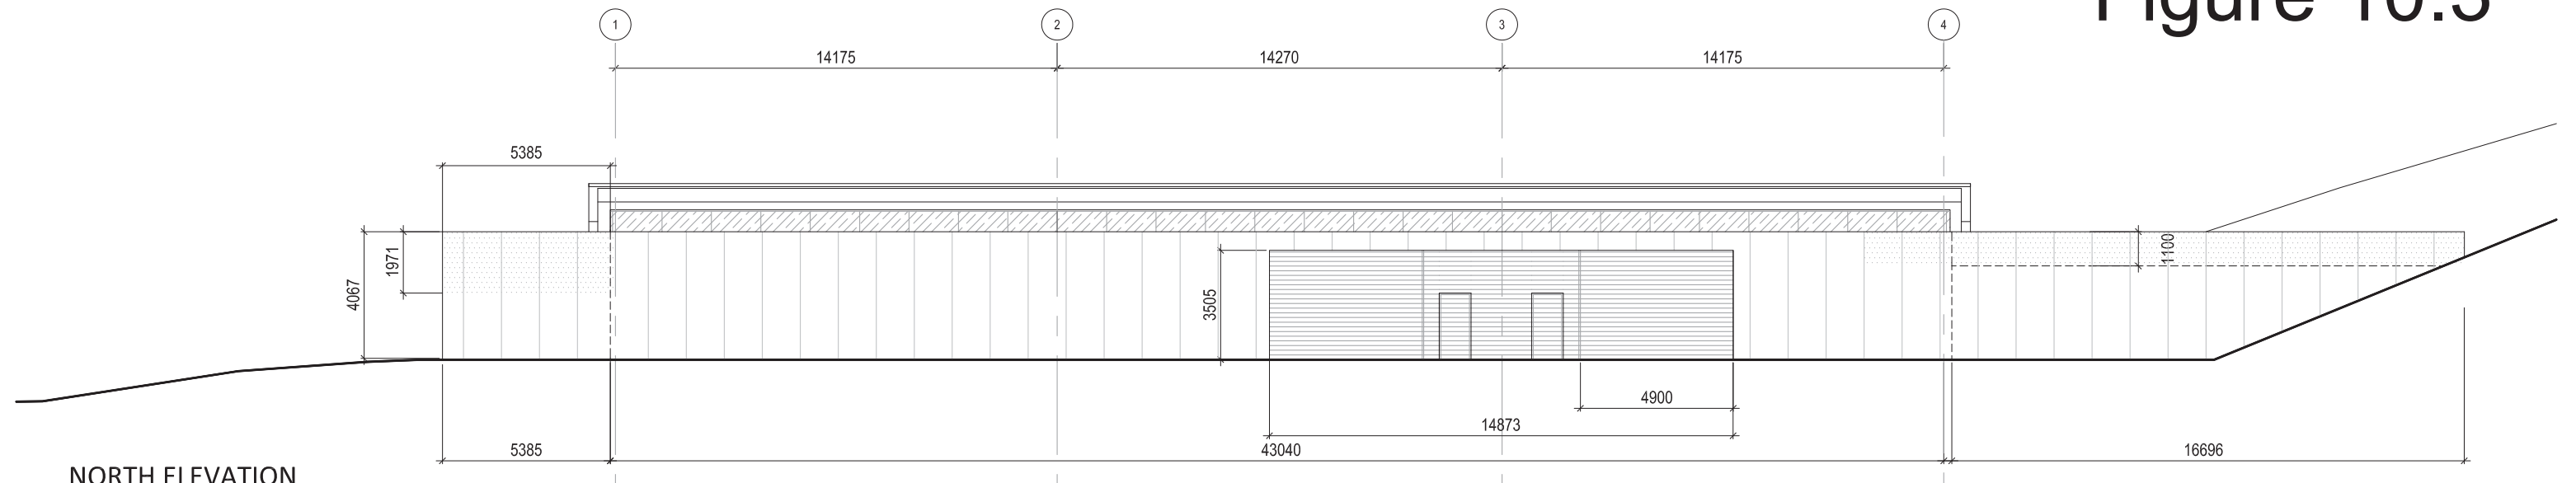
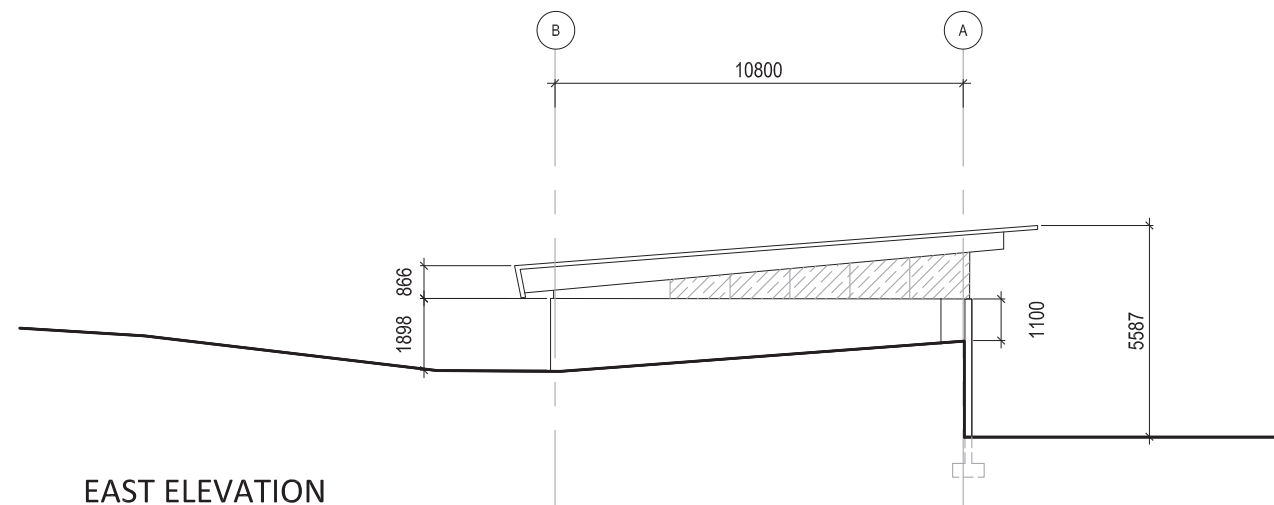
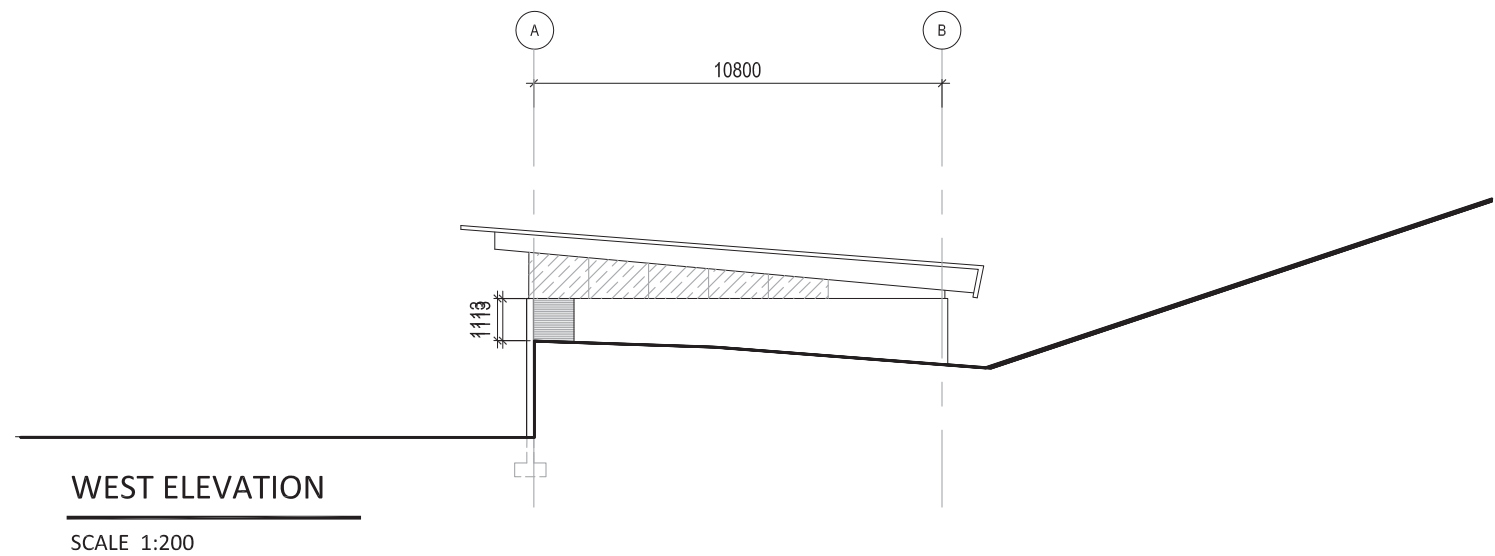
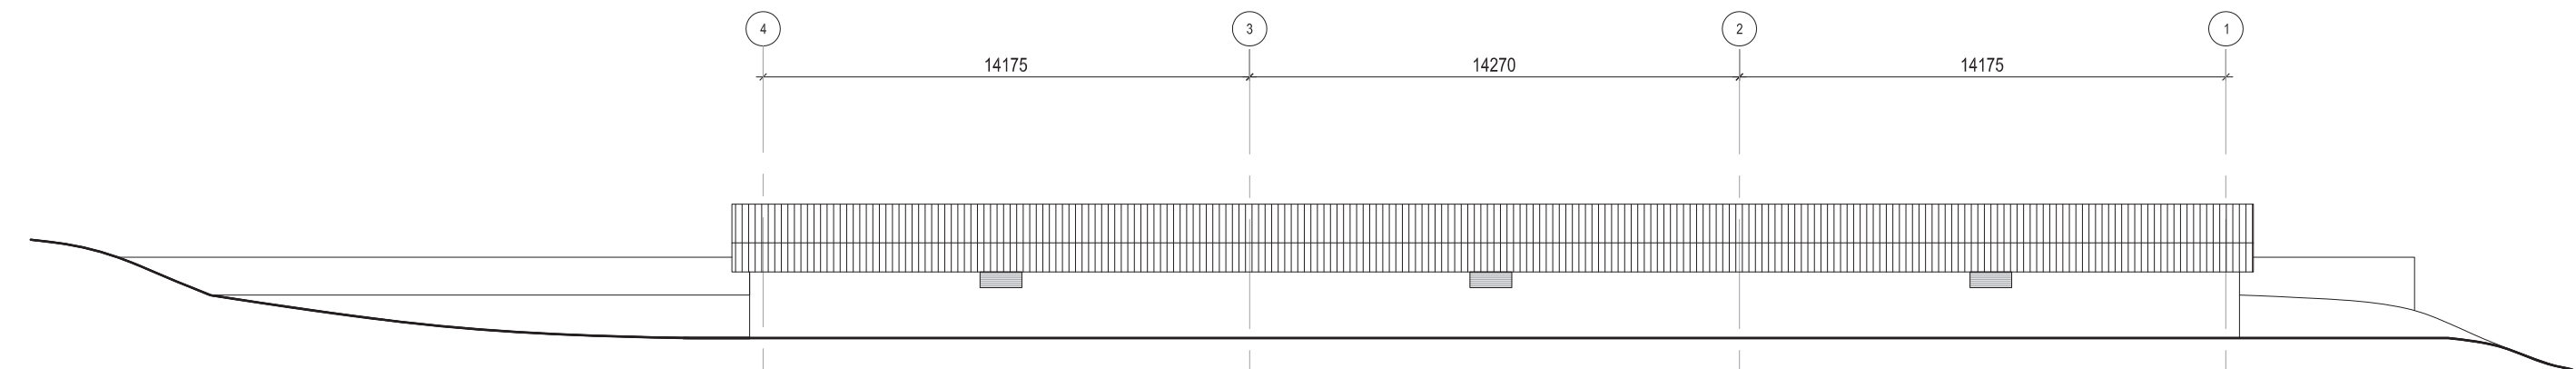
# Figure 10.3

## MUTTART CONSERVATORY STORAGE BUILDING
