**City of Edmonton**  
**Valley Line Stage 1 – Light Rail Transit (LRT) Project**  
**Environmental Impact Screening Assessment Update**  
**Final Report**

Project Number EP - 576

February 2015

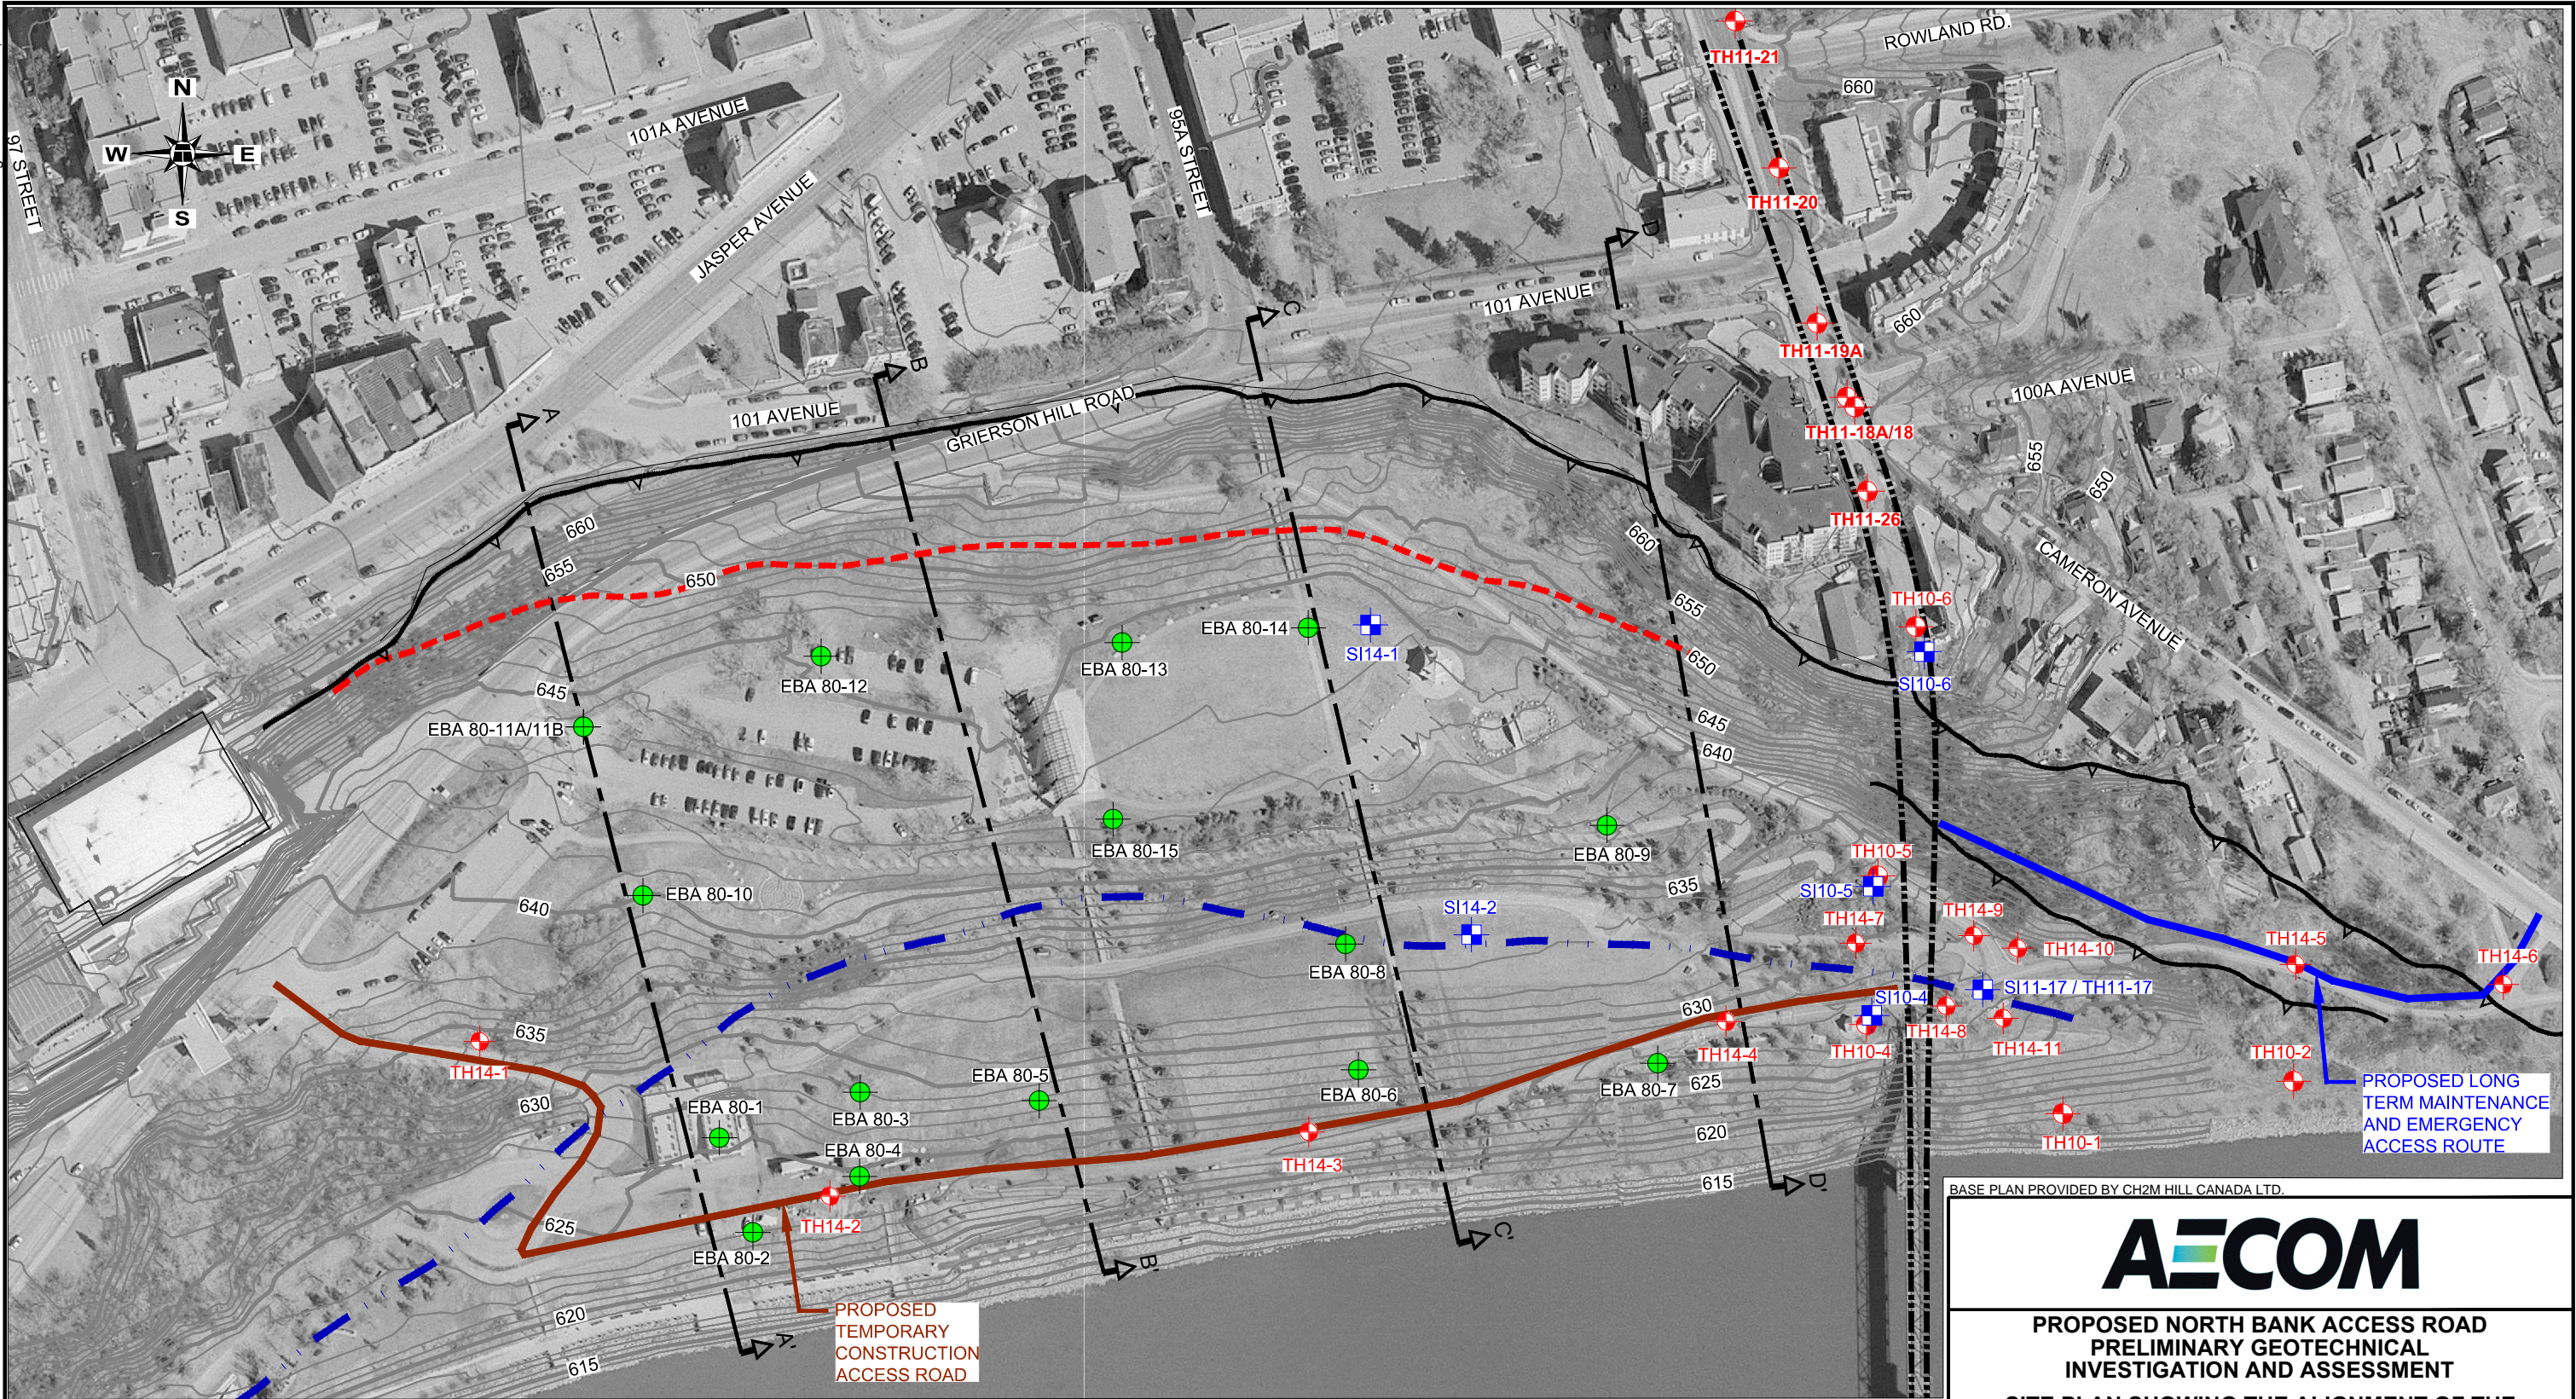
Z:\19\19-5438-102\for time\19-5438-102-1AR.dwg - 1AR - Oct. 09, 2014

- TEST HOLE LOCATION BY THURBER
- PREVIOUS TEST HOLE LOCATION BY OTHERS
- TEST HOLE LOCATION WITH EXISTING SLOPE INCLINOMETER BY THURBER
- CURRENT SLOPE CREST / SCARP (APPROXIMATE)
- APPROXIMATE SLOPE CREST IN 1887 (BEFORE FAILURE)
- APPROXIMATE TOE OF RIVERBANK IN 1887 (BEFORE FAILURE)
- PROPOSED LRT ALIGNMENT

The Grierson Hill slide first occurred in 1901 and was reportedly attributed to toe erosion from river action, weakening of the bedrock in the backslope area caused by coal mining activities, and a prolonged period of precipitation. The landslide measures about 600 m east-west along the riverbank and has a total slope height of about 55 m, with an average slope angle of 11 degrees. It extends from the Shaw Convention Centre at the west end to the Cloverdale pedestrian bridge at the east end; and from Grierson Hill Road at the north end to the river's edge at the south end (see Drawing 19-5438-102-1AR).

The slide mechanism was translational, with the failure mass sliding towards the river on planar near-horizontal shear surfaces that developed along distinct bentonite seams within the bedrock. A schematic diagram of the slide mechanism is shown on Drawing No. 19-5438-102-2AR. Since 1901, the slide scarp has retrogressed more than 35 m and the toe has moved out some 120 m into the river from its original pre-slide location (refer to Drawing 19-5438-102-1AR).

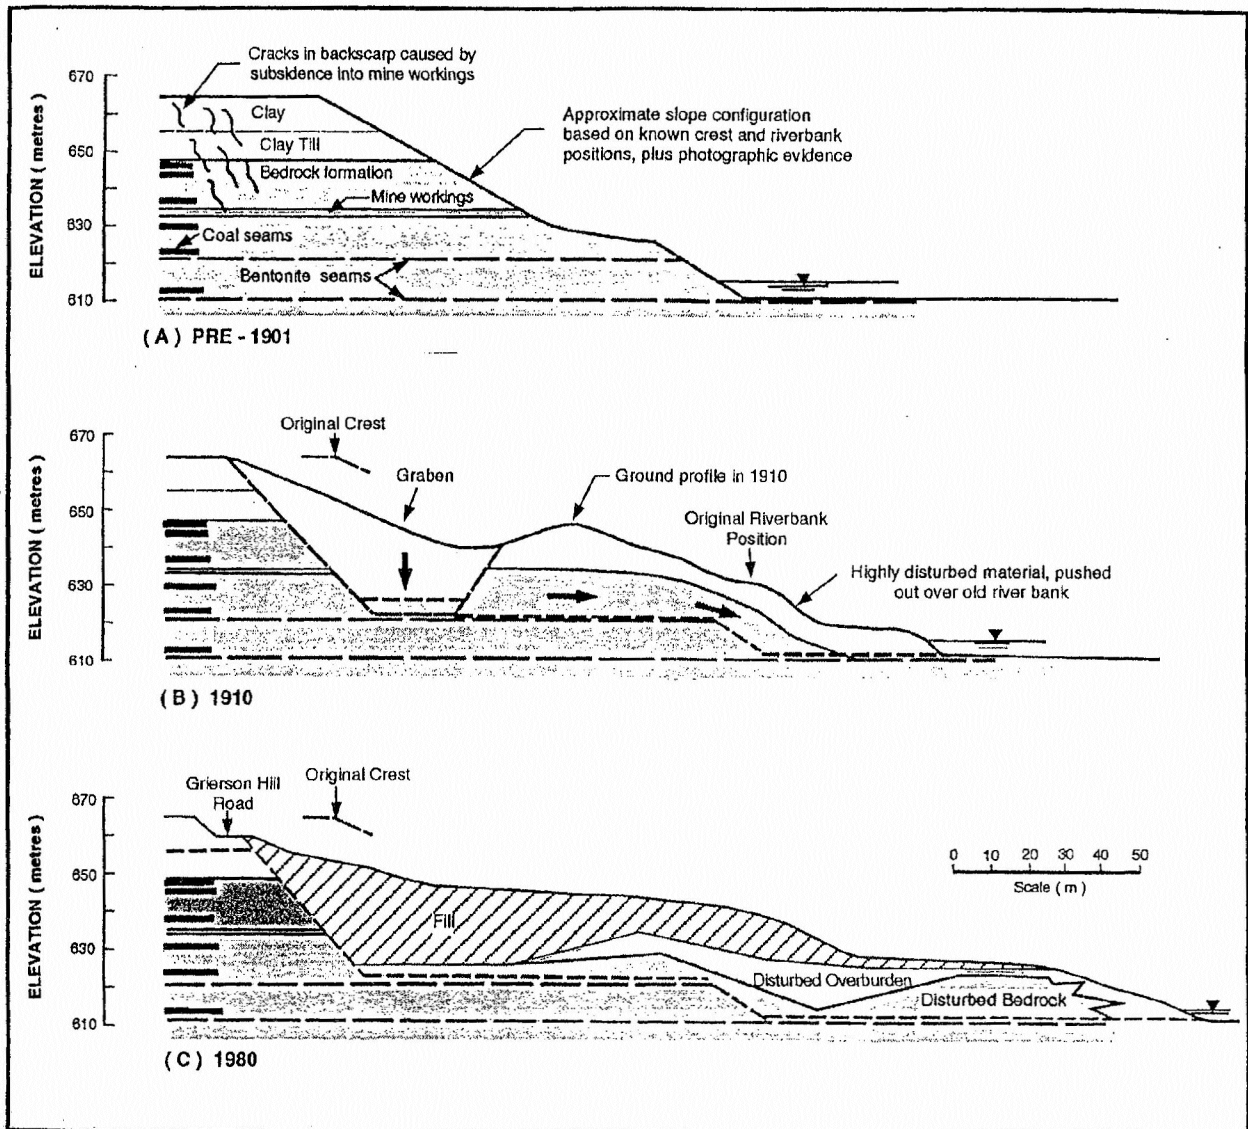
## CROSS-SECTION SHOWING SLIDE DEVELOPMENT

FROM MARTIN et. al., 1998

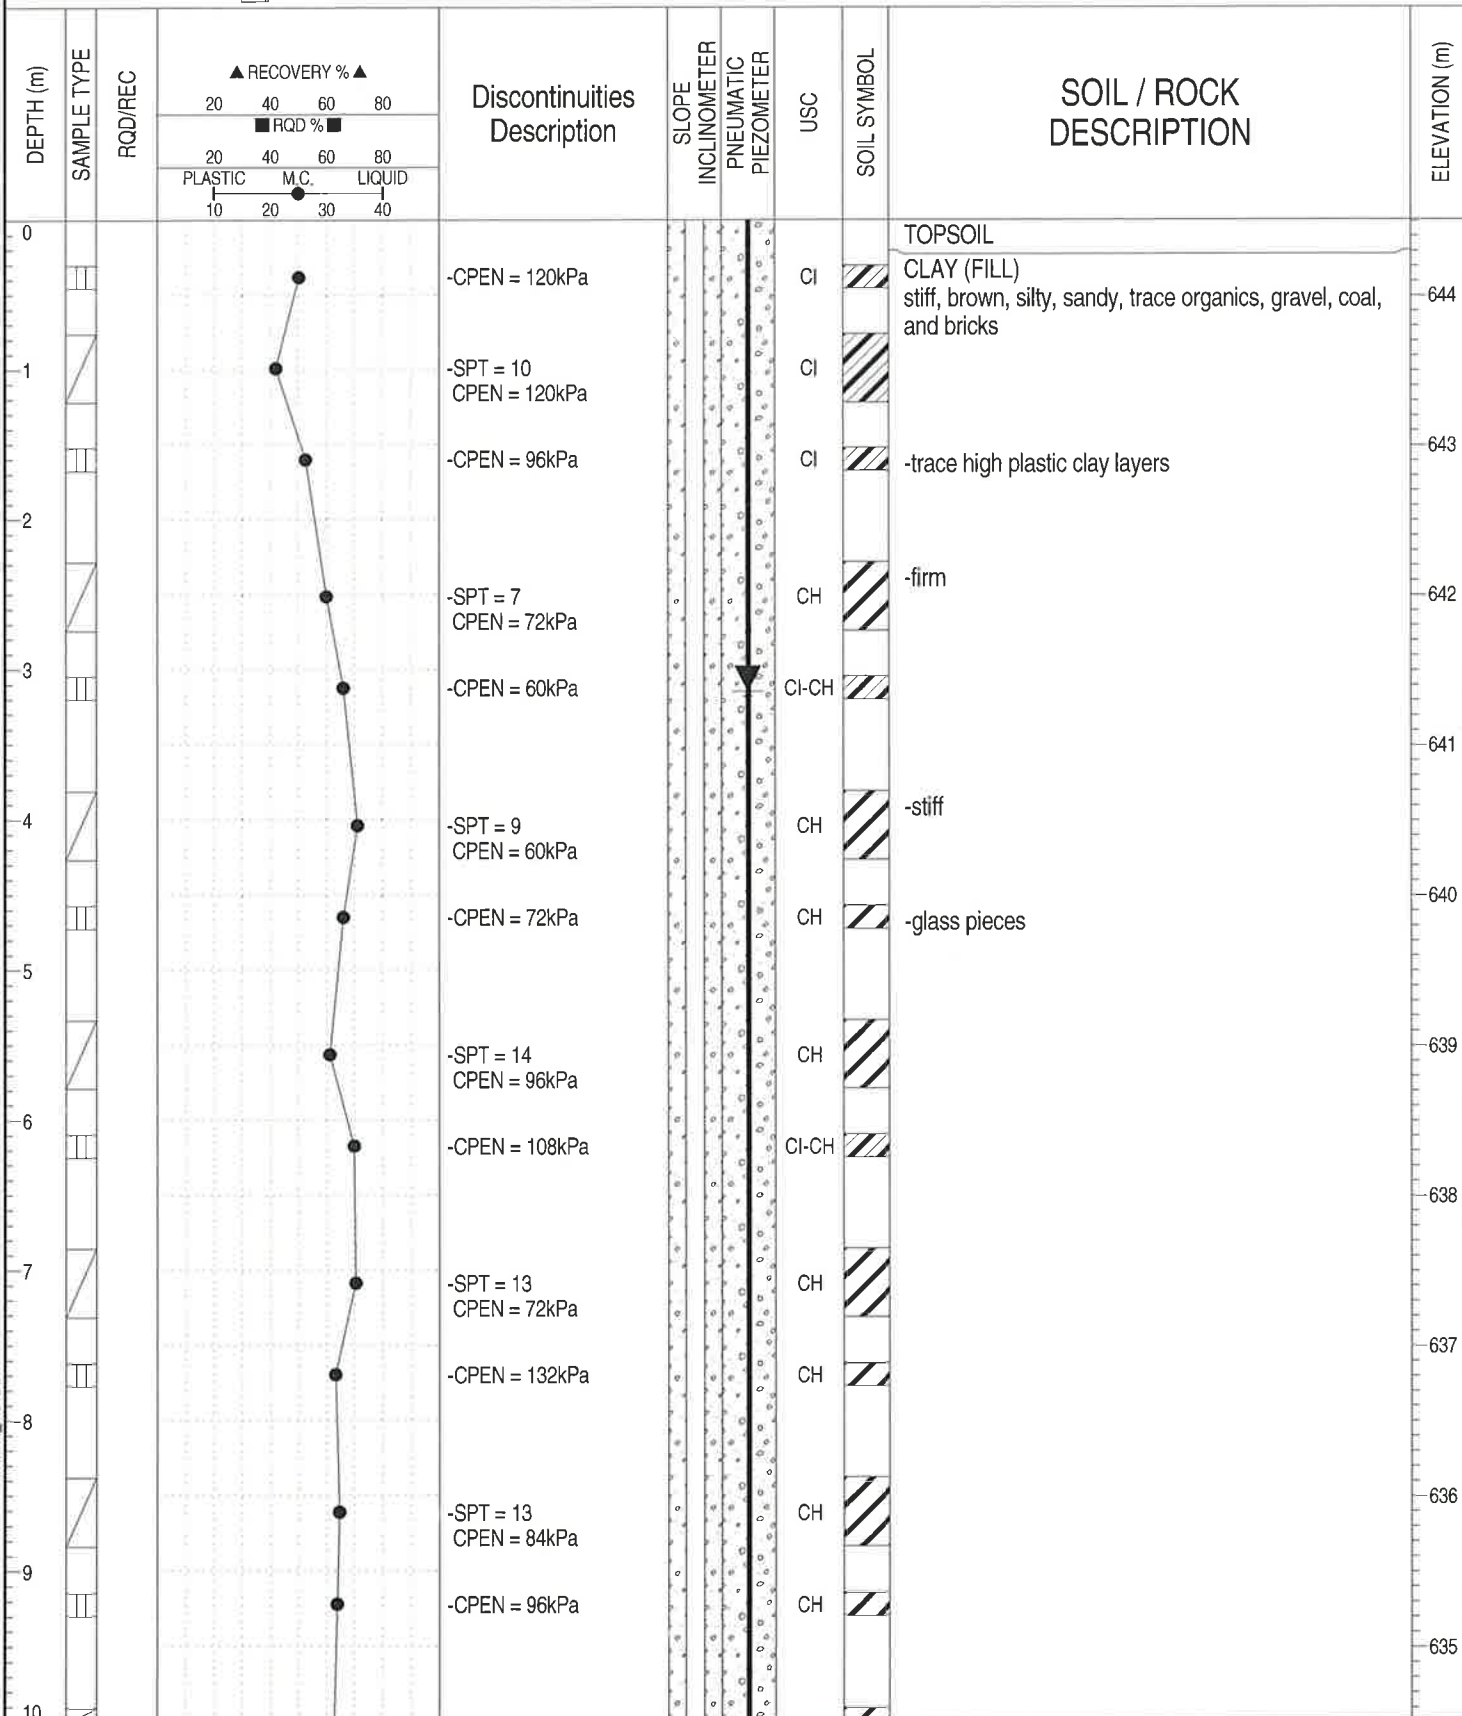
BOREHOLE LOG 19-5438-102-ROCK.GPJ THRB AB.GDT 10/1/14- REGULAR LIBRARY-ROCK-NEW LOGO.GLB

CLIENT: AECOM	PROJECT: EDMONTON SE LRT EXTENTION	BOREHOLE NO: SI14-1
DRILLING COMPANY: Mobile Augers & Research Ltd.	DATE DRILLED: March 19, 2014	PROJECT NO: 19-5438-102
DRILL/METHOD: Core Truck / Solid Stem Augers	LOCATION: N5934499.95, E34488.92	ELEVATION: 644.51 (m)
SAMPLE TYPE	<input type="checkbox"/> GRAB SAMPLE <input checked="" type="checkbox"/> SPT <input type="checkbox"/> CORE	
BACKFILL TYPE	<input checked="" type="checkbox"/> GROUT

CLIENT: AECOM			PROJECT: EDMONTON SE LRT EXTENSION			BOREHOLE NO: SI14-1					
DRILLING COMPANY: Mobile Augers & Research Ltd.			DATE DRILLED: March 19, 2014			PROJECT NO: 19-5438-102					
DRILL/METHOD: Core Truck / Solid Stem Augers			LOCATION: N5934499.95, E34488.92			ELEVATION: 644.51 (m)					
SAMPLE TYPE		<input type="checkbox"/> GRAB SAMPLE	<input checked="" type="checkbox"/> SPT	<input checked="" type="checkbox"/> CORE							
BACKFILL TYPE		<input checked="" type="checkbox"/> GROUT									
DEPTH (m)	SAMPLE TYPE	RQD/REC	▲ RECOVERY % ▲ 20 40 60 80 ■ RQD % ■ 20 40 60 80 PLASTIC M.C. LIQUID 10 20 30 40		Discontinuities Description	SLOPE INCLINOMETER	PNEUMATIC PIEZOMETER	USC	SOIL SYMBOL	SOIL / ROCK DESCRIPTION	ELEVATION (m)
10					-SPT = 13 CPEN = 96kPa			CH			634
					-CPEN = 120kPa			CH			
11											
					-SPT = 17 CPEN = 132kPa -P/N35450			CH		-very stiff	633
12					-CPEN = 48kPa			CI		-some sand lenses	632

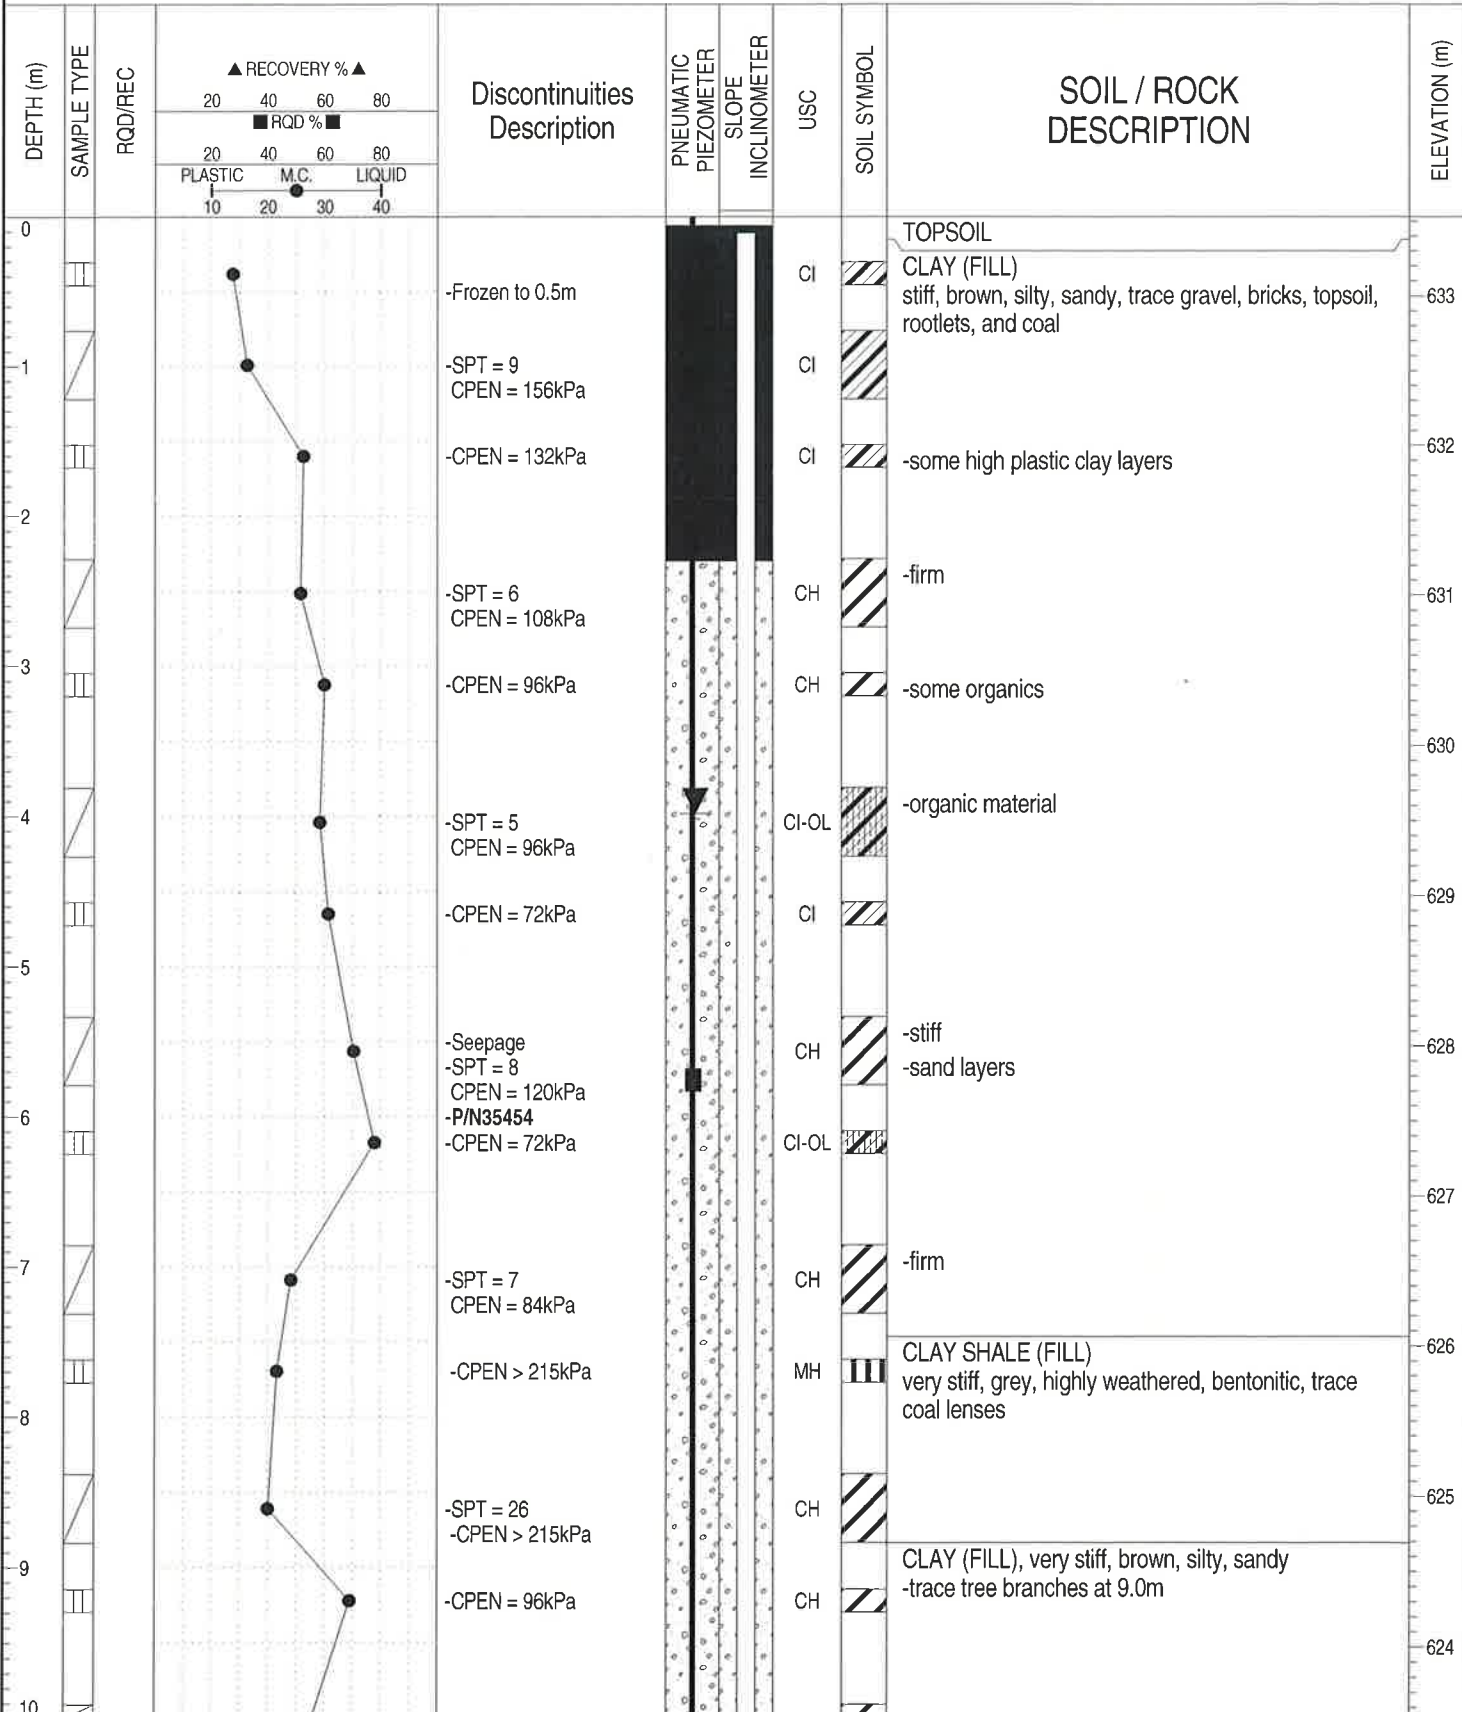
BOREHOLE LOG 19-5438-102-ROCK.GPJ THRB AB.GDT 10/1/14- REGULAR LIBRARY-ROCK-NEW LOGO.GLB

CLIENT: AECOM	PROJECT: EDMONTON SE LRT EXTENTION	BOREHOLE NO: SI14-2
DRILLING COMPANY: Mobile Augers & Research Ltd.	DATE DRILLED: March 17, 2014	PROJECT NO: 19-5438-102
DRILL/METHOD: Core Truck / Solid Stem Augers	LOCATION: N5934403.87, E34520.25	ELEVATION: 633.53 (m)

CLIENT: AECOM			PROJECT: EDMONTON SE LRT EXTENTION			BOREHOLE NO: SI14-2						
DRILLING COMPANY: Mobile Augers & Research Ltd.			DATE DRILLED: March 17, 2014			PROJECT NO: 19-5438-102						
DRILL/METHOD: Core Truck / Solid Stem Augers			LOCATION: N5934403.87, E34520.25			ELEVATION: 633.53 (m)						
SAMPLE TYPE			<input type="checkbox"/> GRAB SAMPLE <input checked="" type="checkbox"/> SPT <input type="checkbox"/> CORE									
BACKFILL TYPE			<input checked="" type="checkbox"/> BENTONITE <input type="checkbox"/> GROUT									
DEPTH (m)	SAMPLE TYPE	RQD/REC	▲ RECOVERY % ▲			Discontinuities Description	PNEUMATIC PIEZOMETER	SLOPE INCLINOMETER	USC	SOIL SYMBOL	SOIL / ROCK DESCRIPTION	ELEVATION (m)
			20 40 60 80									
			20 40 60 80									
			PLASTIC M.C. LIQUID									
			10 20 30 40									
10						-SPT = 17 CPEN = 60kPa -Seepage			CH		CLAY SHALE grey, silty, weathered, trace oxides	623
						-CPEN = 168kPa			CH

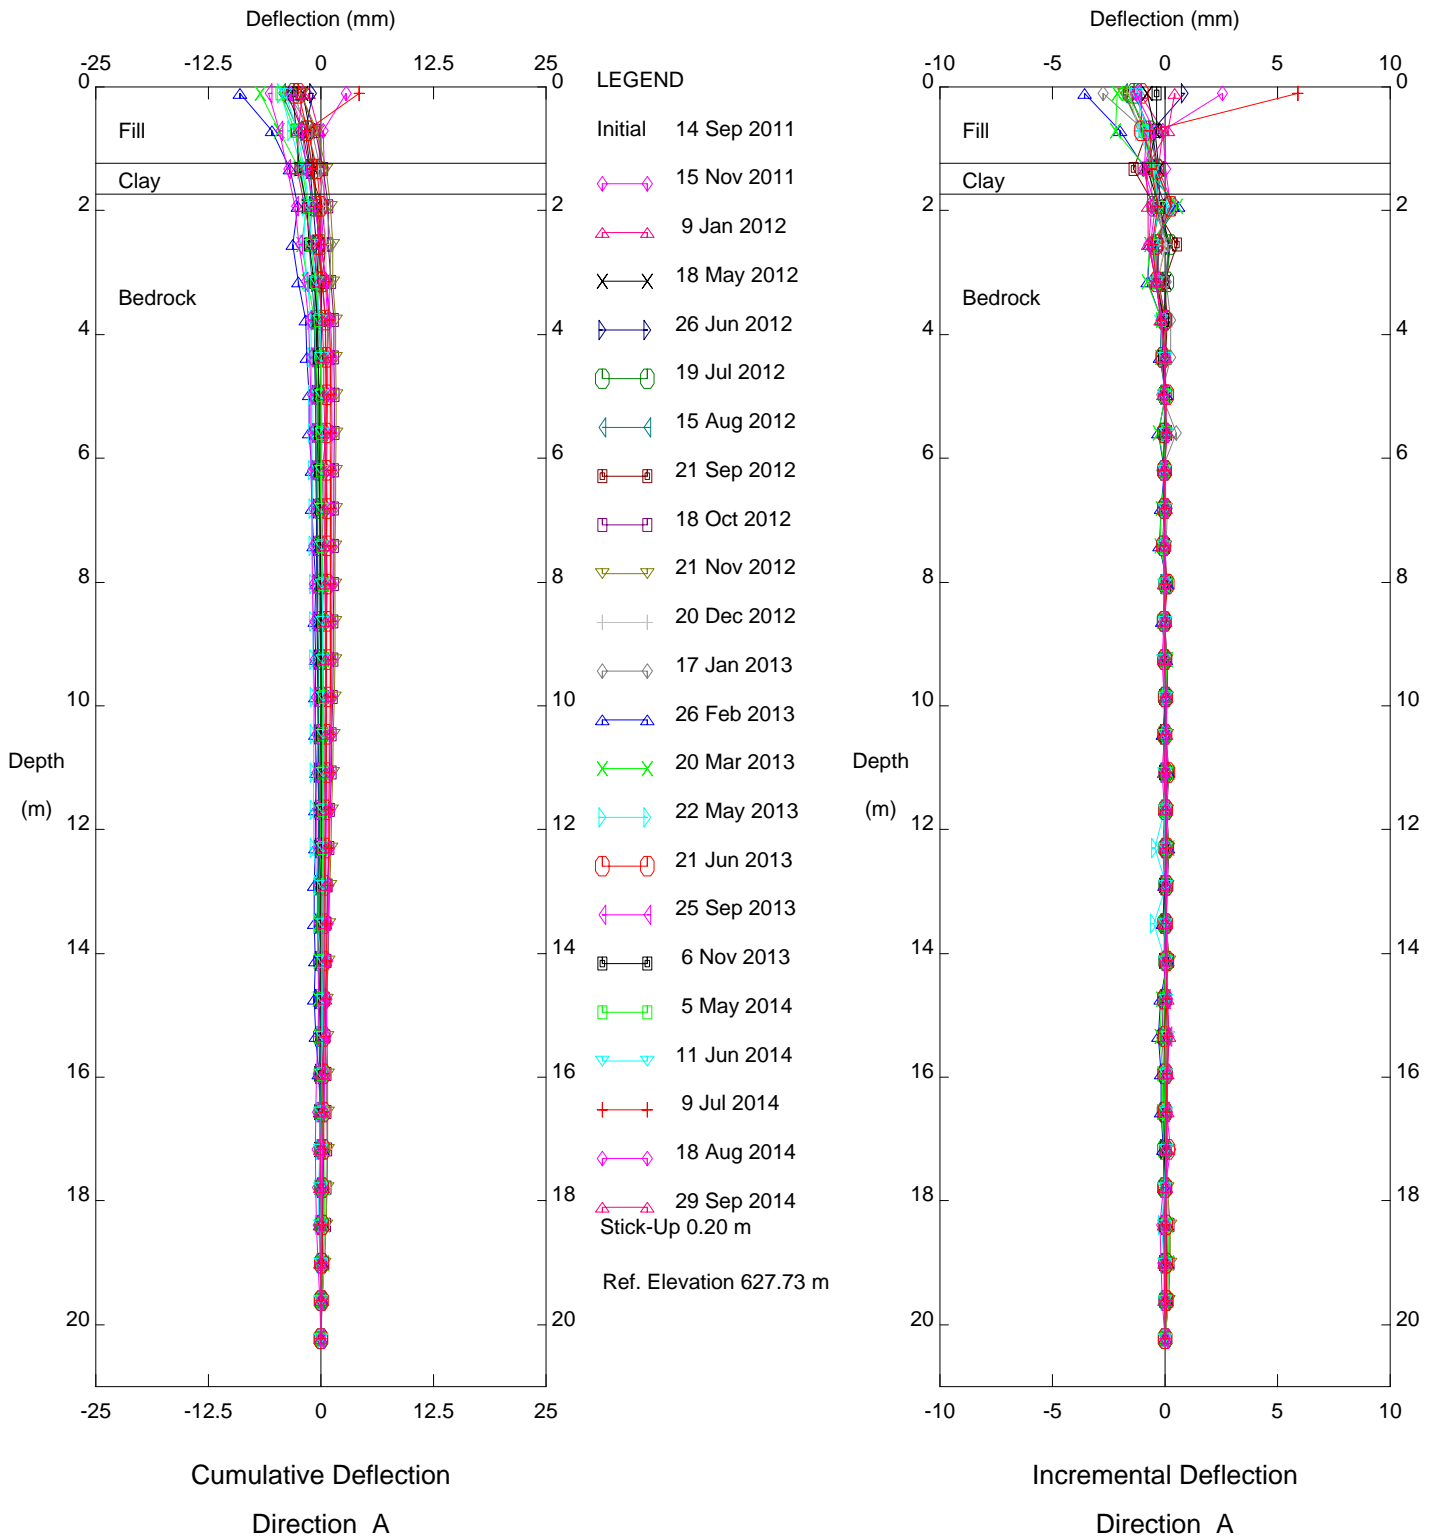
SE LRT Extension, Inclinometer SI10-4

N5934378.81 E34644.45

The stabilization measures noted above have considerably improved the overall slope stability. Two slope inclinometers were installed in March 2000 by the City of Edmonton along the Grierson Hill Road. Available readings of these slope inclinometers (between April and June, 2000) did not indicate any significant slope movements. Four additional slope inclinometers were installed in 2010 and 2011 at the eastern flank of the slide near the LRT-VL alignment. The instruments have been monitored regularly since November, 2010. No noticeable slope movements have been detected to date.

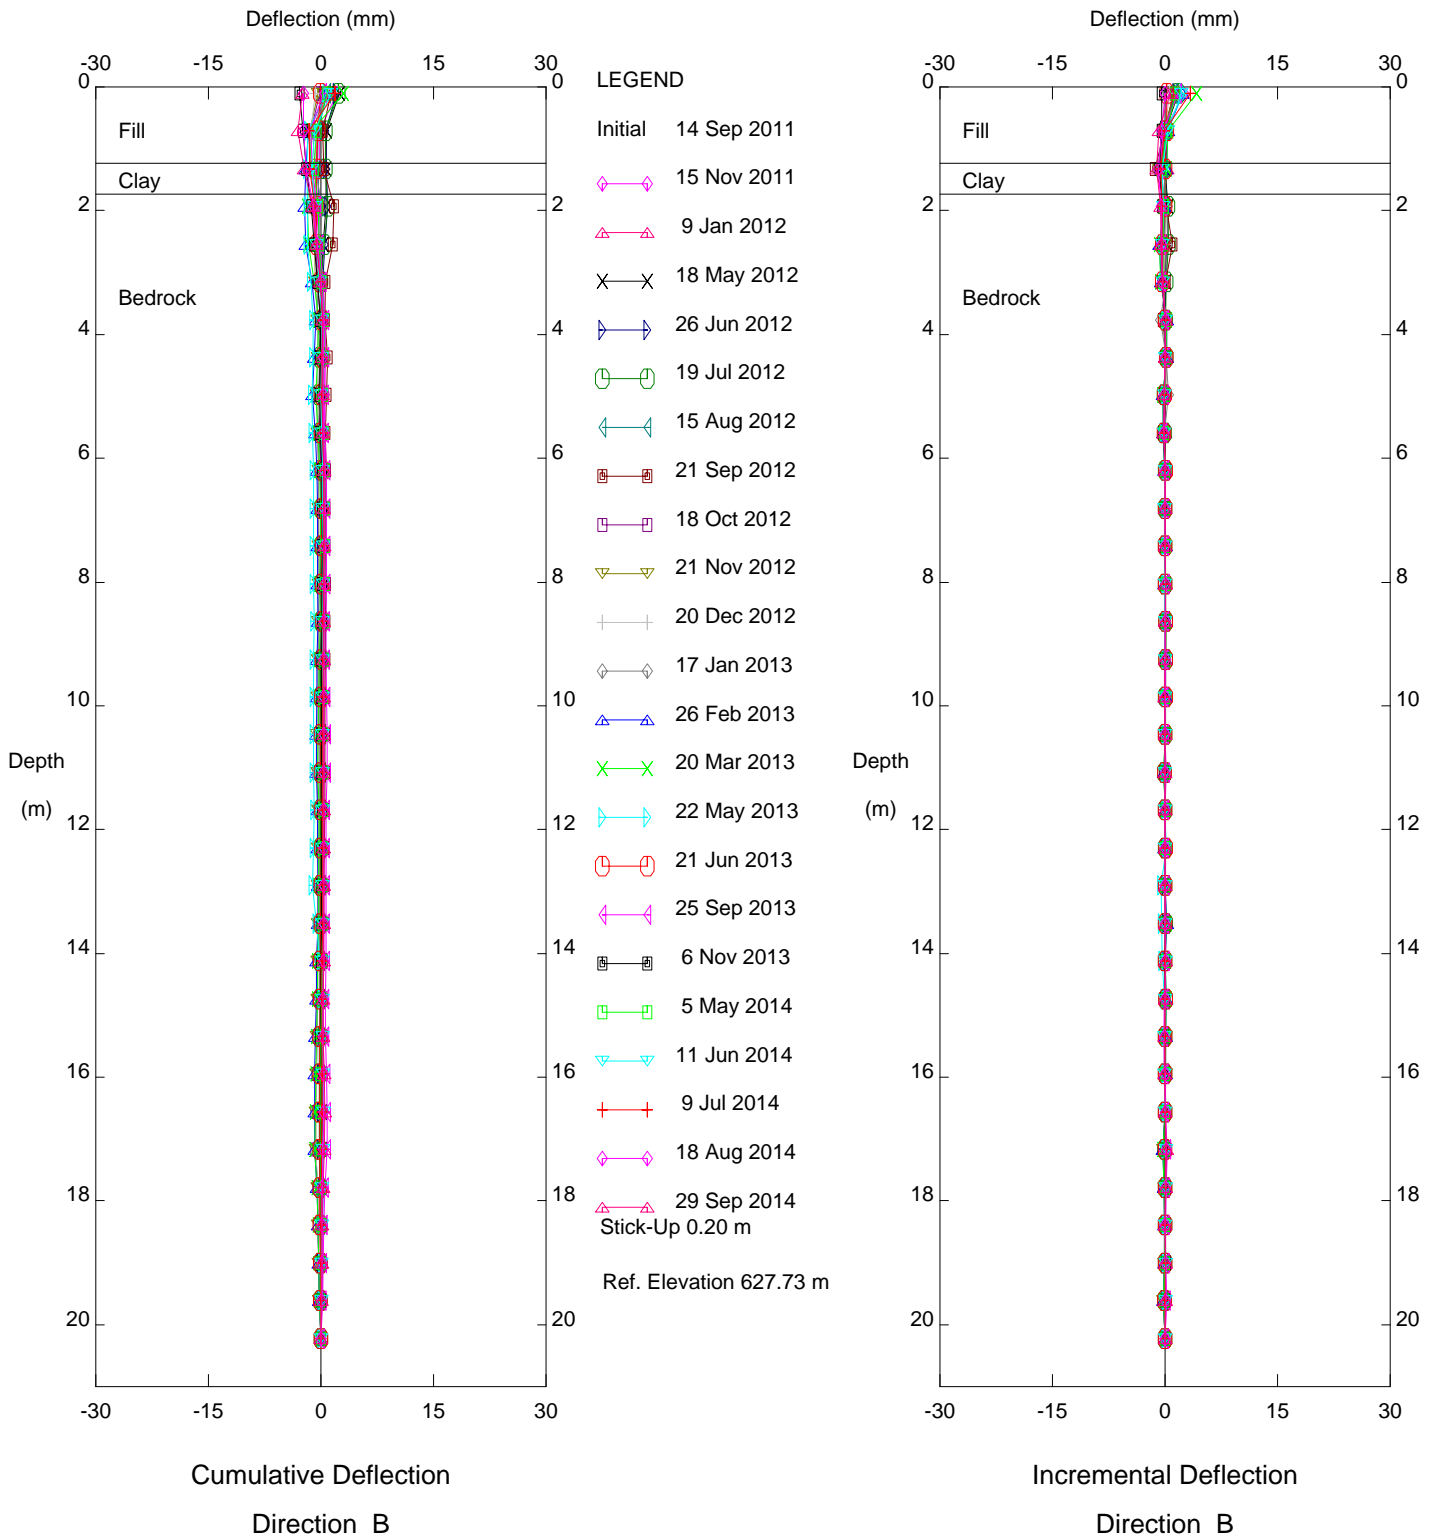
SE LRT Extension, Inclinometer SI10-4

N5934378.81 E34644.45

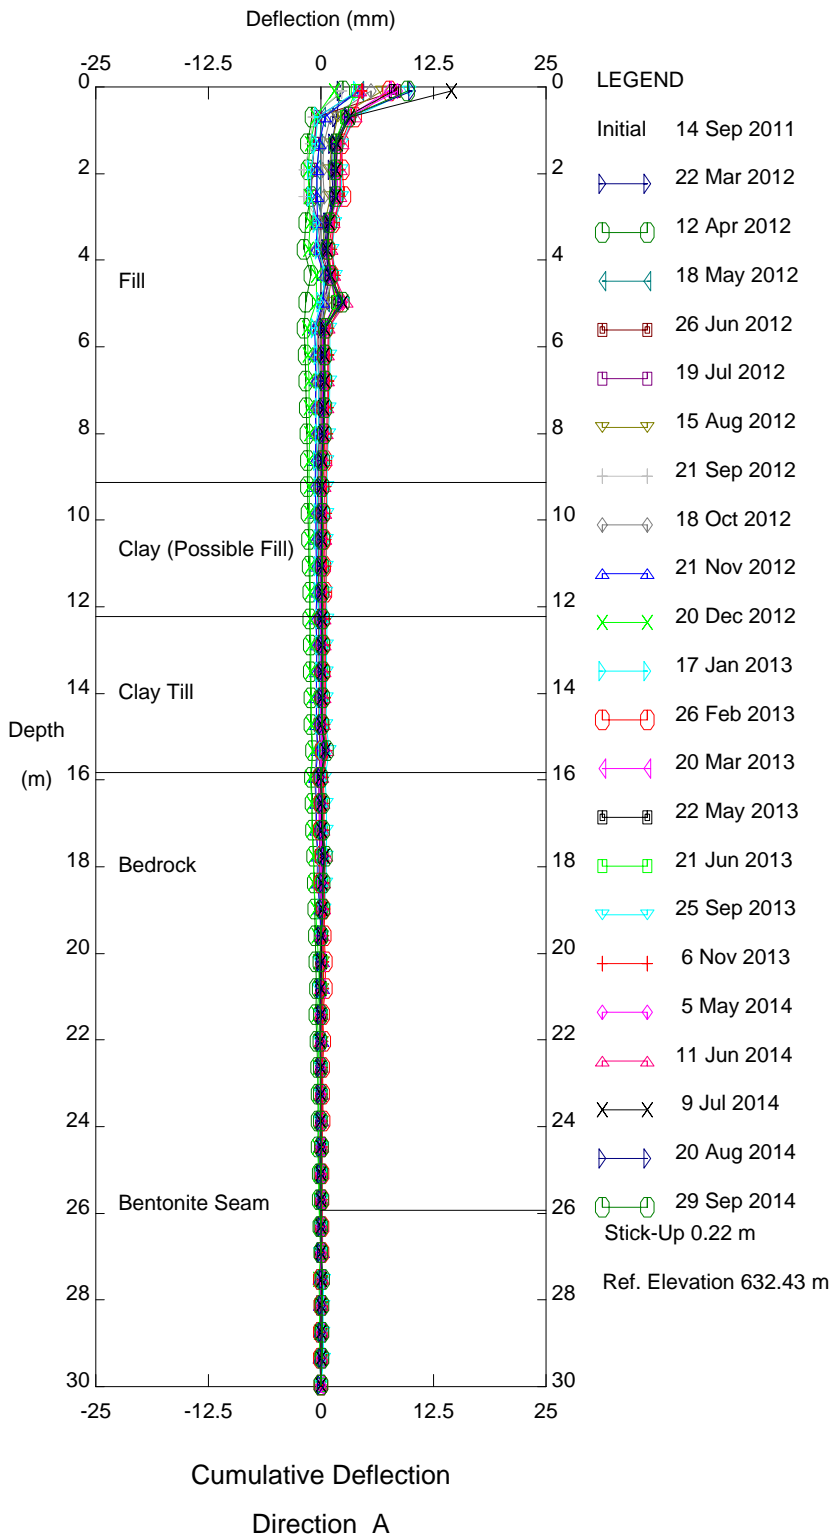
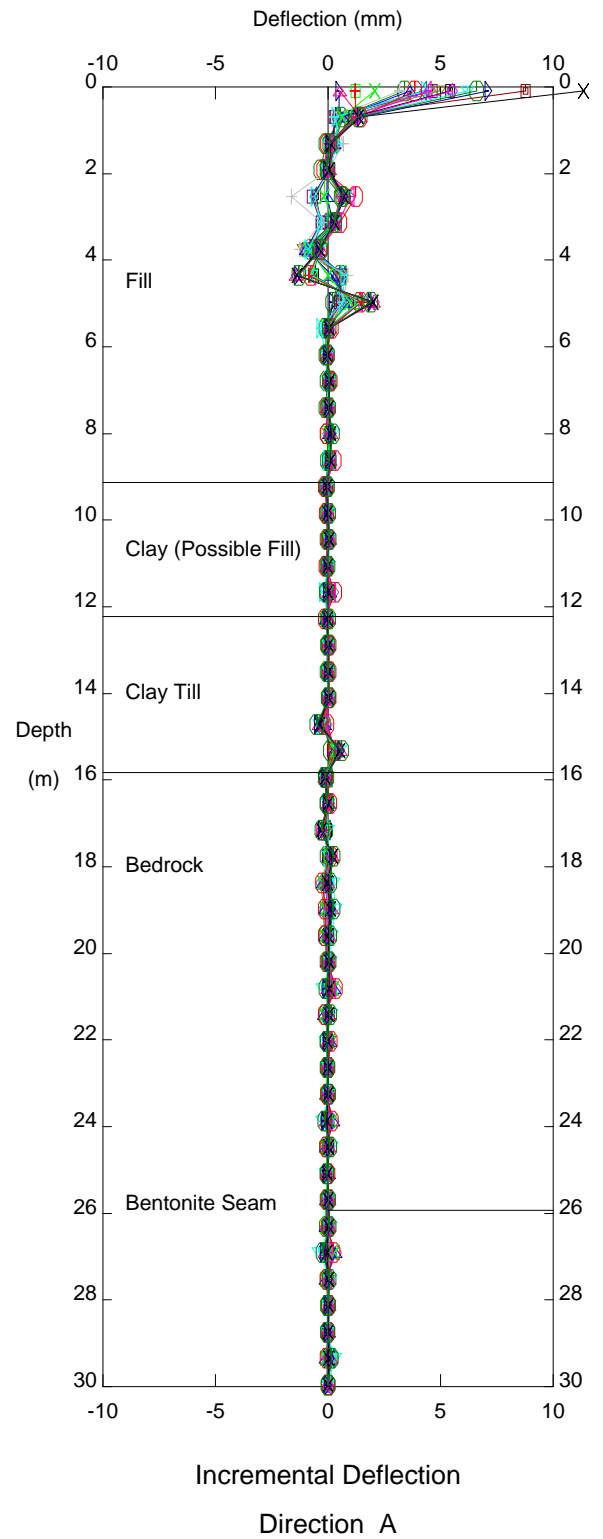
SE LRT Extension, Inclinometer SI10-5

N5934418.85 E34644.87

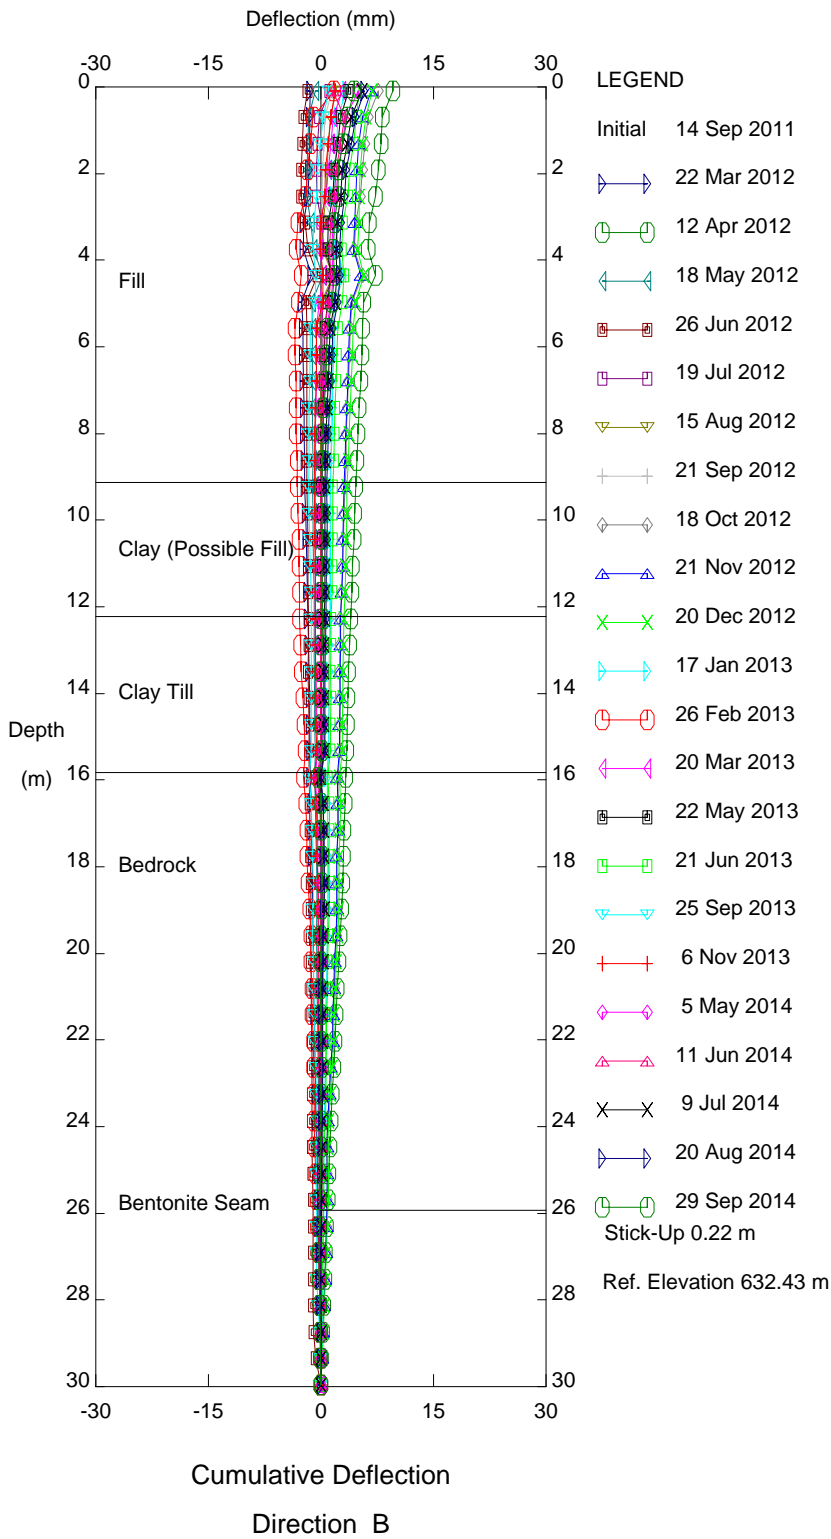
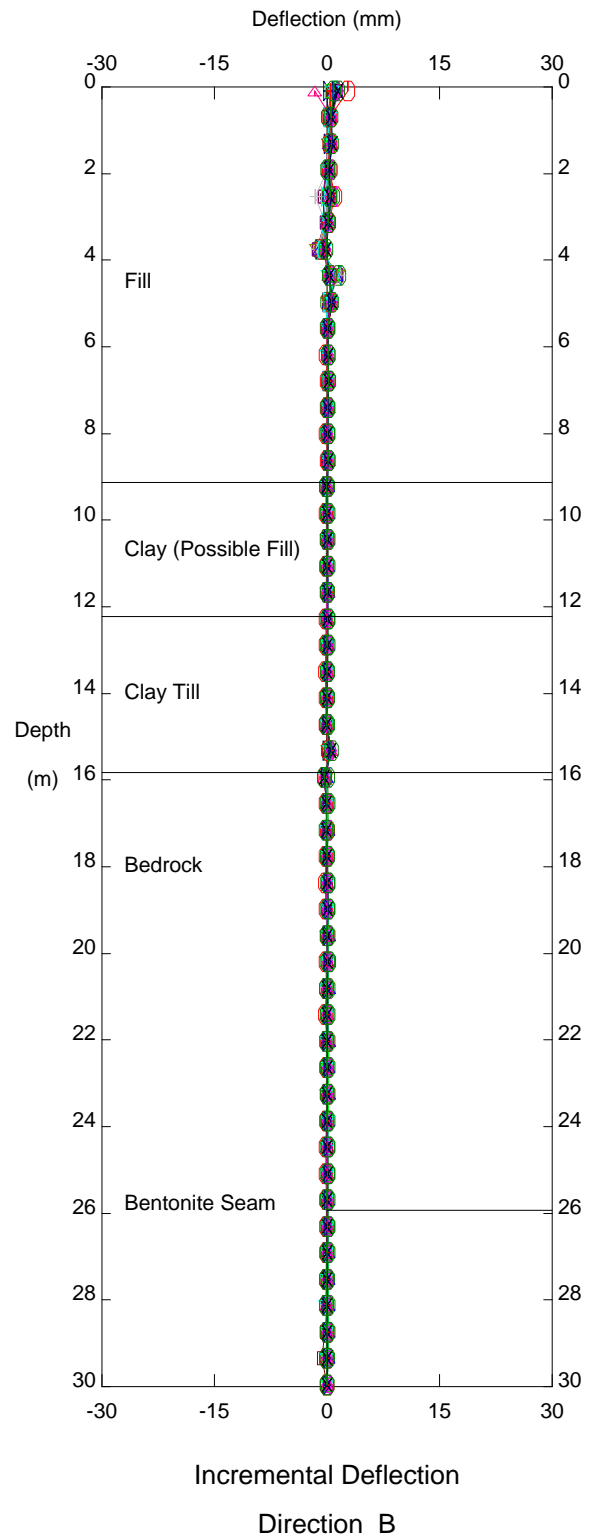
SE LRT Extension, Inclinometer SI10-5

N5934418.85 E34644.87

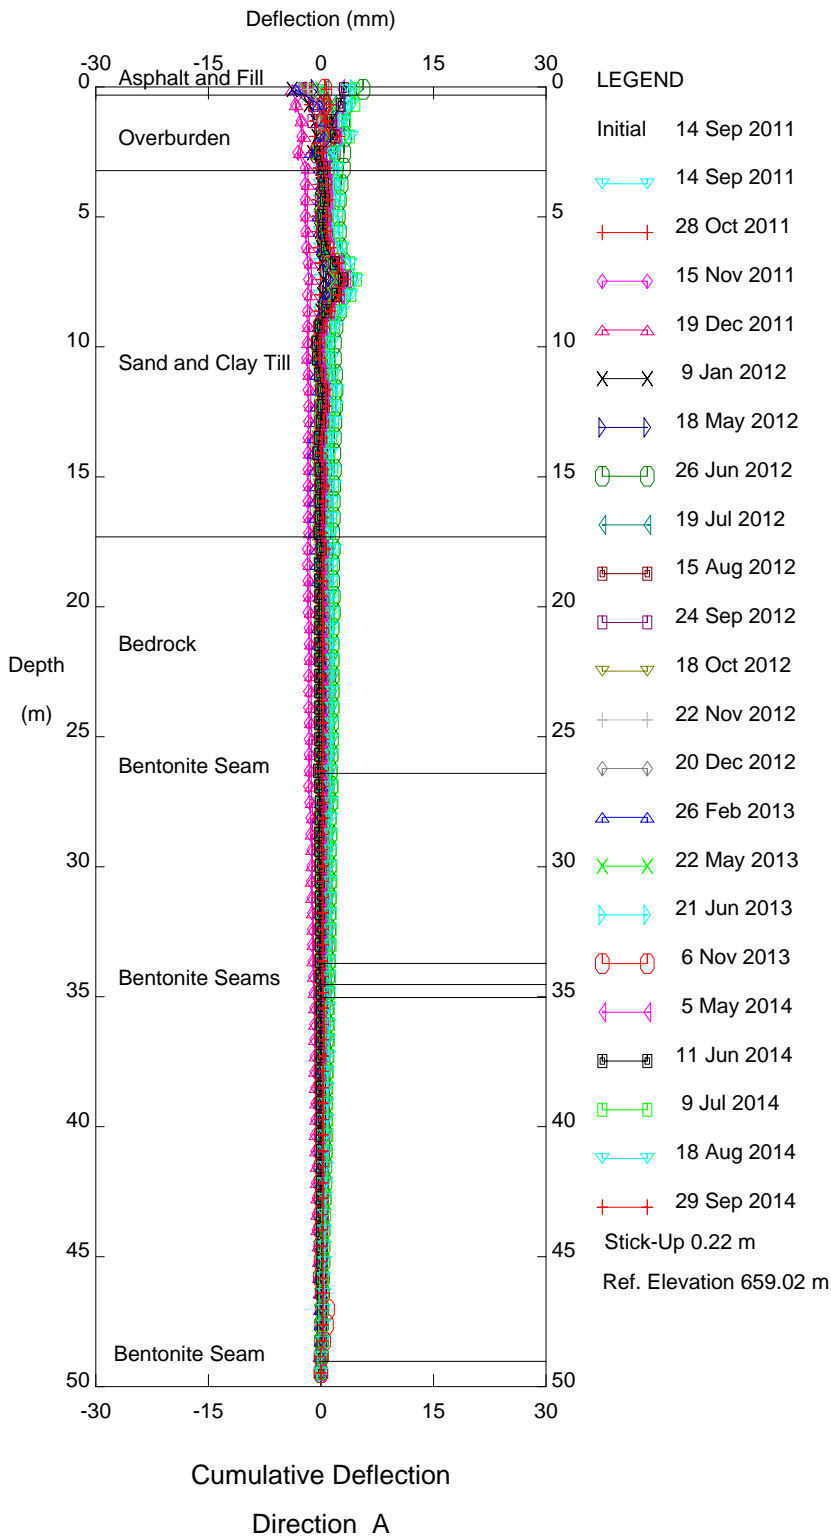
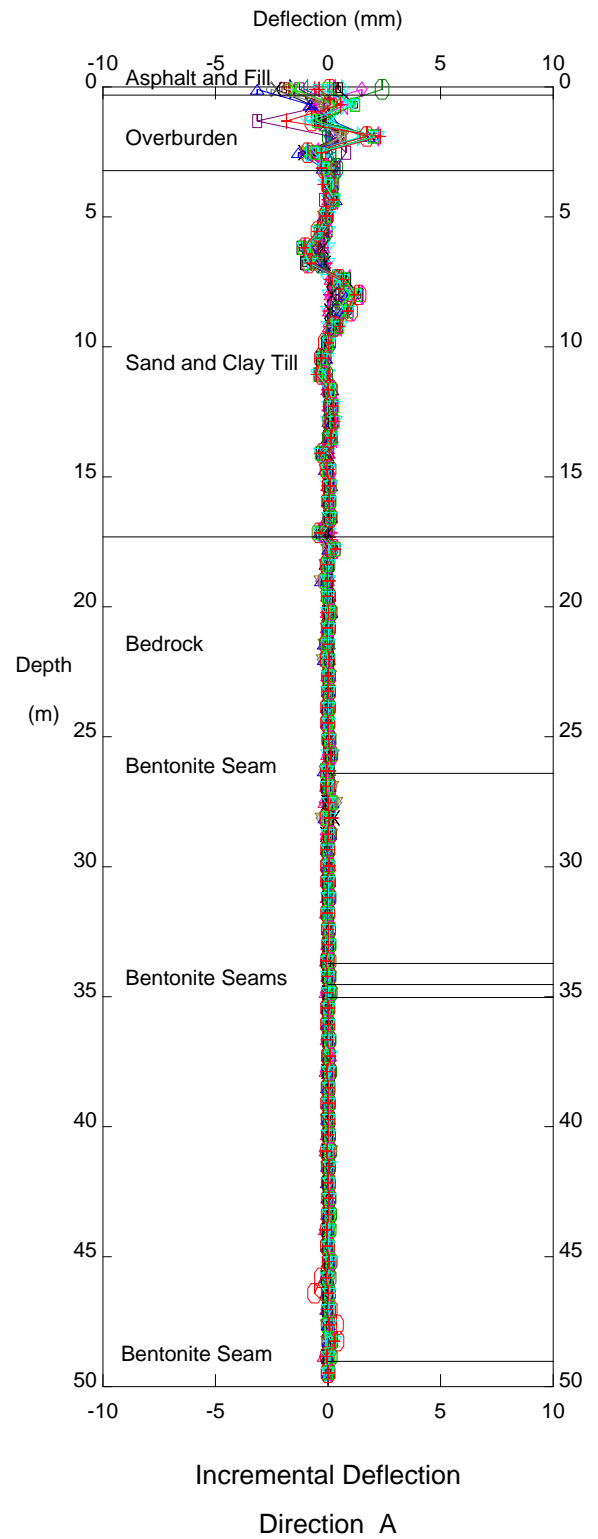
SE LRT Extension, Inclinator SI 10-6

N5934491.68 E34660.77
