**City of Edmonton**  
**Valley Line Stage 1 – Light Rail Transit (LRT) Project**  
**Environmental Impact Screening Assessment Update**  
**Final Report**

Project Number EP - 576

February 2015

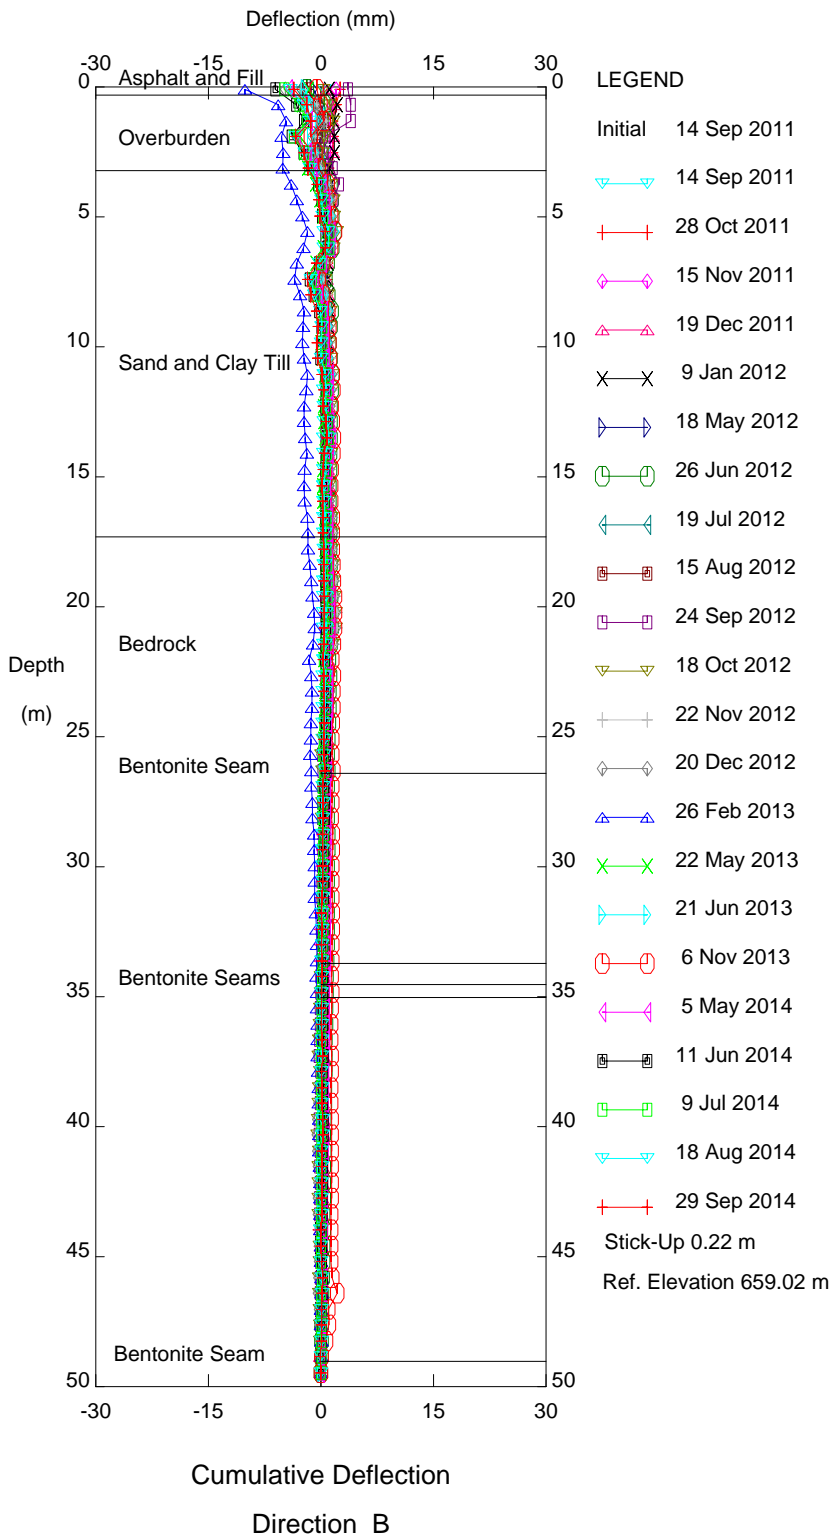
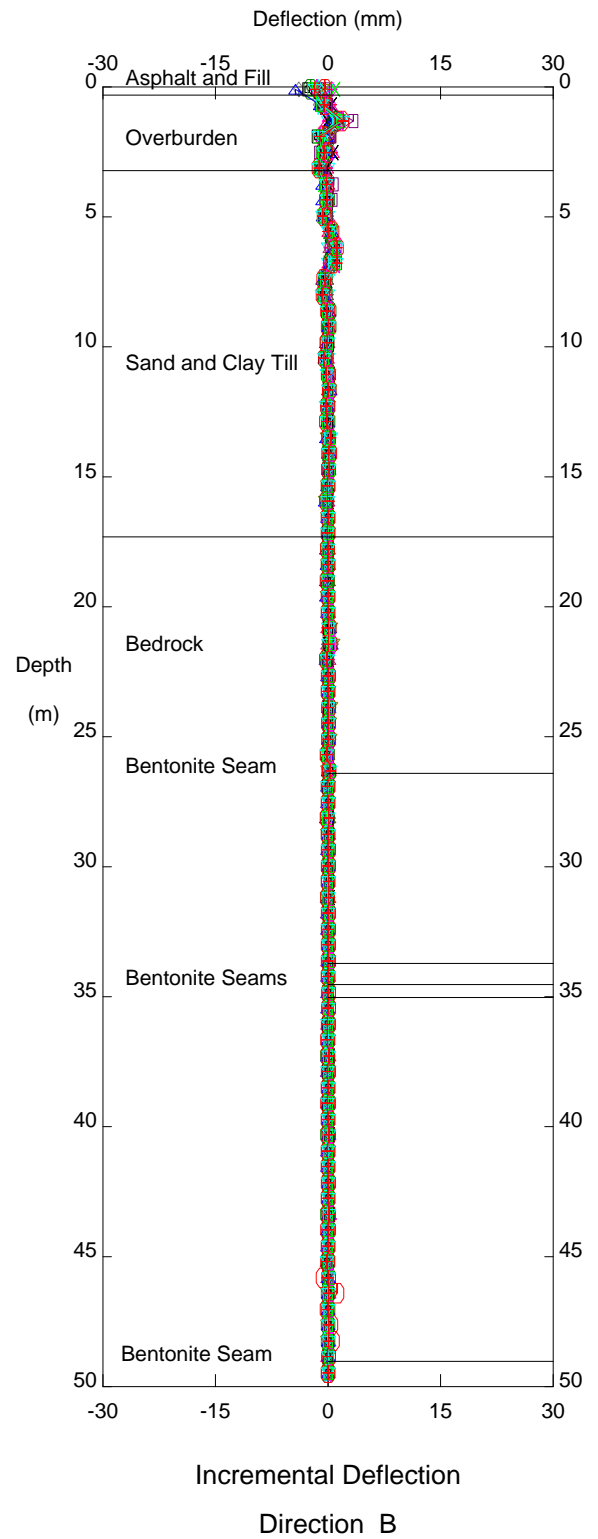
SE LRT Extension, Inclinator SI 10-6

N5934491.68 E34660.77

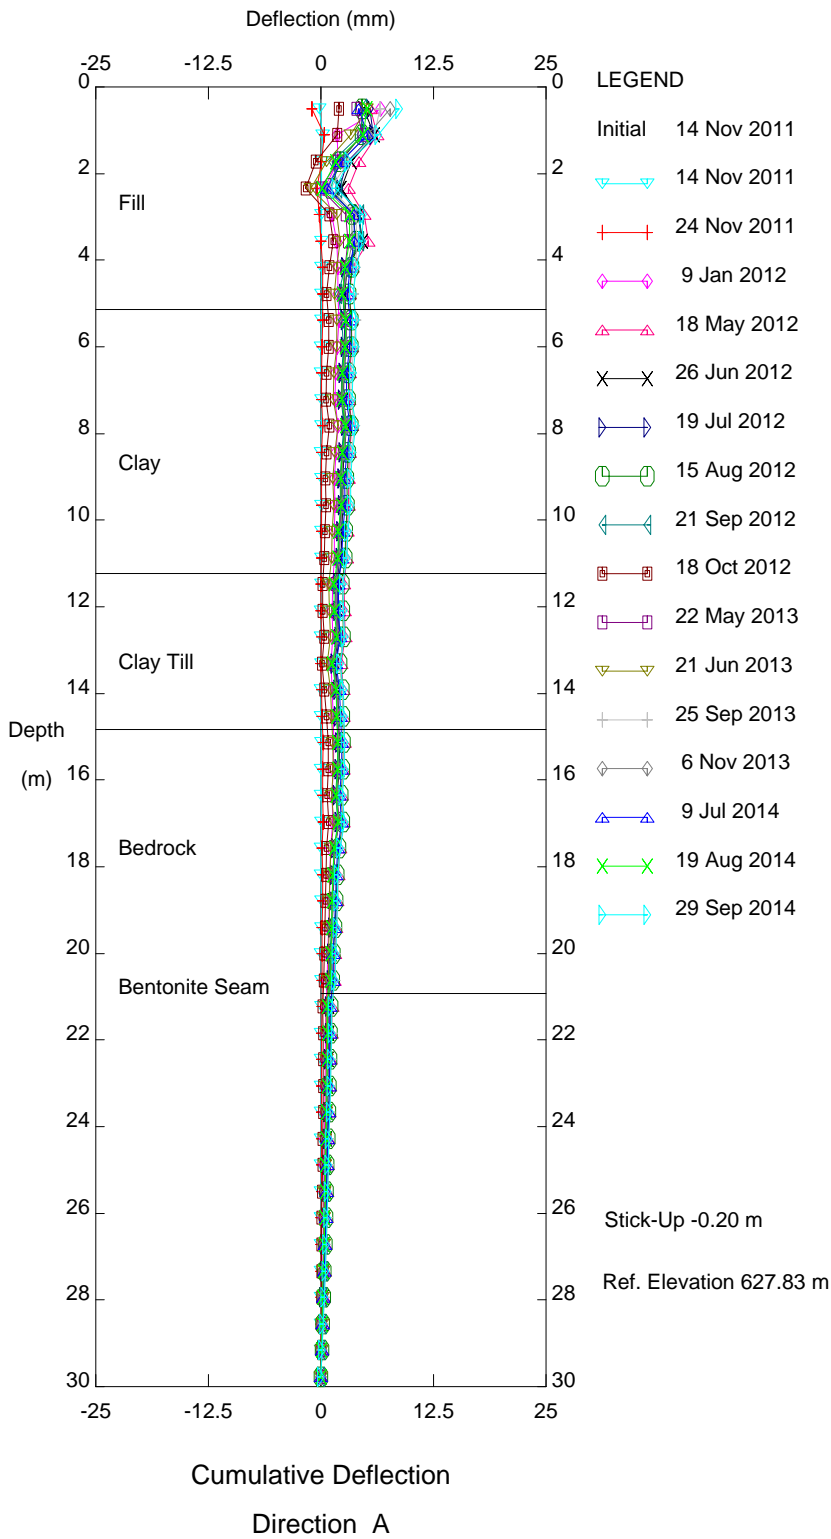
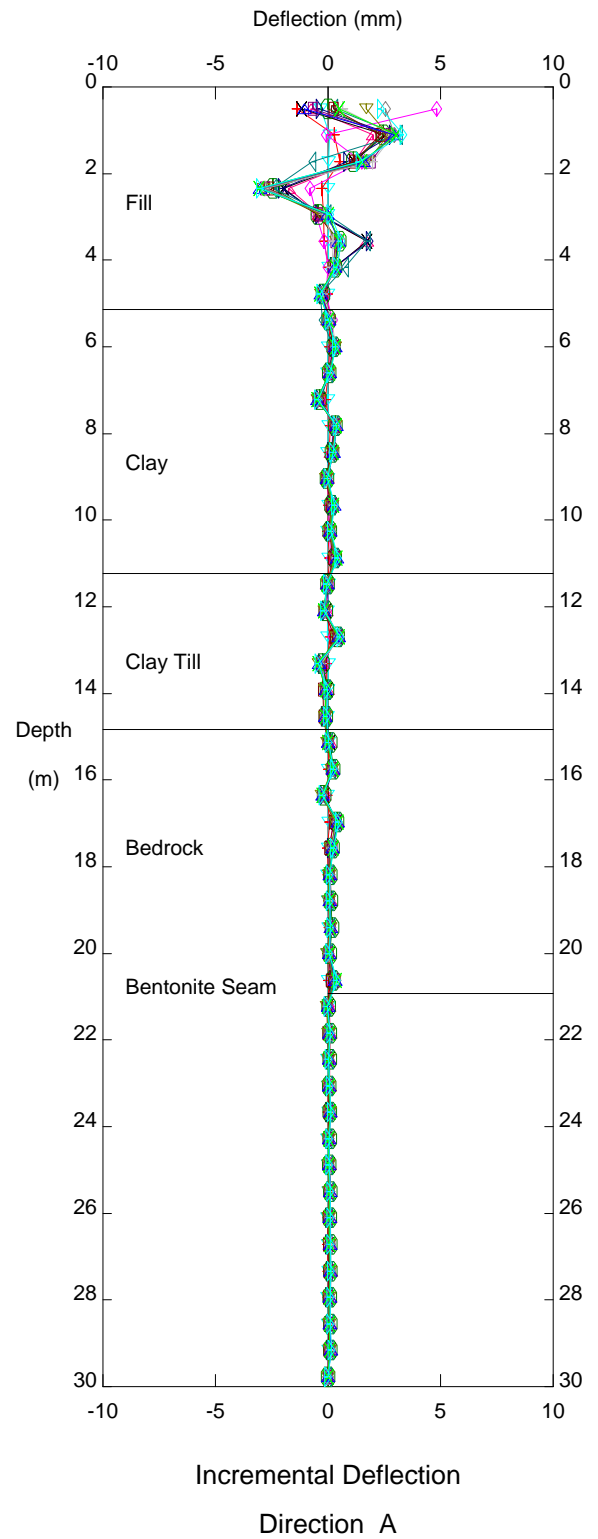
SE LRT Extension, Inclinator SI 11-17

N5934386.82 E34678.91

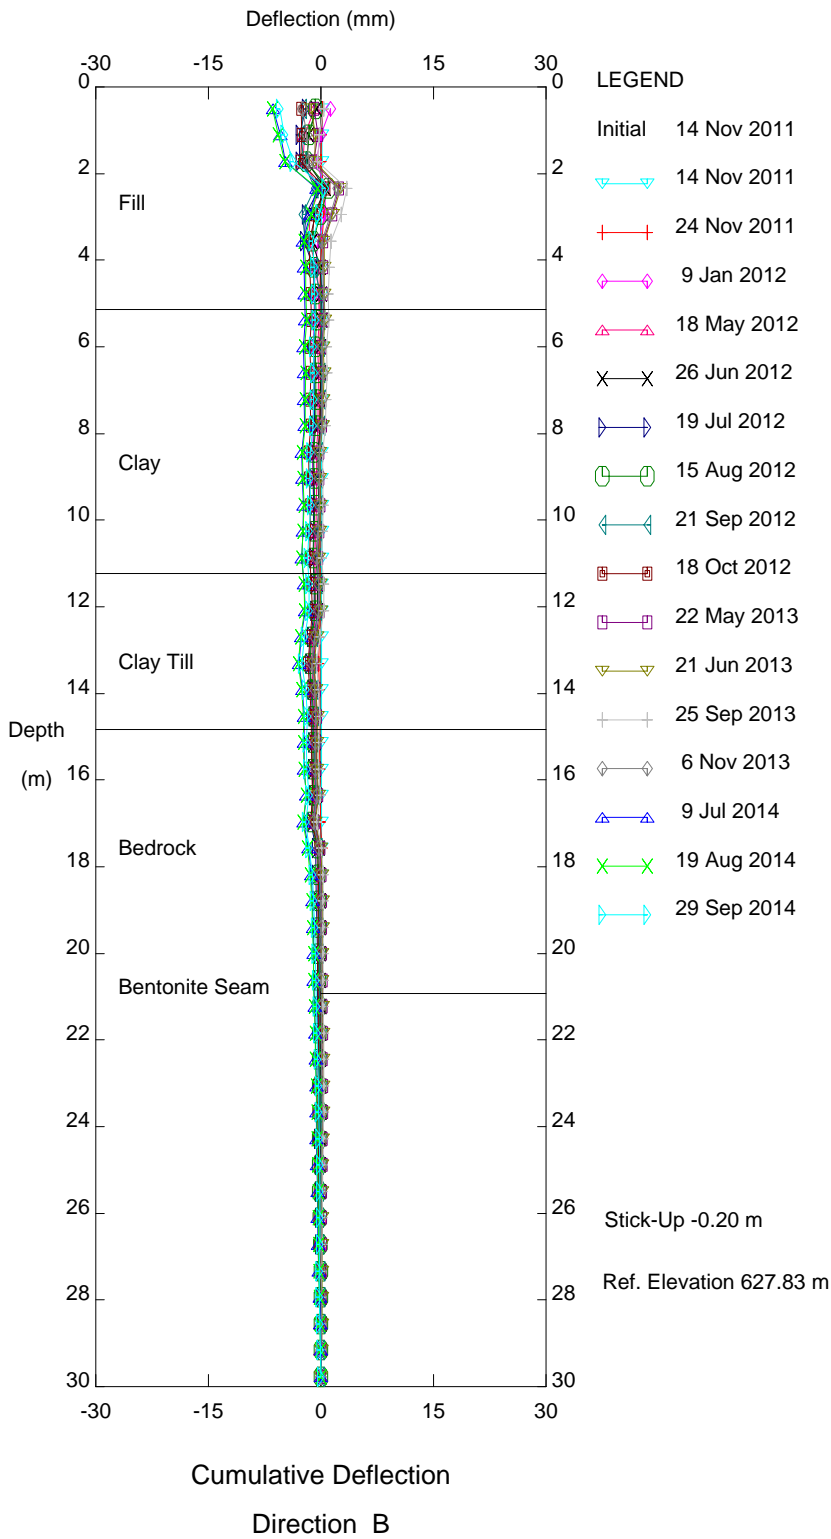
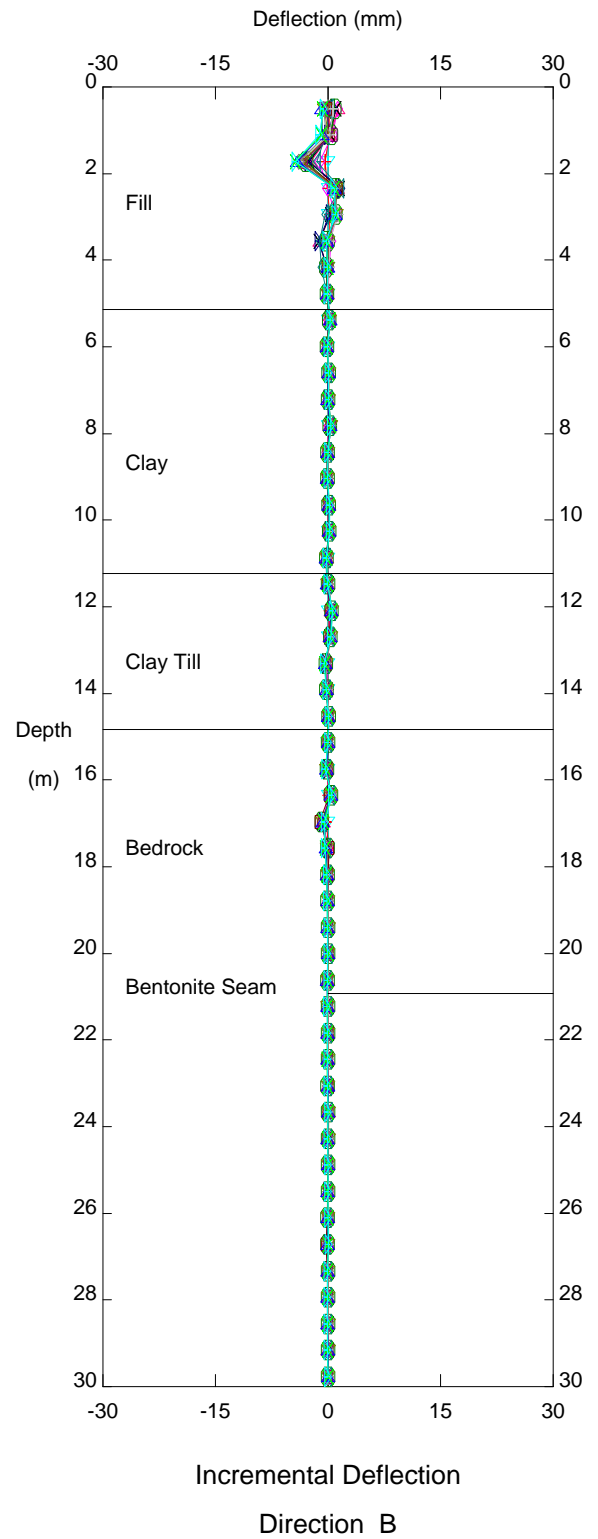
SE LRT Extension, Inclinator SI 11-17

N5934386.82 E34678.91

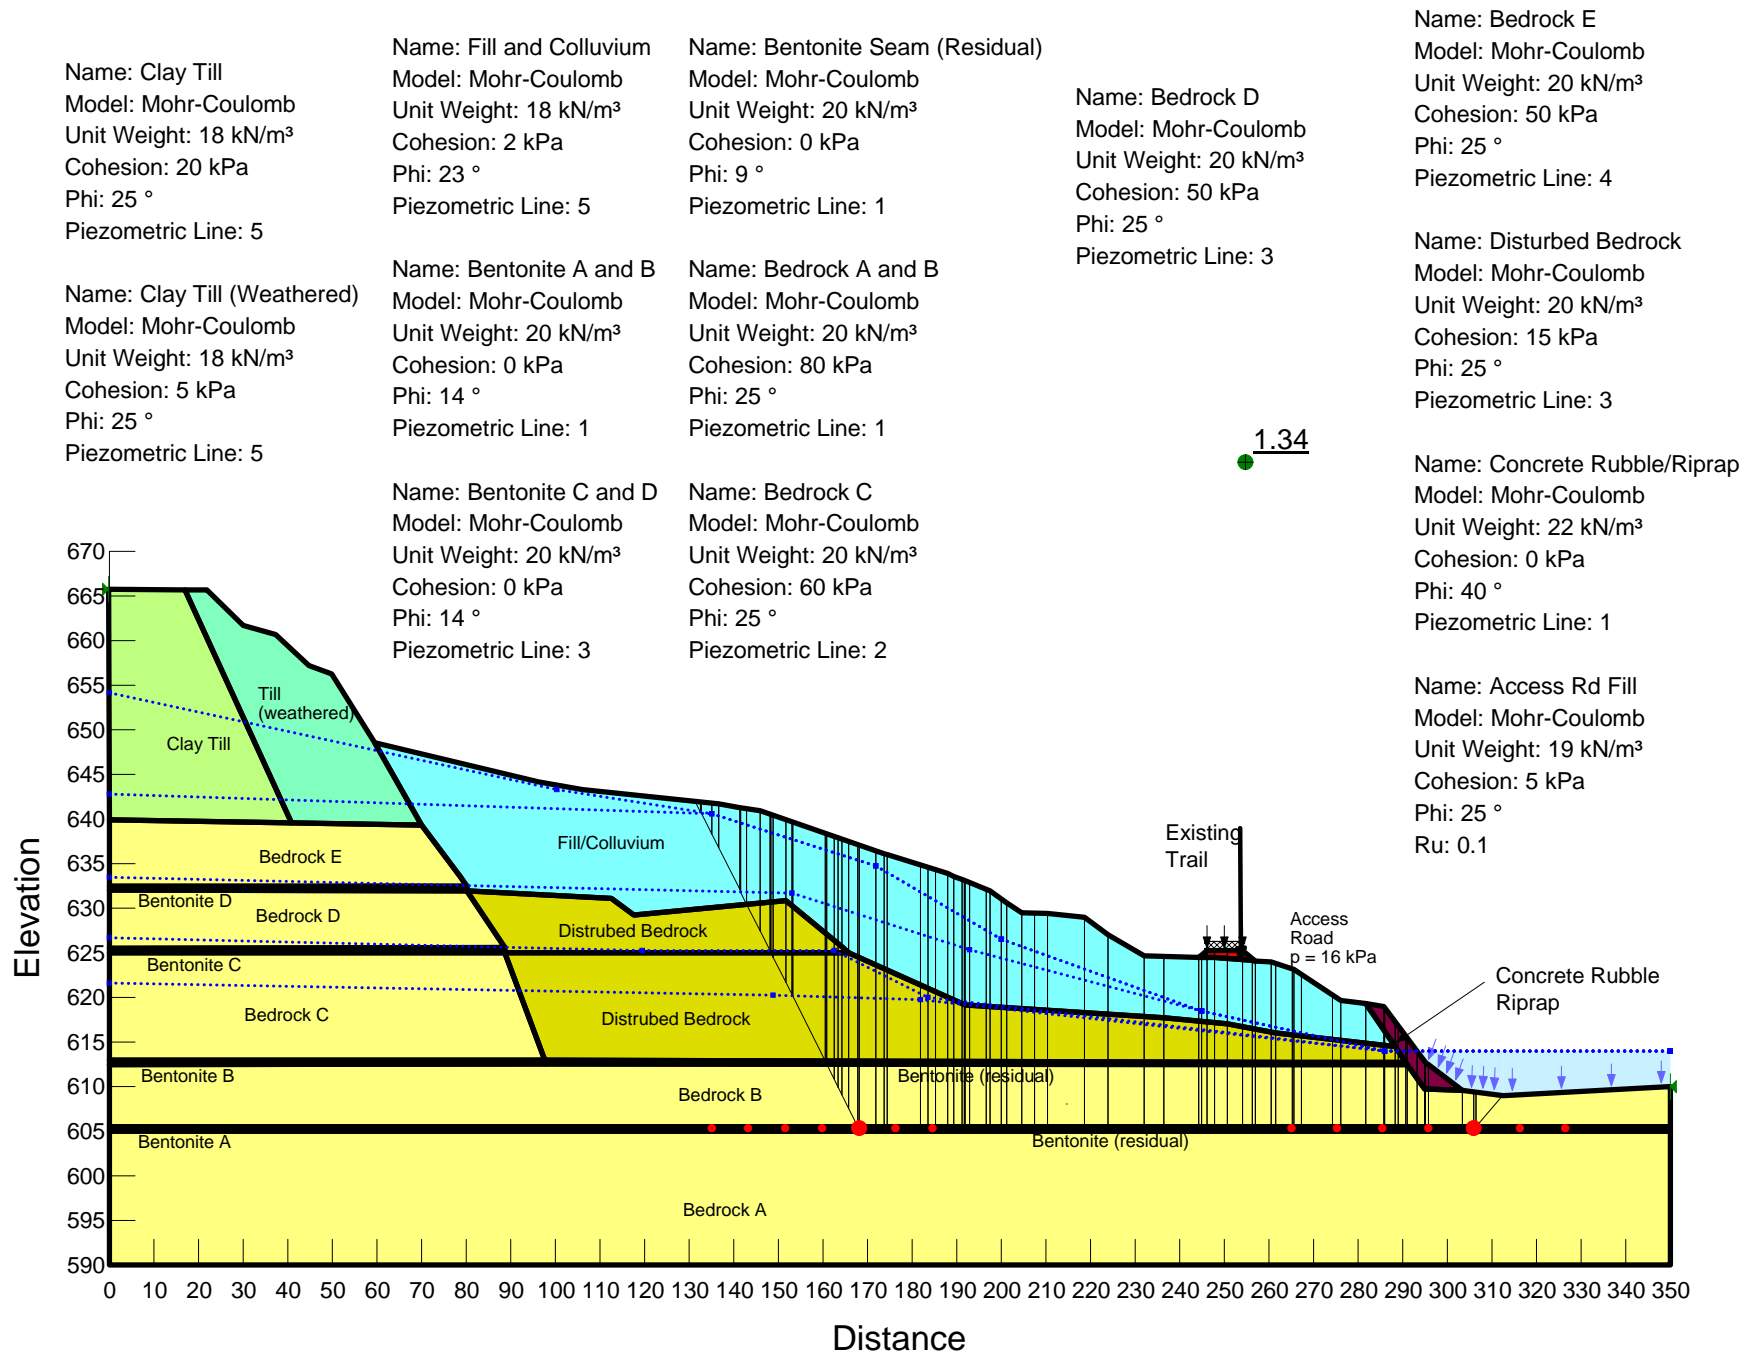
Name: Clay Till  
Model: Mohr-Coulomb  
Unit Weight: 18 kN/m<sup>3</sup>  
Cohesion: 20 kPa  
Phi: 25 °  
Piezometric Line: 5

Name: Clay Till (Weathered)  
Model: Mohr-Coulomb  
Unit Weight: 18 kN/m<sup>3</sup>  
Cohesion: 5 kPa  
Phi: 25 °  
Piezometric Line: 5

Name: Disturbed Bedrock  
Model: Mohr-Coulomb  
Unit Weight: 20 kN/m<sup>3</sup>  
Cohesion: 15 kPa  
Phi: 25 °  
Piezometric Line: 3

Name: Concrete Rubble/Riprap  
Model: Mohr-Coulomb  
Unit Weight: 22 kN/m<sup>3</sup>  
Cohesion: 0 kPa  
Phi: 40 °  
Piezometric Line: 1

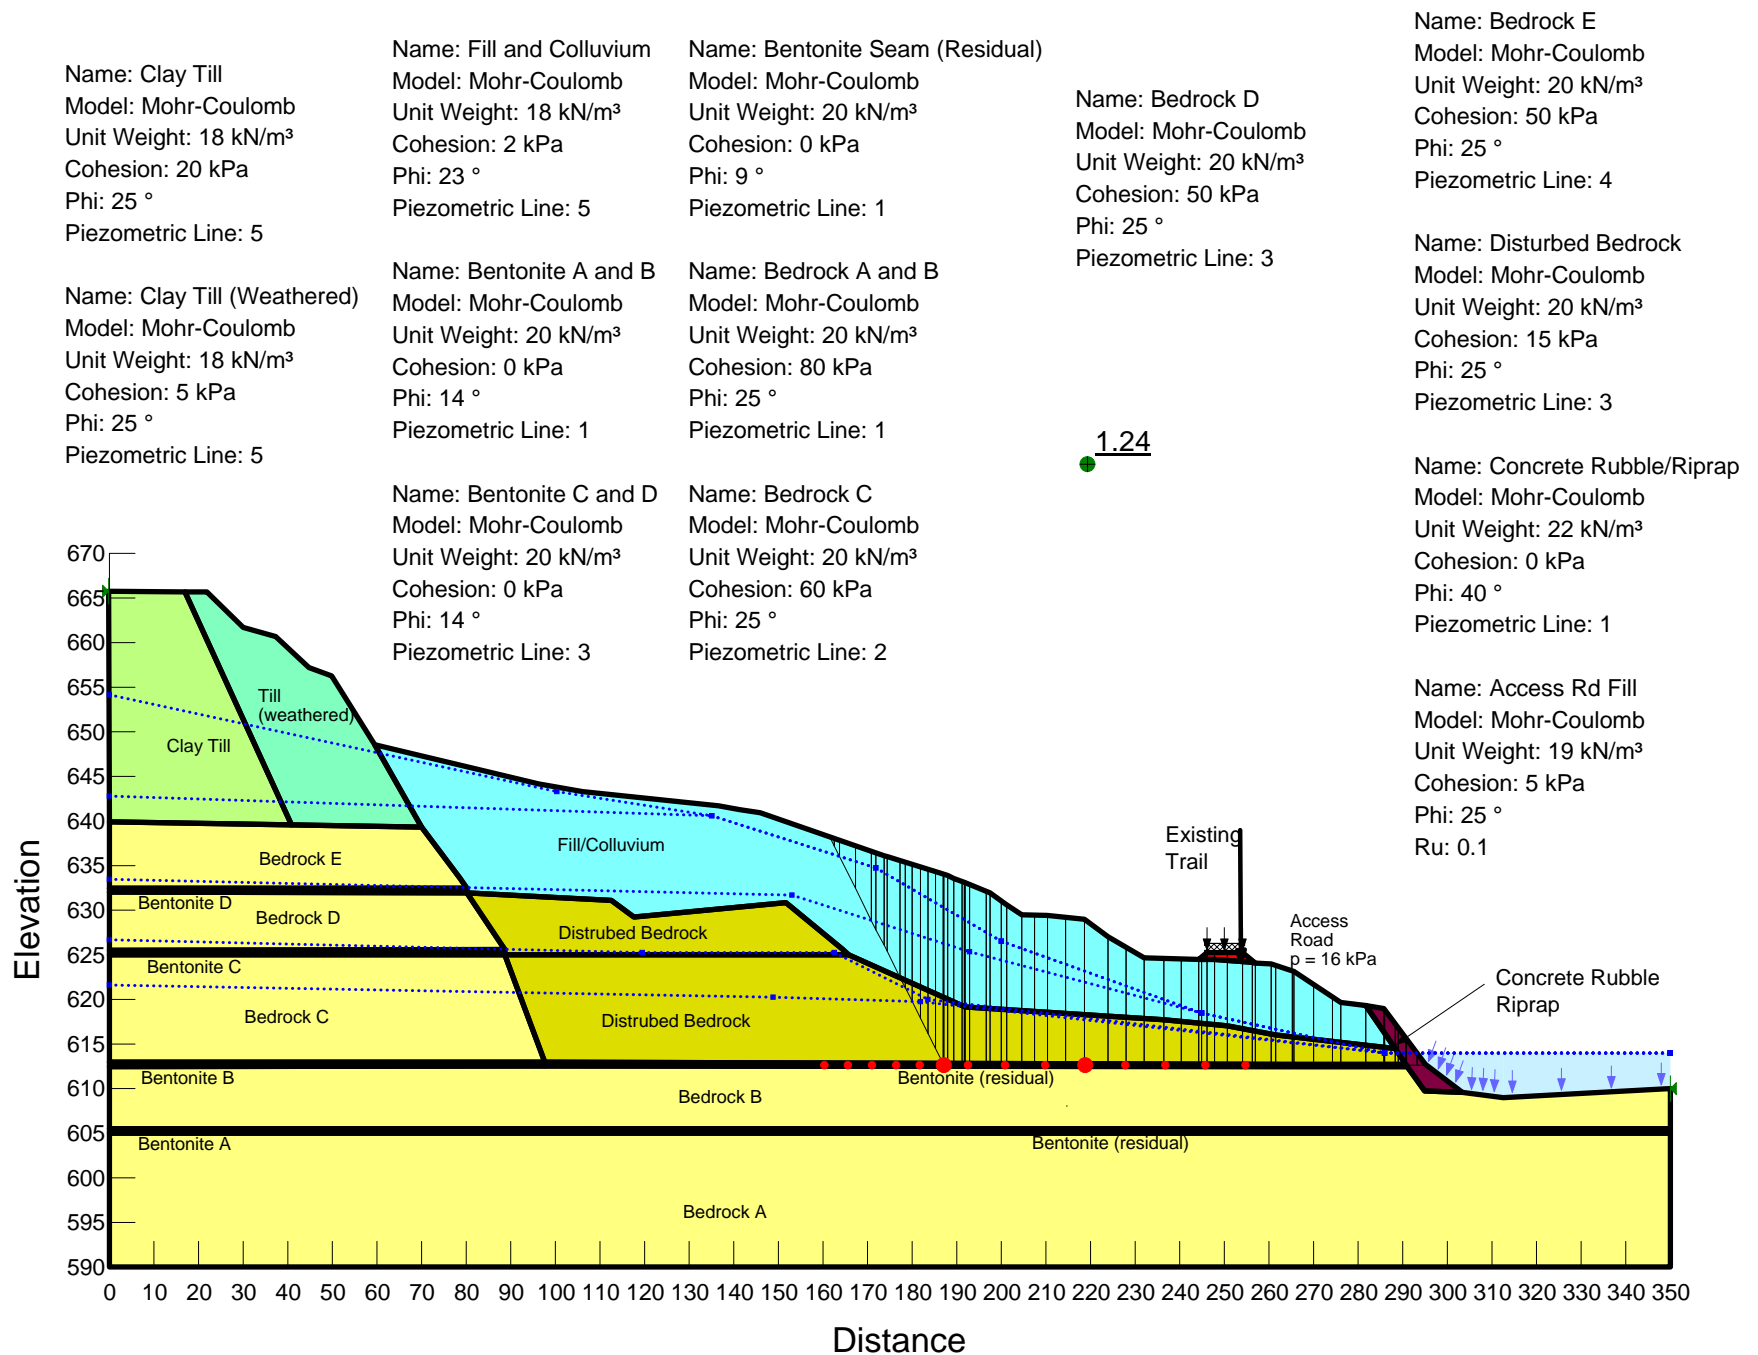
Name: Clay Till  
Model: Mohr-Coulomb  
Unit Weight: 18 kN/m<sup>3</sup>  
Cohesion: 20 kPa  
Phi: 25 °  
Piezometric Line: 5

Name: Clay Till (Weathered)  
Model: Mohr-Coulomb  
Unit Weight: 18 kN/m<sup>3</sup>  
Cohesion: 5 kPa  
Phi: 25 °  
Piezometric Line: 5

Name: Disturbed Bedrock  
Model: Mohr-Coulomb  
Unit Weight: 20 kN/m<sup>3</sup>  
Cohesion: 15 kPa  
Phi: 25 °  
Piezometric Line: 3

Name: Concrete Rubble/Riprap  
Model: Mohr-Coulomb  
Unit Weight: 22 kN/m<sup>3</sup>  
Cohesion: 0 kPa  
Phi: 40 °  
Piezometric Line: 1

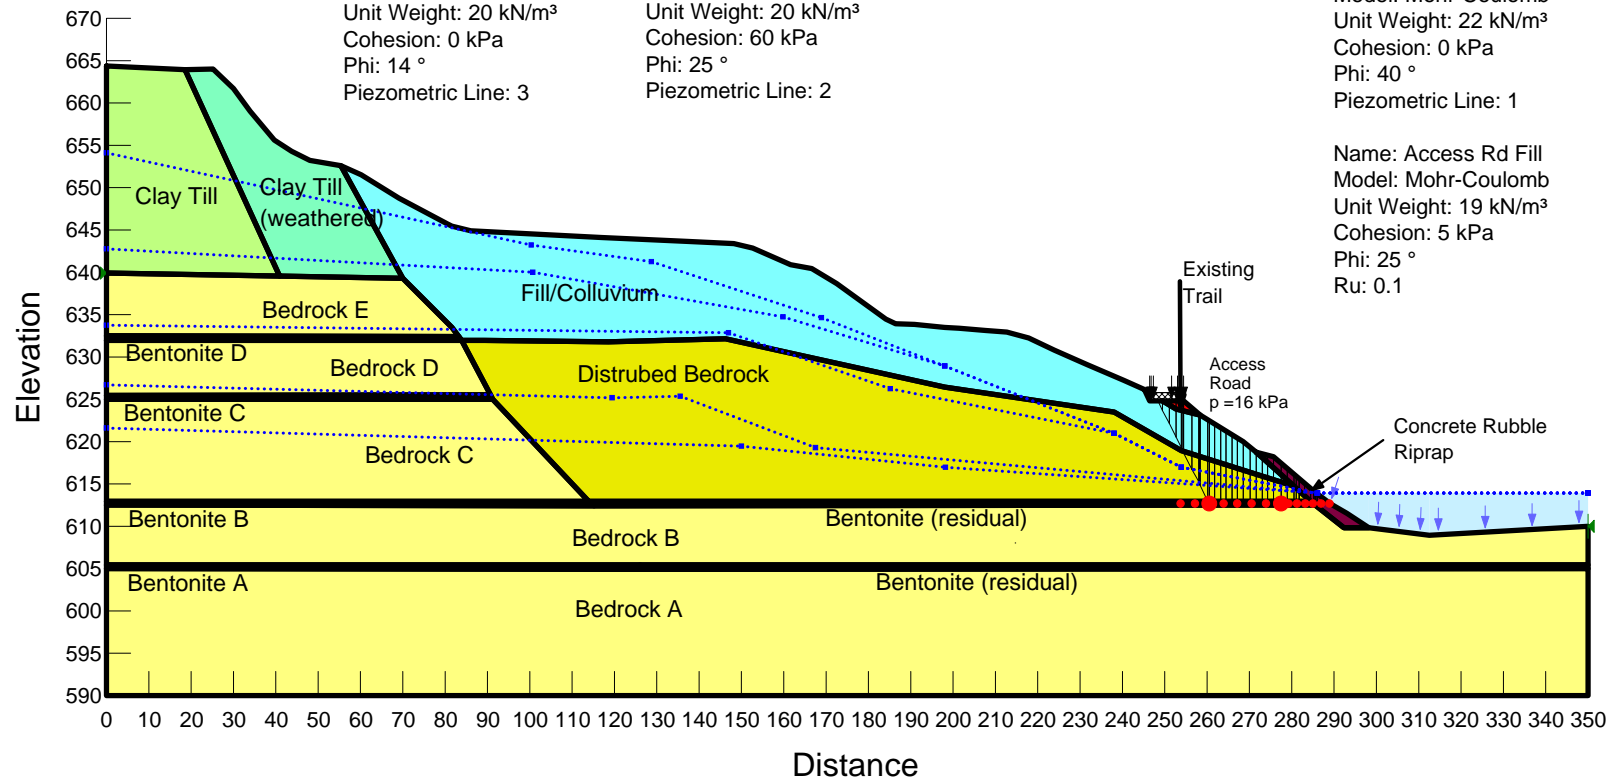
Name: Clay Till  
Model: Mohr-Coulomb  
Unit Weight: 18 kN/m<sup>3</sup>  
Cohesion: 20 kPa  
Phi: 25 °  
Piezometric Line: 5

Name: Fill and Colluvium  
Model: Mohr-Coulomb  
Unit Weight: 18 kN/m<sup>3</sup>  
Cohesion: 2 kPa  
Phi: 23 °  
Piezometric Line: 5

Name: Concrete Rubble/Riprap  
Model: Mohr-Coulomb  
Unit Weight: 22 kN/m<sup>3</sup>  
Cohesion: 0 kPa  
Phi: 40 °  
Piezometric Line: 1

Name: Access Rd Fill  
Model: Mohr-Coulomb  
Unit Weight: 19 kN/m<sup>3</sup>  
Cohesion: 5 kPa  
Phi: 25 °  
Ru: 0.1

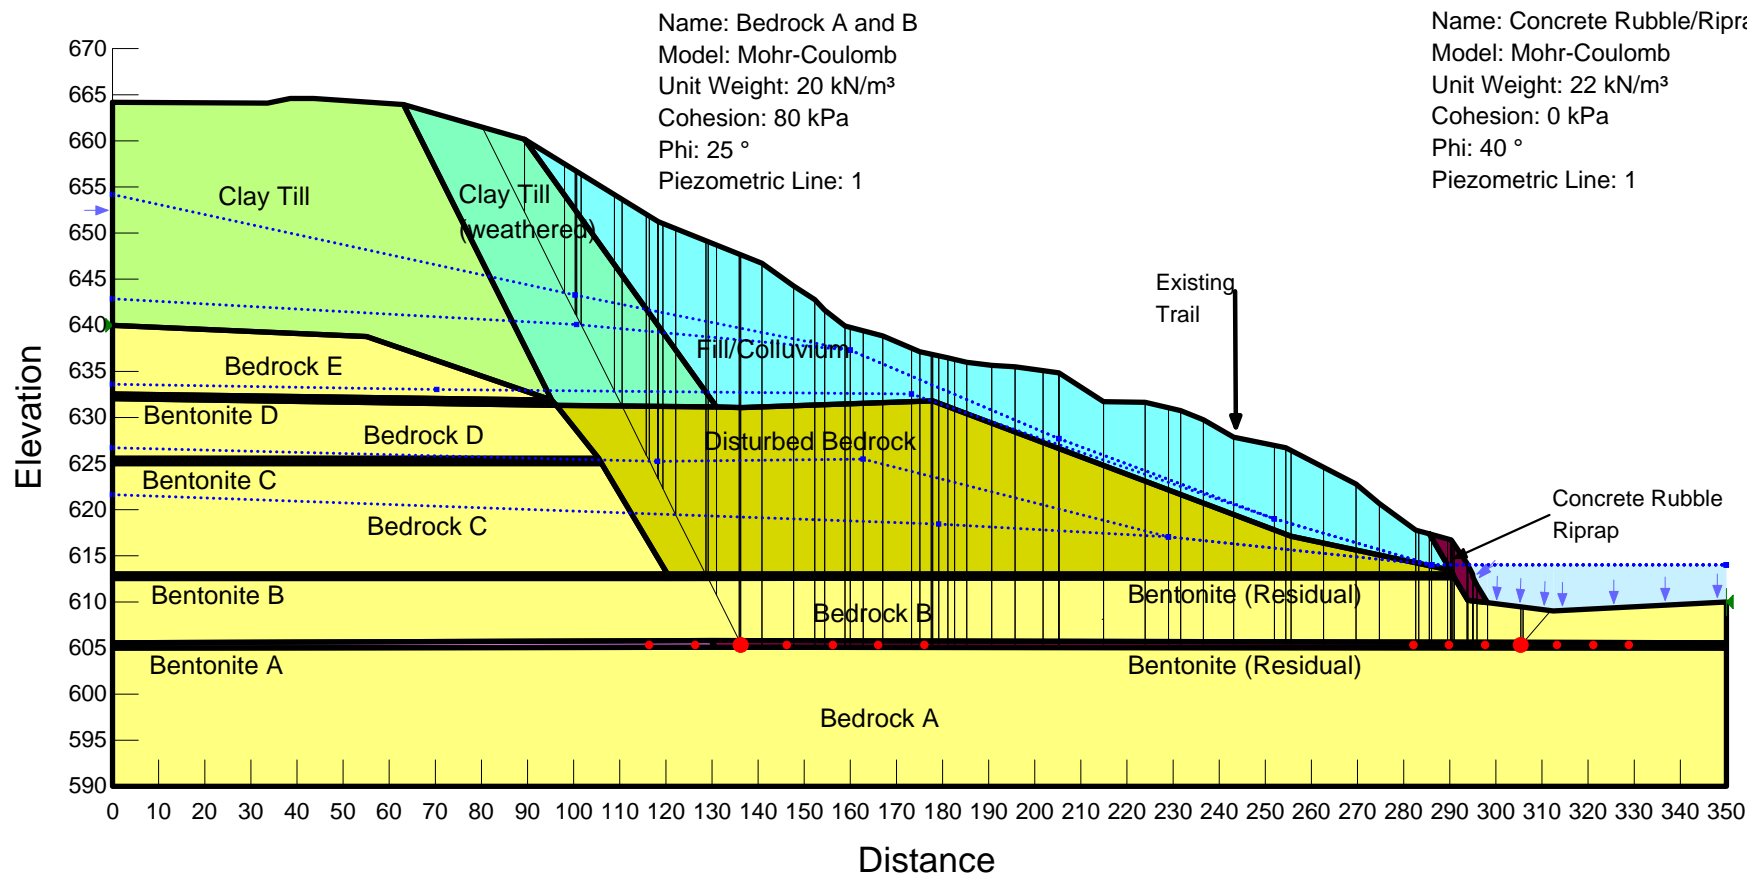
Name: Clay Till Model: Mohr-Coulomb Unit Weight: 18 kN/m <sup>3</sup> Cohesion: 20 kPa Phi: 25 ° Piezometric Line: 5	Name: Fill and Colluvium Model: Mohr-Coulomb Unit Weight: 18 kN/m <sup>3</sup> Cohesion: 2 kPa Phi: 23 ° Piezometric Line: 5	Name: Bentonite C and D Model: Mohr-Coulomb Unit Weight: 20 kN/m <sup>3</sup> Cohesion: 0 kPa Phi: 14 ° Piezometric Line: 3	Name: Bedrock C Model: Mohr-Coulomb Unit Weight: 20 kN/m <sup>3</sup> Cohesion: 60 kPa Phi: 25 ° Piezometric Line: 2	Name: Bedrock E Model: Mohr-Coulomb Unit Weight: 20 kN/m <sup>3</sup> Cohesion: 50 kPa Phi: 25 ° Piezometric Line: 4
Name: Clay Till (Weathered) Model: Mohr-Coulomb Unit Weight: 18 kN/m <sup>3</sup> Cohesion: 5 kPa Phi: 25 ° Piezometric Line: 5	Name: Bentonite A and B Model: Mohr-Coulomb Unit Weight: 20 kN/m <sup>3</sup> Cohesion: 0 kPa Phi: 14 ° Piezometric Line: 1	Name: Bentonite Seam (Residual) Model: Mohr-Coulomb Unit Weight: 20 kN/m <sup>3</sup> Cohesion: 0 kPa Phi: 9 ° Piezometric Line: 1	Name: Bedrock D Model: Mohr-Coulomb Unit Weight: 20 kN/m <sup>3</sup> Cohesion: 50 kPa Phi: 25 ° Piezometric Line: 3 <u>1.23</u>	Name: Disturbed Bedrock Model: Mohr-Coulomb Unit Weight: 20 kN/m <sup>3</sup> Cohesion: 30 kPa Phi: 25 ° Piezometric Line: 3

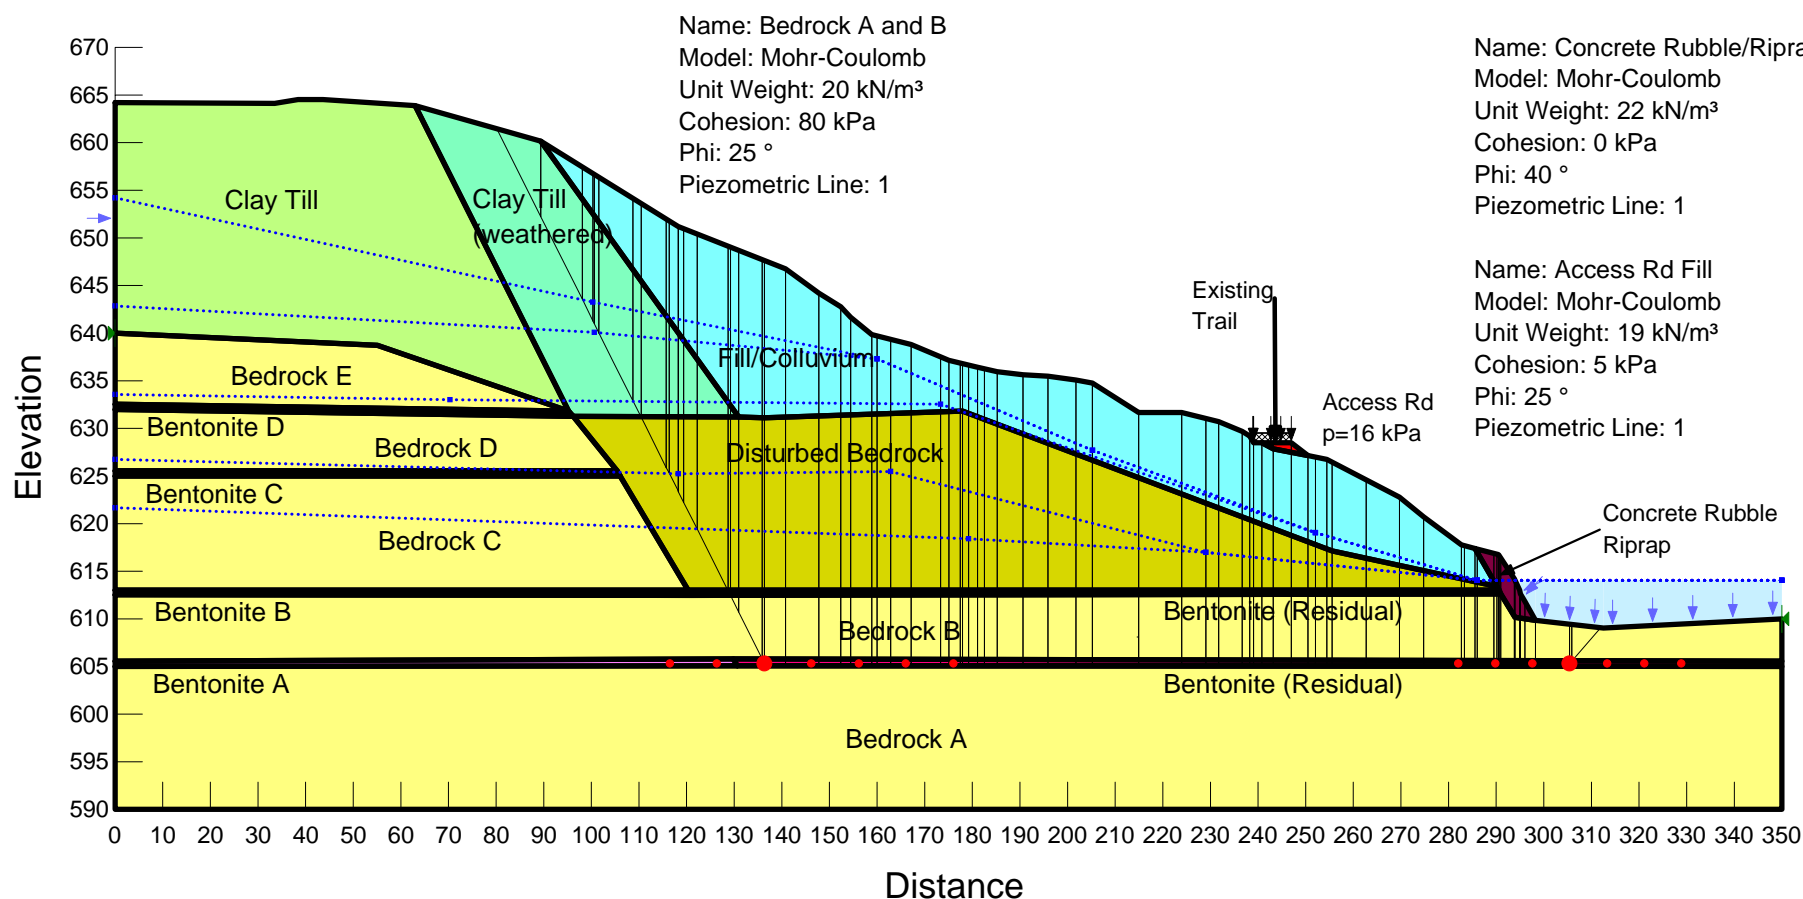
Name: Clay Till  
Model: Mohr-Coulomb  
Unit Weight: 18 kN/m<sup>3</sup>  
Cohesion: 20 kPa  
Phi: 25 °  
Piezometric Line: 5

Name: Fill and Colluvium  
Model: Mohr-Coulomb  
Unit Weight: 18 kN/m<sup>3</sup>  
Cohesion: 2 kPa  
Phi: 23 °  
Piezometric Line: 5

Name: Concrete Rubble/Riprap  
Model: Mohr-Coulomb  
Unit Weight: 22 kN/m<sup>3</sup>  
Cohesion: 0 kPa  
Phi: 40 °  
Piezometric Line: 1

Name: Access Rd Fill  
Model: Mohr-Coulomb  
Unit Weight: 19 kN/m<sup>3</sup>  
Cohesion: 5 kPa  
Phi: 25 °  
Piezometric Line: 1

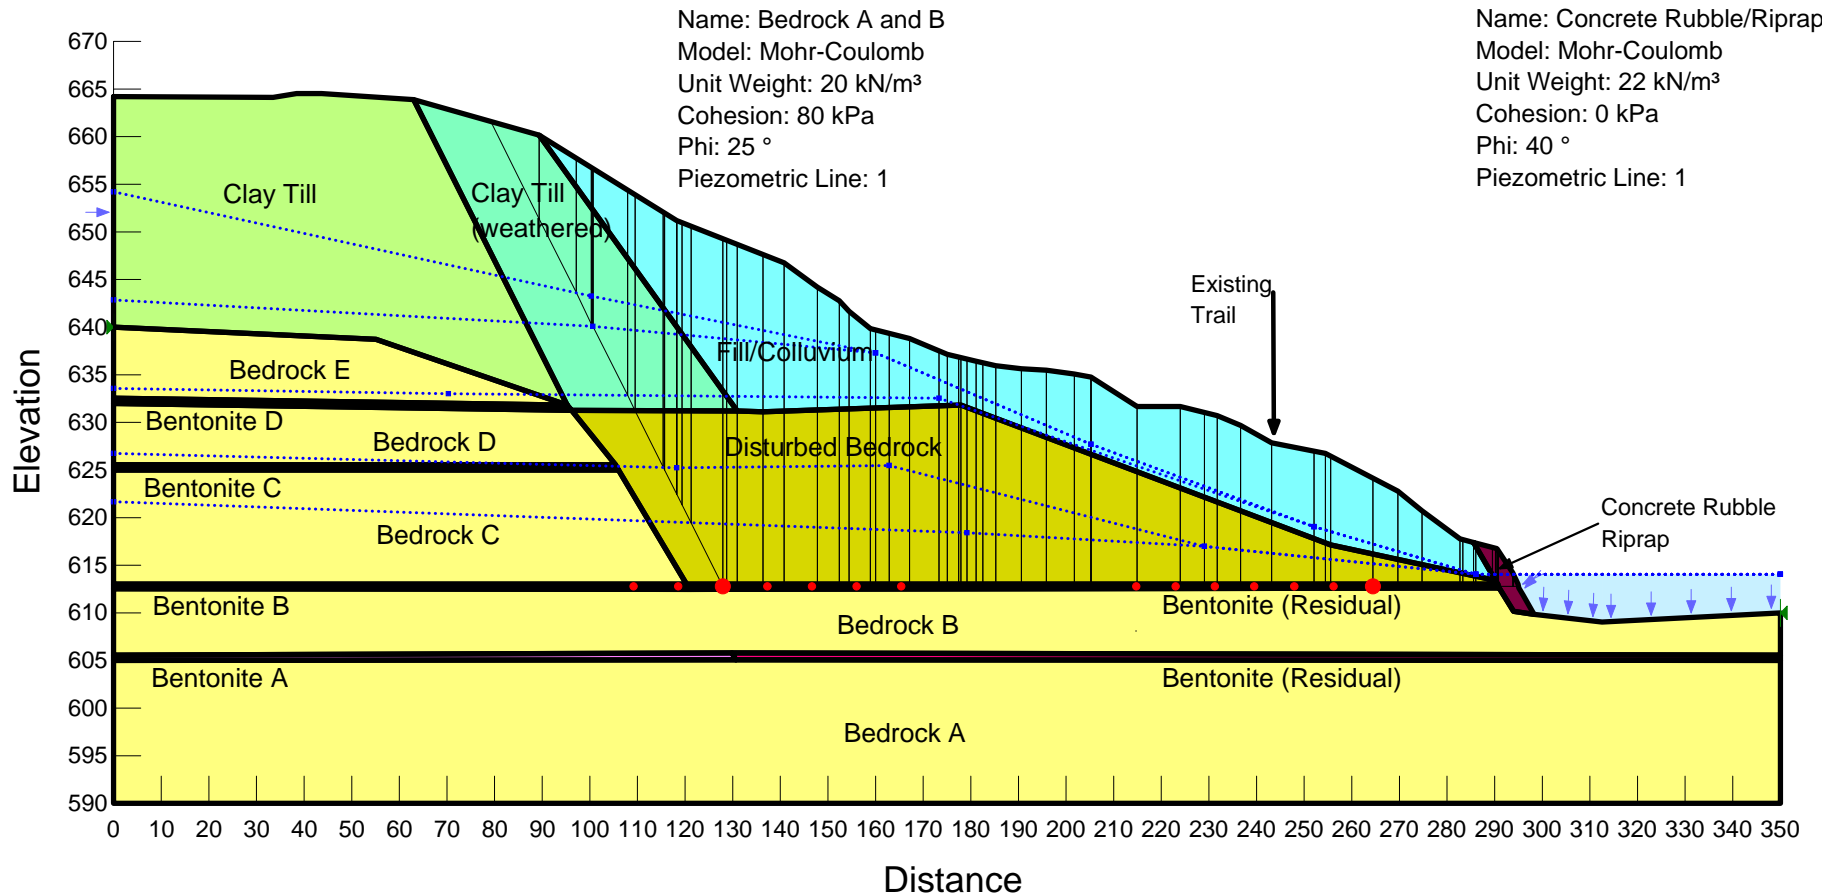
Name: Clay Till  
Model: Mohr-Coulomb  
Unit Weight: 18 kN/m<sup>3</sup>  
Cohesion: 20 kPa  
Phi: 25 °  
Piezometric Line: 5

Name: Fill and Colluvium  
Model: Mohr-Coulomb  
Unit Weight: 18 kN/m<sup>3</sup>  
Cohesion: 2 kPa  
Phi: 23 °  
Piezometric Line: 5

Name: Disturbed Bedrock  
Model: Mohr-Coulomb  
Unit Weight: 20 kN/m<sup>3</sup>  
Cohesion: 30 kPa  
Phi: 25 °  
Piezometric Line: 3

Name: Concrete Rubble/Riprap  
Model: Mohr-Coulomb  
Unit Weight: 22 kN/m<sup>3</sup>  
Cohesion: 0 kPa  
Phi: 40 °  
Piezometric Line: 1

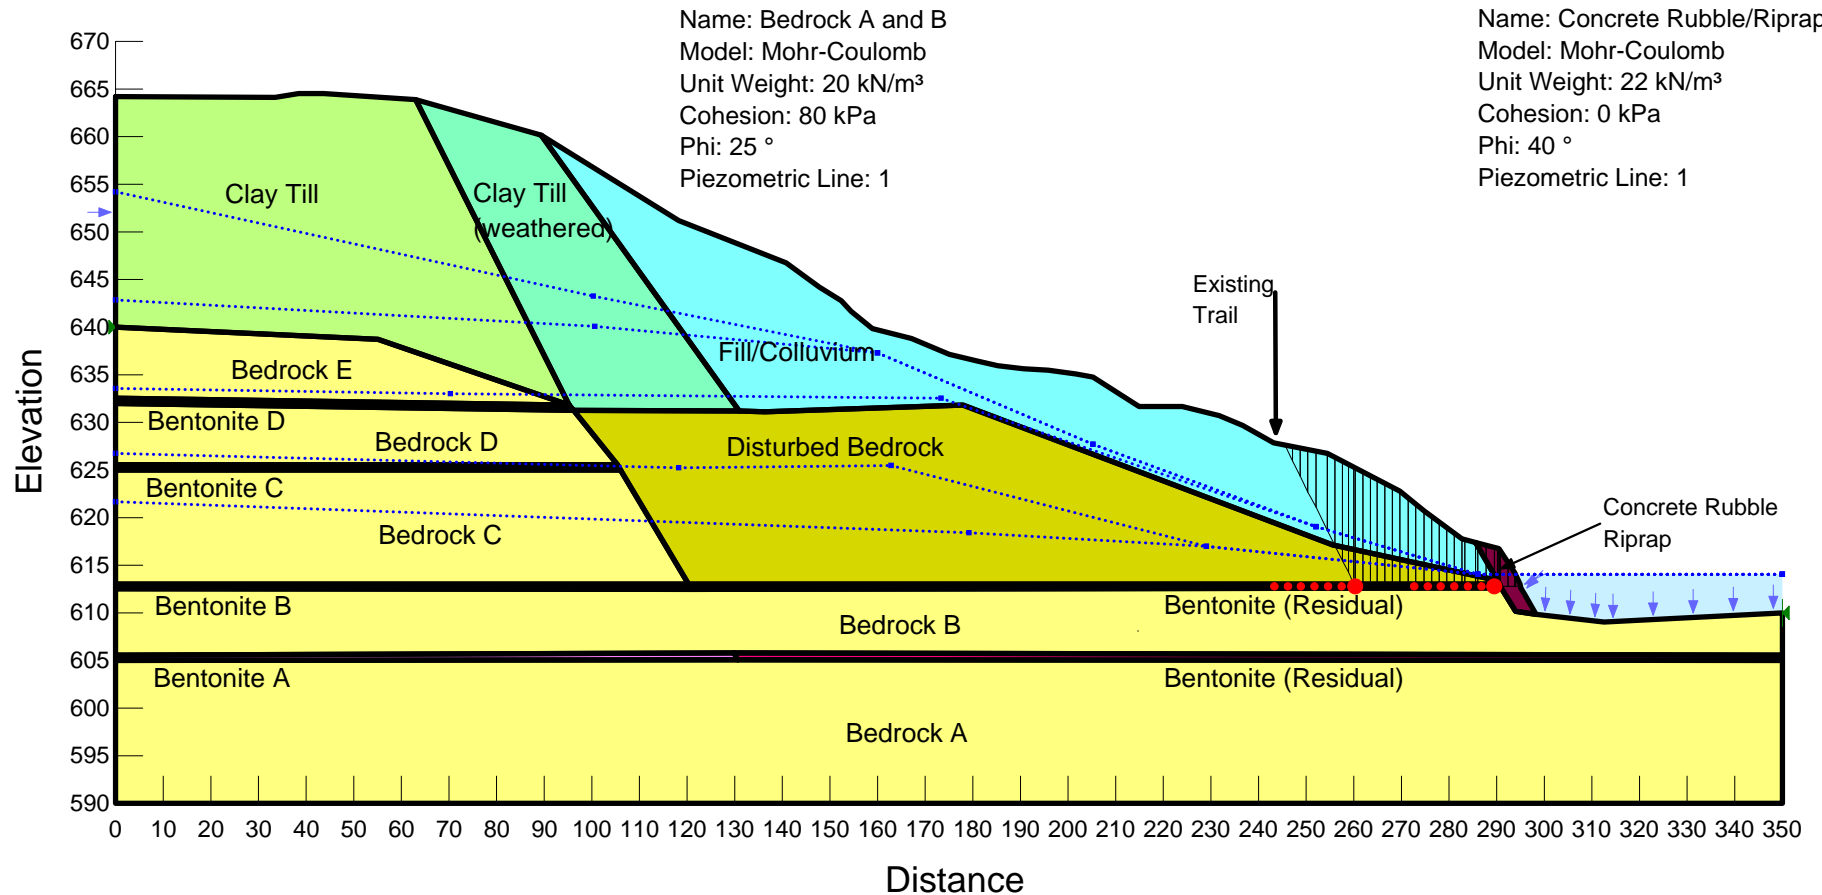
Name: Clay Till  
Model: Mohr-Coulomb  
Unit Weight: 18 kN/m<sup>3</sup>  
Cohesion: 20 kPa  
Phi: 25 °  
Piezometric Line: 5

Name: Fill and Colluvium  
Model: Mohr-Coulomb  
Unit Weight: 18 kN/m<sup>3</sup>  
Cohesion: 2 kPa  
Phi: 23 °  
Piezometric Line: 5

Name: Concrete Rubble/Riprap  
Model: Mohr-Coulomb  
Unit Weight: 22 kN/m<sup>3</sup>  
Cohesion: 0 kPa  
Phi: 40 °  
Piezometric Line: 1

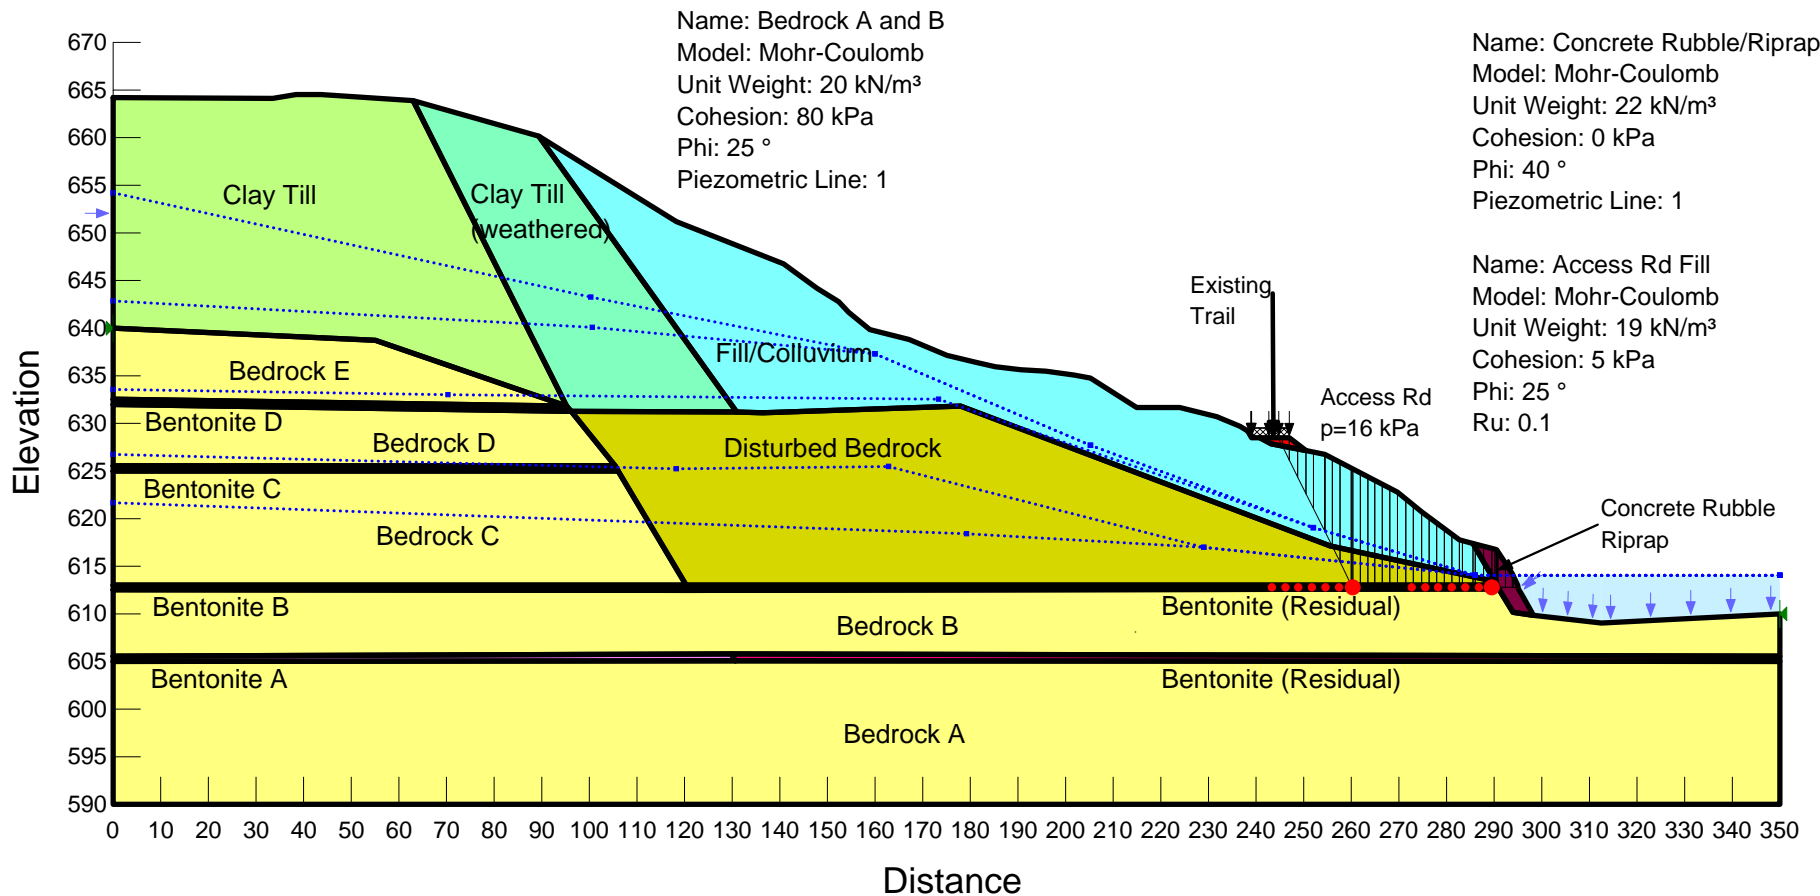
Name: Clay Till  
Model: Mohr-Coulomb  
Unit Weight: 18 kN/m<sup>3</sup>  
Cohesion: 20 kPa  
Phi: 25 °  
Piezometric Line: 5

Name: Fill and Colluvium  
Model: Mohr-Coulomb  
Unit Weight: 18 kN/m<sup>3</sup>  
Cohesion: 2 kPa  
Phi: 23 °  
Piezometric Line: 5

Name: Concrete Rubble/Riprap  
Model: Mohr-Coulomb  
Unit Weight: 22 kN/m<sup>3</sup>  
Cohesion: 0 kPa  
Phi: 40 °  
Piezometric Line: 1

Name: Access Rd Fill  
Model: Mohr-Coulomb  
Unit Weight: 19 kN/m<sup>3</sup>  
Cohesion: 5 kPa  
Phi: 25 °  
Ru: 0.1
