# PLANNING AND DEVELOPMENT

## JOHN WALTER MUSEUM 9100 - WALTERDALE HILL

#### **Description of Historic Place**

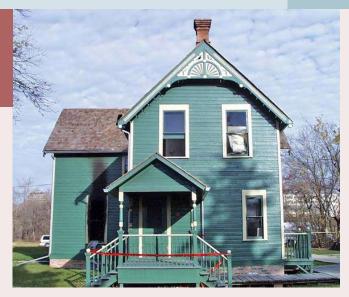
- its highly visible assembly of three early dwellings;
- the 1875 house constructed of rough hewn logs laid horizontally with corner dovetail joints and chinking between the logs, A-framed roof with horizontal ties, simple flat board trim around windows and door, 12-paned

- wooden sash windows and internal red brick chimney;
- the 1884 house constructed of rough hewn logs laid horizontally with corner dovetail joints with chinking between the logs, A-framed roof with horizontal ties, simple flat board trim around windows and door, fir for the first floor, double-hung 4-over-4 wooden sash windows, internal red brick chimneys at both ends and a door on east side with transom; and

- the 1901 house constructed with cross-gabled roof with double-height bay window on the north façade, double assembly double-hung 1-over-1 wooden sash windows in the second floor bay flanked by double-hung 1-over-1 wooden sash windows, large ground floor window with stained glass detailing in the upper portion, double-hung 1-over-1 wooden sash windows, wood drop siding with cornerboards, flat wooden trim with modest crowning detail around doors and windows, stained glass casement window under the eaves above the open half-width front verandah, rear covered porch with gabled roof, decorative spindle work and bargeboards, elaborate pierced gable screens, tongue-and-groove soffits, diagonally set front door opening onto the front verandah, a wood shingle roof, exposed brick foundation and two red brick internal chimneys with corbelling detail.
