## EXISTING SITE REVIEW

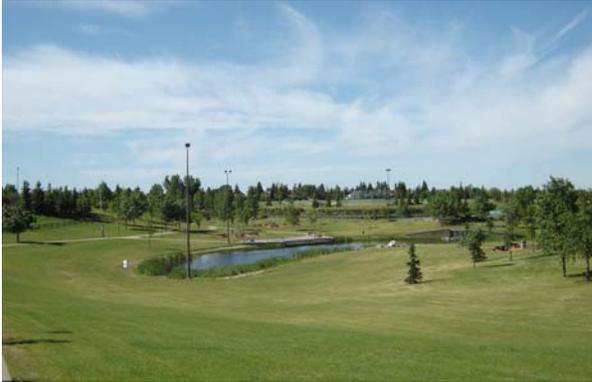
Drainage at the site is generally very good. The site has a stormwater management facility, as shown in the photo to the left, which serves the surrounding community and also collects the majority of the drainage for the site. The remainder of the drainage is collected in catch basins. Sport fields in the park are generally well drained. Currently four fields have irrigation and another field is slated to have irrigation installed in 2008.

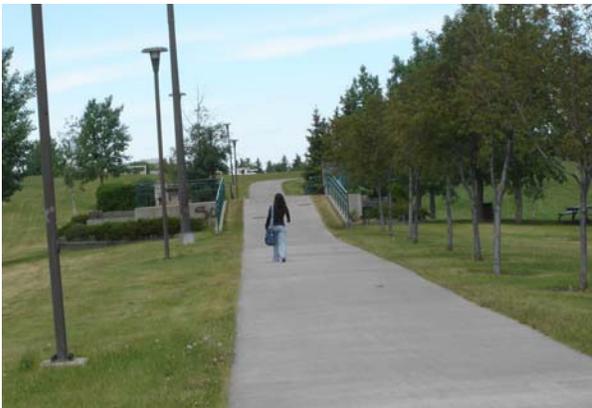
There is good pedestrian connectivity in the east half of the site, with well lit concrete walkways as shown in the photo to the left. However, there is no connection from the east side to the schools, the Recreation Centre or the sport fields in the west half of

the site. Desire lines are prevalent; particularly worn paths linking the crosswalk on 23 Avenue to the two schools and Recreation Centre.

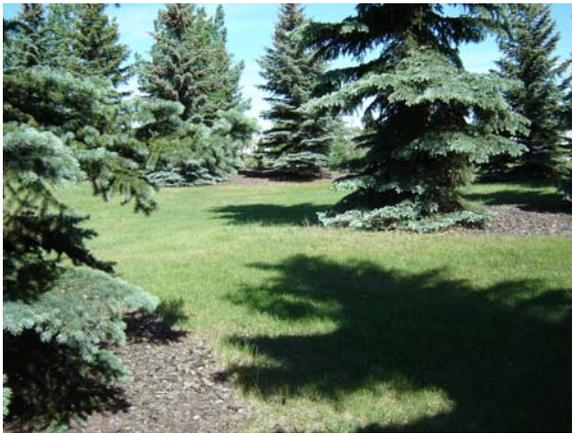
Landscaping of the site was completed with the original sports field development and there are many mature trees on site. The City standard planting requirements for a District Activity Park is 70 trees per plantable hectare, equaling 959 trees for the Mill Woods site. There are approximately 1000 trees on site, which exceeds the minimum requirements; however, this planting is not evenly distributed throughout the park. While the east side is heavily treed, the west and central portion of the site are rather sparsely planted.
