PROJECT RIVER VALLEY BRIDGE AND STAIR REPLACEMENT PROJECT

PHOTO REFERENCE

TREE PROTECTION DETAILS

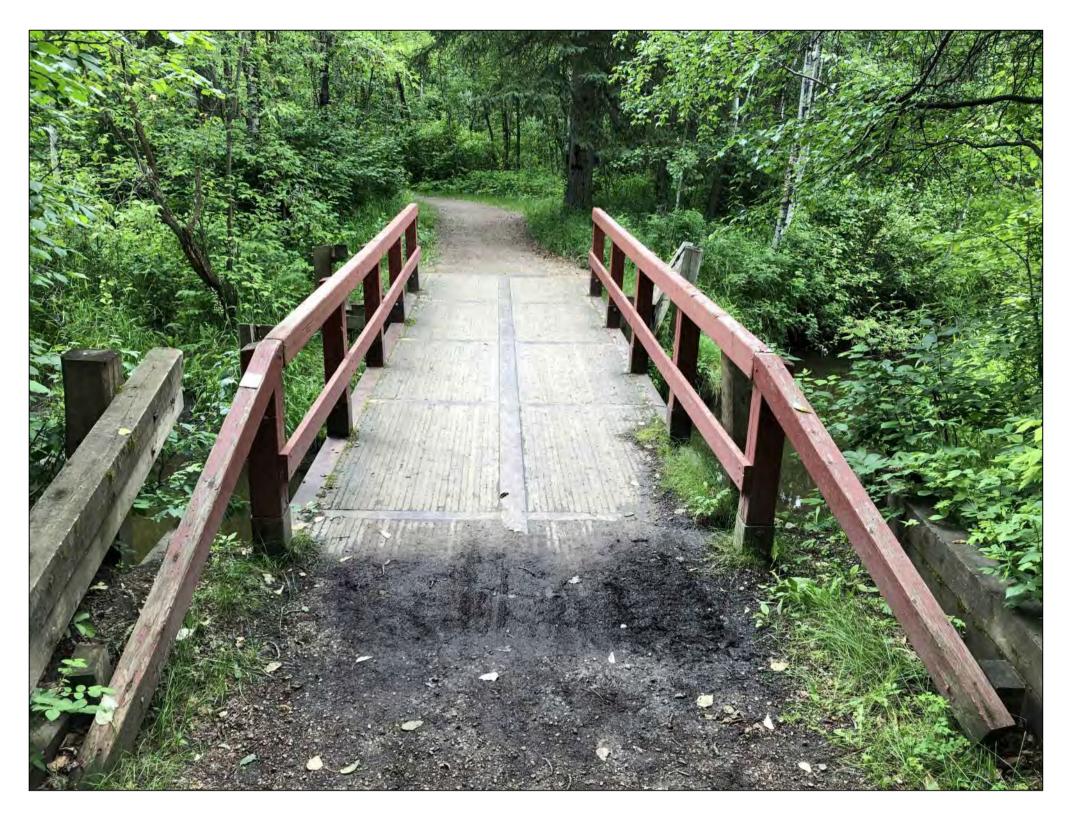
a BRIDGE VIEW FACING NORTH (SUMMER)
PHOTO

-CROUP OF ASPEN -LARGE SPRUCE TO REMOVE -BRCH TO REMOVE

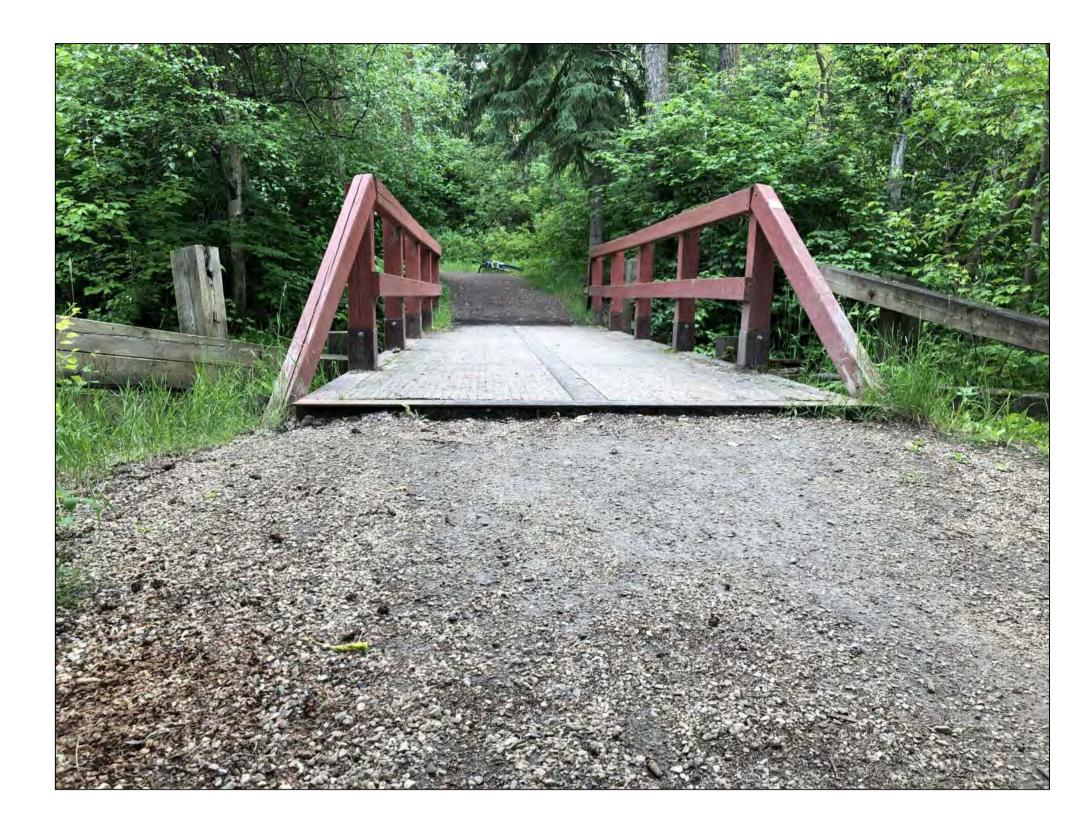
C BRIDGE VIEW FACING SOUTH (SUMMER)
PHOTO

BIRCH TO REMOVE

\_LARGE SPRUCE TO SAVE

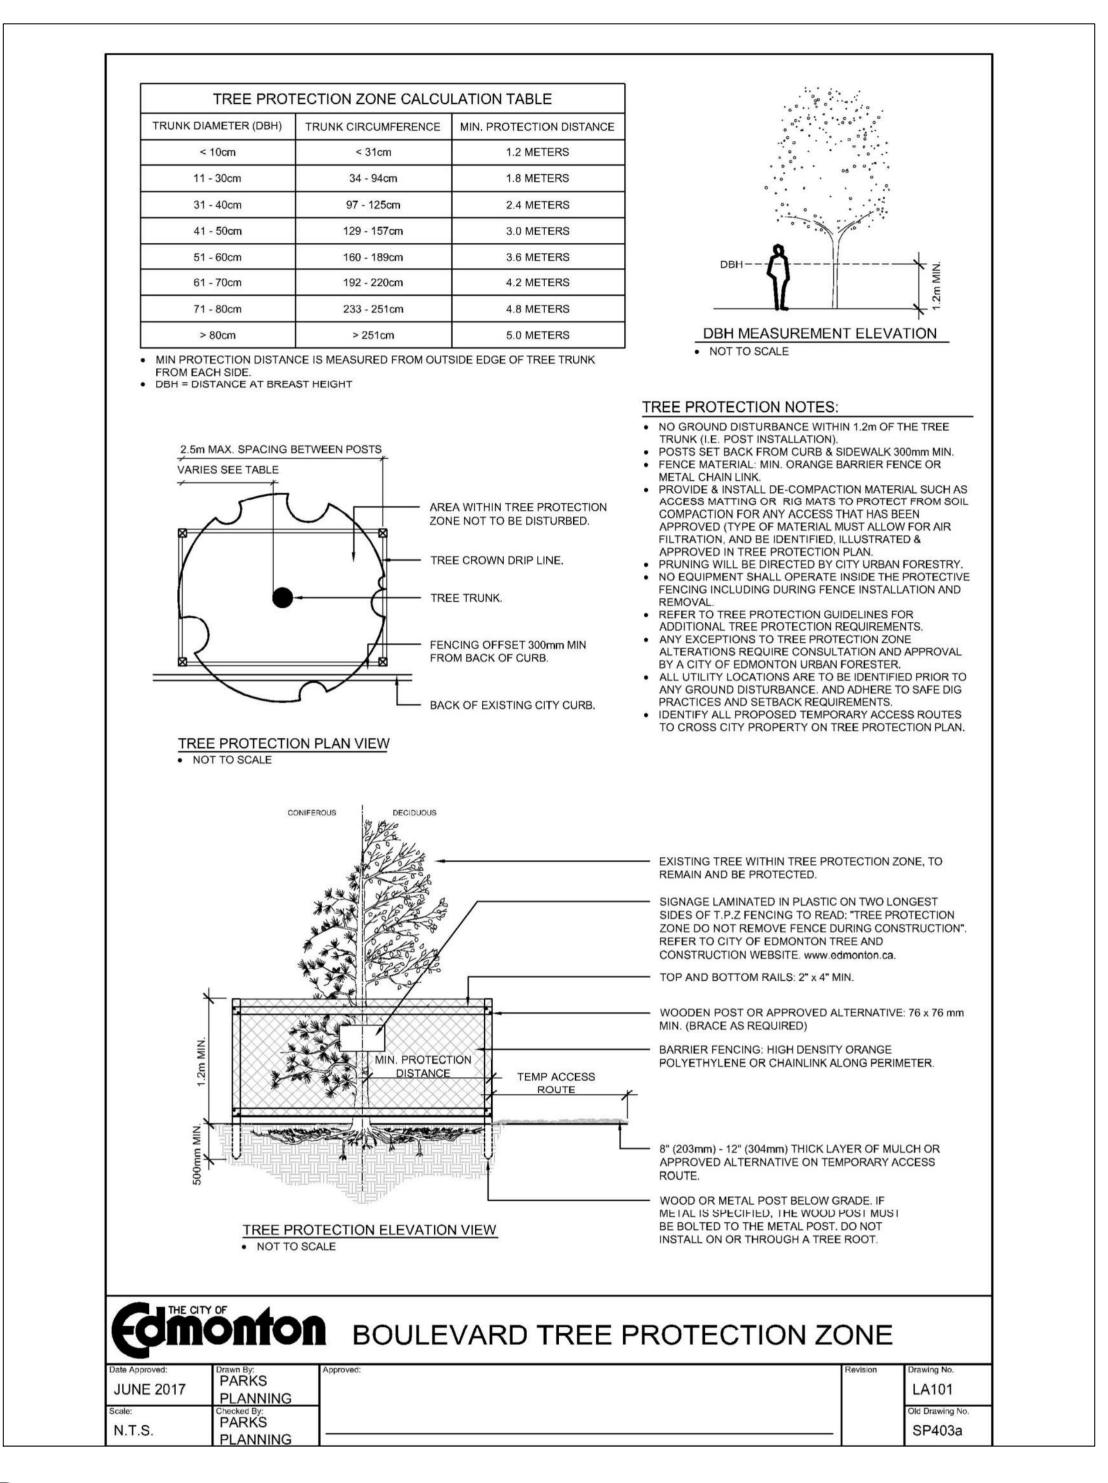
\_06 / DETAIL

a TYPICAL TREE PROTECTION
