WALTERDALE BRIDGE REPLACEMENT

PROJECT UPDATE

(November 2013)

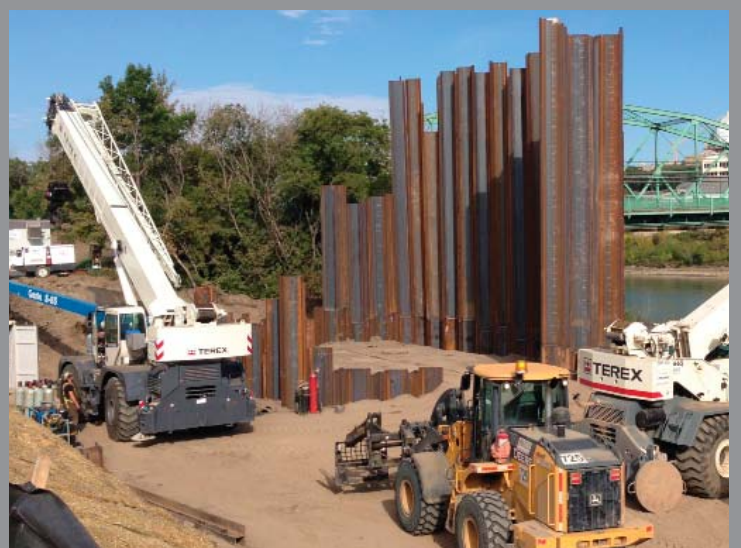
A square cofferdam takes form as sheet pilings are installed on the south side. Once all pilings are in place, soil inside is removed to create a dry work area.

The sheet pilings will create watertight cofferdams (*see box*) where concrete thrust blocks will soon be built. The thrust blocks will serve to anchor the future bridge arches.

A cofferdam, or 'coffer', is a temporary enclosure built within or nearby a body of water that allows for water to be pumped out, creating a dry work environment for construction. They are often used for oil platforms, bridge piers and other support structures in or over water. Cofferdams are usually welded steel structures made up of sheet piling, wales and cross braces. They are usually dismantled after work is completed.

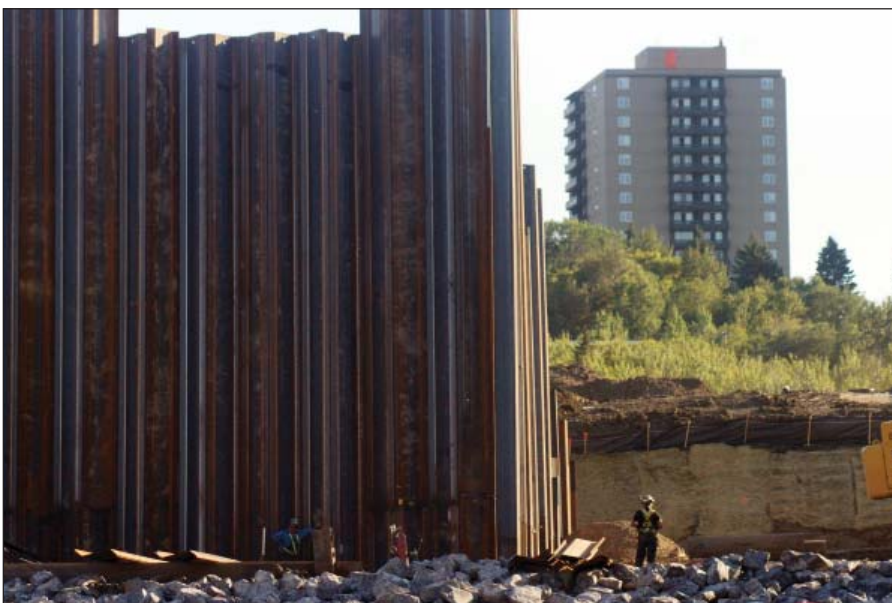
Workers standing next to sheet pilings on the south side demonstrate the scale of work involved in bridge construction.
