# STRATHCONA POOL ASSESSMENT

OCTOBER 07, 2009

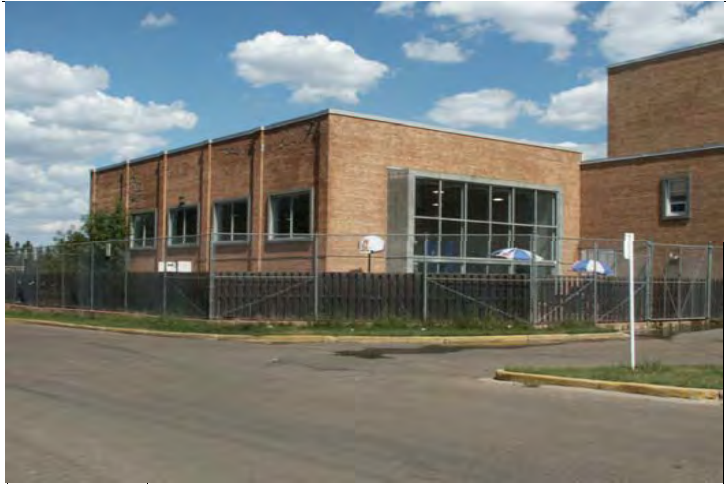
Photo No.	1
Reference	
Comment	Swimming pool from the south west with the exterior deck in the foreground.

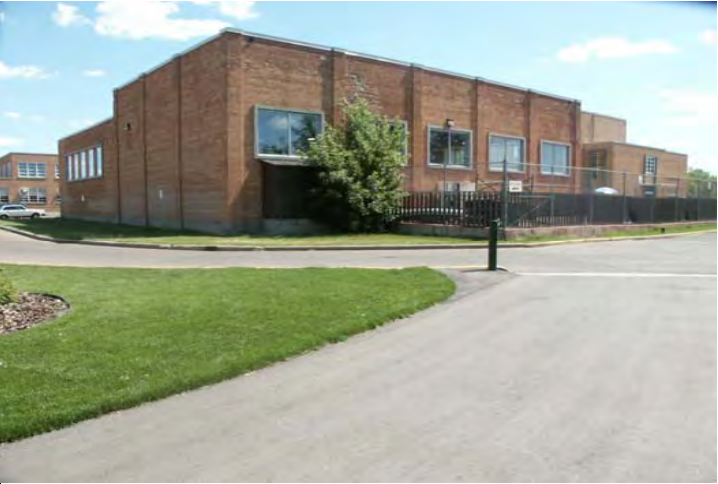
Photo No.	2
Reference	
Comment	Exterior View of pool from the north west side.

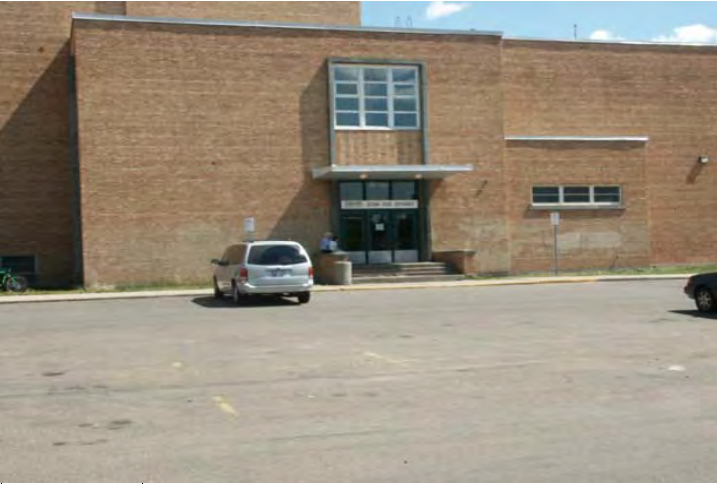
Photo No.	3
Reference	
Comment	Exterior View of pool from the west side showing entrance to both the pool and Strathcona High Schools.

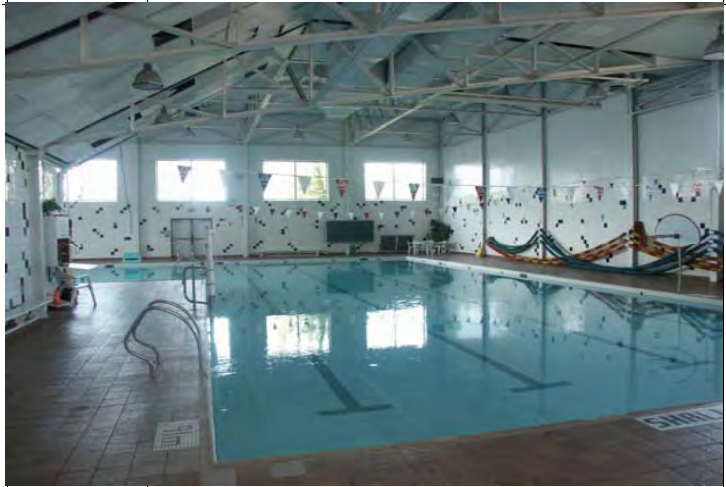
Photo No.	4
Reference	
Comment	Interior view of the swimming pool from the top of the ramp down to change rooms (south east corner).

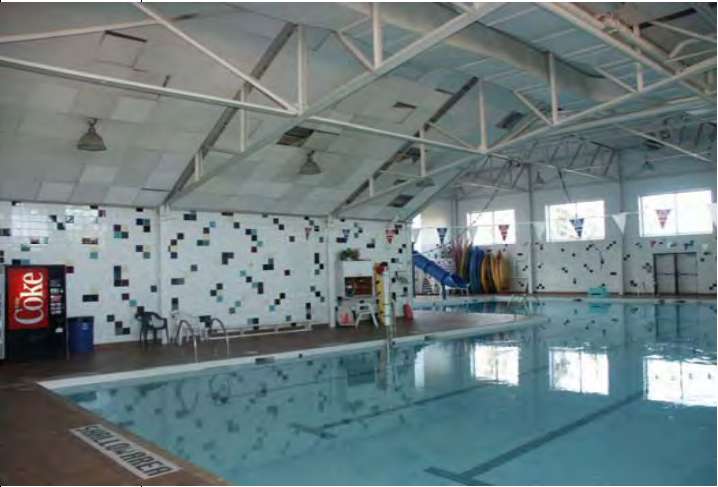
Photo No.	5
Reference	
Comment	Interior view of pool from the north east corner.

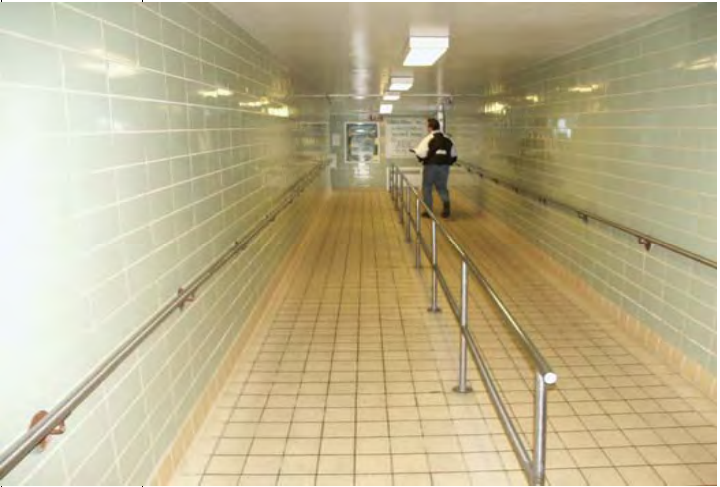
Photo No.	6
Reference	
Comment	Interior view of the steep ramp from change rooms up to pool.

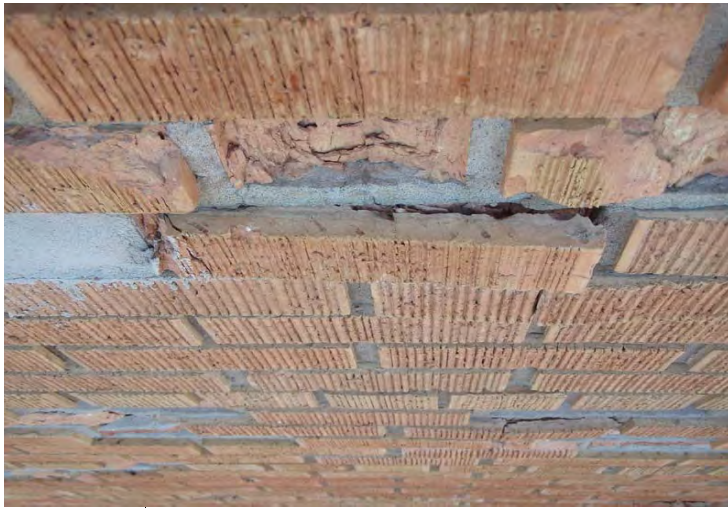
The exterior brick is seriously deteriorated, with extensive spalling of the brick particularly near the top of the walls. The cause of the spalling is freeze-thaw damage caused by the condensation of humid air leaking through defects in the wall. This damage will continue and may even accelerate as the number of freeze-thaw cycles accumulate, unless remedial repairs are made to the envelope.

Photo No.	19
Reference	B2010.02.03-5
Comment	Brick fragments ready to fall.

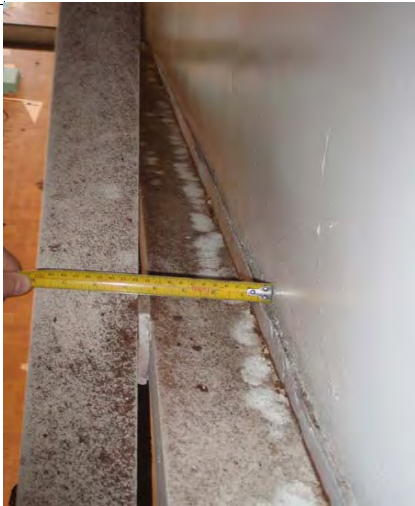
25

There are numerous cracks in the brick ranging in width from hairline to extremely wide. The masonry is out of plumb and bulging in some locations. We believe these defects are much more likely related to movement of the foundations than to condensation within the walls. Our comments regarding this problem are therefore contained in the Structural section of the report.

West elevation masonry wall panel south of northwest corner displaced outwards 1 inch from adjacent steel roof truss.

The cracking can be stopped by underpinning the foundations. Underpinning may also be used to somewhat improve the current out-of-plumbness and bulging of the masonry walls.

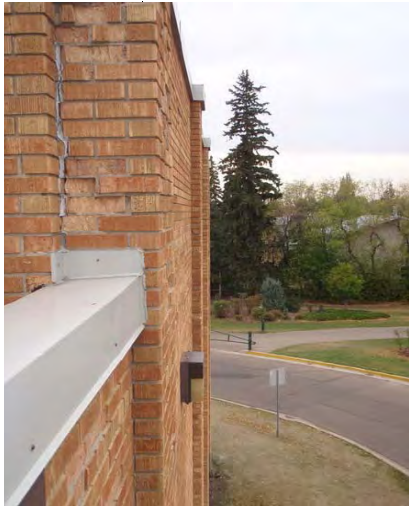
27

Top of second column from west bulging out approximately 1.5 inches on north elevation.

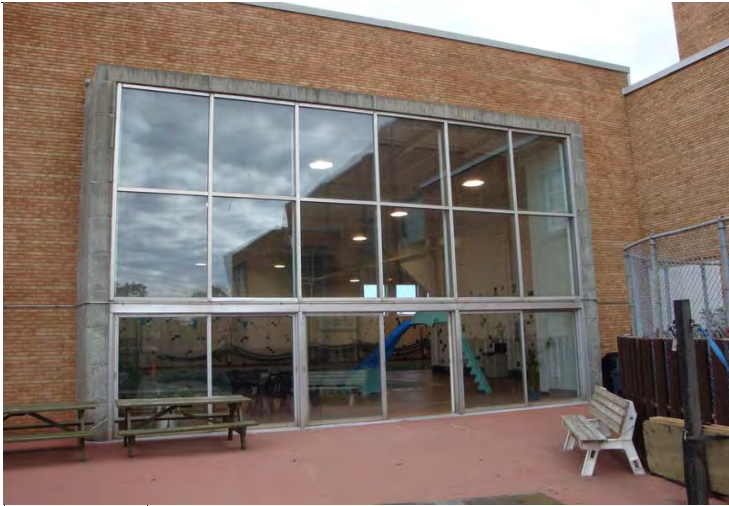
Photo No.	35
Reference	B2020.03-1
Comment	The south elevation is dominated by a curtainwall type glazing system. There are sliding doors incorporated into the curtainwall.

At the time these wall repairs are made the existing low performance window, doors and curtainwall systems should be replaced with modern high performance glazing systems that include high condensation resistance, high thermal resistance and proper drainage. Typically such systems utilize aluminum curtainwall tube sections with large thermal breaks and incorporate sealed glazing units with thermally efficient spacer bars and low emissivity glass coatings. These systems can be effectively connected to the air/vapour barrier membrane to eliminate air leakage around the windows.

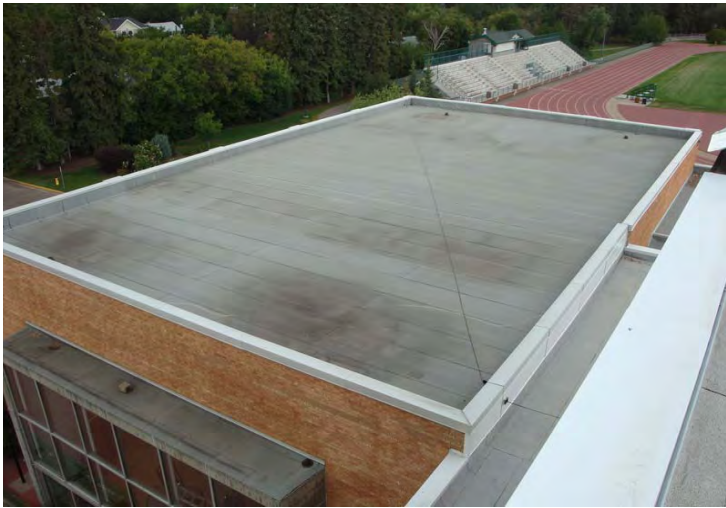
The roofs are approximately eighteen years old and exhibit defects such as blisters, insufficient drains and wet insulation. Some defects may be related to condensation within the parapets however more detailed investigations are required to determine the exact cause.

Photo No.	38
Reference	B3010.04.04-1
Comment	View of R1, the largest roof over the pool. All the roofs were replaced about 19 years ago.

The roofs should also be replaced at this time. The new roofing system would likely be similar in principle to the existing roofing system however the details at the perimeters would be carried out to prevent condensation and water penetration. The insulation thickness could be increased to meet life cycle costing or LEEDS requirements. Additional drains would also be added.

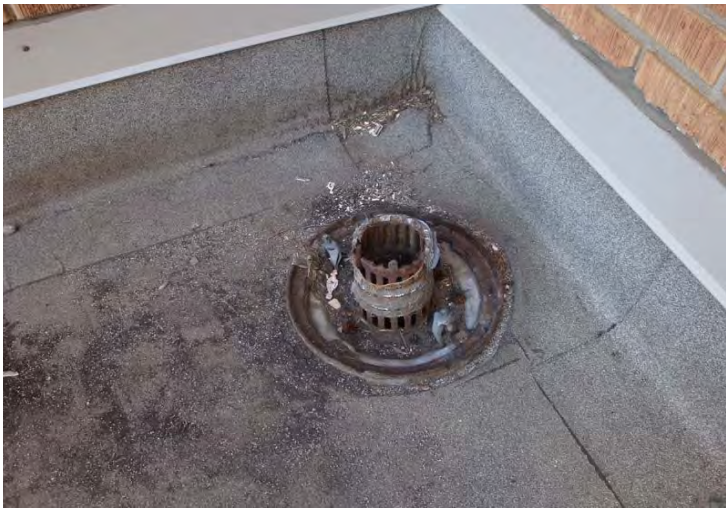
Photo No.	41
Reference	B3010.04.04-4
Comment	This drain on R5 is undersized.

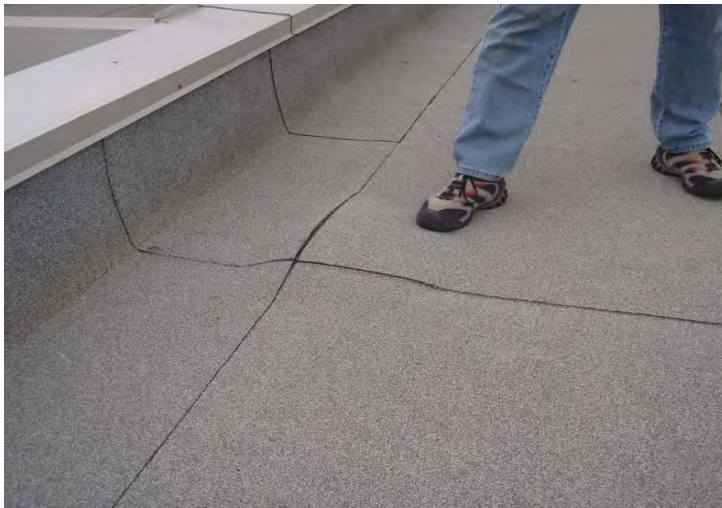
Photo No.	42
Reference	B3010.04.04-5
Comment	A typical blister. There are numerous blisters on R2 and some blisters on R1.

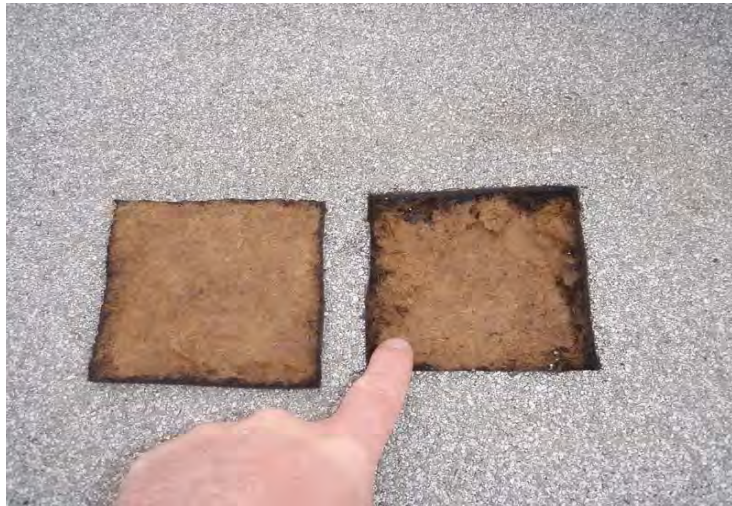
Photo No.	43
Reference	B3010.04.04-6
Comment	Wood fibreboard was wet at Roof R1 test cut.

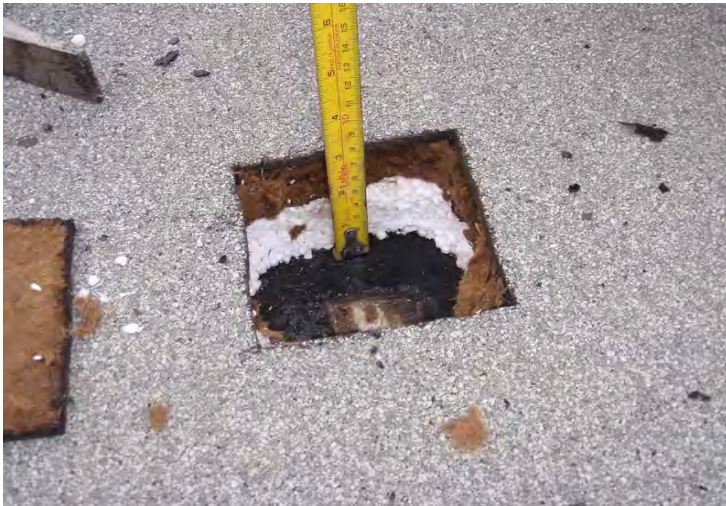
Photo No.	44
Reference	B3010.04.04-7
Comment	Roof composition at Roof R1 test cut. 2-ply SBS membrane, wood fibreboard, expanded polystyrene insulation and vapour barrier are visible.

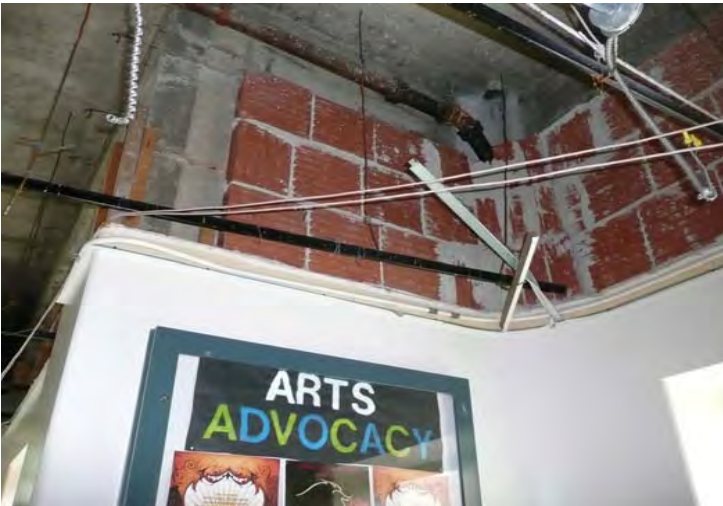
Photo No.	45
Reference	C1010.01.03
Comment	Typical partition in change room area. Plaster finish over hollow clay tile.

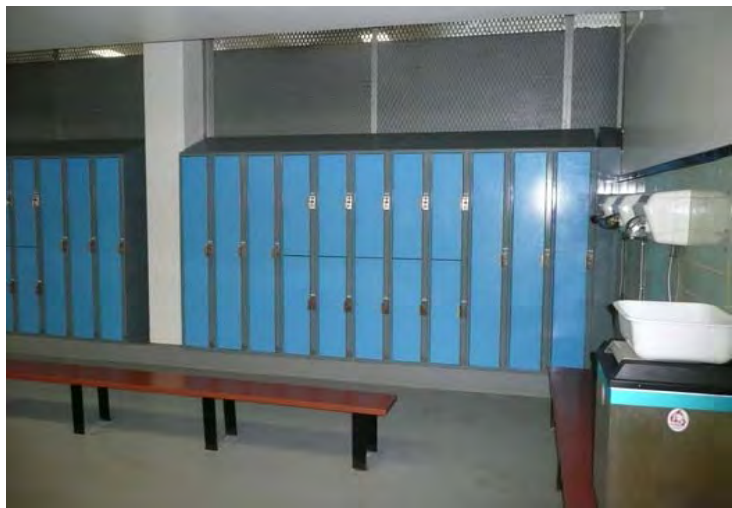
Photo No.	46
Reference	C1030.10
Comment	Lockers in both change rooms are relatively new

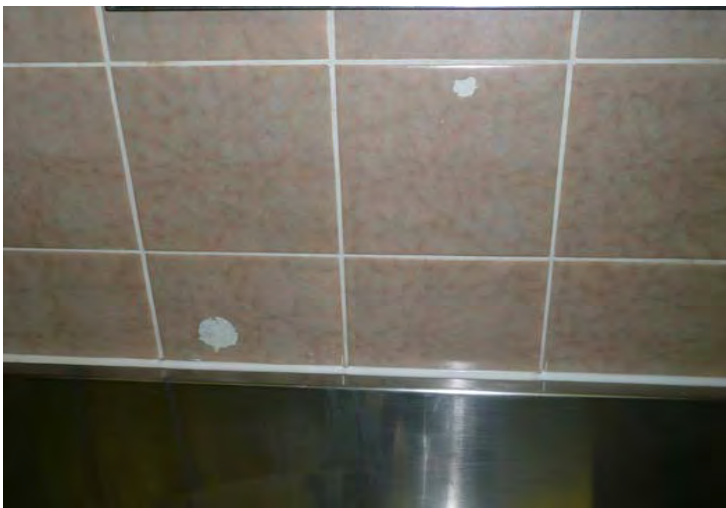
Photo No.	47
Reference	C3010.06-1
Comment	1975 ceramic tile has been patched in areas but generally acceptable

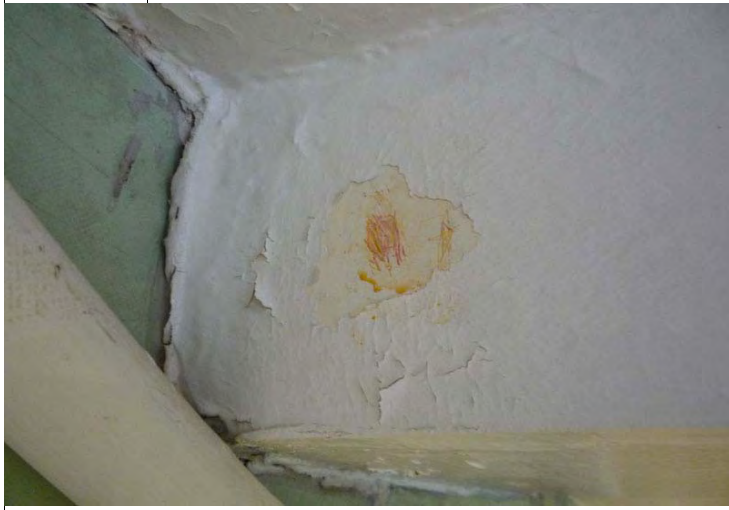
Photo No.	56
Reference	F2020.09-2
Comment	Plaster wall finish used throughout building with layer of white lead-containing paint.

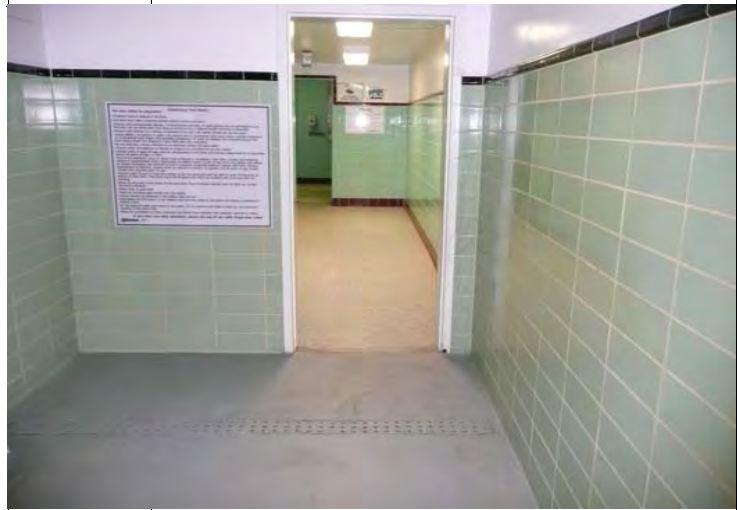
Photo No.	61
Reference	K4020.07
Comment	Floor slab in change rooms is flat and staff must squeeze water to floor grille at end of day. Code requires that floor slope to drain.

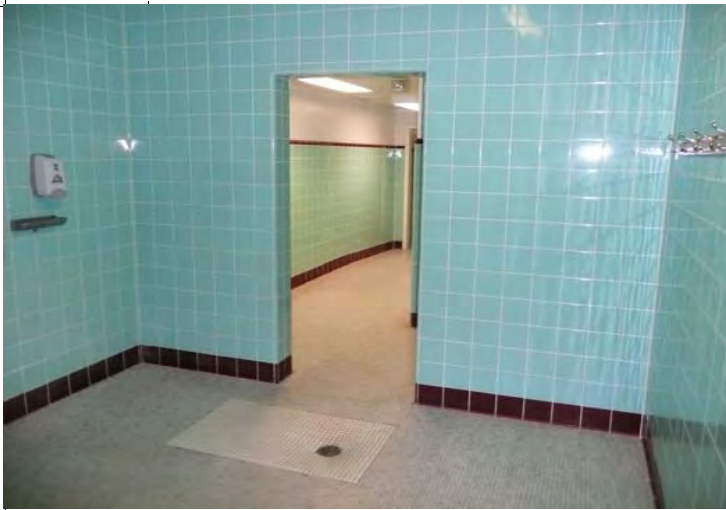
Photo No.	62
Reference	K4020.08
Comment	Single drain in shower rooms does not comply to code as soiled water must flow directly to a drain without others walking through it.

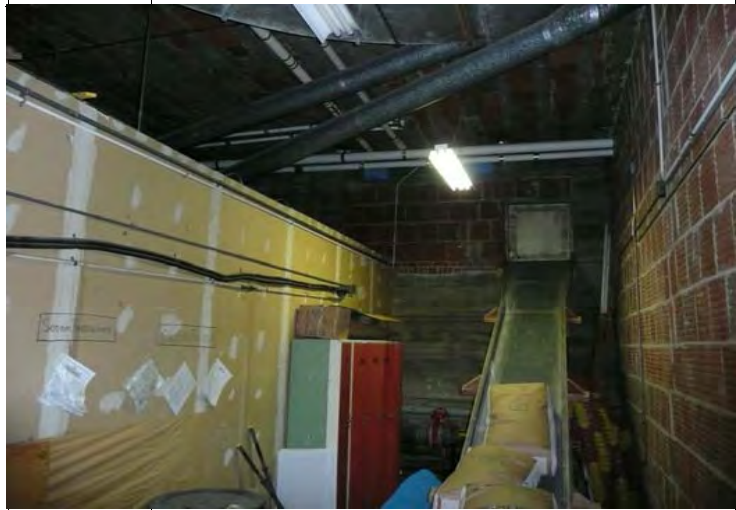
Photo No.	63
Reference	K4020.09
Comment	Chemical storage room required to be enclosed in fire separation. Partition on left is partial hieght and lacks rated ceiling.

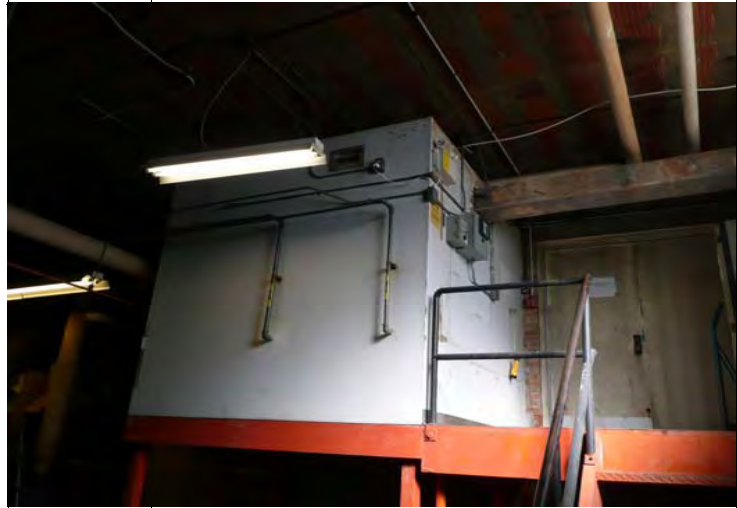
Photo No.	64
Reference	K4020.10-3
Comment	Chlorine Storage room does not have required fire separations.

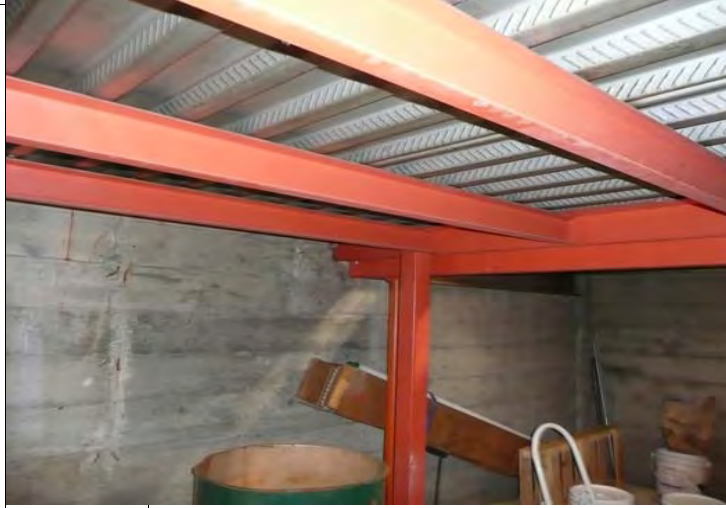
Photo No.	65
Reference	K4020.10-2
Comment	Chlorine Storage room. Unprotected steel below floor slab does not comply to code.

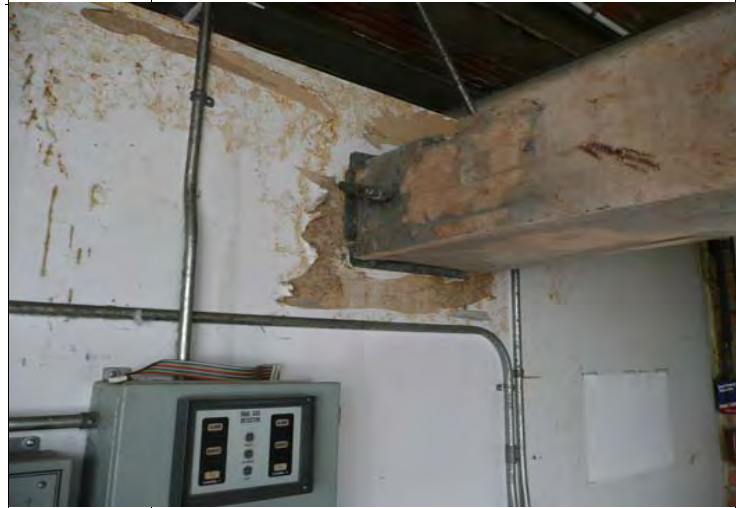
Photo No.	66
Reference	K4020.10-3
Comment	Chlorine Storage room. Duct without fire damper and non-rated ceiling over room.

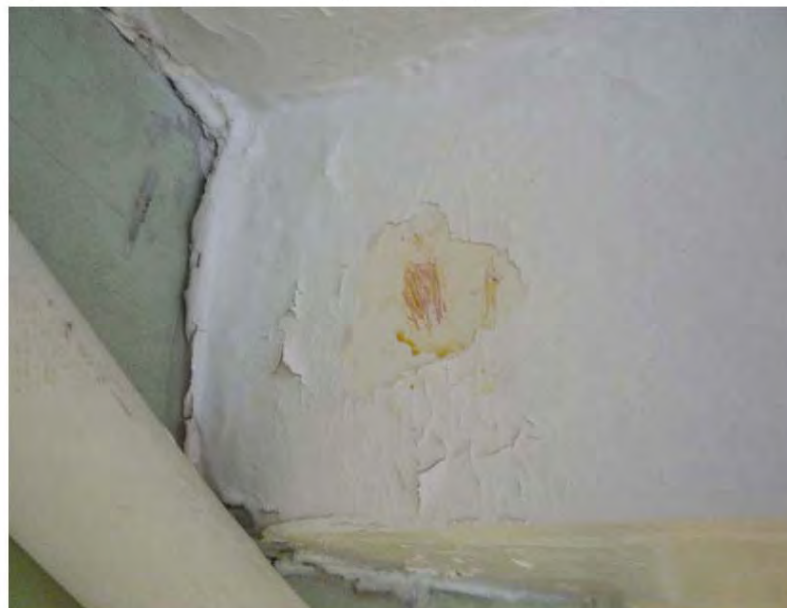
3.1.1 Lead hazards at Strathcona Pool were assessed by both non-destructive and destructive sampling methods. Field screening using Lead Check® swabs indicated that lead paint was not found on the exposed surface layer of paint on any of the structures. While all of the painted structures examined had a minimum of 3 layers of paint, lead paint was only detected on one of these layers. Lead Check® swabs detected lead-containing paint on the metal beam roof supports in the main pool area, on the doorframe to the lifeguard room, on the wall in the ladies change room and on the ceiling of the ramp leading down to the change rooms. Additionally, lead paint was detected on a silver painted cast iron pipe in the storage area under the pool. Lead solder was detected on pipes used in the mechanical room and on the pipes connected to the drinking water fountain on the pool deck.

Figure 6: Lead solder on copper pipes in mechanical room

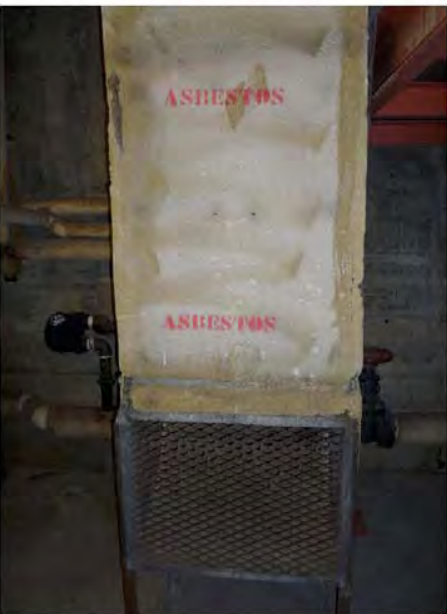
Figure 10: Asbestos insulated pipe elbows and straight-run chases.

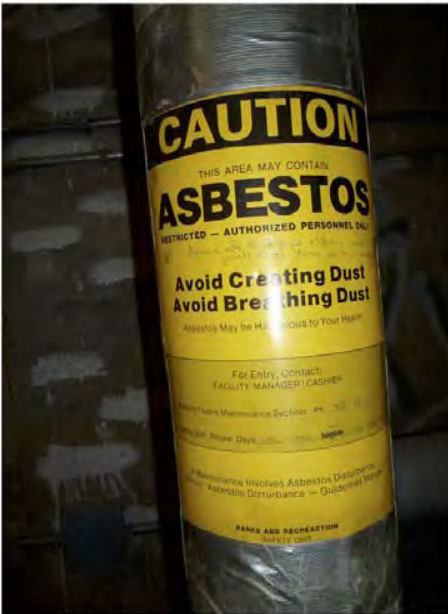
Figure 12: Cinderblocks on roof mechanical room may have asbestos-containing insulation

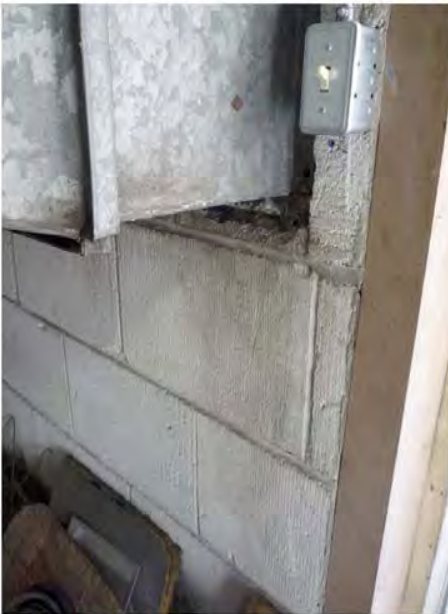
Figure 13: Previous asbestos abatement in roof mechanical room

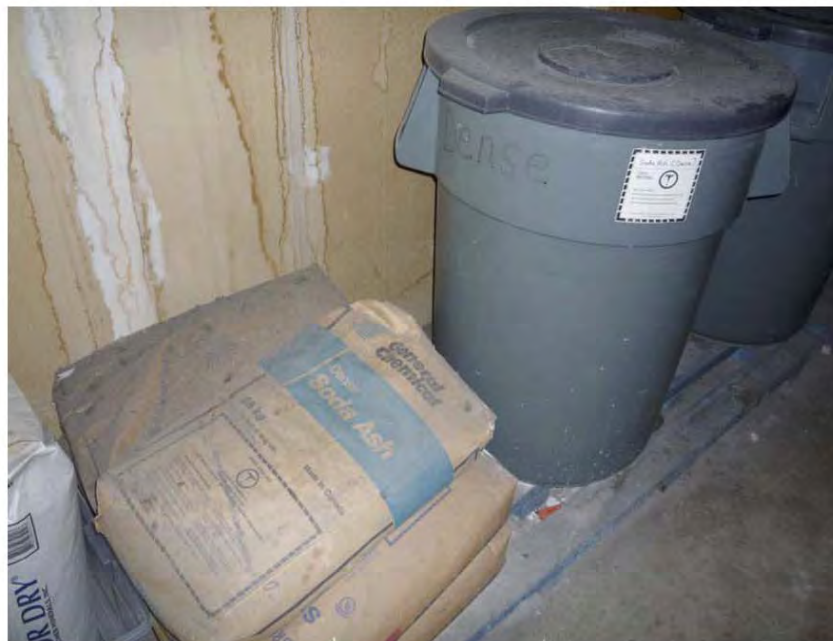
- 3.5 Other Hazardous Materials
- 3.5.1 A variety of chemicals were found in the mechanical rooms. These chemicals include: muriatic acid, Aquaguard 301, Silkleer Filter Aid, Lithium Shock Chlorinating Granules, Dense Soda Ash, calcium chloride, sodium thiosulphate, sodium hydroxide, ALGYSOLVE, diatomaceous earth, and refractory ceramic fiber product. They are stored on pallets and some chemicals were in plastic tubs. Chlorine gas cylinders are stored in a separate ventilated room with access only from the outdoors.

Figure 15: Dense soda ash, calcium chloride, and diatomite absorbent stored on pallets
